# RESTORATION OF PATAN ROYAL PALACE COMPLEX

MUL CHOWK, KOT PATI, STONE GATES

**PHASE I - FINAL REPORT**

KATHMANDU VALLEY PRESERVATION TRUST

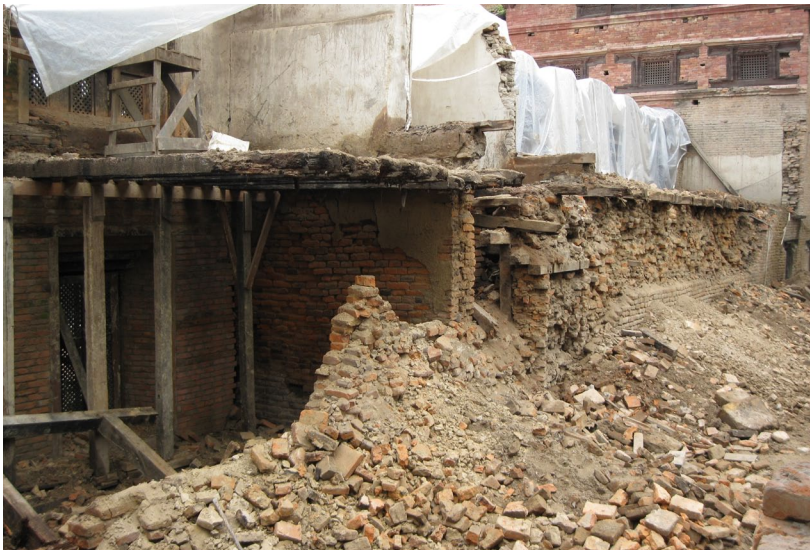
October 2010: The completely dismantled east wing, showing the severely damaged timber joists. None of the structural timber components could be reused for the restoration.

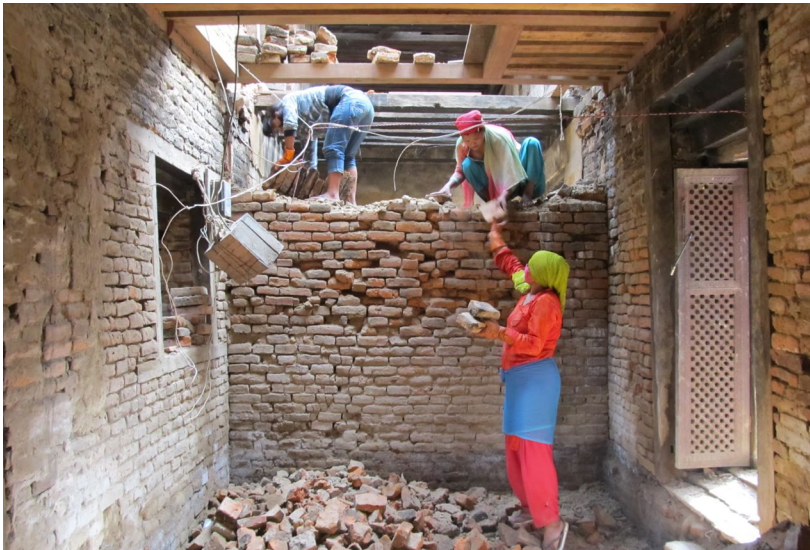
August 2011: Dismantling the dilapidated partition wall on the west wing.

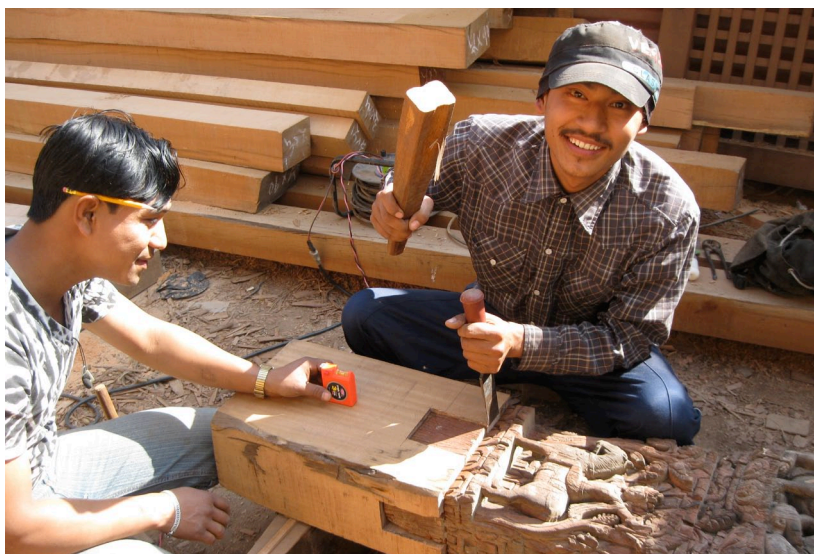
October 2011: Grafting on an extension to a damaged roof strut, employing a cross-joint.

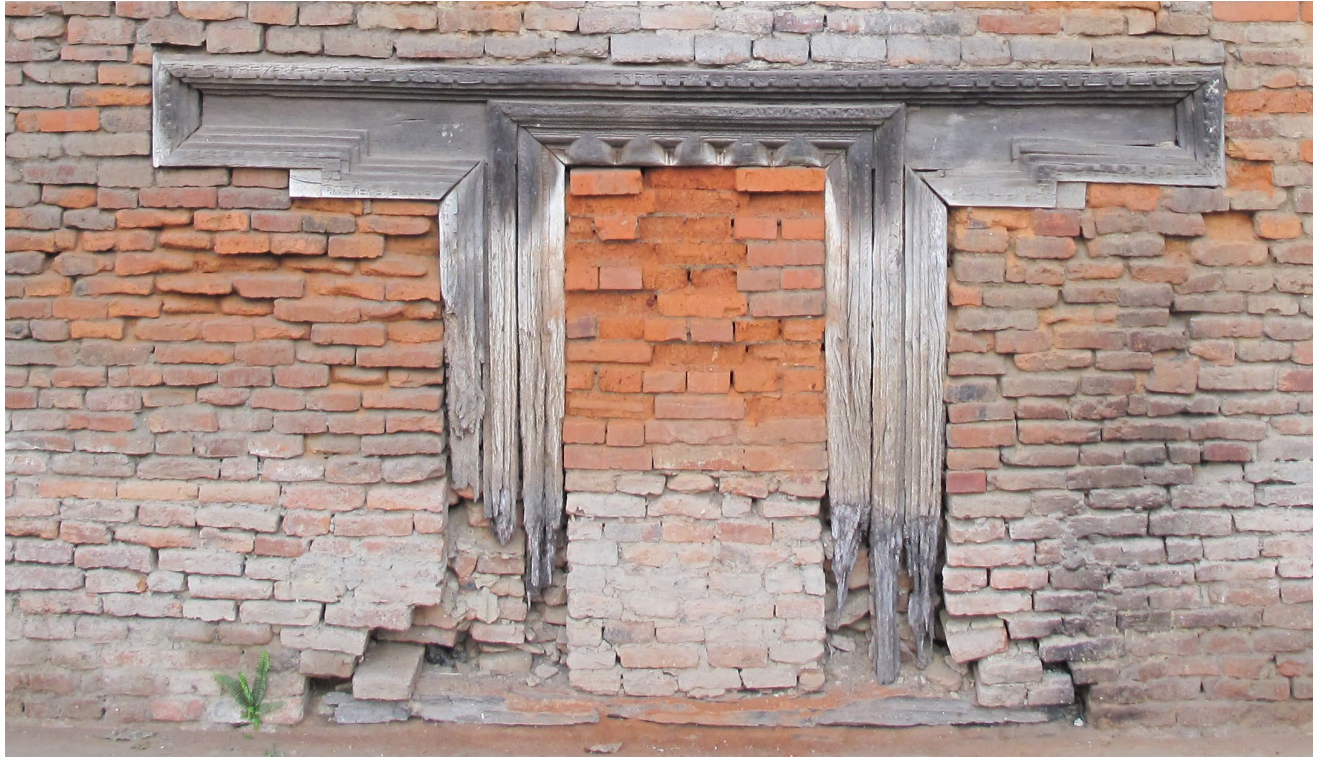
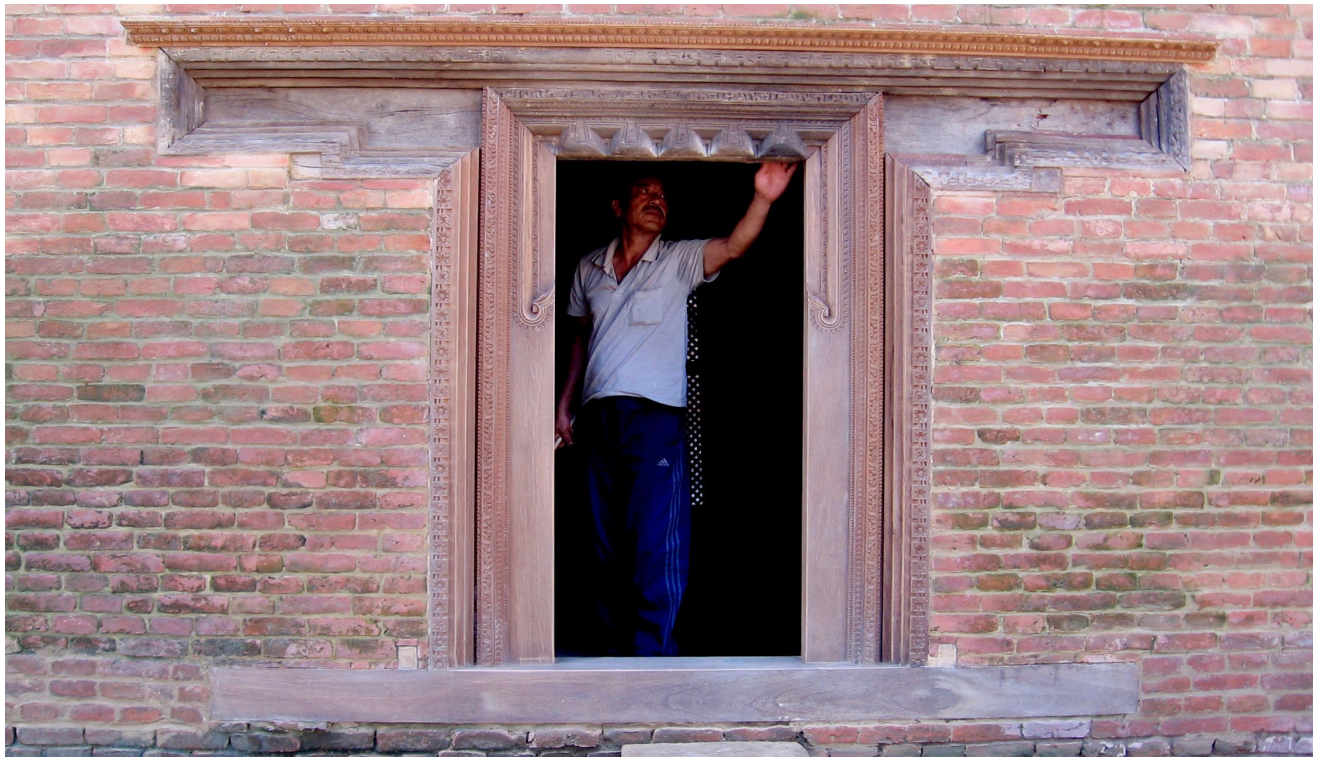
February 2007, October 2010: An existing east wing door-frame that had fallen into disrepair was repaired, reusing as much of the historical timber elements as possible. The doorway is shown here before and during restoration period.

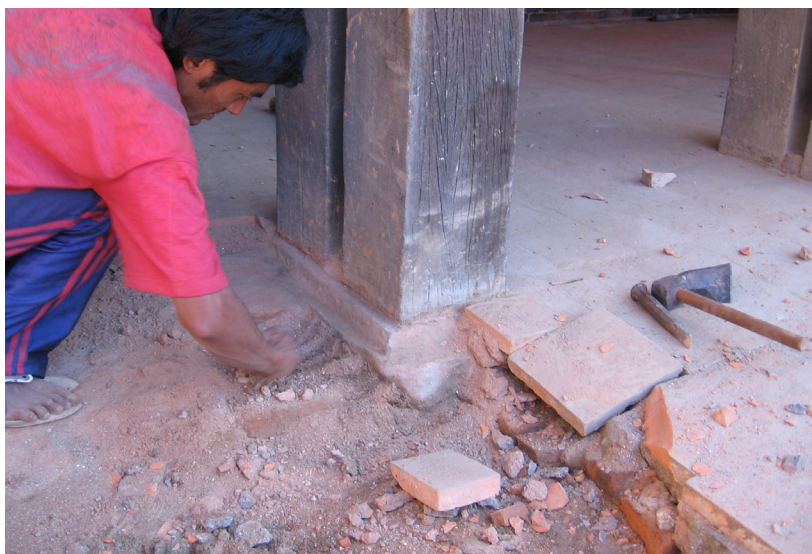
December 2012: Removing the old plinth pavement that covered the stone bases of the pillars.

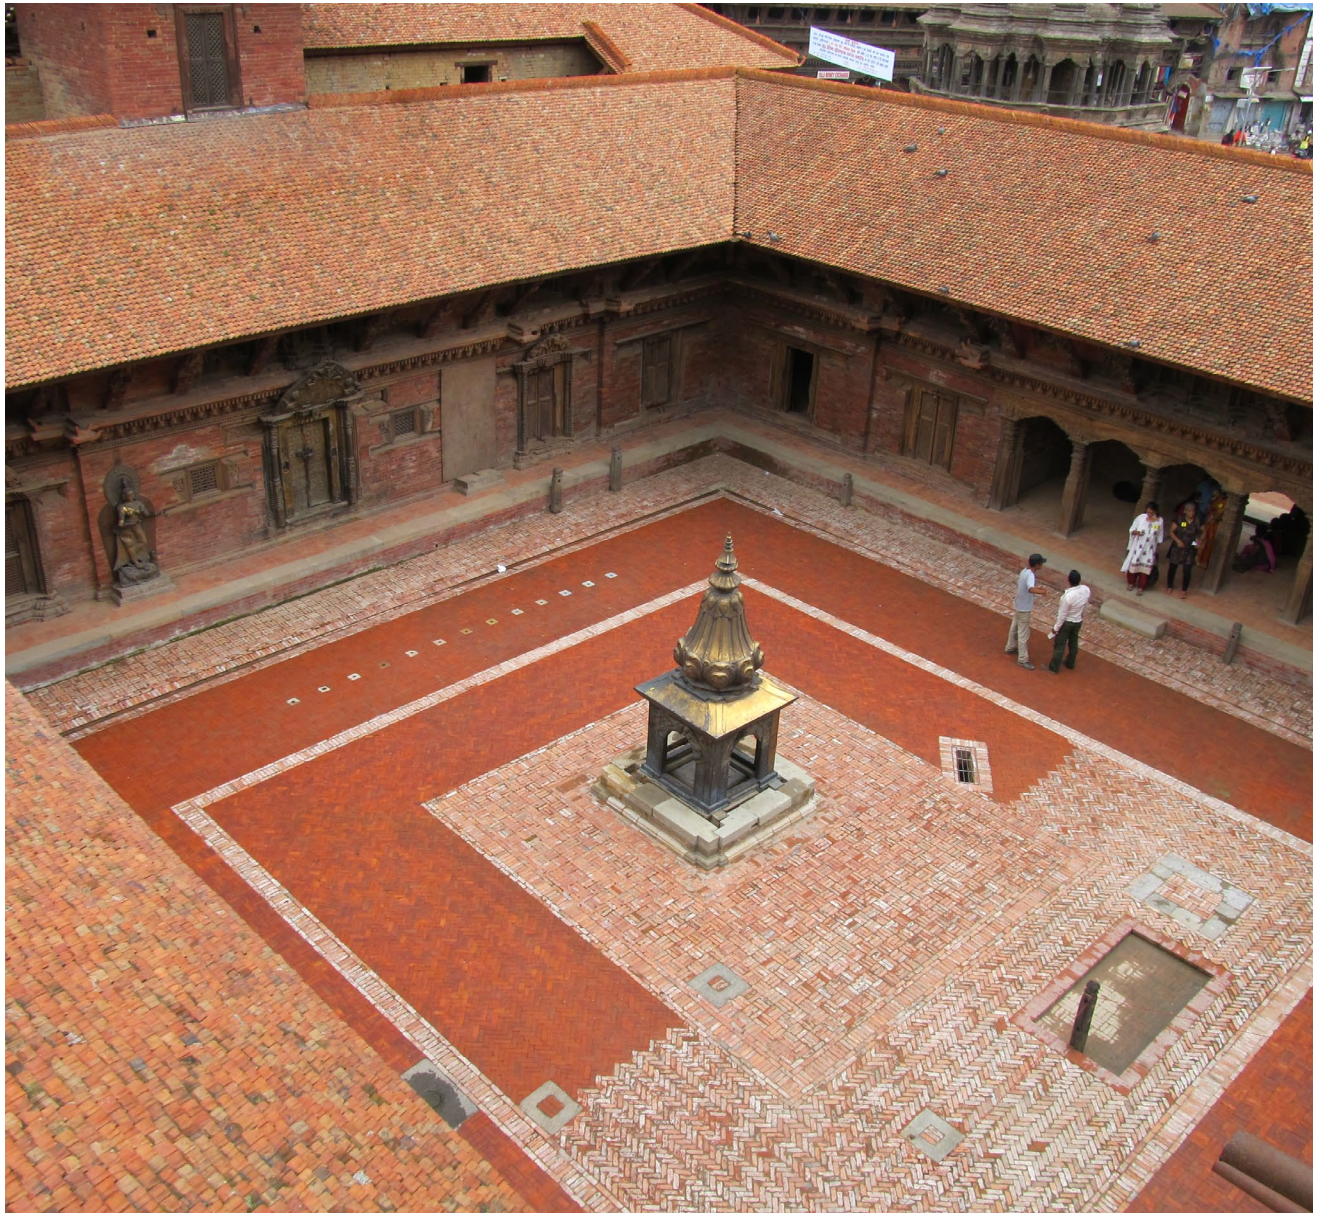
June 2012: Courtyard shortly after complete restoration. The redder bricks are newly made custom bricks and the rest are existing historical bricks that were reused.

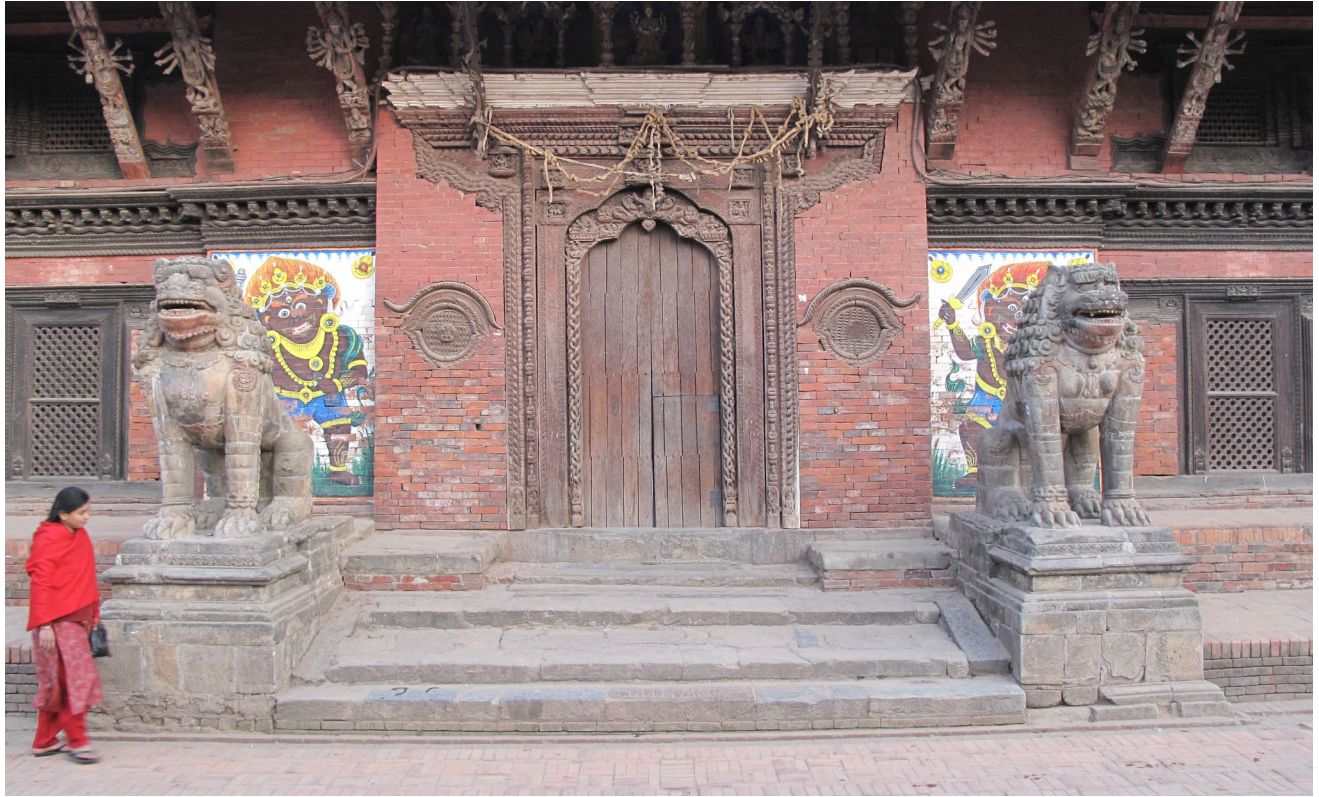
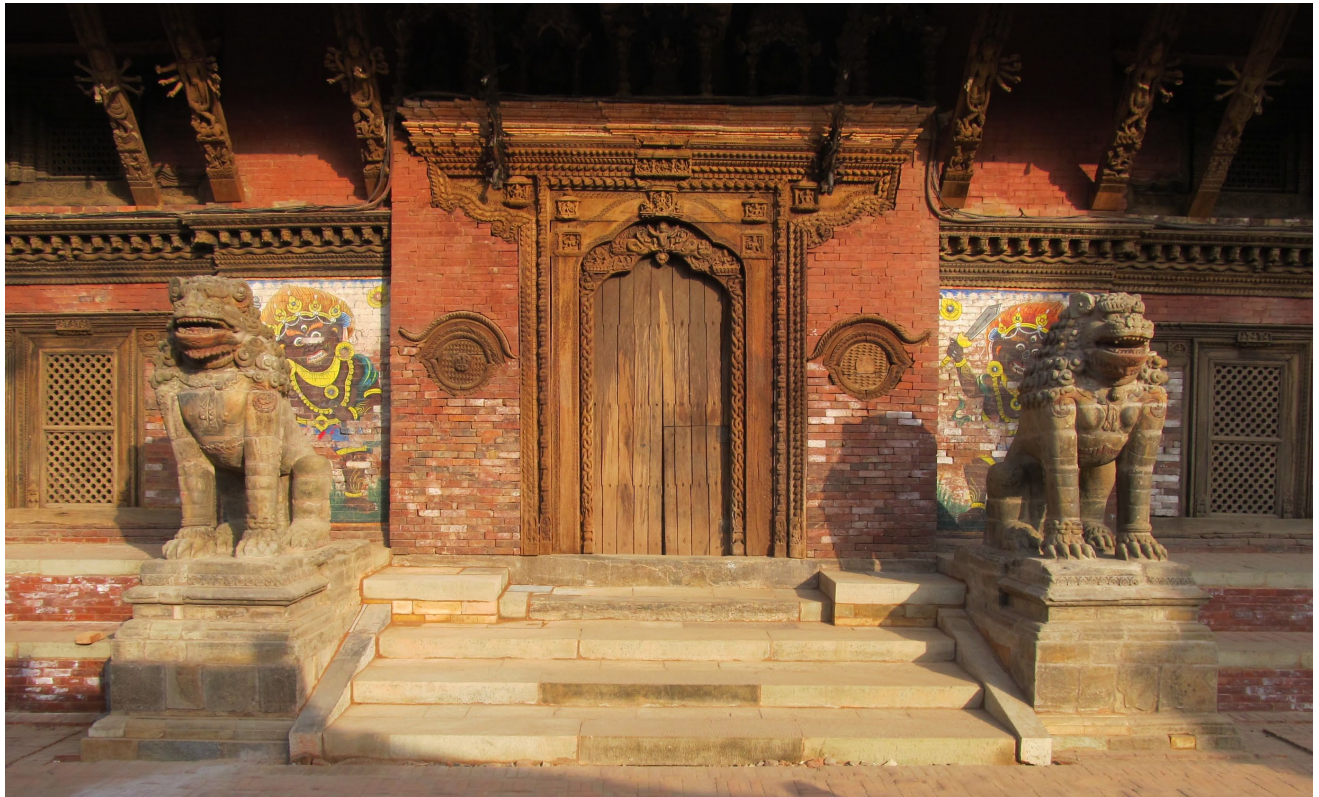
January 2011, March 2012: Mul Chowk gate before and after restoration.

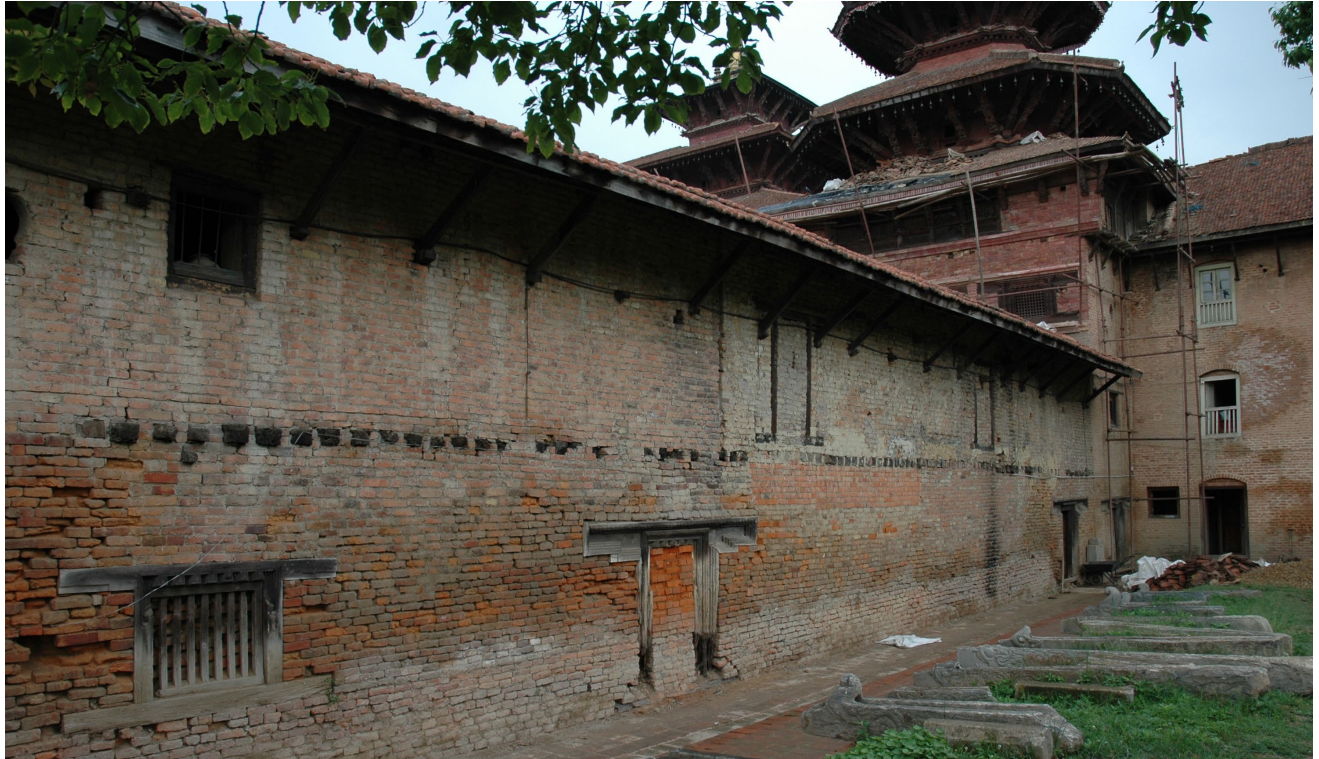
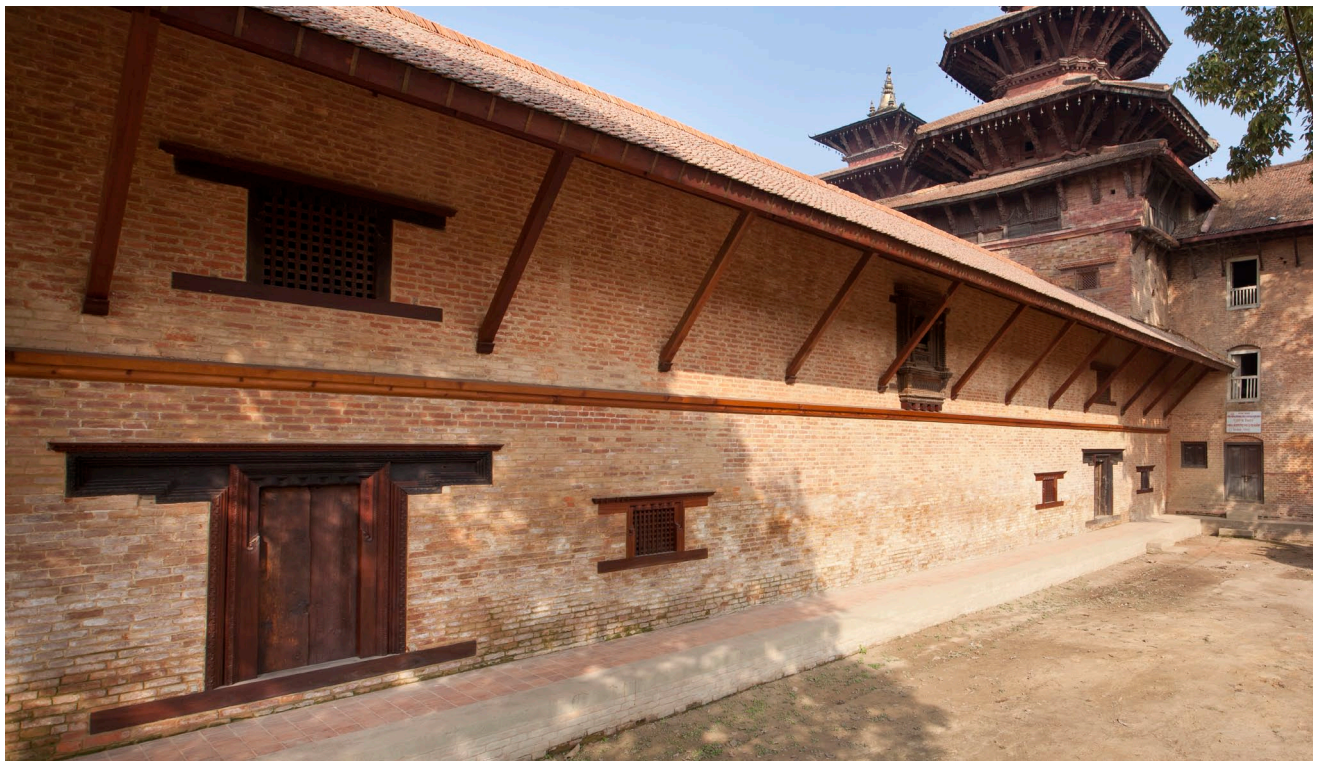
May 2006, December 2011: The east façade of the east wing of Mul Chowk before and after restoration.

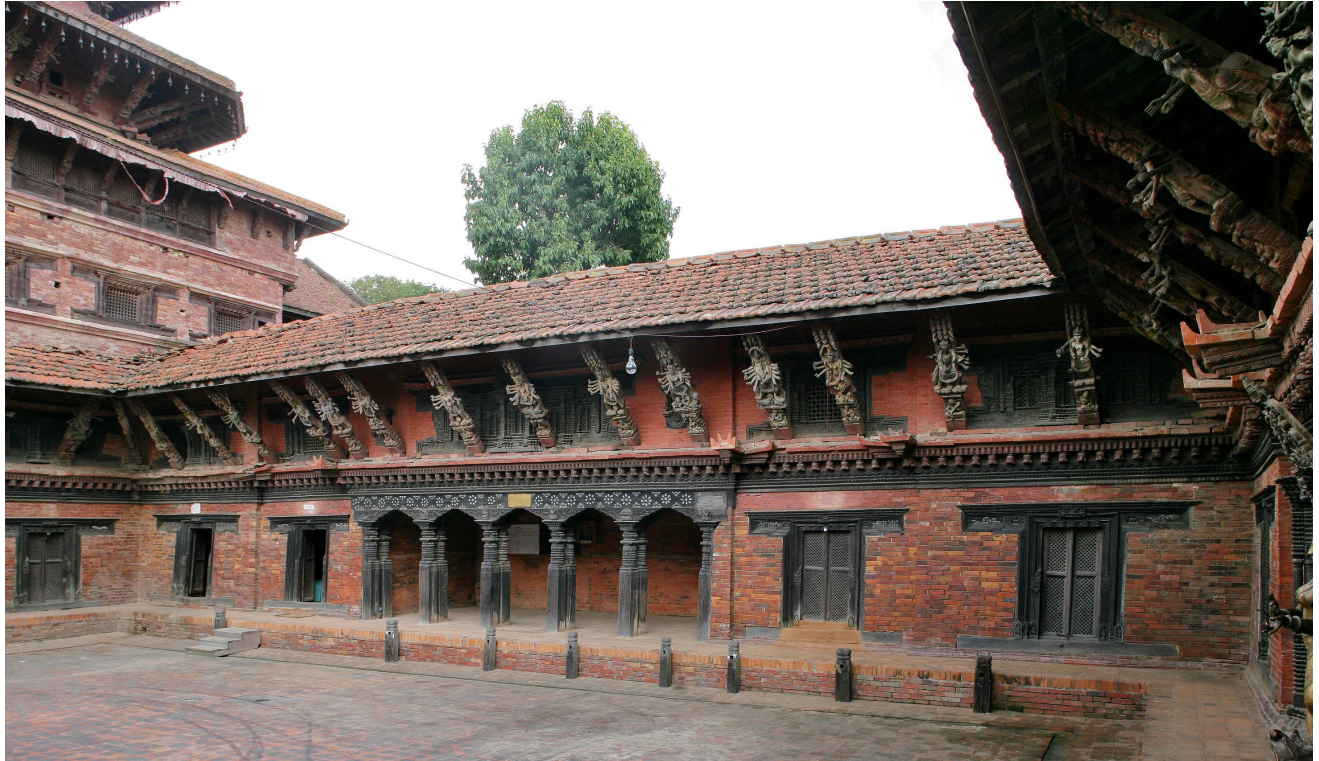
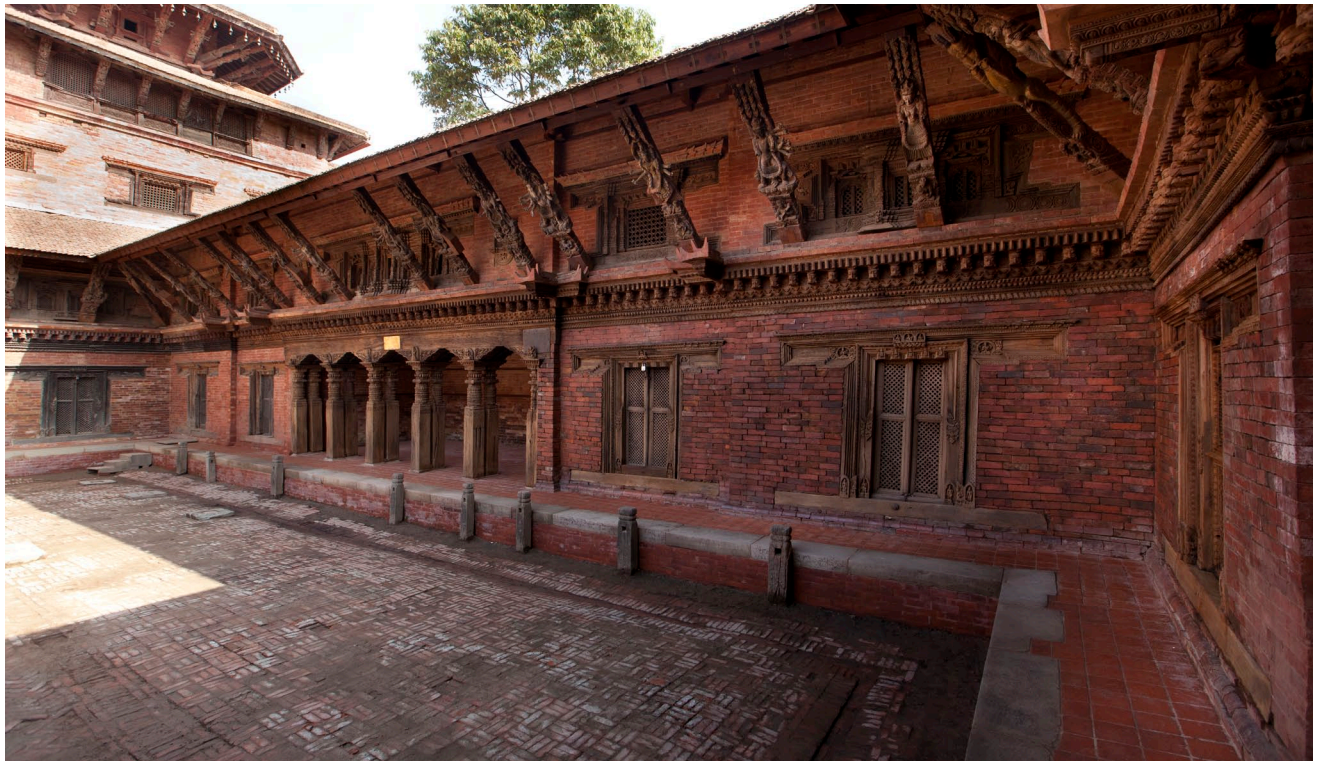
October 2006, December 2012: The courtyard façade of the east wing of Mul Chowk before and after restoration.

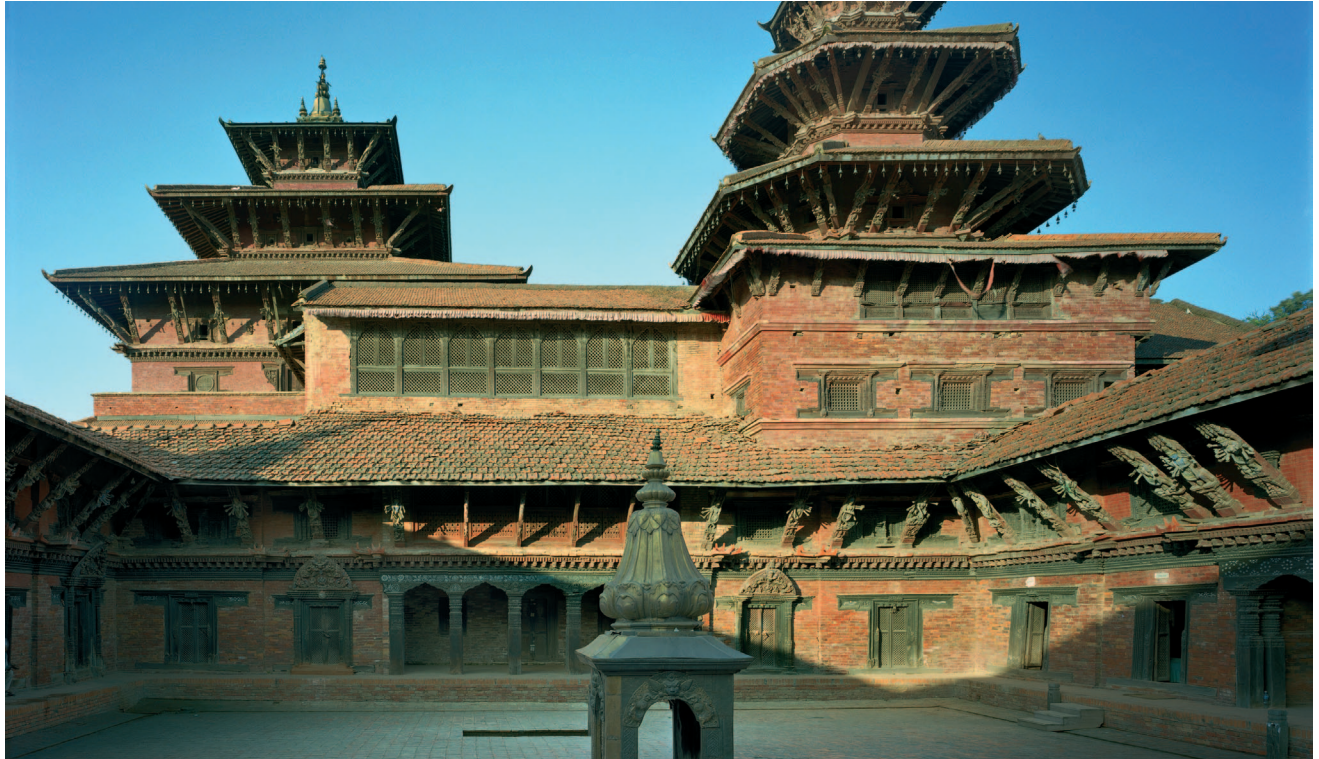
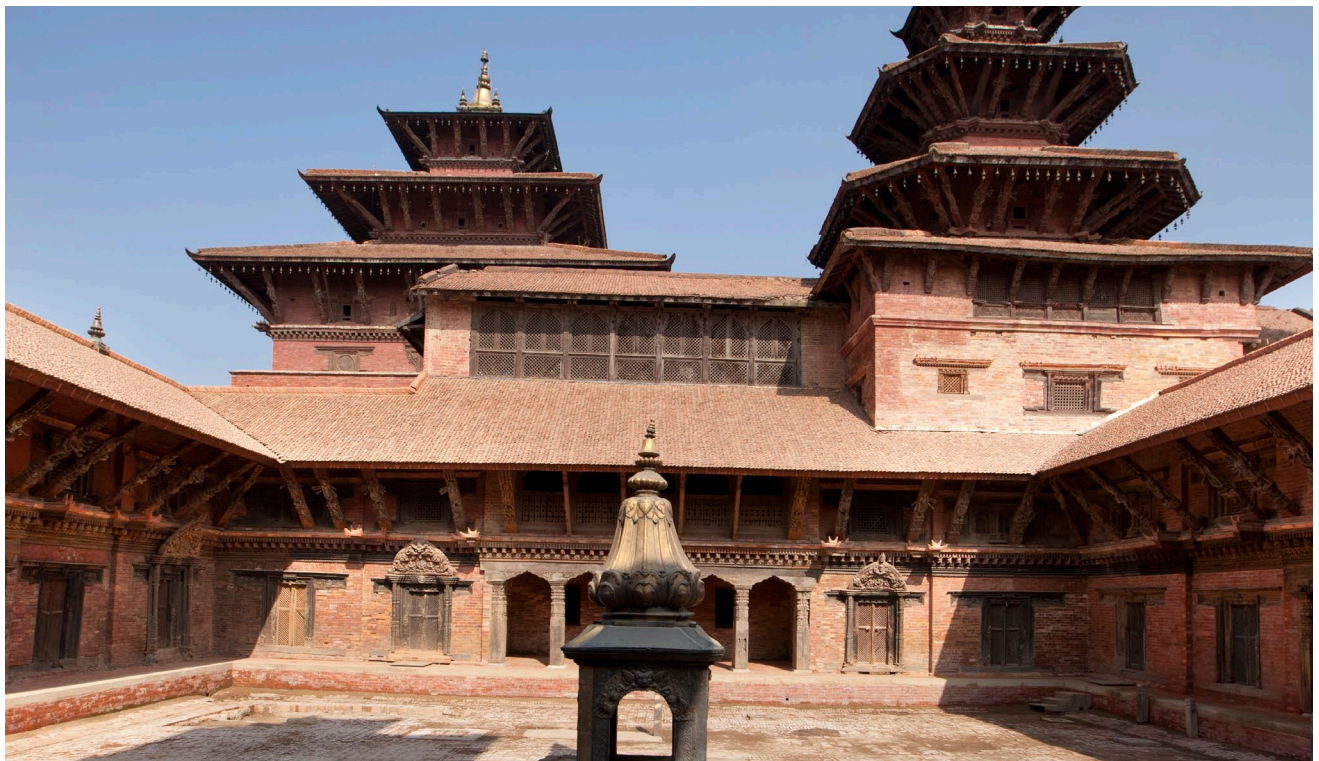
October 2006, December 2012: The courtyard façade of the east wing of Mul Chowk before and after restoration. Taleju Temple, at right, was structurally reinforced.

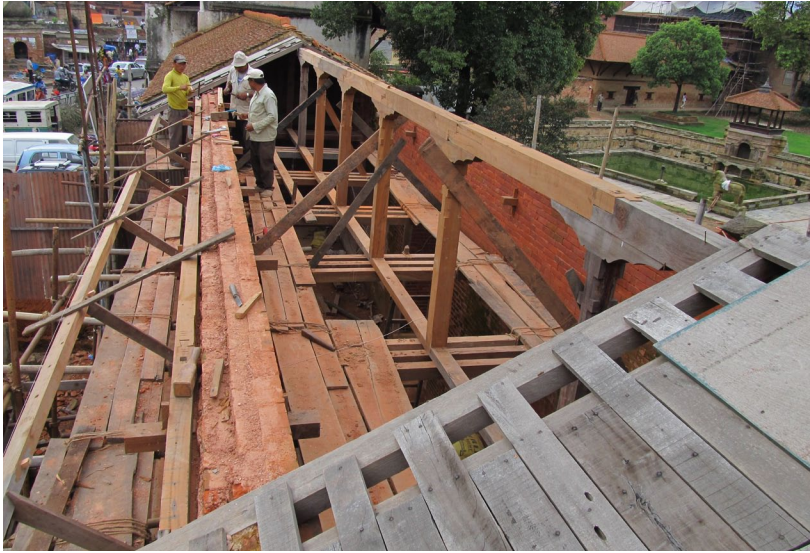
August 2012: Reconstruction of the Pati's roof structure after dismantling the existing, damaged timber elements.

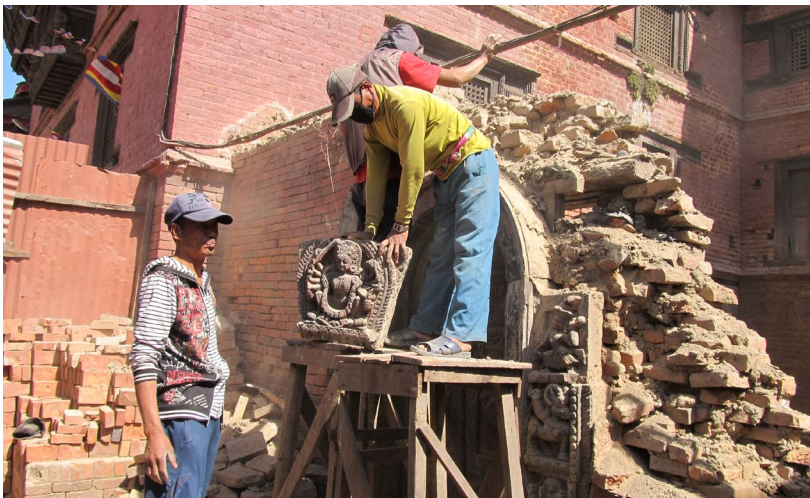
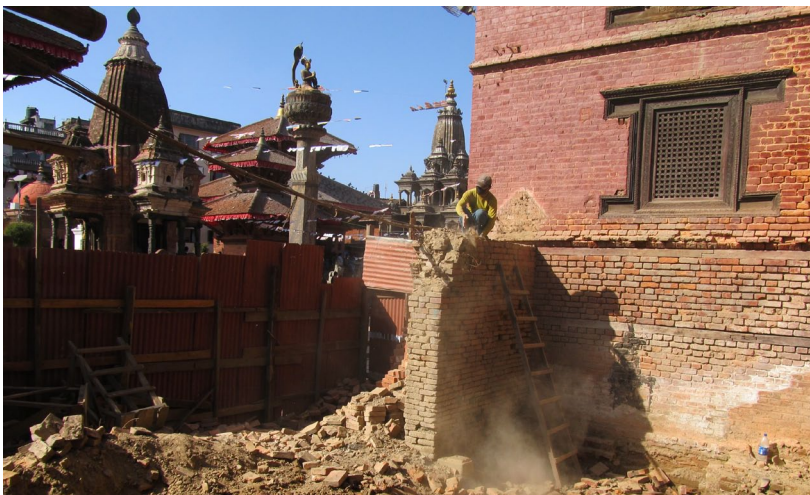
February 2012: The badly damaged courtyard wall surrounding the south Stone Gate was demolished

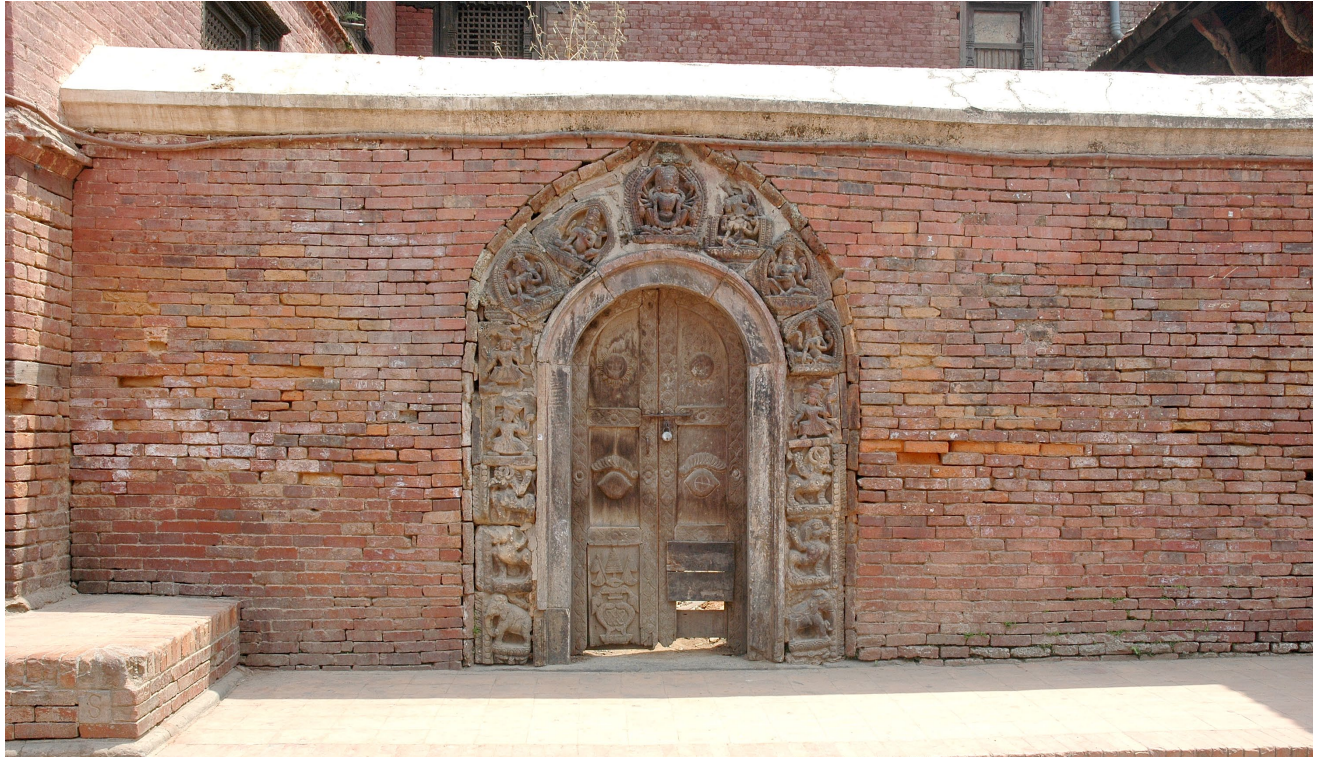
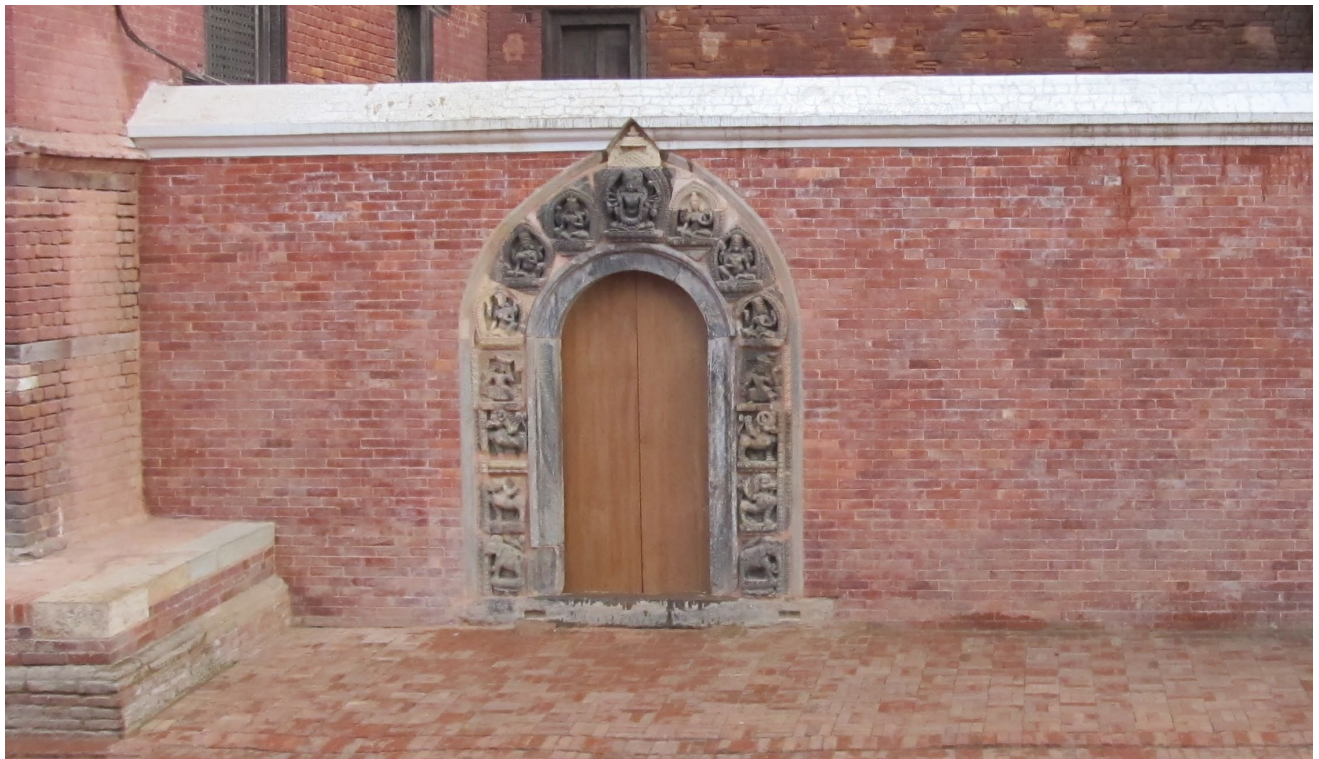
April 2008, November 2012: South stone gate before and after restoration. The inner courtyard will be part of the future Architecture Galleries at Mul Chowk.

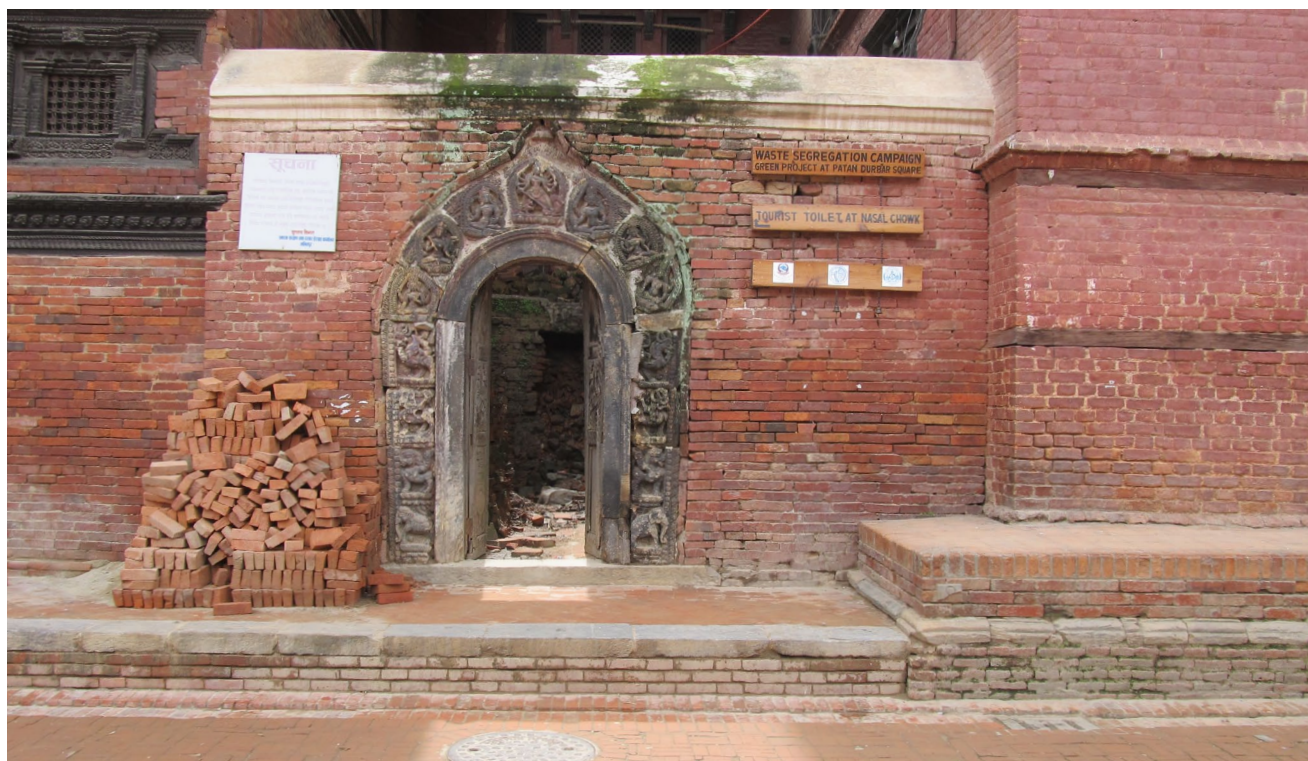
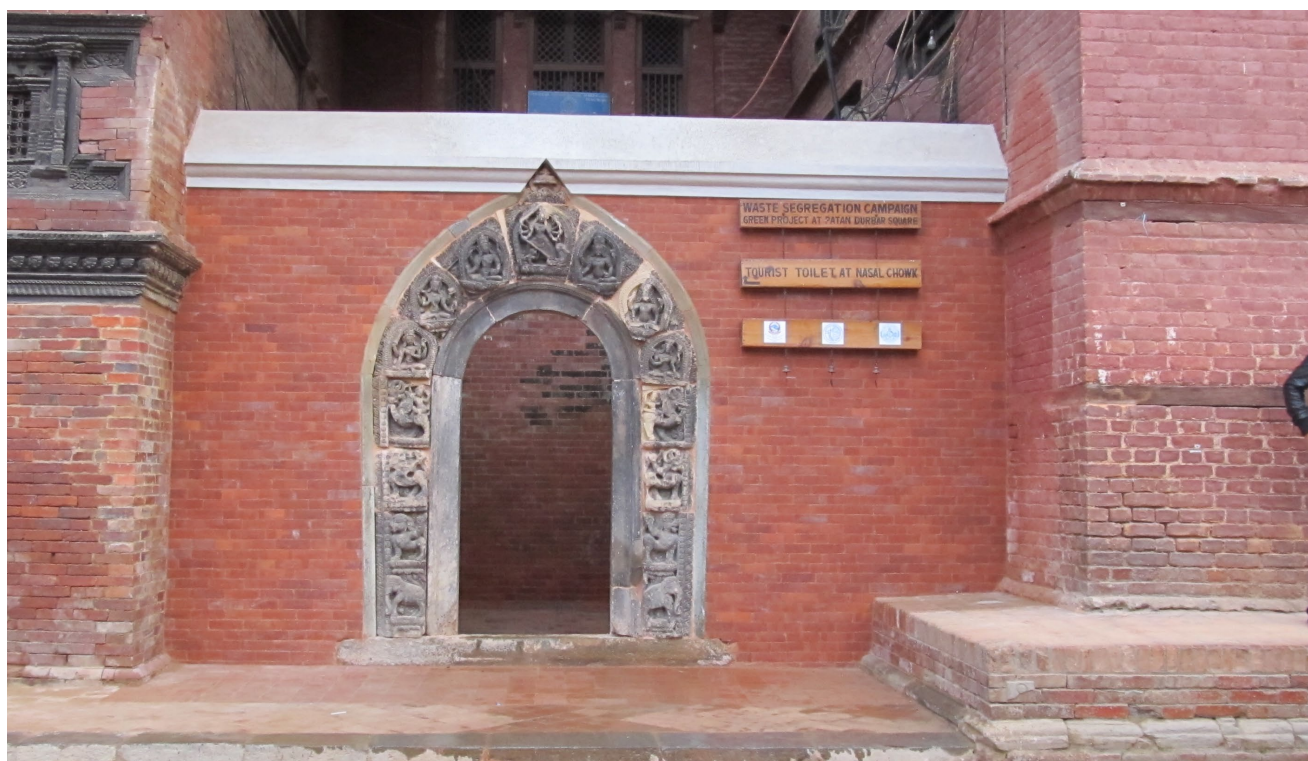
July 2012, November 2012: North stone gate before and after restoration.
