**PATUKVA AGACHE**  
**PATUKVA TOL, PATAN**

**HISTORIC STRUCTURE REPORT**  
**JUNE, 1994**

**ERICH G. THEOPHILE**  
**ROHIT K. RANJITKAR**  
**KATHMANDU VALLEY PRESERVATION TRUST**  
**IN COLLABORATION WITH**  
**HIS MAJESTY'S GOVERNMENT**  
**DEPARTMENT OF ARCHAEOLOGY**

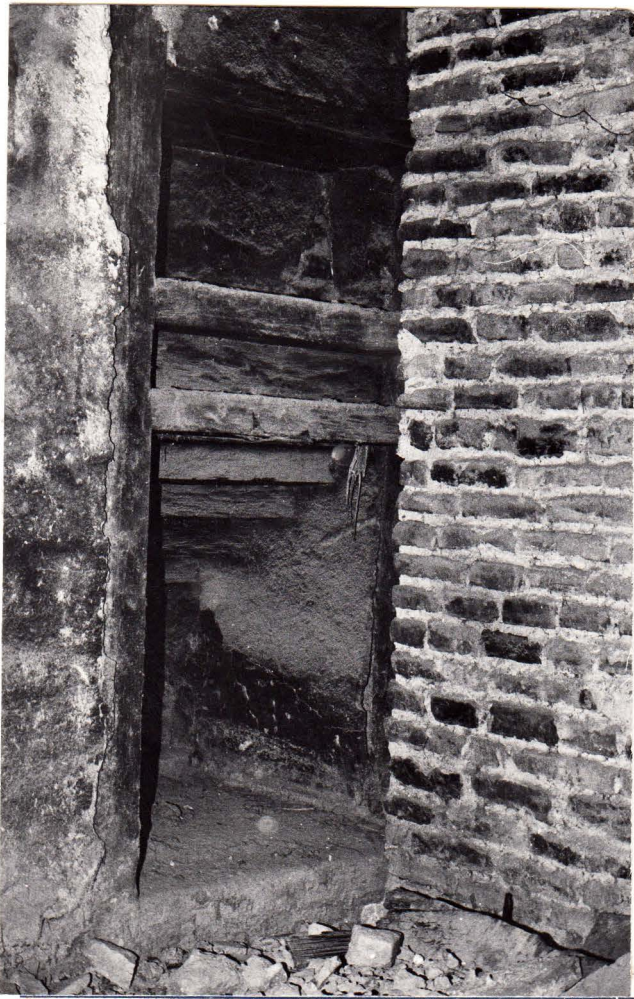
**Above left: Partition on first floor (14" thick) wall was added in 1954 and partially blocks the window.**

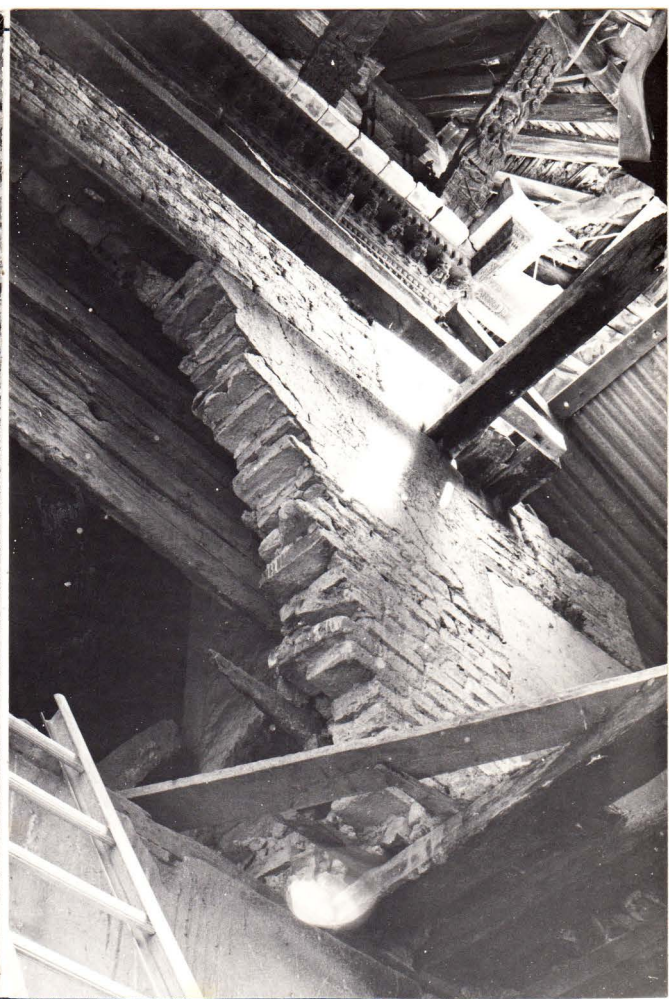
**Above right: The masonry wall added in 1954 which led to collapse of joists below and roof above. Seen from below, summer 1993.**

The most significant failure of the structure consists of the buckling out and collapse of a later added masonry wall directly behind the 2nd floor shrine. This 9" thick wall appears to have been added as a security precaution for the shrine (otherwise closed only by timber planking at this level). Because of insufficient support by the historical floor joists, this wall led to the collapse not only of the joists it sat on, but also of the rafters above and portions of the original middle masonry wall.

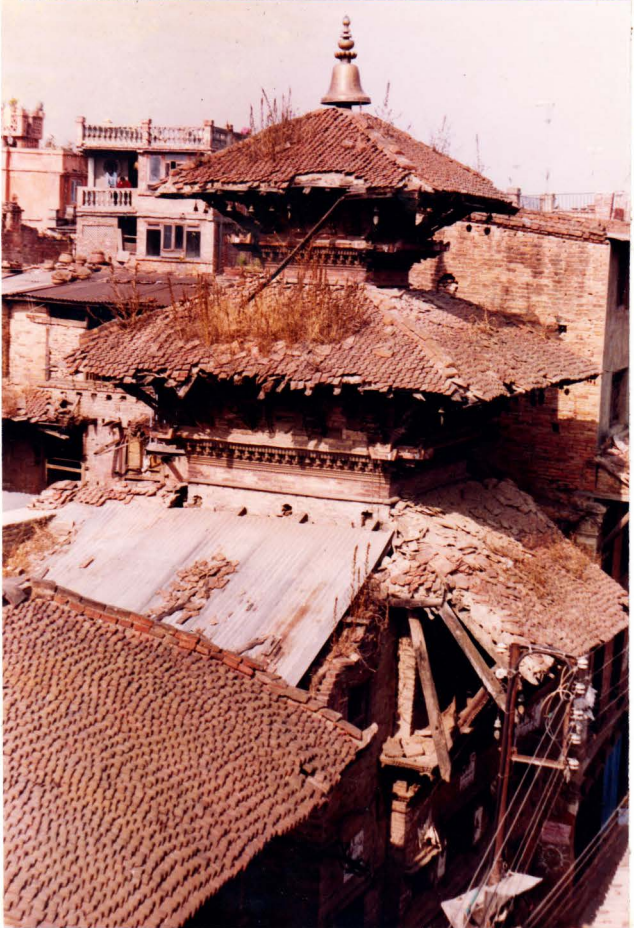
**Below: Zinc sheet on lower roof south, installed 1977.**

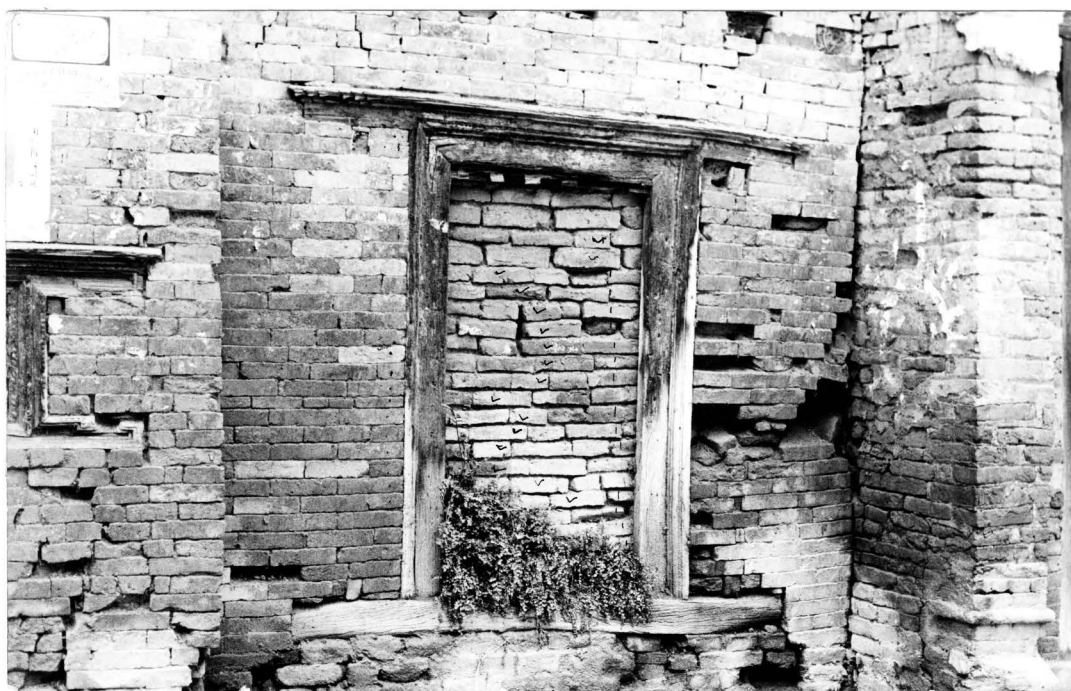
**Above : Right (northern) door of principal facade: adjacent area with missing bricks.**

been pulled out leaving several gaps, notably one to the right of the northern door 2'2" wide by 4 courses high. The spalling is a result of the lack of damp proof course.

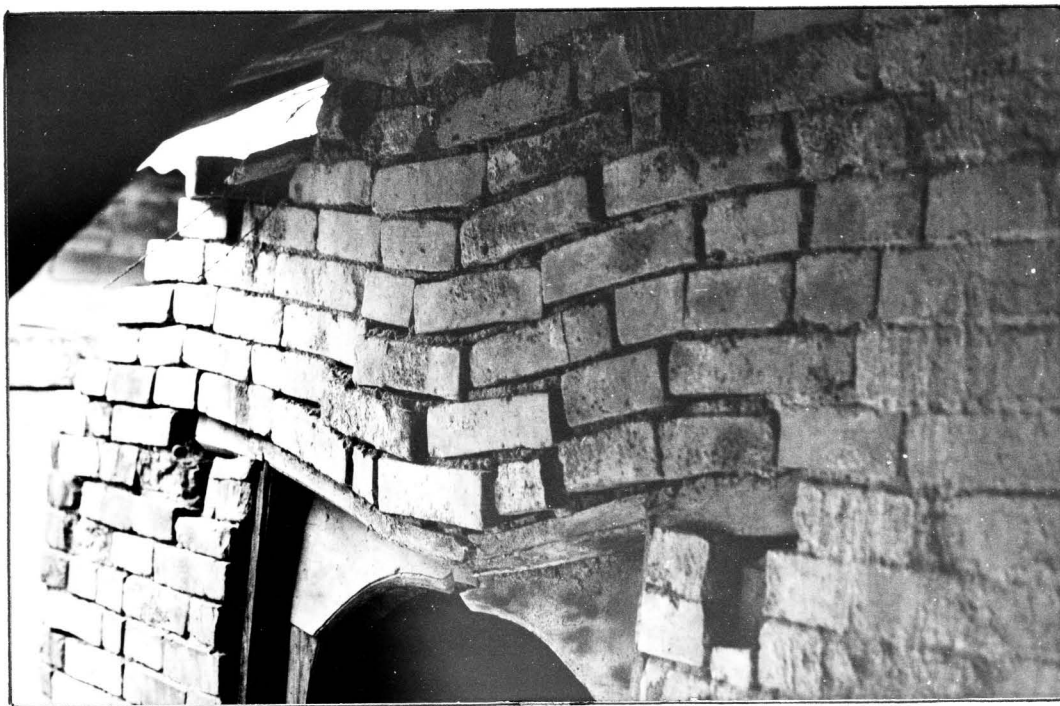
Above the second floor southern window of the principal facade, a failed timber lintel has resulted in the deflection of several masonry courses above. This failure has been caused by water damage allowed by the poor roof condition.

**Above : Settlement of brick work above the second floor window resulting from roof damage and water penetration. August 1993.**

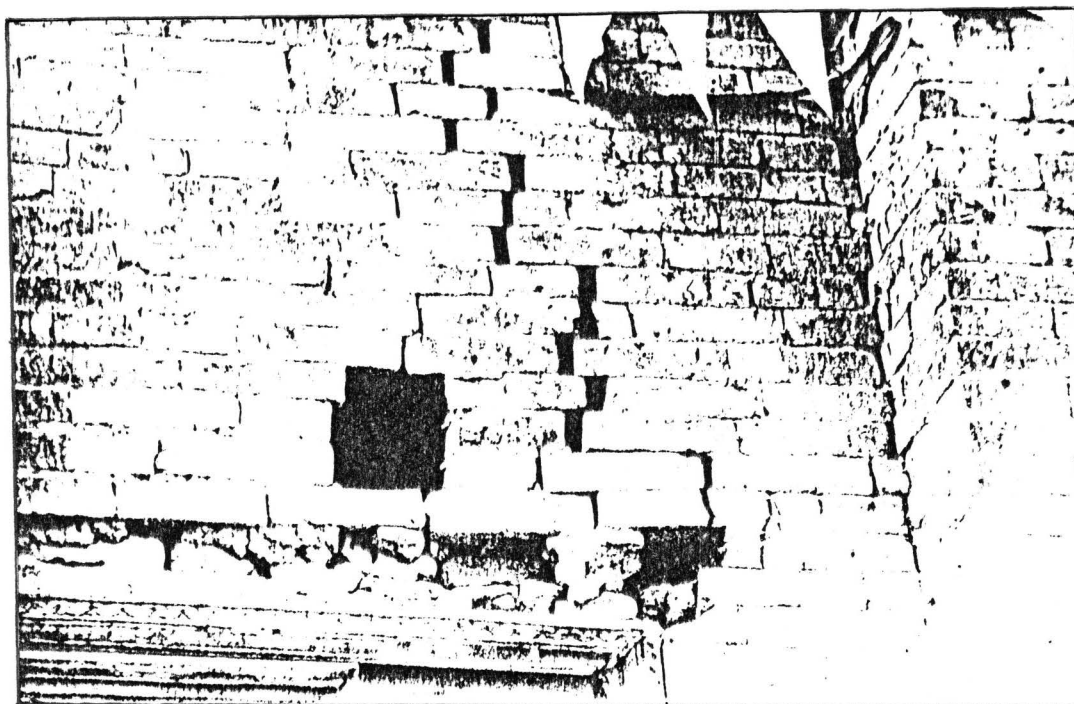
On the principal facade (south side, above first floor window) is found a structural crack 16 courses tall spreading two feet to the south with maximum gaps of 2-1/4" both inside and out. This crack again appears to result from water damage from the lost roof above, exacerbated by poor bonding at this the intersection of the old principal facade and 14 year old south wall.

**Below : Wall crack above the first floor lattice window, south side principal facade. August 1993.**

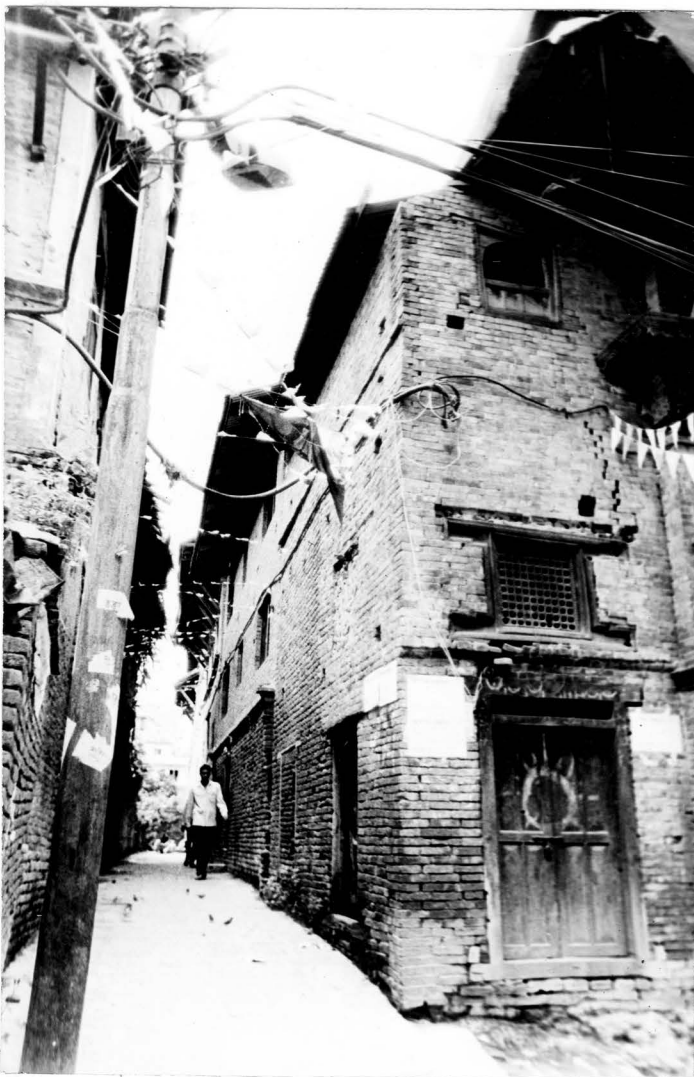
Southeast corner: notice later patch at corner at plinth level. August, 1993.

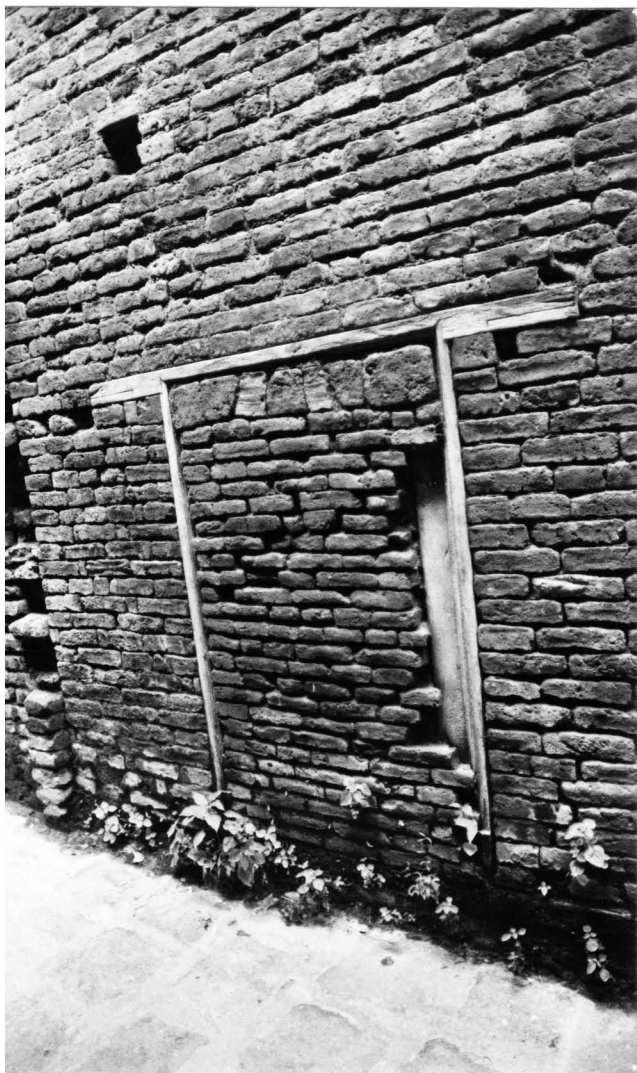
**Left : Wall opening on South facade blocked by brick wall in 1977 repair.**

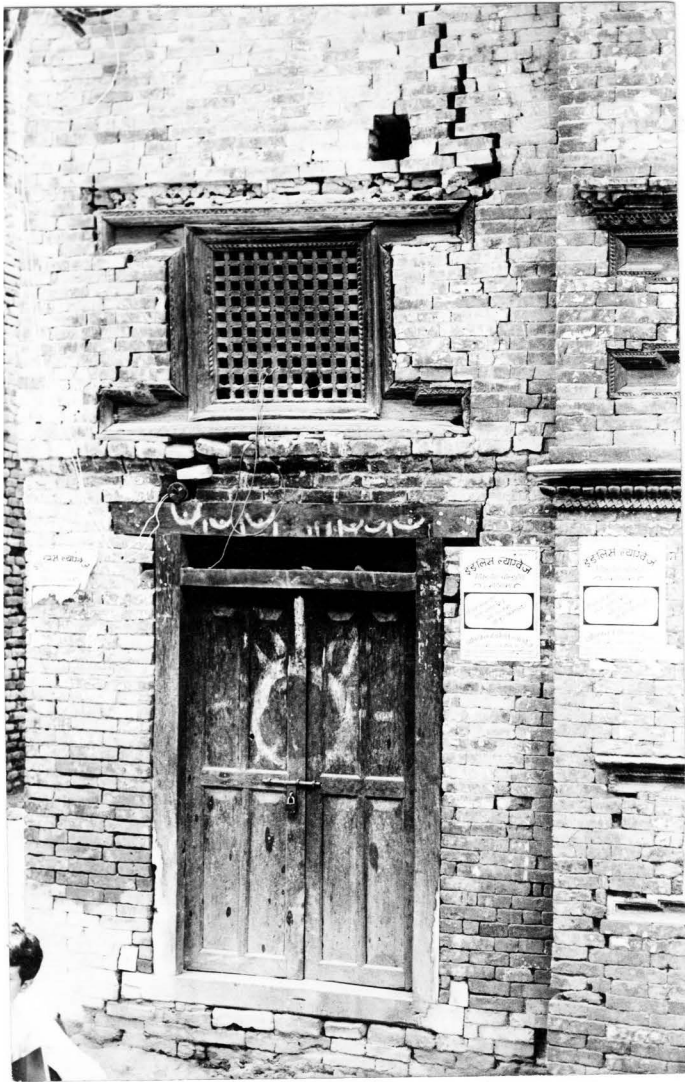
**Above : New opening front facade left, from 1977 repairs.**

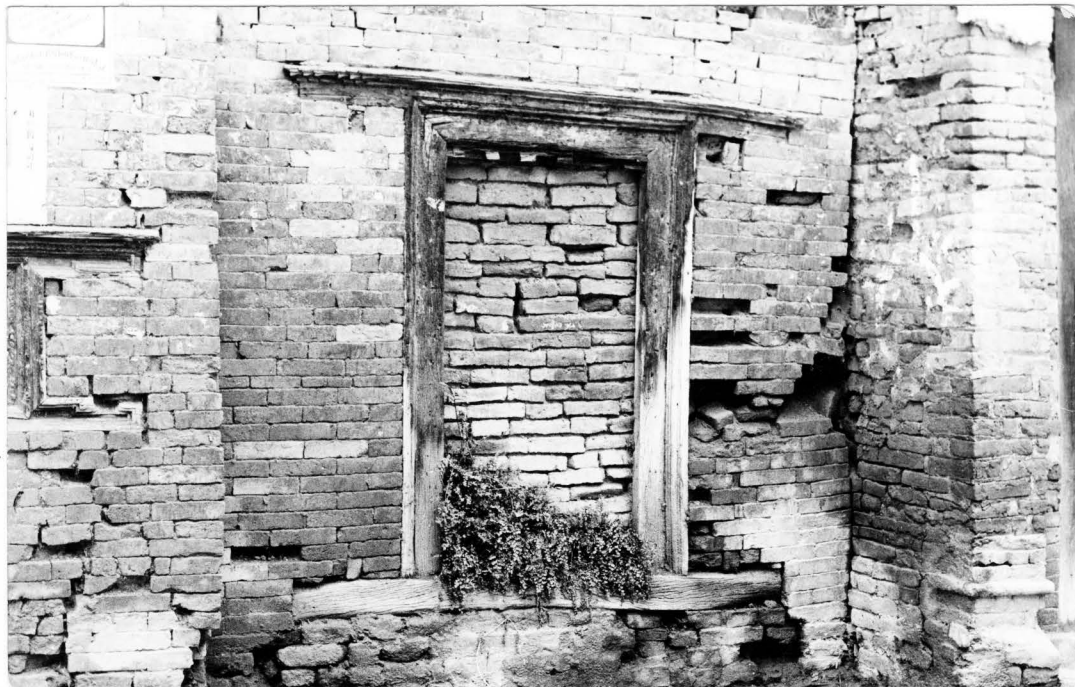
**Below : Historical door, principal facade north, blocked by brick in 1977 repairs.**

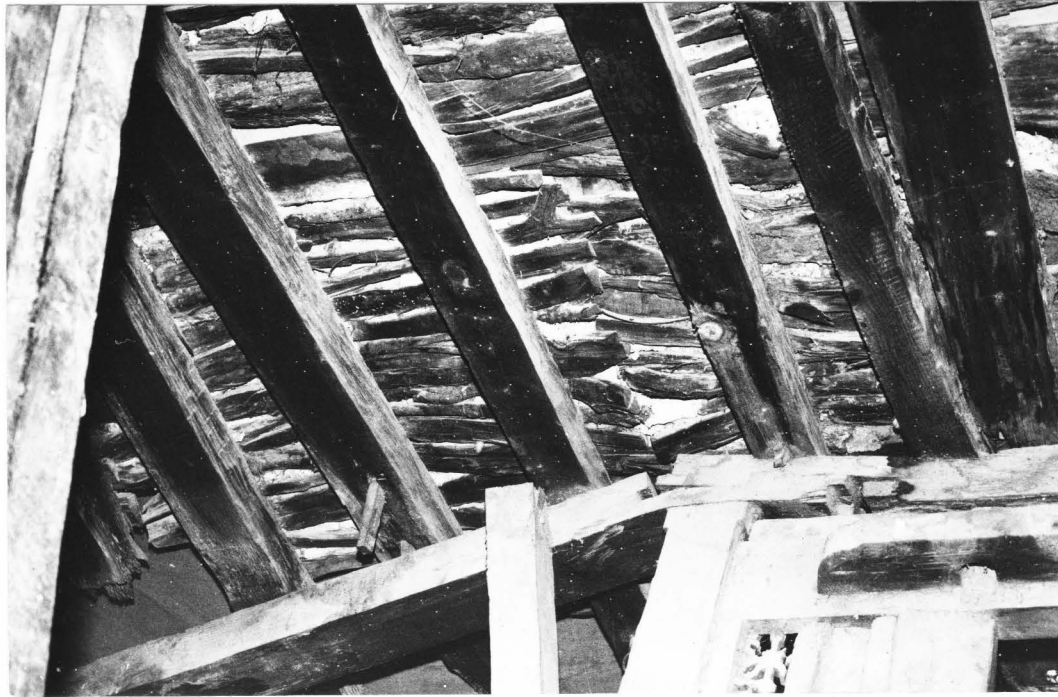
**Timber lath above pine rafters has transmitted dampness from mud to rafter. Principal facade, August 1993.**

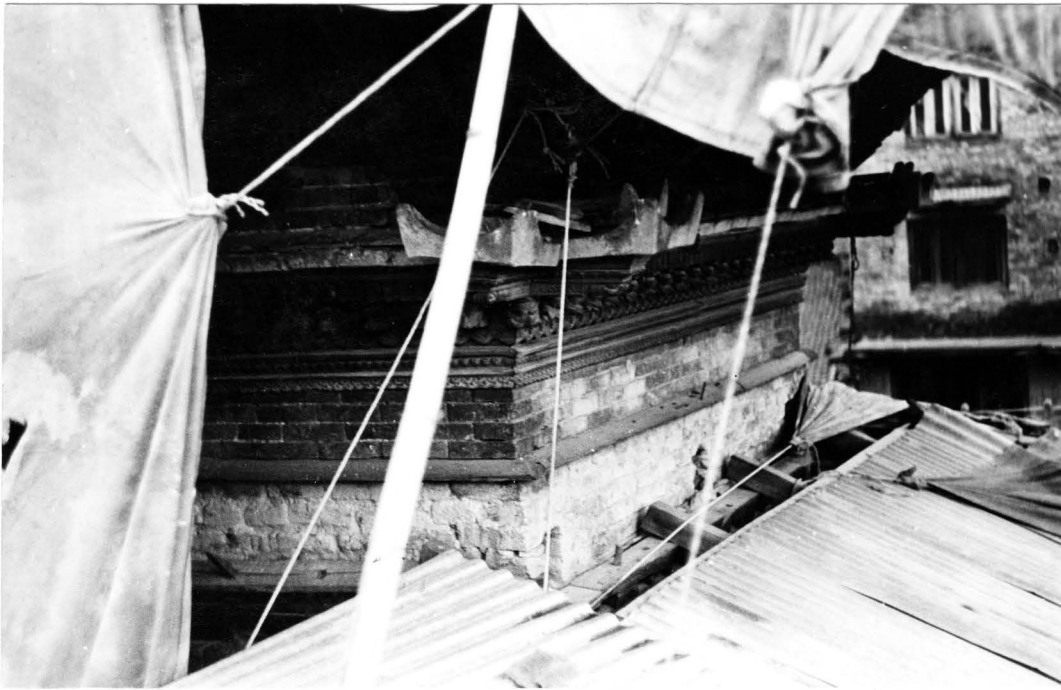
Above: Zinc roof on south side of building from 1977 repairs. Although zinc sheet is relatively easy to fix (especially in comparison with *Jhingati*), nevertheless, improperly executed repairs with zinc sheets have allowed water to enter the building.

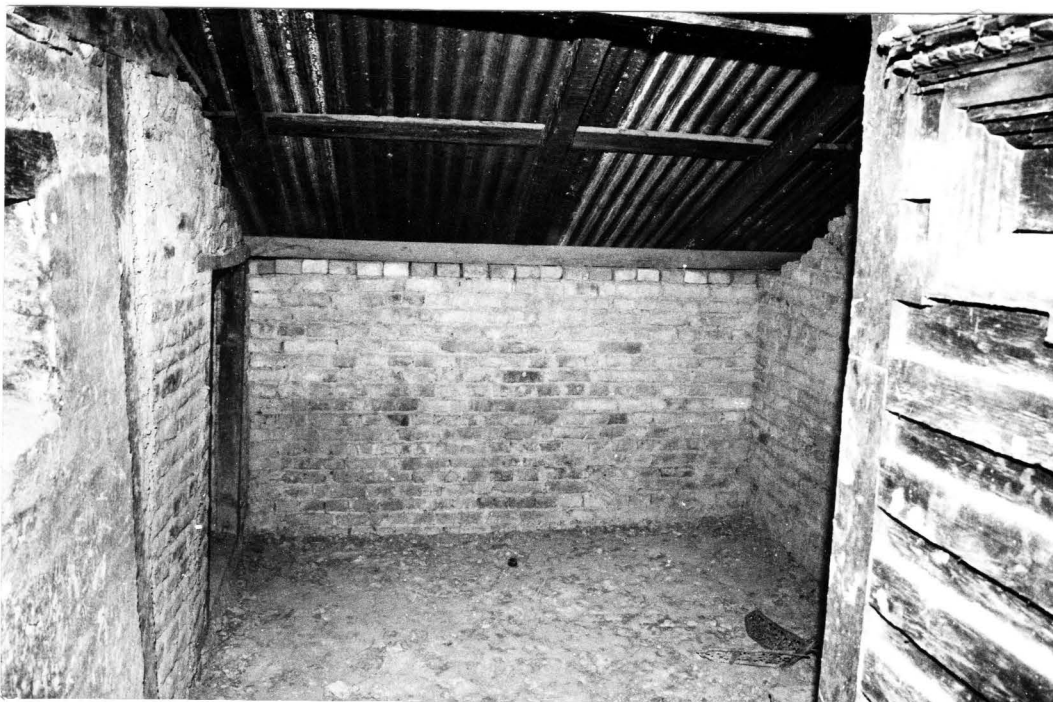
Below: Replacement with zinc sheets allowed minimally rebuilt roof frame (rafter spacing +/- 3'7" o.c.).

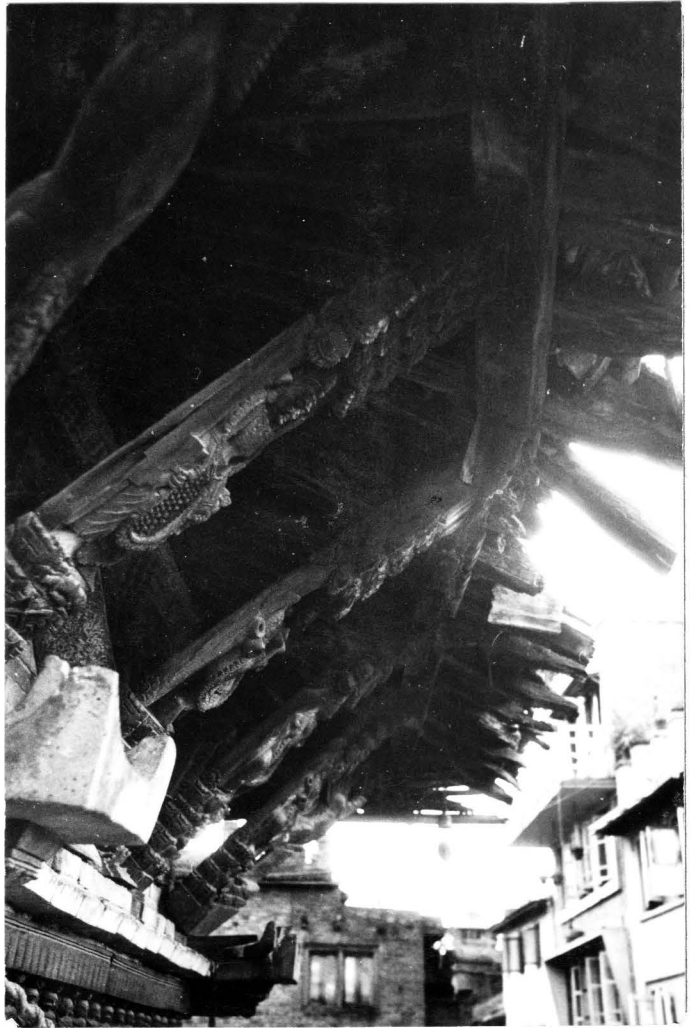
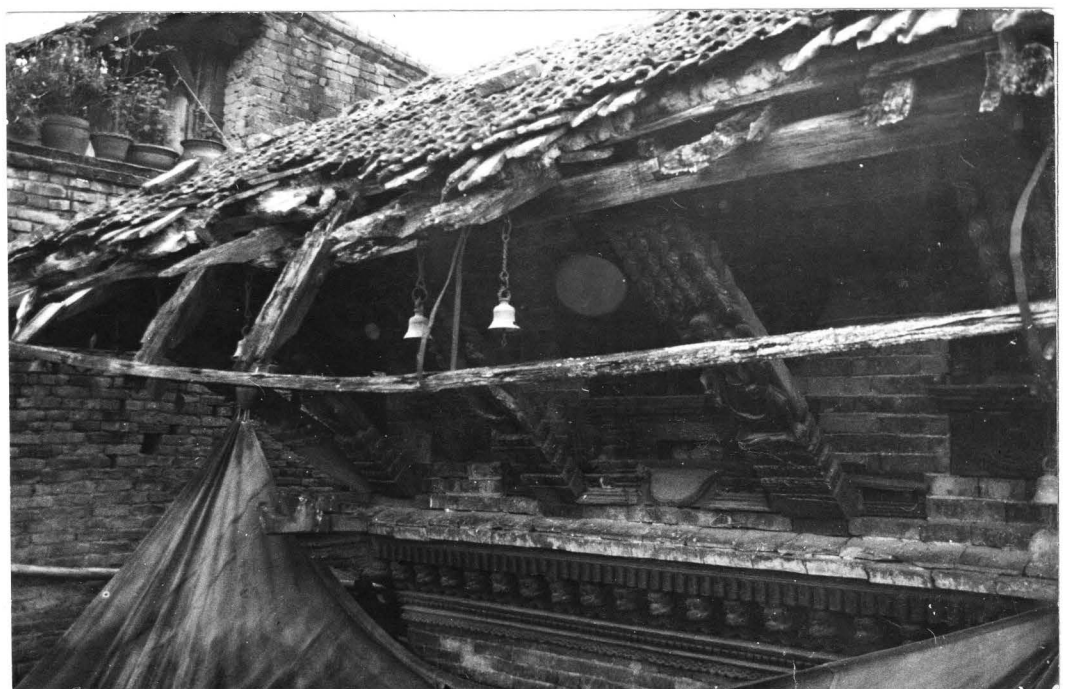
**Right: Eavesboard already lost and rafter ends rotted off, Upper pagoda(lower of two roofs) , south elevation. August 1993.**  
**Below: Only a few metal strips hold a damaged eavesboard on west facade, upper pagoda (lower of two roofs).August 1993.**

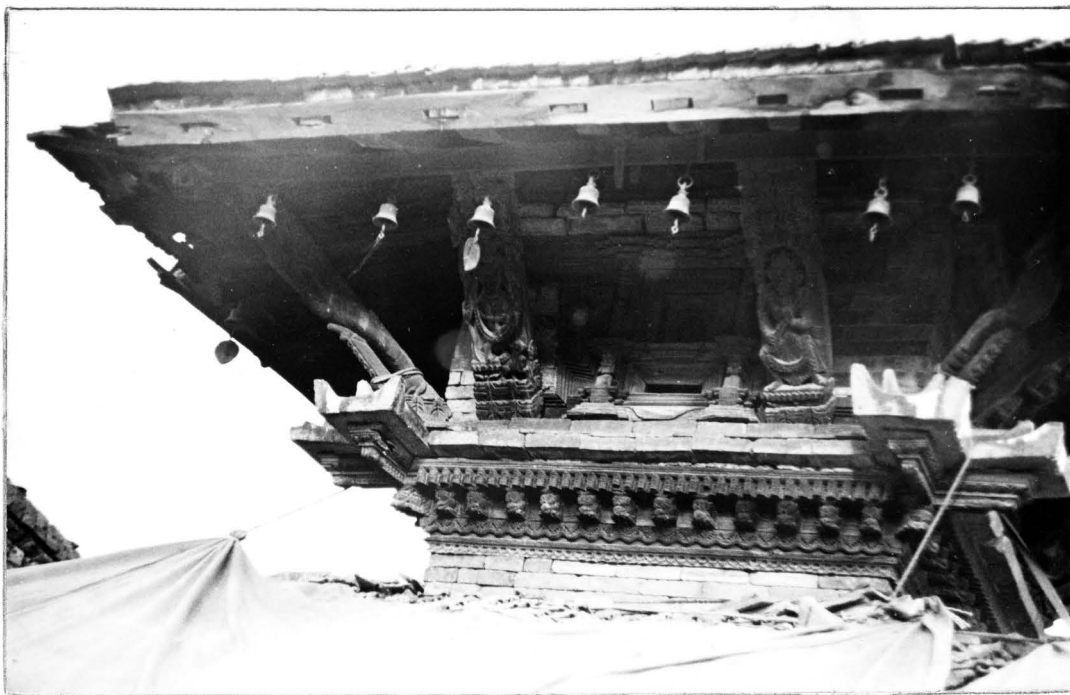
**Above : Uppermost pagoda roof from west shows broken eaves on North-West corner.  
August 1993.**

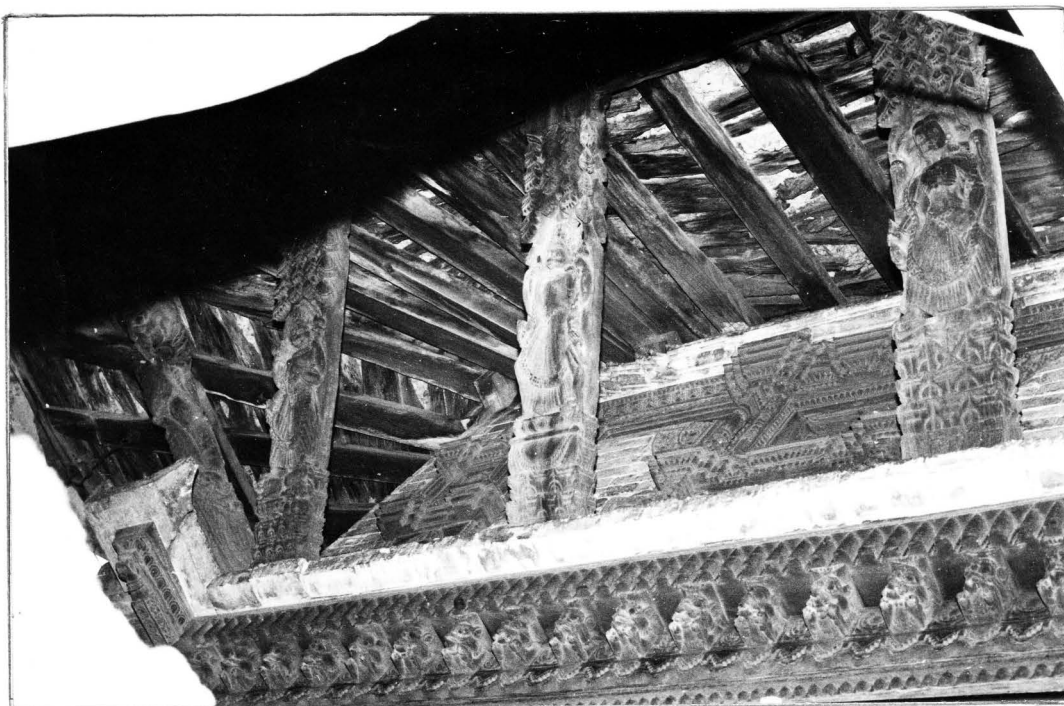
**Below : Middle roof shows timber lath above pine rafters, typical of upper and lower pagoda roofs.  
August 1993.**

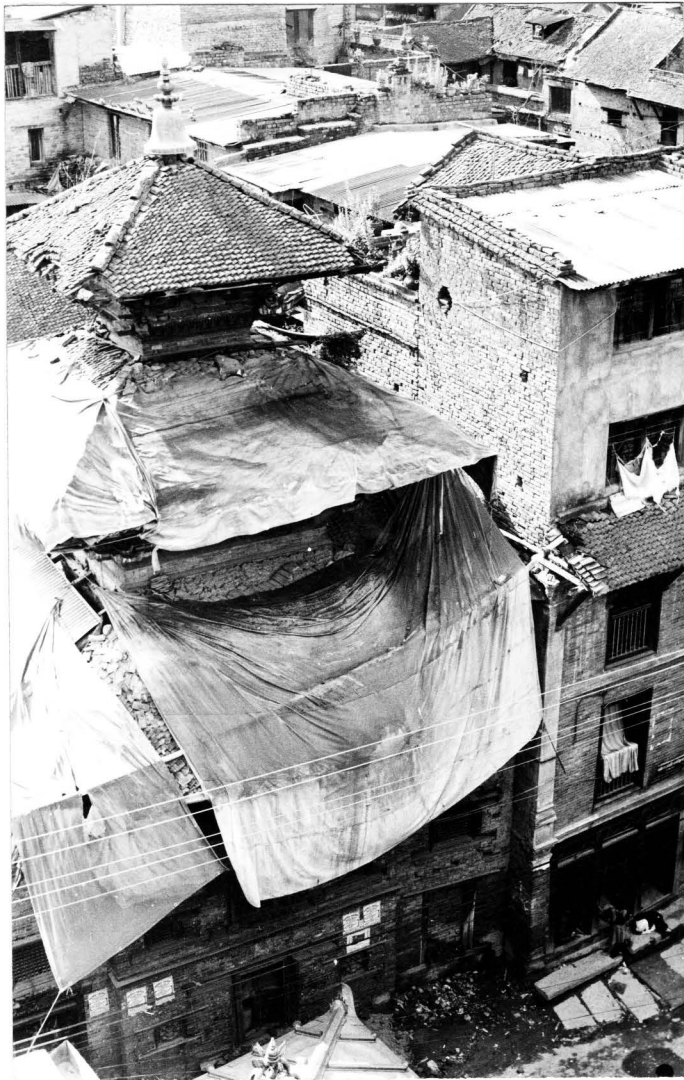
**Left : Gap between bottom of pinnacle and roof tiles. August 1993.**

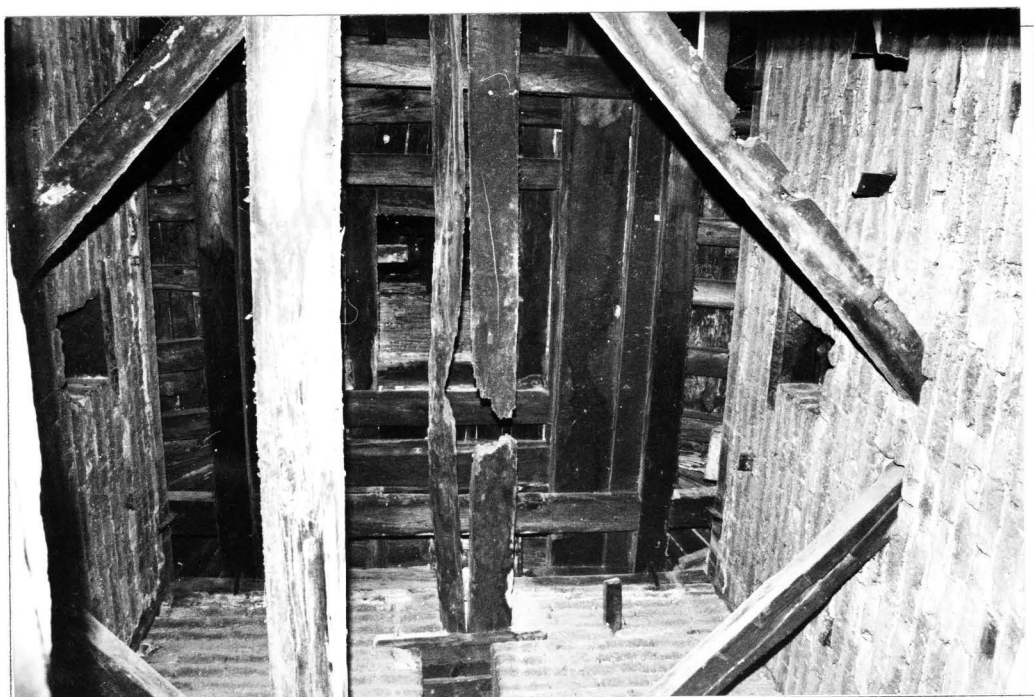
**Below : Inside timber structure of upper pagoda showing damaged tie in center and corner bracing, perhaps added in 19th c. reconstruction. August 1993.**

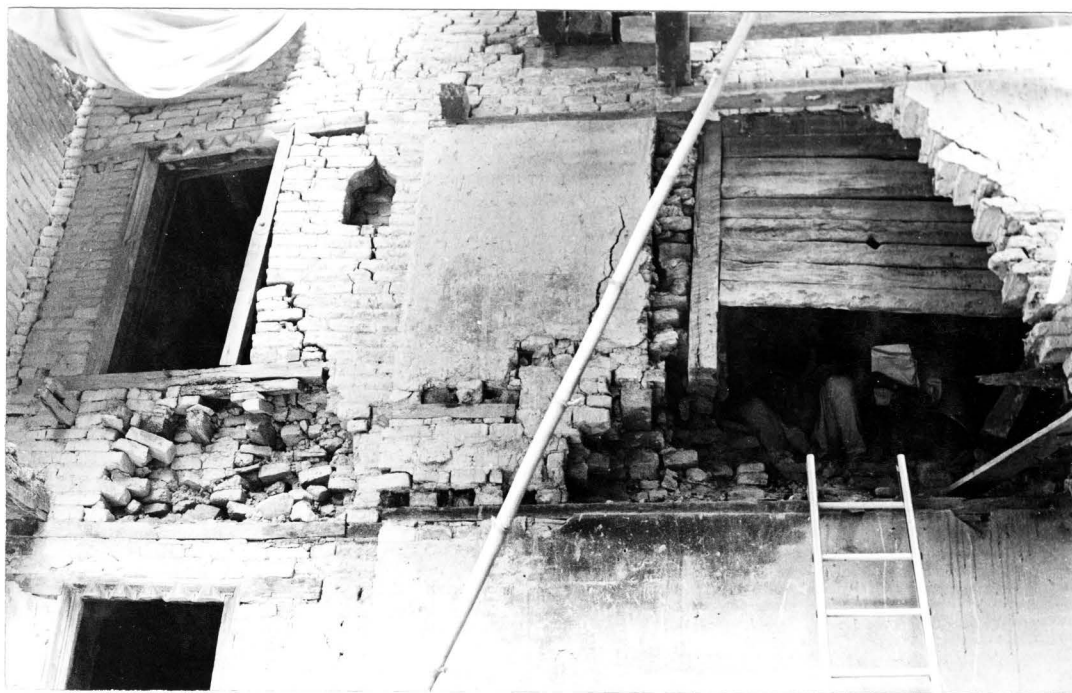
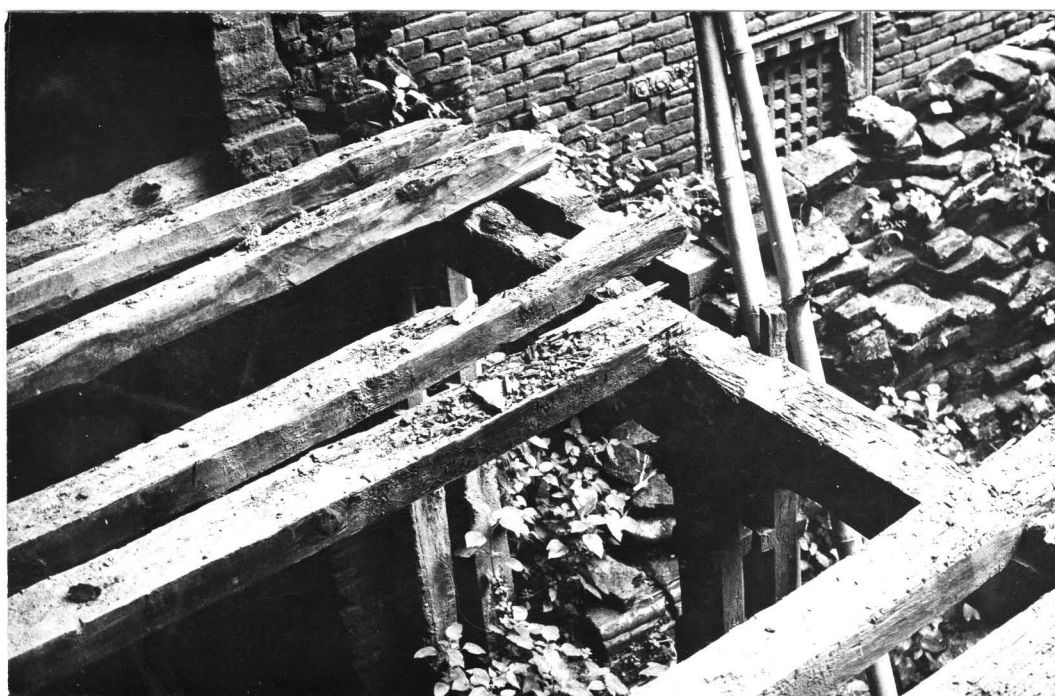
**Above: Back of main building ("middle wall") showing second floor shrine location where masonry wall added behind timber partition led to structural collapse of rear gallery. Summary 1993. Below: First floor of rear gallery showing missing joist and partially collapsed adjacent masonry wall (left).**

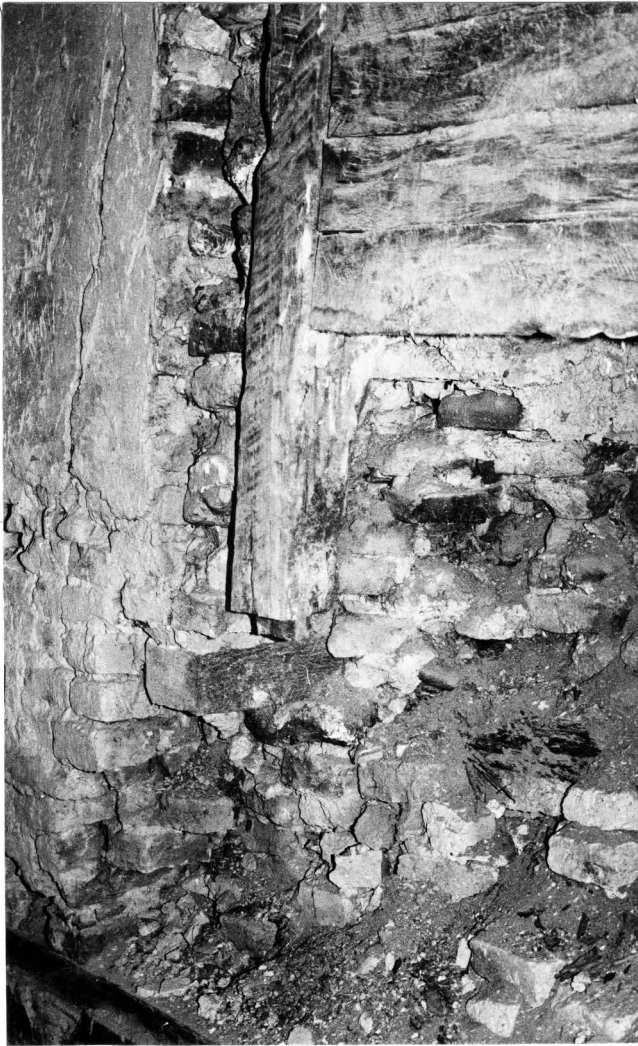
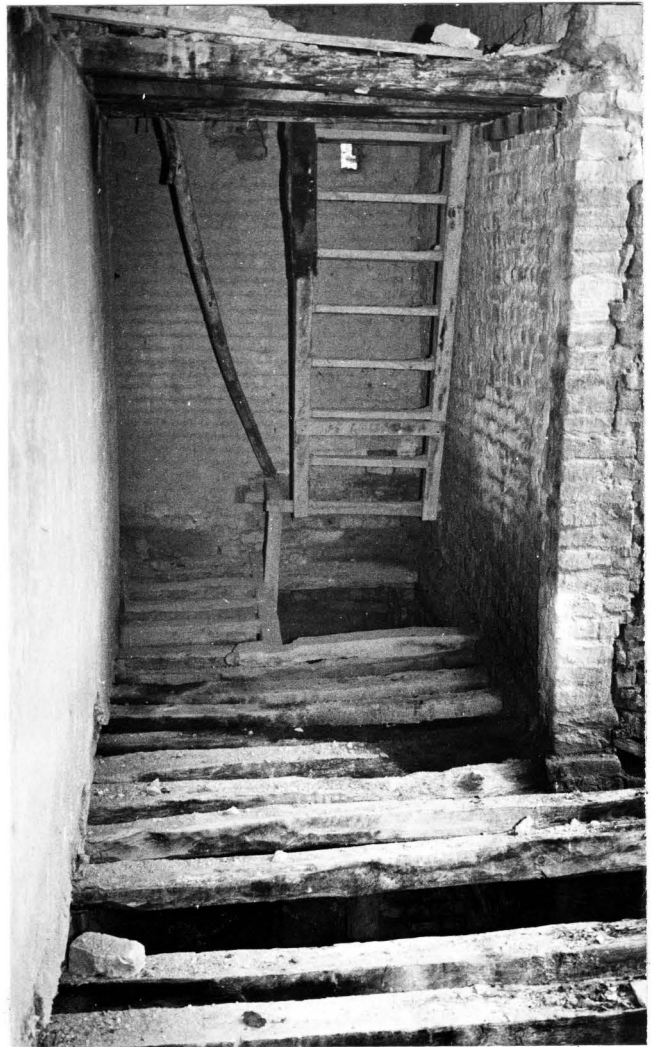
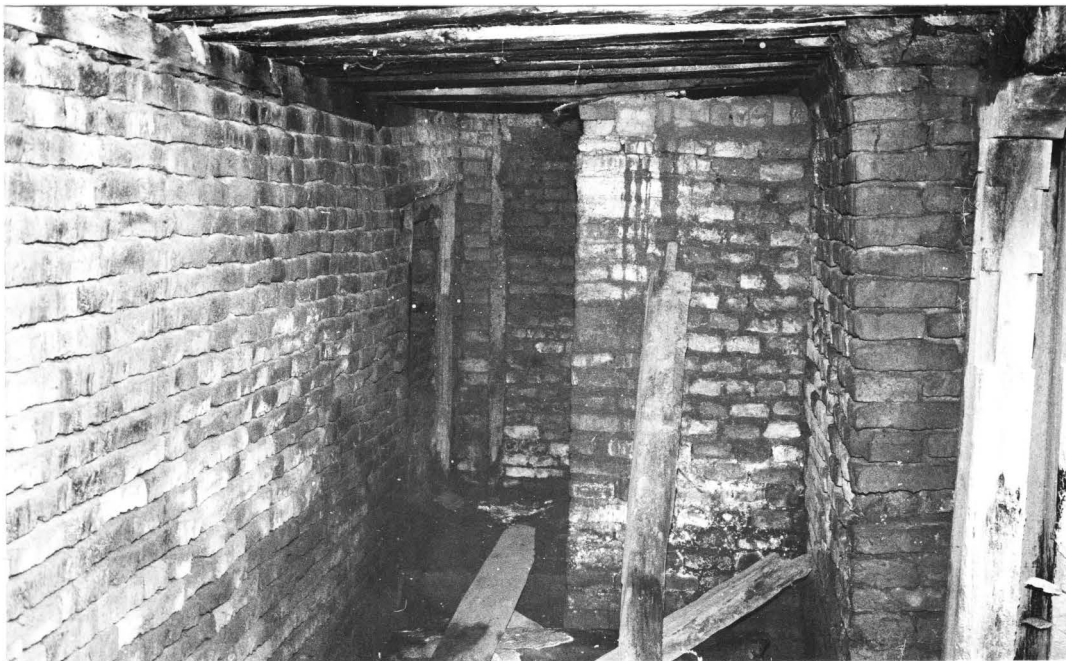
**Above left: Back of esoteric shrine, second floor, showing original planking partition as well as later added and partially collapsed masonry wall behind, summer 1993. Above right: first floor level at back wing looking south to stair ladder. Below: Ground floor at back wing looking south, showing masonry stair middle, and gallery timber pier right.**

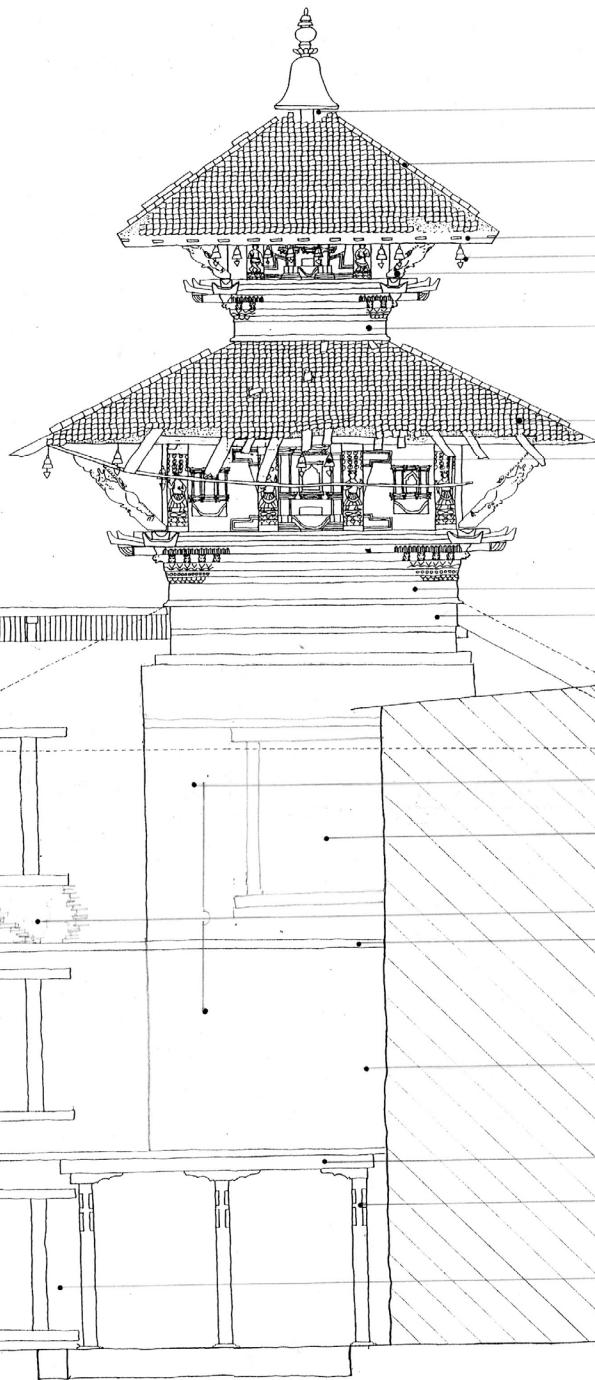
Missing base platform of pinnacle

Roof tile intact, ridge tiles replaced by brick.

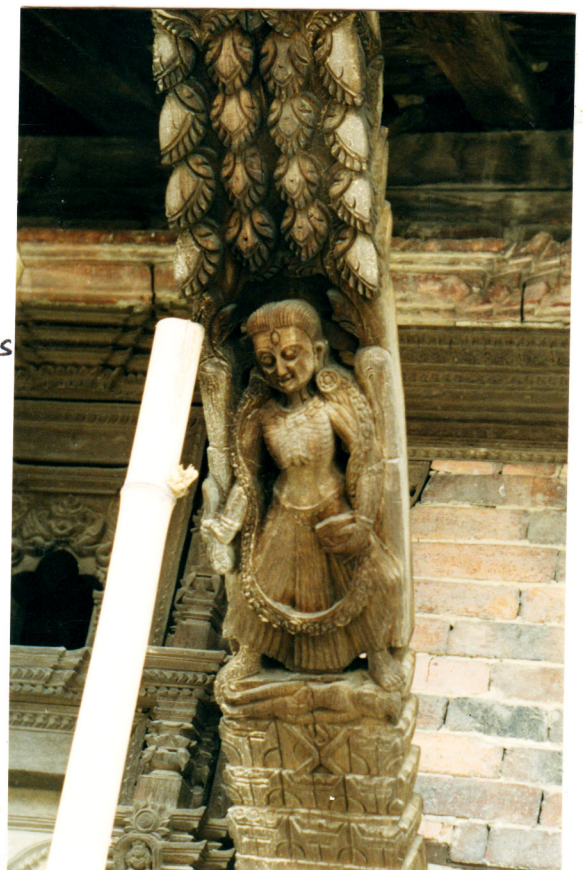
- structural condition good
- wet rot damage on upper part of strut.
