# RESTORATION OF THE PATUKVA AGAM,

A 17TH CENTURY ESOTERIC SHRINE BUILDING  
PATAN DARBAR WORLD HERITAGE SITE

## FINAL REPORT

KATHMANDU VALLEY PRESERVATION TRUST  
ERICH THEOPHILE AND ROHIT RANJITKAR , DECEMBER, 1998

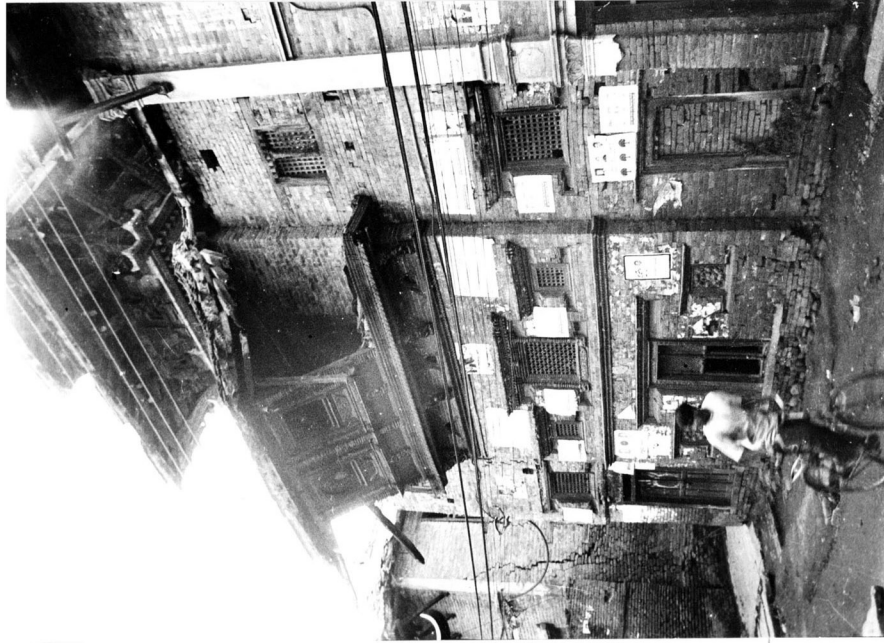
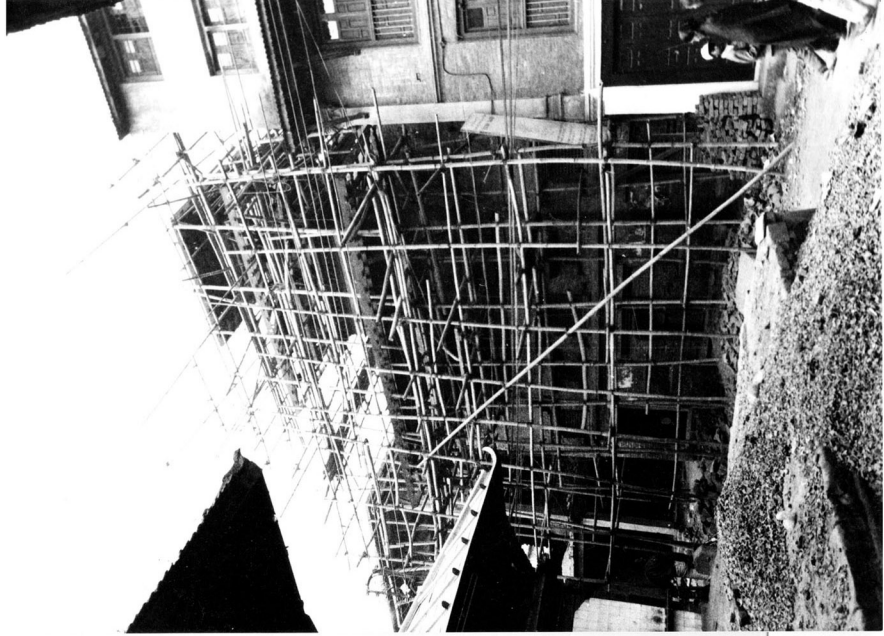
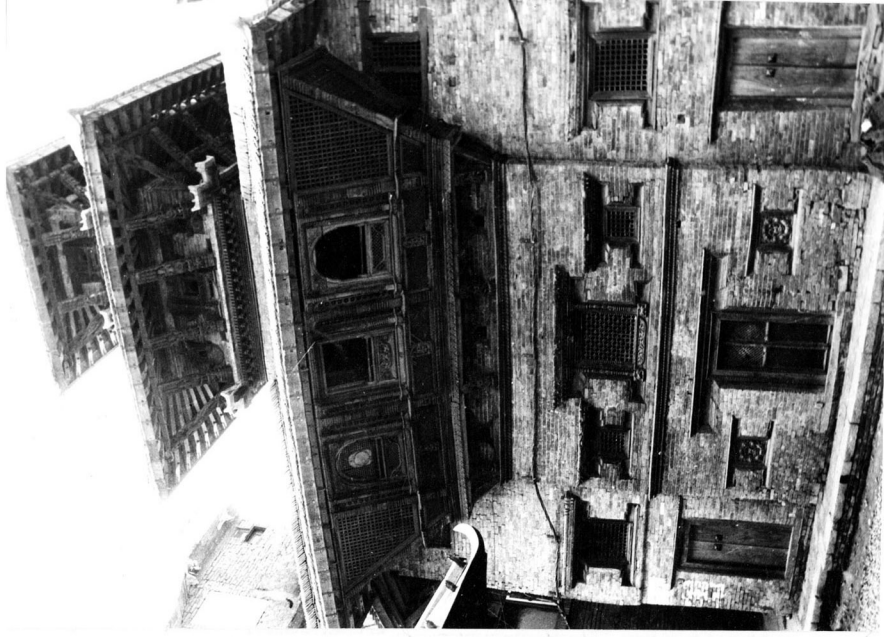
**Patukva Agam**  
view of principal facade and superstructure from Patukva Square  
before restoration (1991), during (1993), and after (1997)

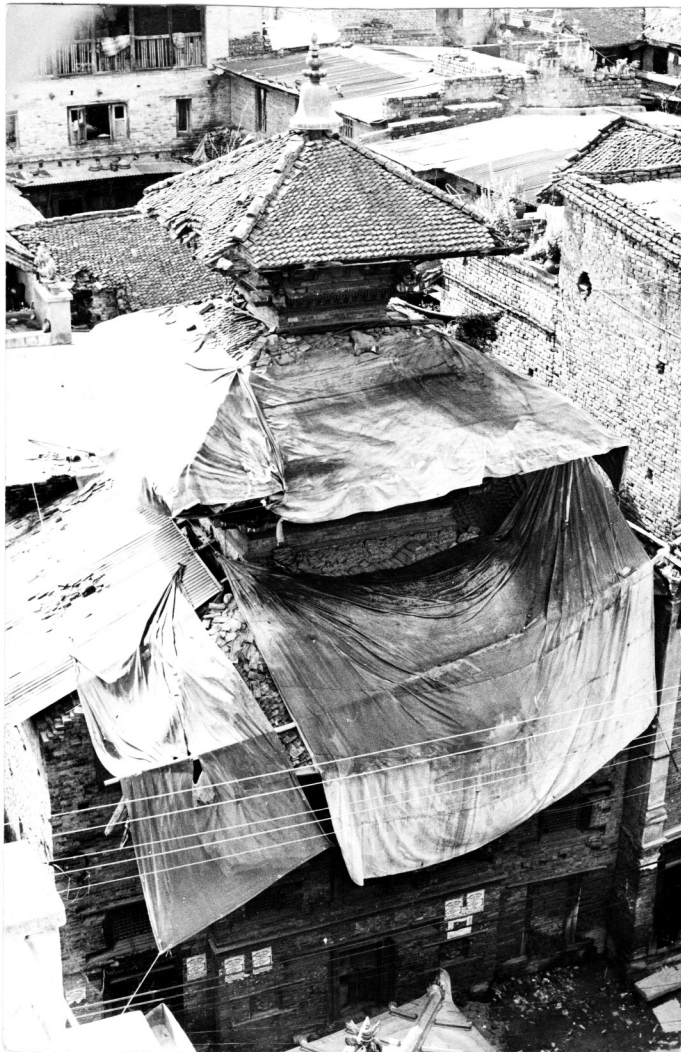
**Pre-project activities**  
SE view after emergency tarpaulin cover on the roof to  
protect from monsoon rain, 1992.

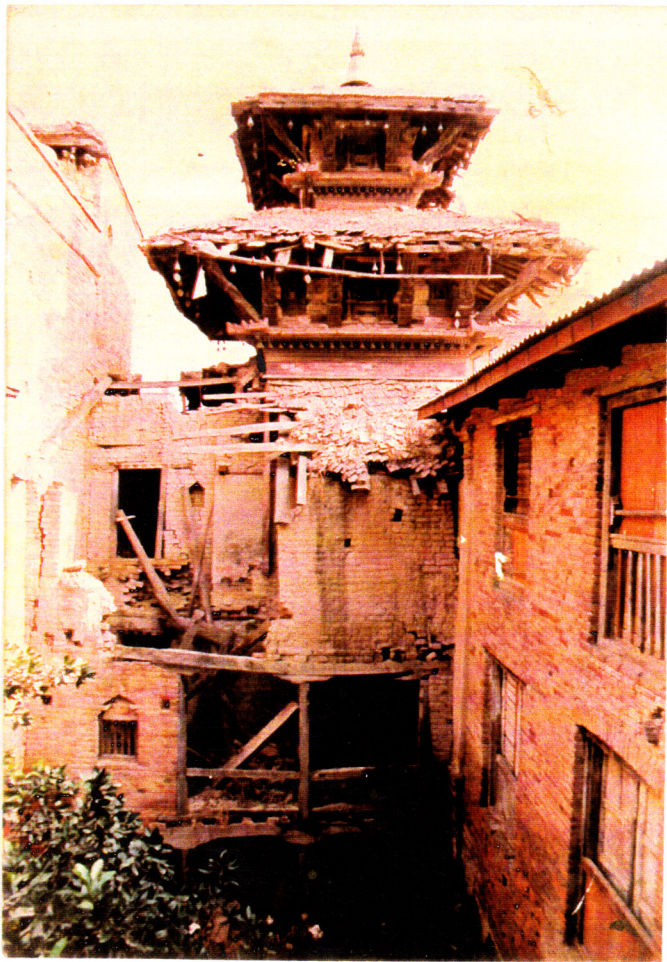
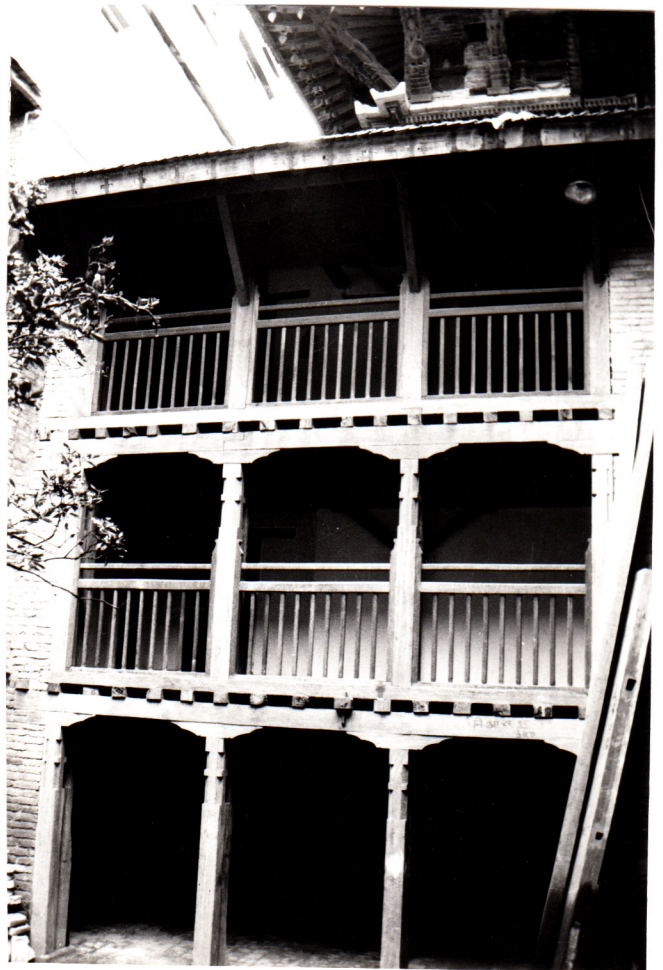
Courtyard elevation (west)  
before and after restoration showing rebuilt gallery.

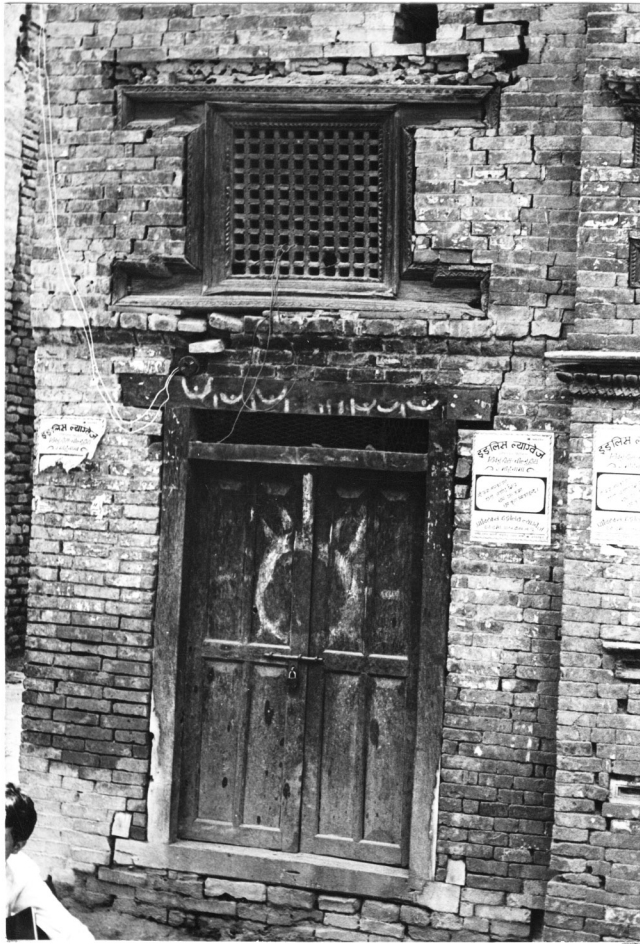
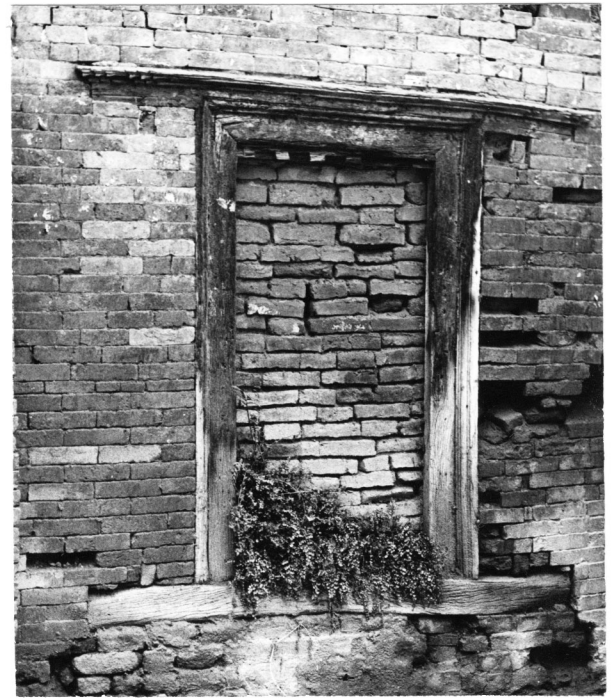
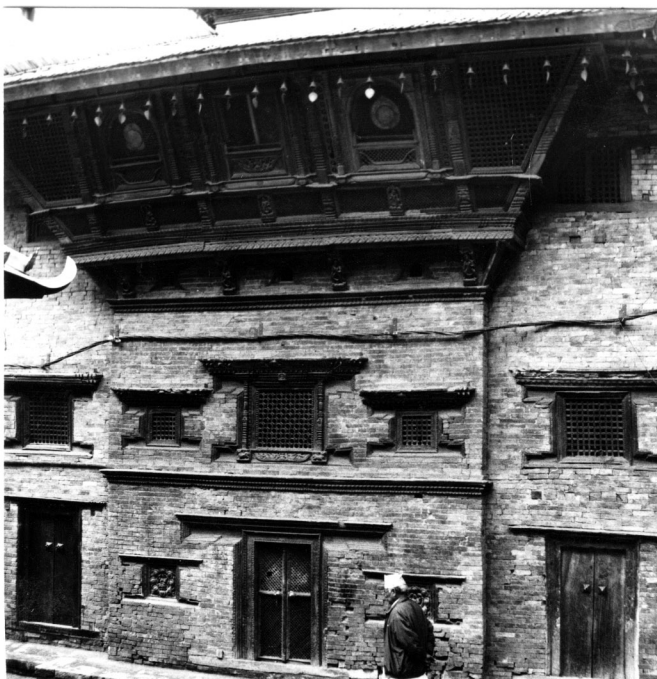
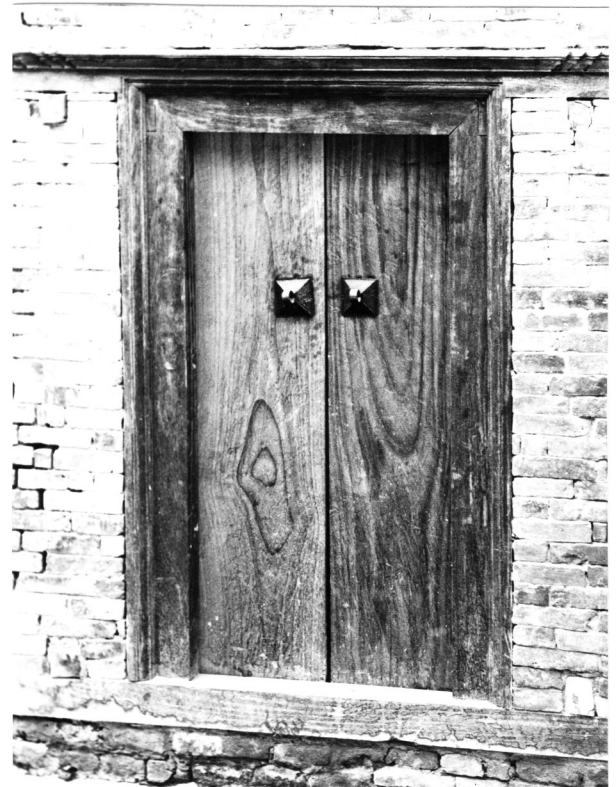
#### Restoration of historical facade openings

Upper left: South doorway on the ground floor had been replaced with a larger modern doorway for use as a shopfront. Top right: North doorway on the ground floor had been blocked up with bricks during recent repair by the guthi. Bottom left: Lower three floors of the front facade after restoration. Bottom right: south door, principal facade after restoration with historically appropriate plain timber blades.

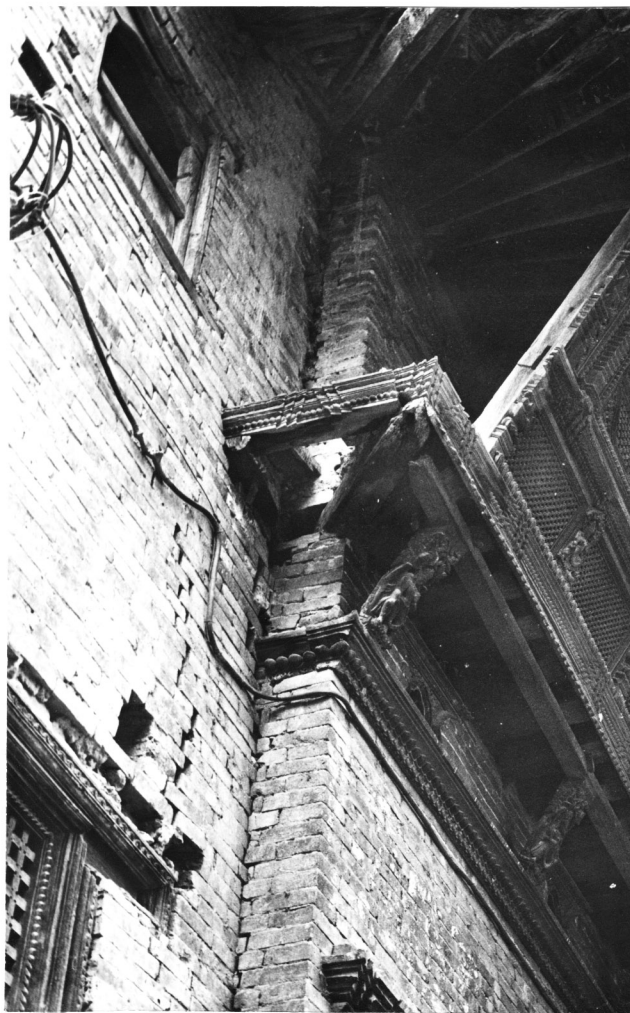
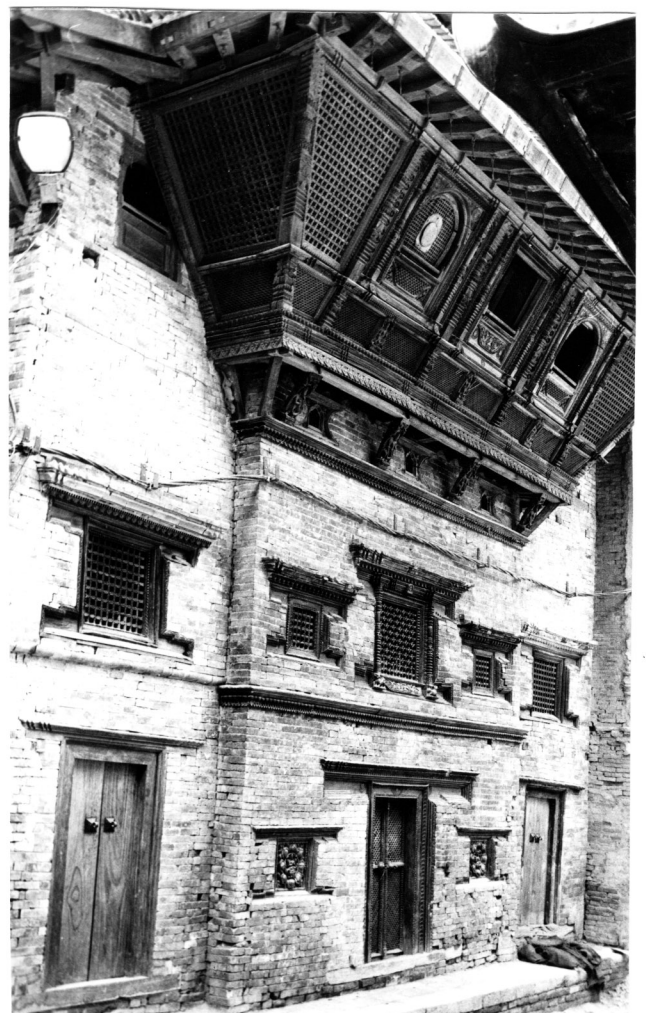
**Bay window (san jhyah)**

Left: lost southern portion of bay window on principal facade. Right: after restoration incorporating historical corner post and new replacement lattice work (south end only).

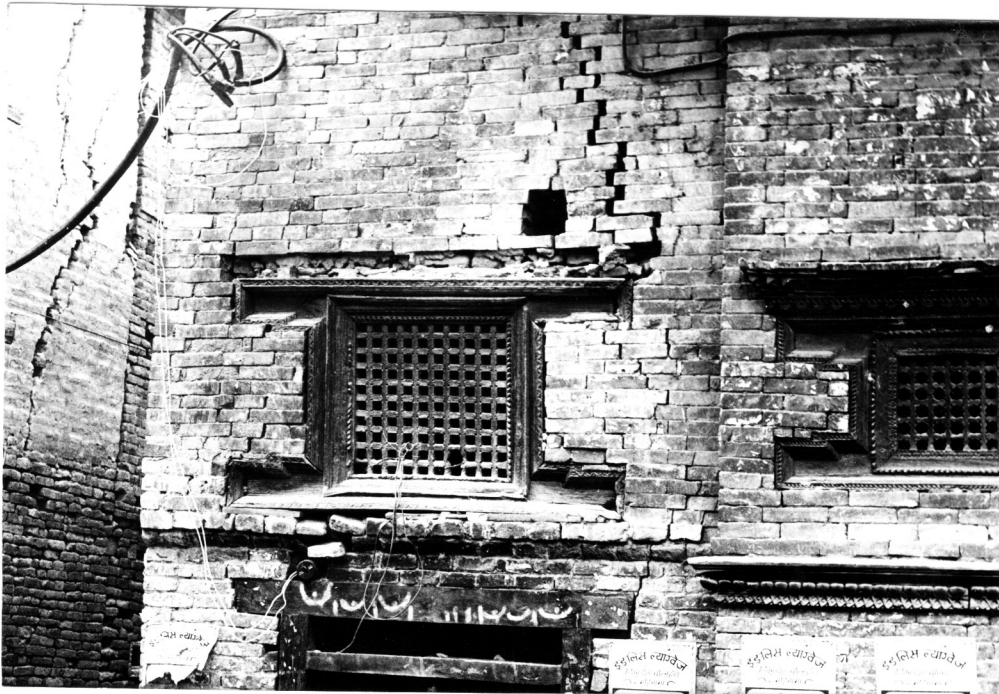
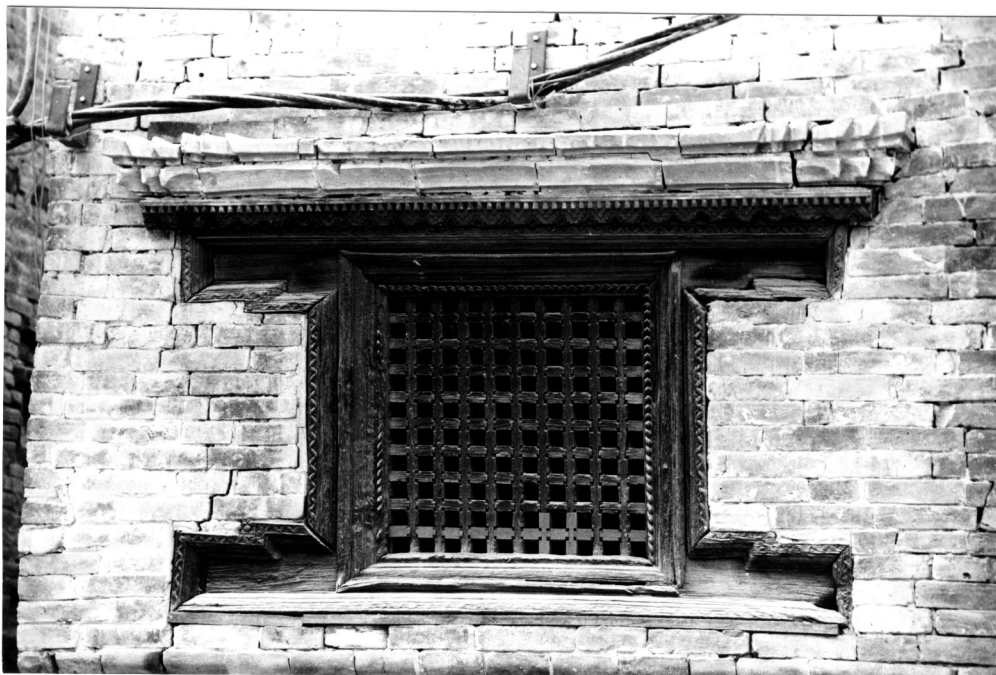
#### Decorative terracotta

Lost terracotta cornice elements above the window (above) were replaced with new elements made to match (below).

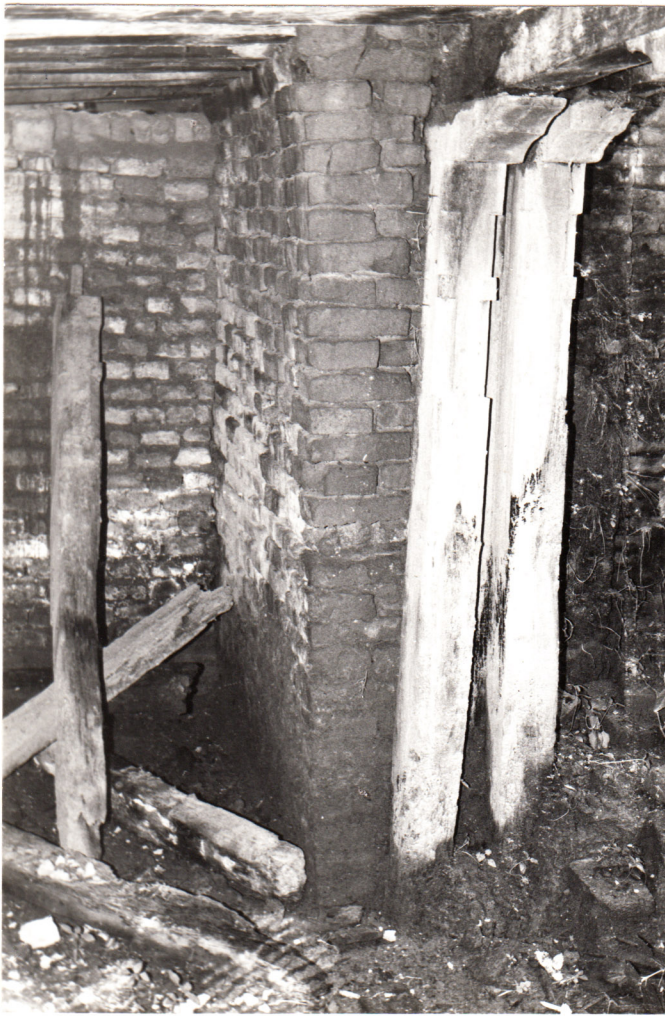
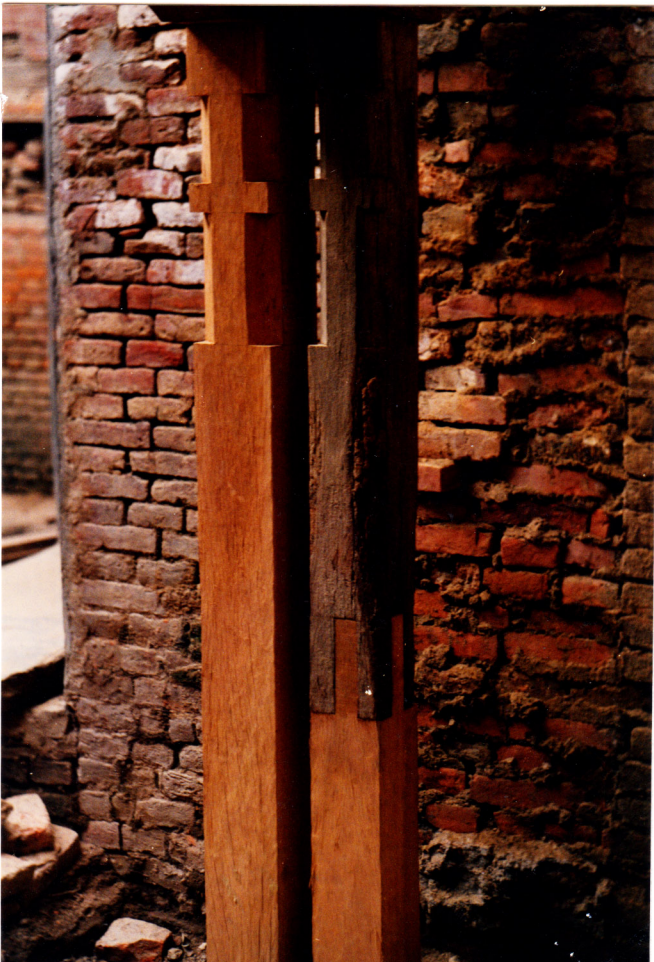
#### Repair of timber columns

Top: The timber columns rotten at their bases after years of dampness, while the upper 2/3 were still in fair condition. Below: Upper 2/3 of the old column (right) preserved as a historical fragment with new "foot".

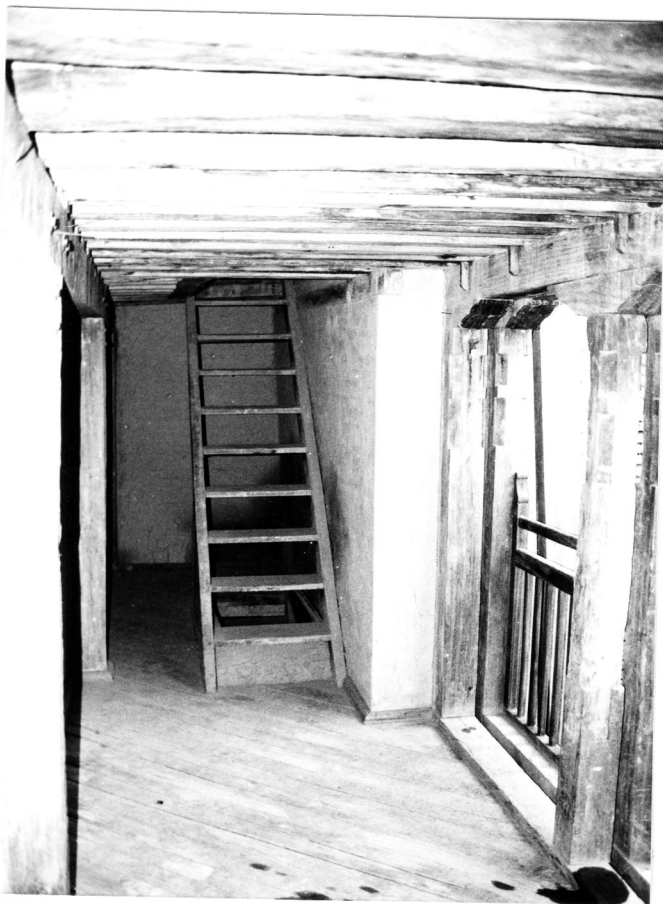
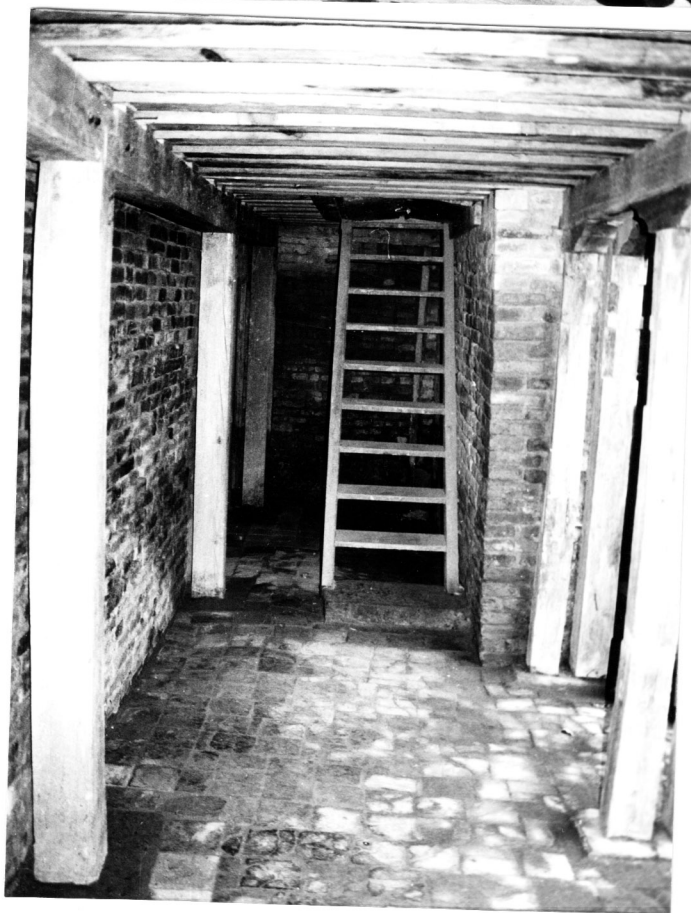
#### Mud and tiles

Above: all mud floors were removed to reduce dead loads. Below: the tile of the ground floor was maintained to demonstrate the rich lustre of the historical brick despite cracking.

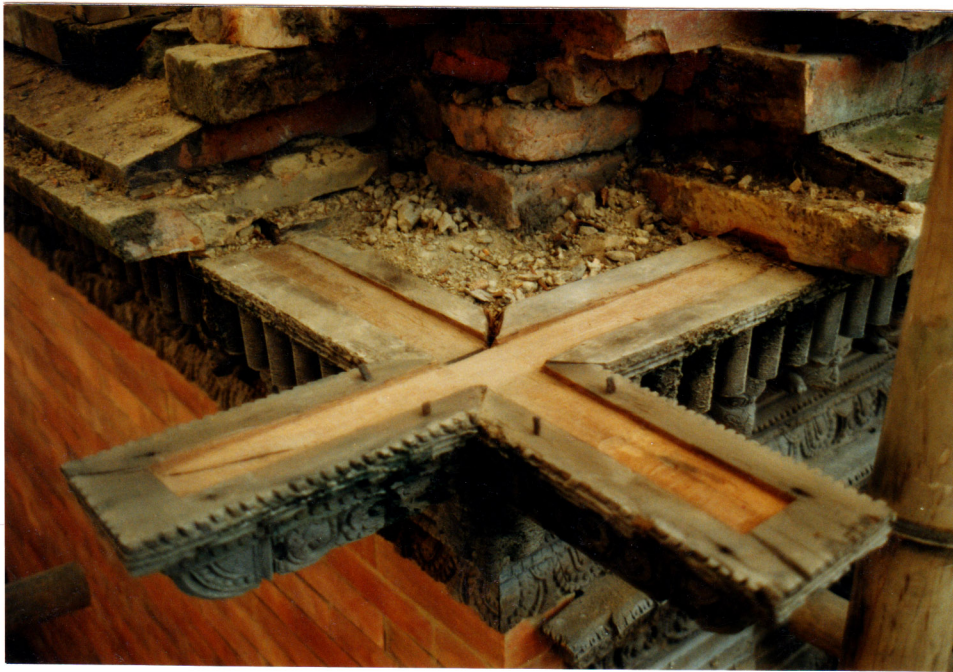
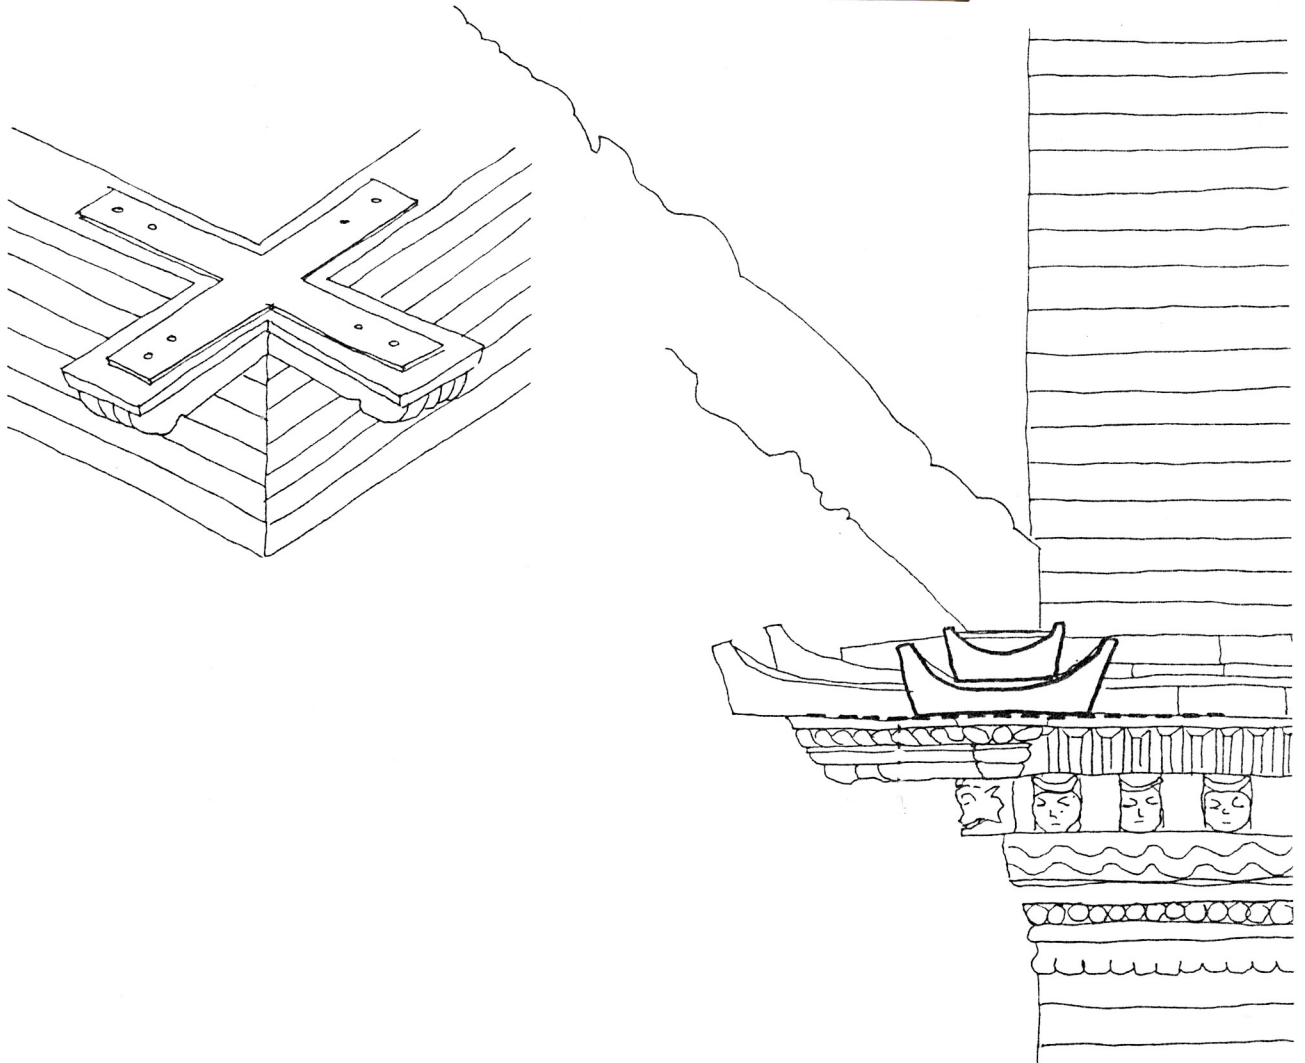
#### Reinforcement of lah-kah

Top: The corners of the decorative timber cornices (Newari: Lah-kah) just below the corner strut bear heavy terracotta corner pieces. Because the timber corner pieces are half notched their section is insufficient to bear the load of the terra cotta pieces. This often leads to broken corners and fallen terracotta lah-kah. Bottom: A metal cross pieces is screwed on top of the lah-kah which prevents failure. The terracotta pieces rest above thereby concealing its presence.

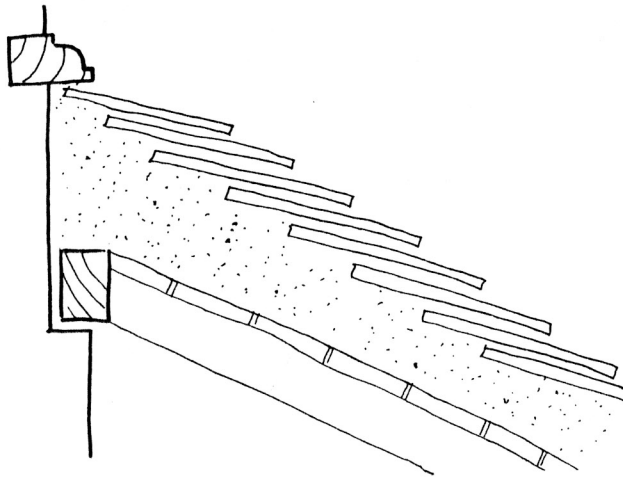
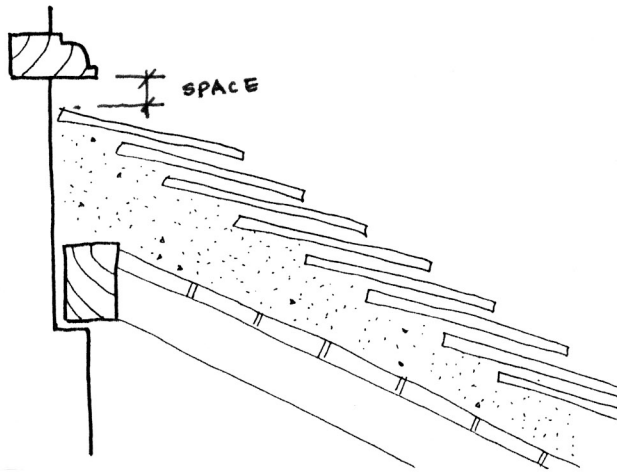
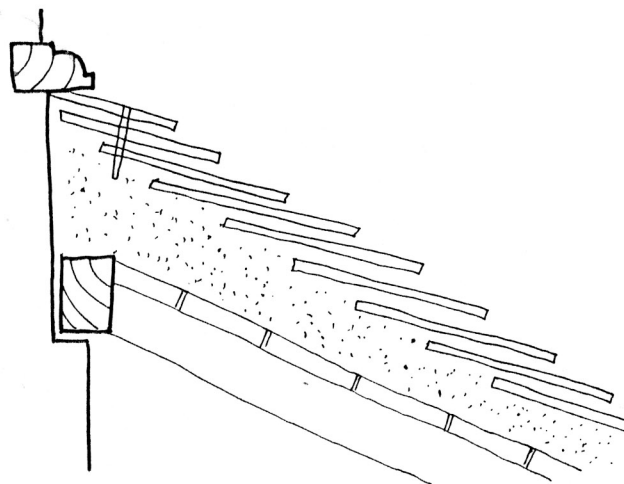
#### Roof tile (jhingati) detailing

Top: Typical detail with the upper most row of jhingati laid just under a timber cornice. During the shifting of the tile with time this upper row of the tiles slides down. And all the lower jhingati always overlapped and only app. 1/4 of the total length is visible. But the upper most jhingati are visible totally, except overlapped by the timber cornice on the wall. Middle: When jhingati are laid on a thick mud bed, after the mud dries there is always settling, which makes aspace between the timber cornice and jhingati., Bottom: A few days after the laying of the jhingati (when mud has dried) there is space between the timber cornice and jhingati to add a 3/4 length jhingati. This does not allow shifting.

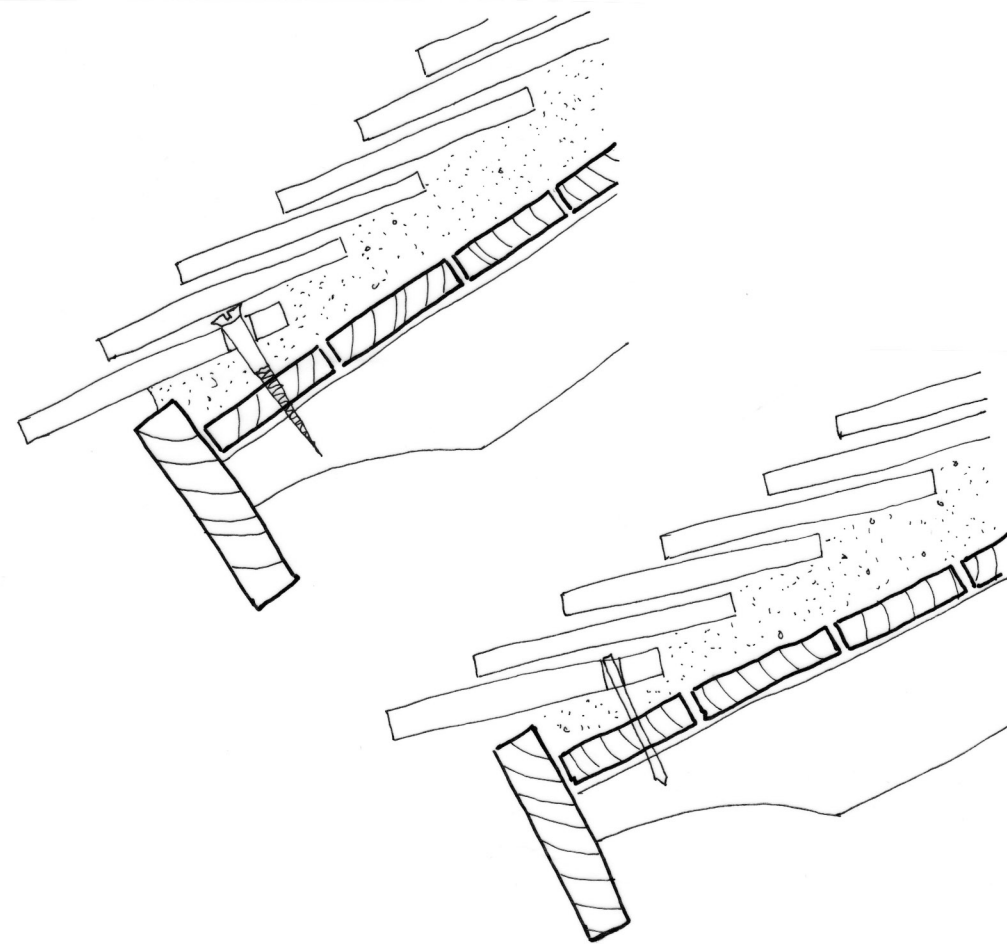
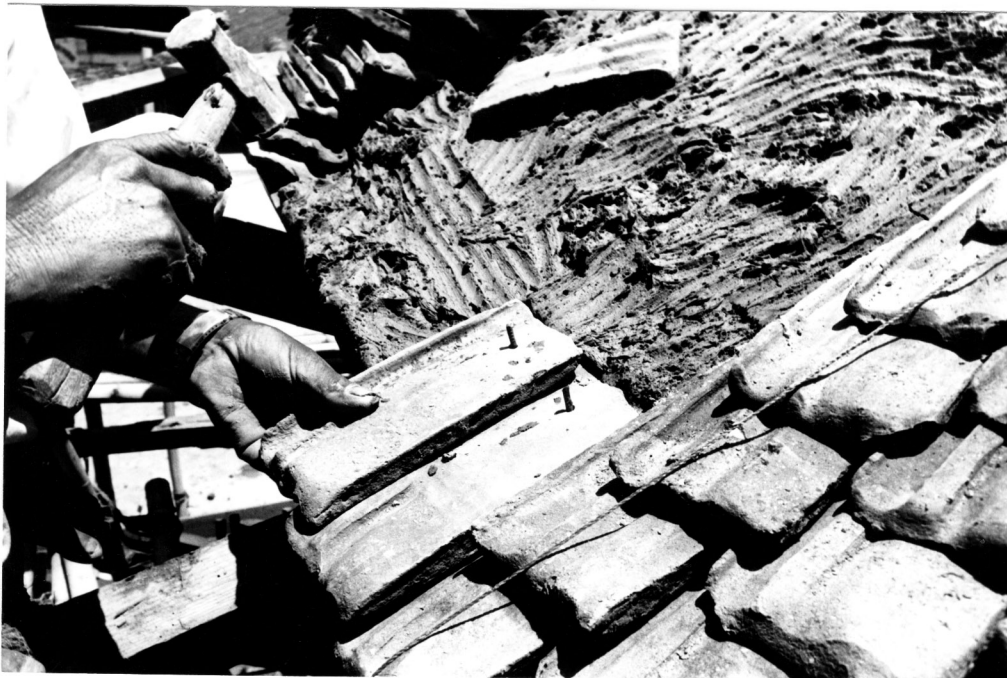
**Improved detail for fixing the first row of jhingati (roof tiles) on the roof**

Top: Typical detail with half of the jhingati in the first row overhang the eaves board. Once the first row falls away further loss continues above. In the Hanuman Dhoka Restoration Project the first row of jhingati were screwed into place to prevent loss. After some years many jhingati were lost. Replacement, however, was difficult, due to the screw heads which must be removed before jhingati replacement can be undertaken. Middle: Improved detail with the first row of jhingati fixed with headless nails. If it becomes necessary to replace jhingati one simply lifts the second row of jhingati to insert replacement onto headless nail. Bottom: photograph showing the first row of jhingati with headless nails.

- 4.2 Jhingati roof tiles  
Project architect Ranjitkar developed a nailing solution to attach the roof tiles on lower roofs at the first row, i.e. where they spring from butting walls. This is the place where animals and birds tend to dislodge the tiles. This measure will increase the life of the roof.
- 4.3 Roof cover-protective membrane  
In place of the waterproof layer of tarfelt for the roof cover, we attempted to substitute a longer-life elephant skin newly produced in India. Delivery time proved to be too long (2 yrs +), however, and tar felt + bitumen was used instead. The elephant skin will be an appropriate solution after supply routes are in place.

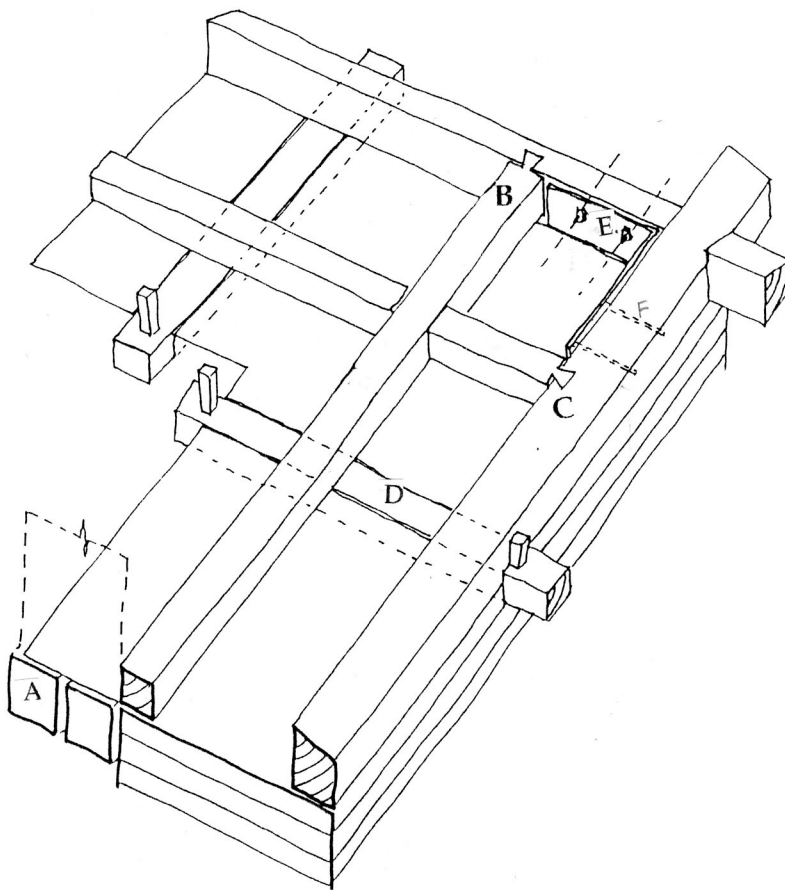
#### Reinforcement of wall plates

Top: Section showing location of wall plate level. Bottom: Axonometric view at wall plate level below the roof rafters. Metal collar connection in between the outer wall plates to improve the weak corner of a half-lap joint, which must carry the thrust of the rafters.

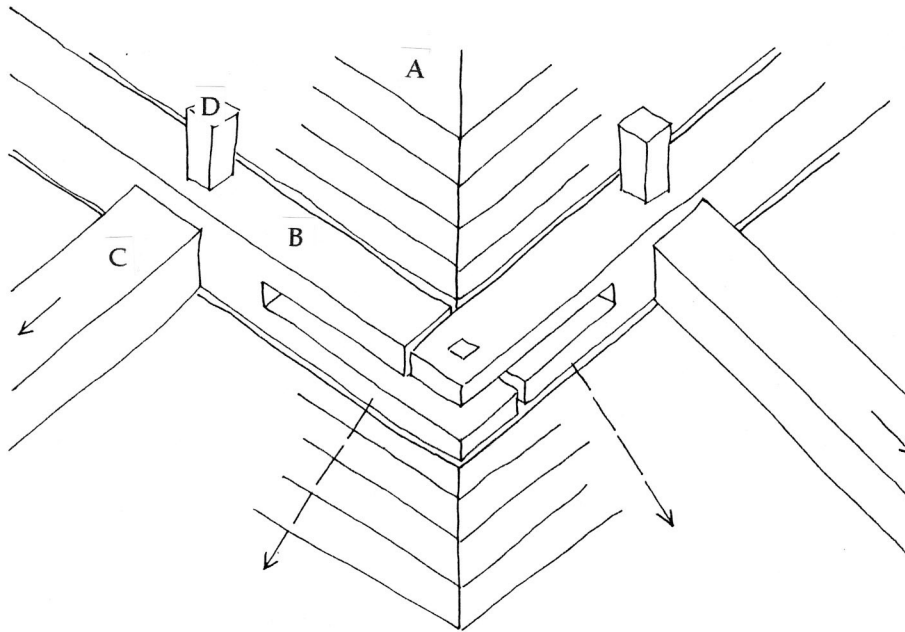
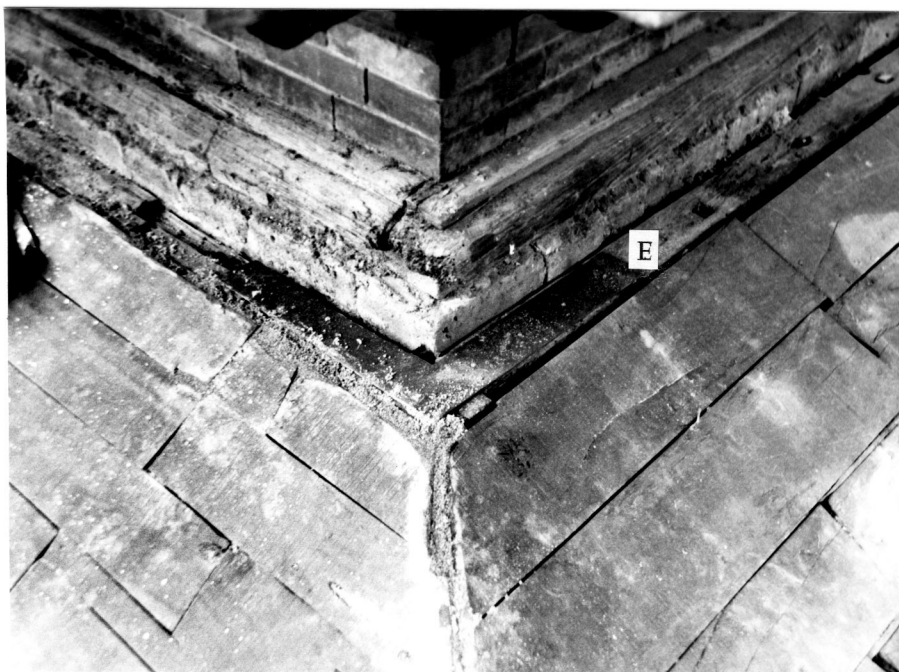
#### Reinforcement of upper wall plates

Top: Because of heavy roof loads, rafters tend to slide down, outwards. Bottom: Metal strip in "L" shape bolted in between the upper wall plates, connecting upper wall plates together to prevent failure of timber joinery.

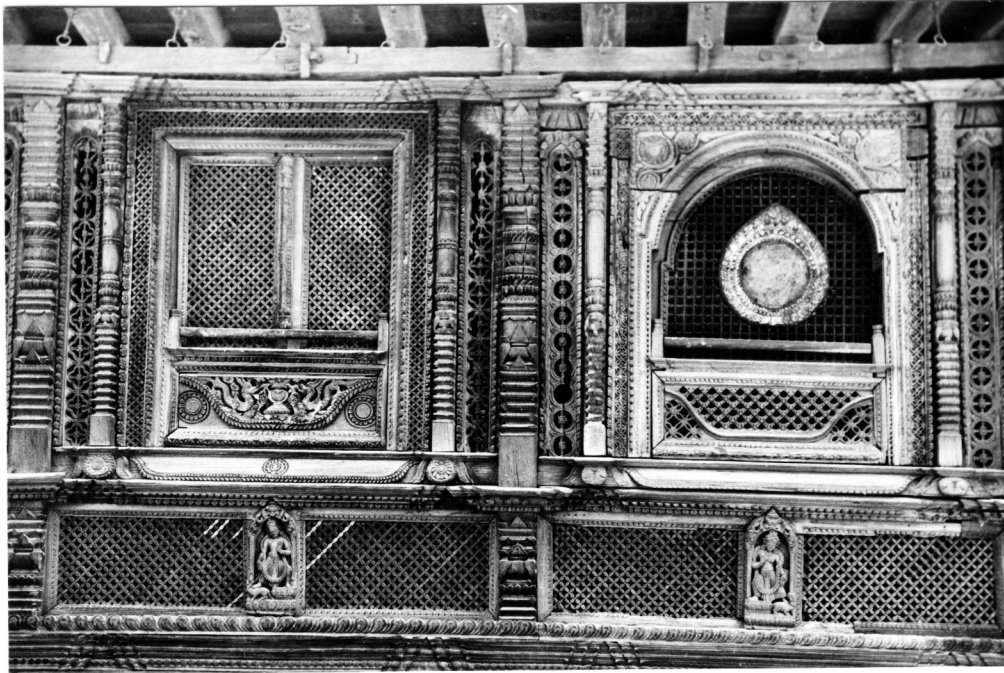
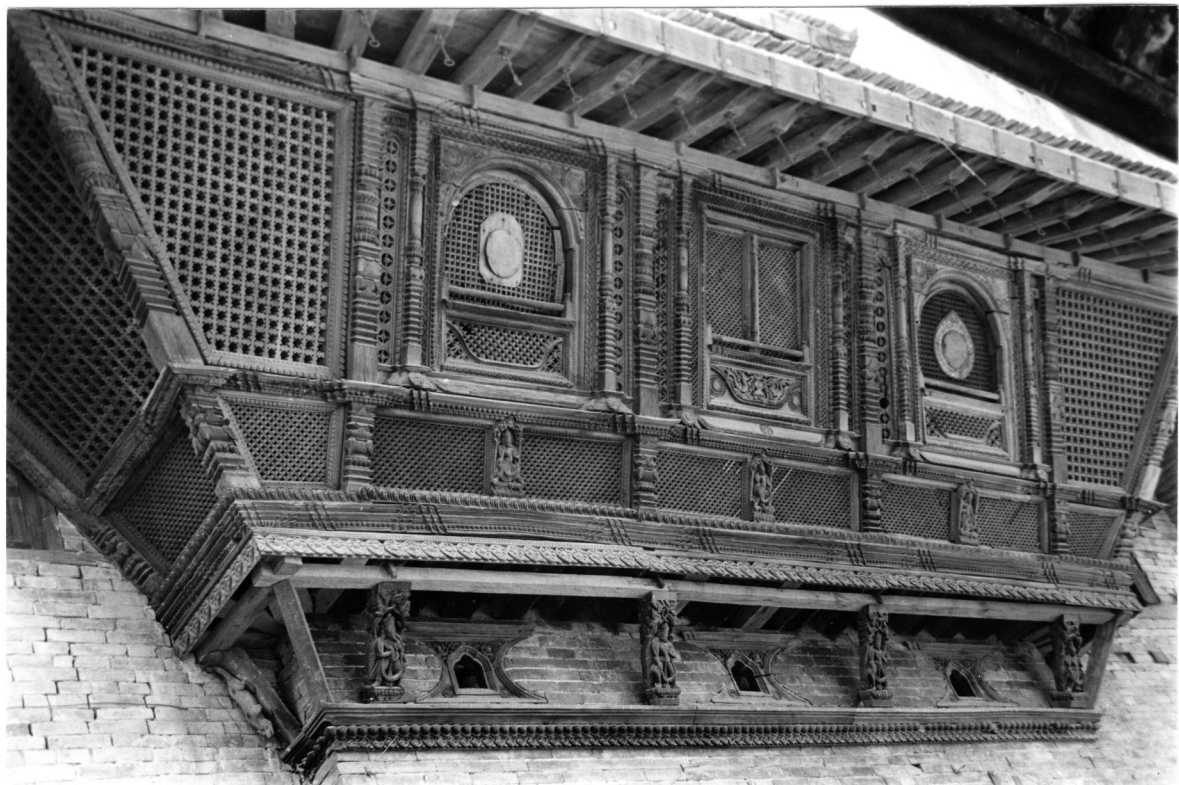
#### Recarving of lost elements

Top: East main facade, left side bay, right side bay and right end of the carved sanjhya (bay window) were damaged due to the lack of roof maintenance. Some parts were kept in storage, but many were lost. Bottom: Lost parts were recarved. New parts are assembled together with historical components.

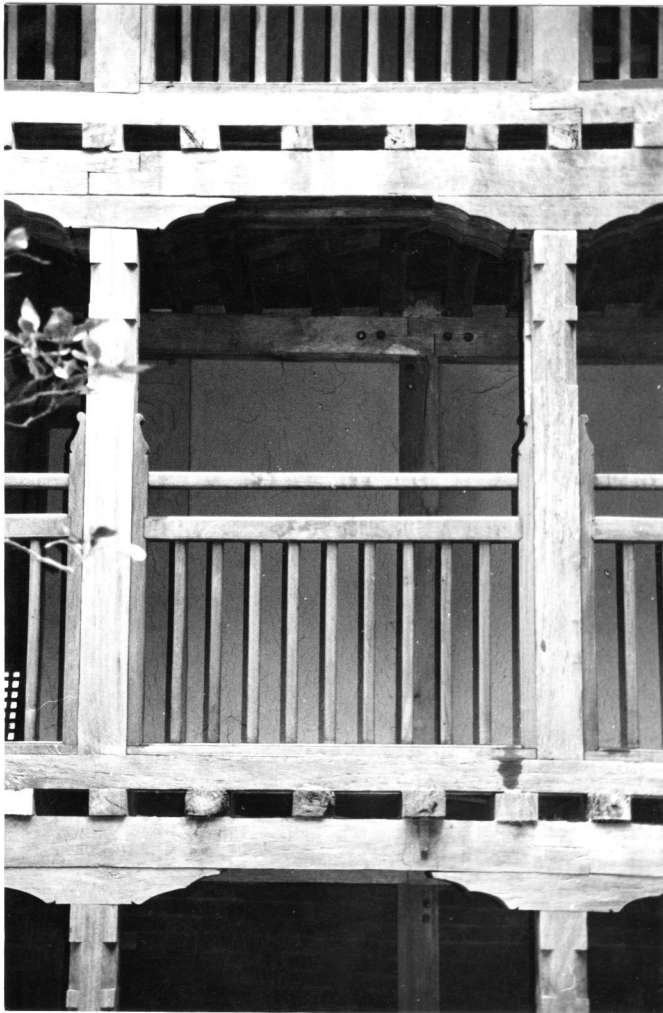
Courtyard elevation (west)  
after restoration showing rebuilt gallery incorporating four historical timber posts with new "feet".
