**RADHA KRISHNA TEMPLE**  
**SWATHA TOL, PATAN**

**HISTORIC STRUCTURES REPORT**  
**MARCH, 1992**

**ERICH G. THEOPHILE**  
**ROHIT K. RANJITKAR**  
**KATHMANDU VALLEY PRESERVATION TRUST**  
**IN COLLABORATION WITH**  
**HIS MAJESTY'S GOVERNMENT**  
**DEPARTMENT OF ARCHAEOLOGY**

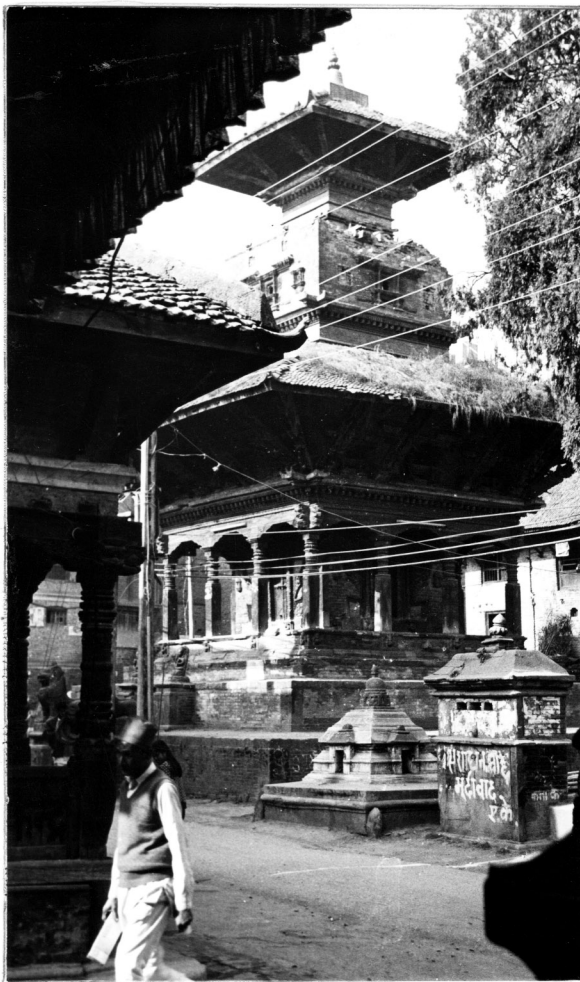
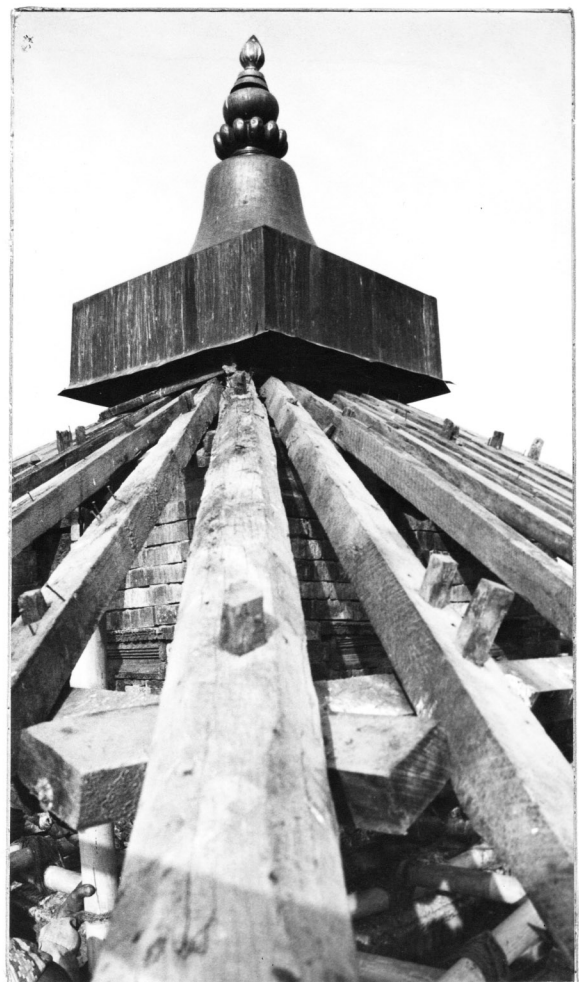
**LEFT:** VIEW FROM NORTHEAST, JANUARY 1992. **RIGHT:** GILT PINNACLE WITH PLAIN COPPER SHEET BASE ADDED IN 1967, MARCH 1992. DISCUSSED UNDER 5.06.

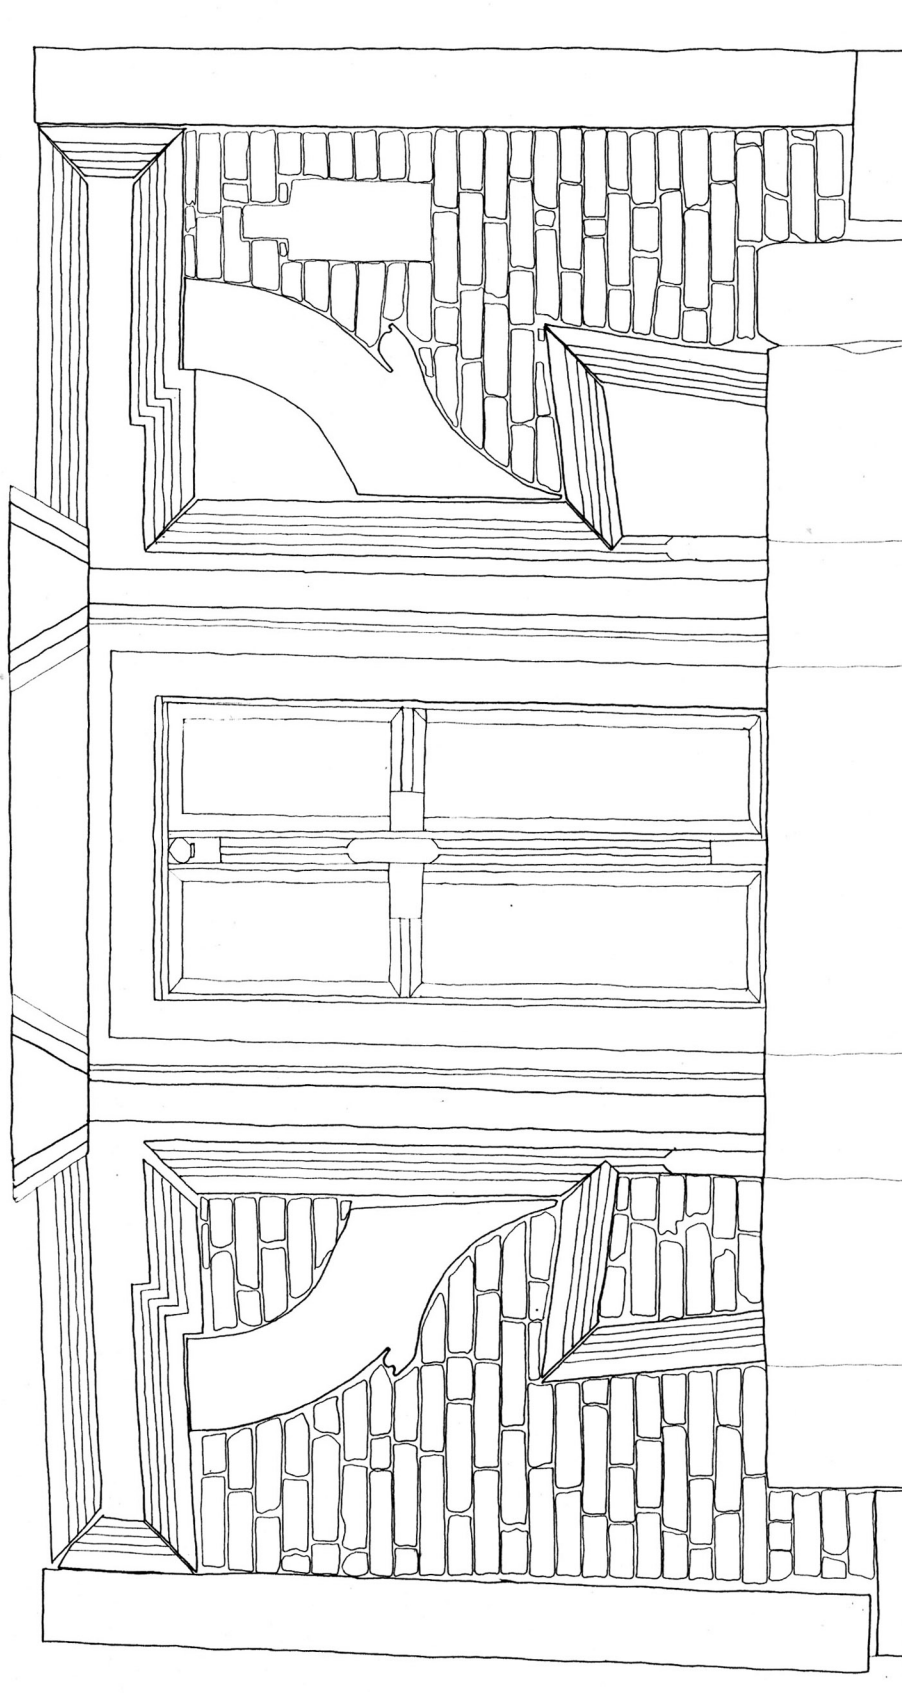
EXISTING CONDITIONS: FEBRUARY, 1992  
GROUND FLOOR EAST ELEVATION

SURKHI (CEMENT) POINTING  
LOST CARVING  
SPREAD TIMBER JOINT (>1")

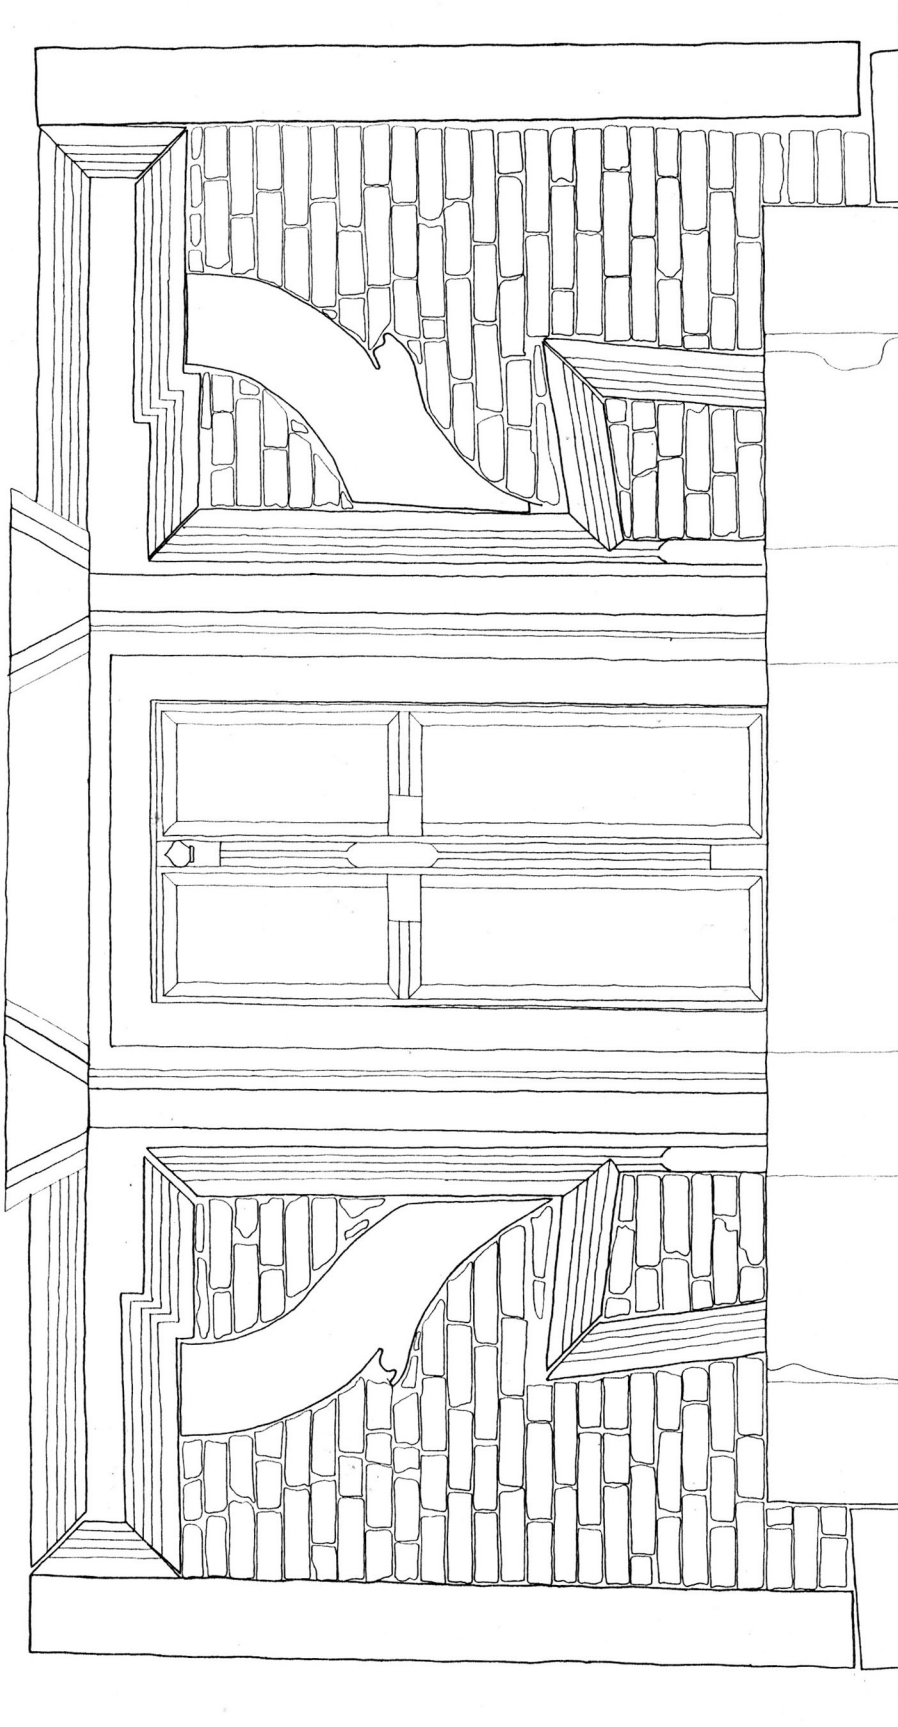
**RADHA KRISHNA MANDIR**  
PATAN DARBAR WORLD HERITAGE SITE  
EXISTING CONDITIONS: FEBRUARY, 1992  
GROUND FLOOR SOUTH ELEVATION

SURKHI (CEMENT) POINTING  
LOST CARVING  
SPREAD TIMBER JOINT (>1")

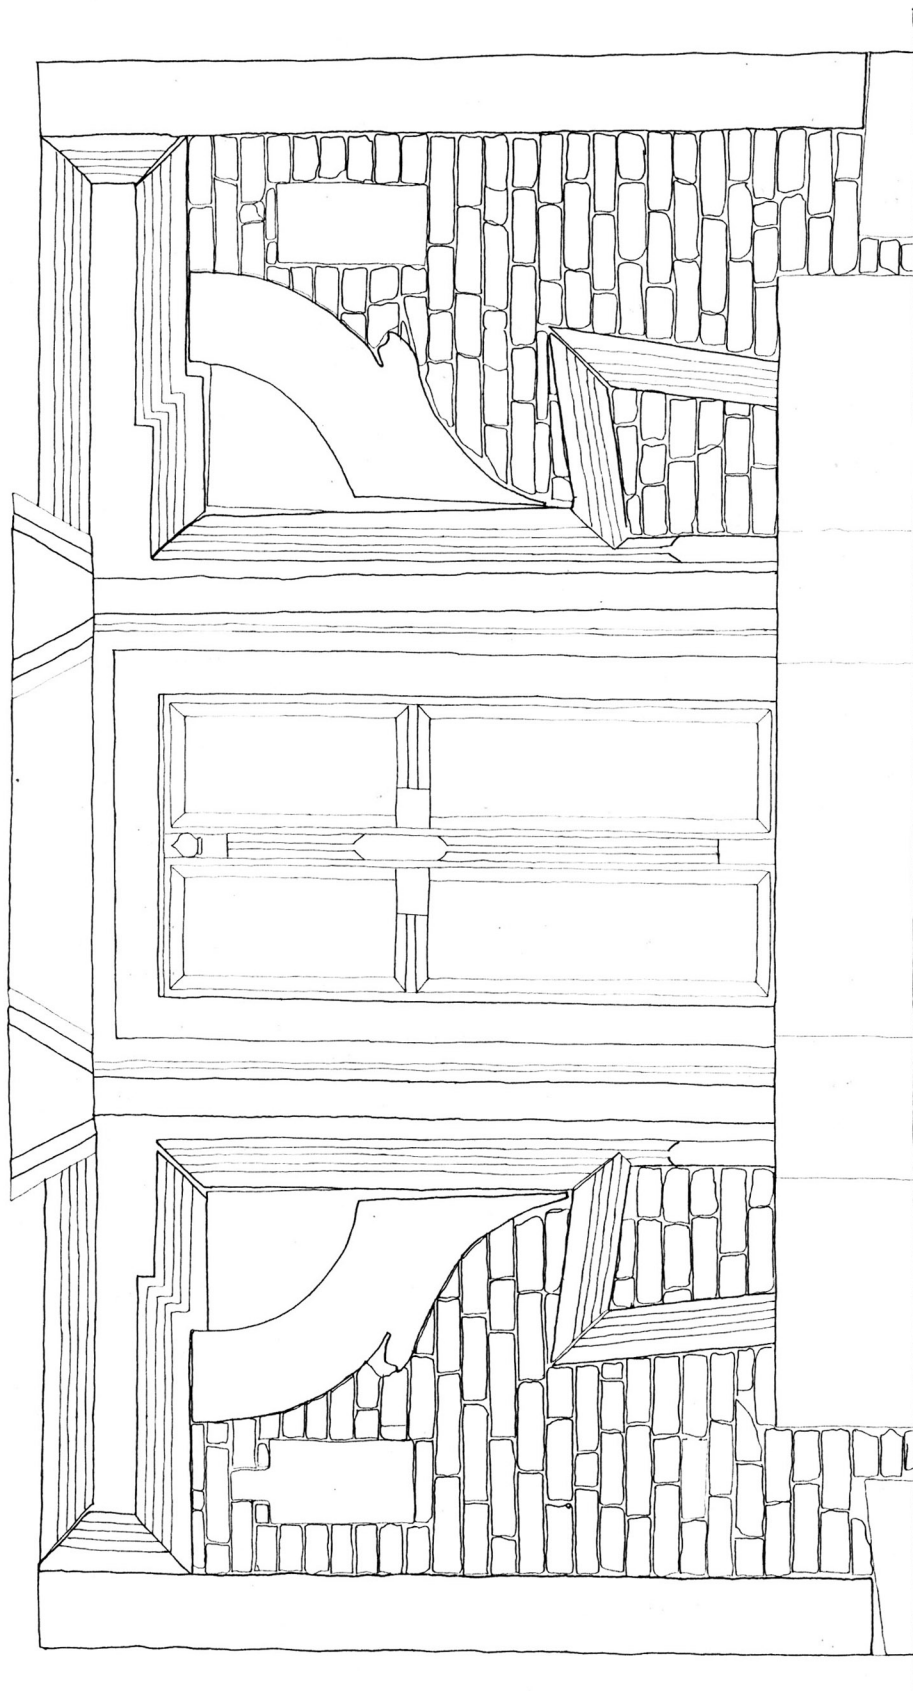
**RADHA KRISHNA MANDIR**  
PATAN DARBAR WORLD HERITAGE SITE  
EXISTING CONDITIONS: FEBRUARY, 1992  
GROUND FLOOR WEST ELEVATION

SURKHI (CEMENT) POINTING  
LOST CARVING  
SPREAD TIMBER JOINT (>1")

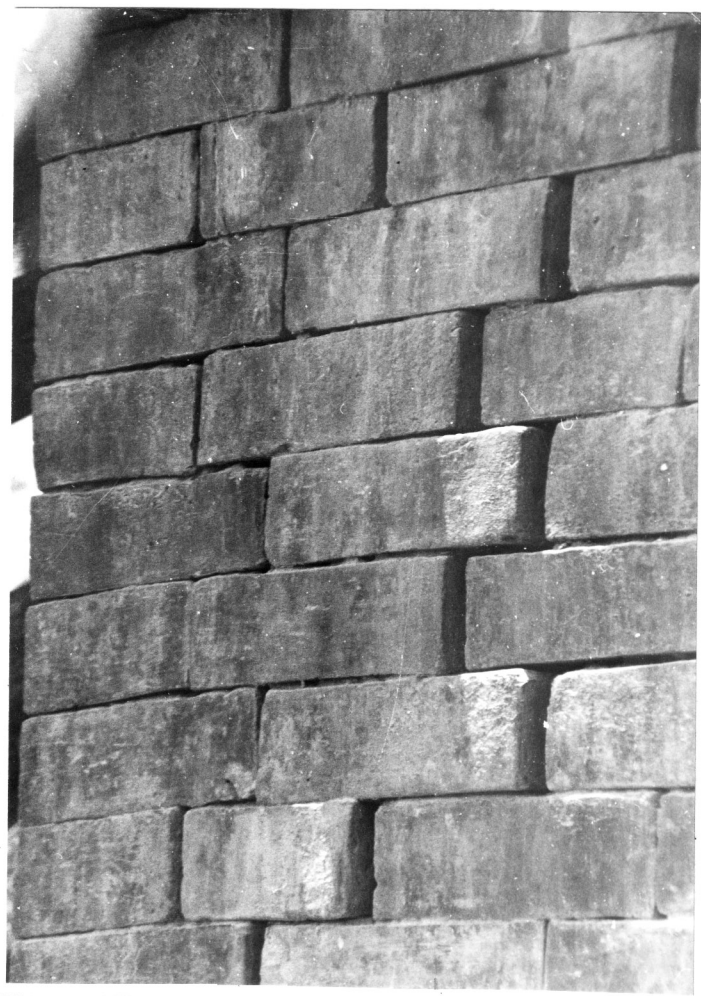
#### WALL CRACKS

LEFT: SOUTH ELEVATION UPPER BASE STORY, RIGHT SIDE. RIGHT: DETAIL OF MIRROR IMAGE CRACK, SOUTH ELEVATION, LEFT SIDE.

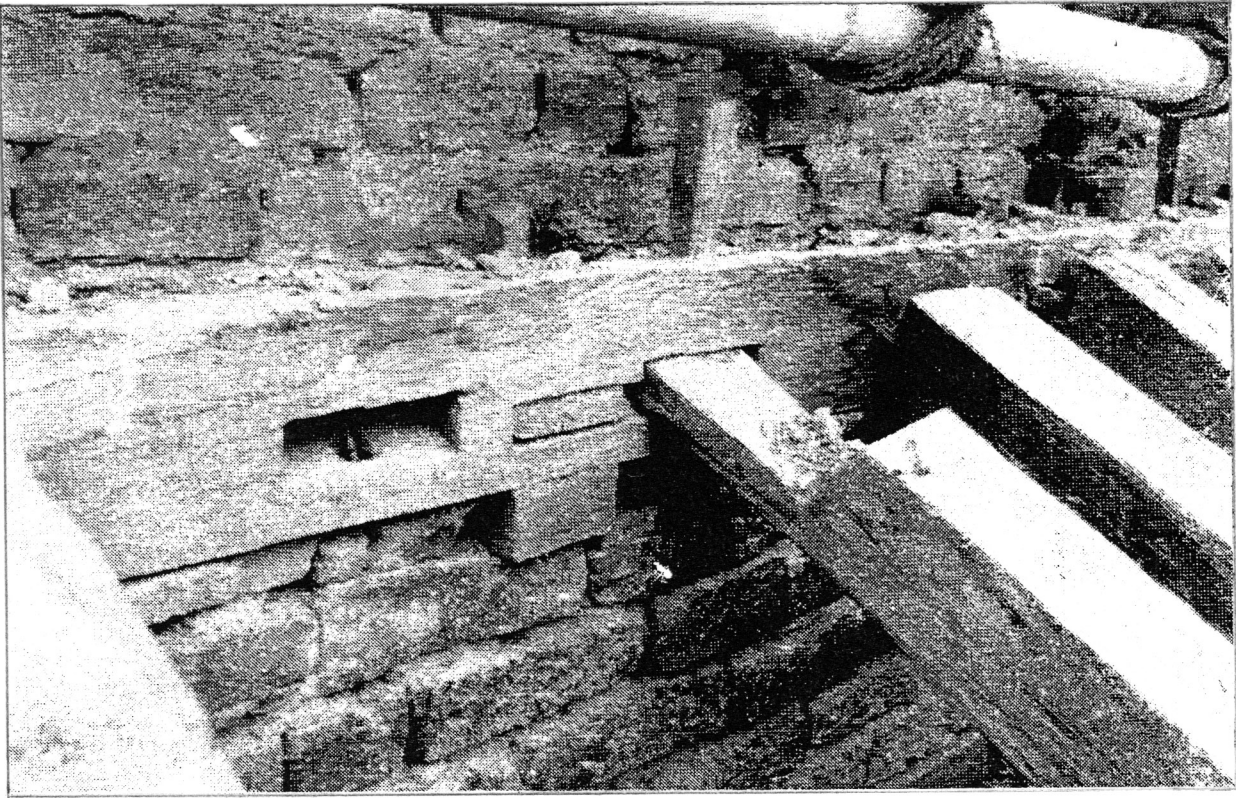
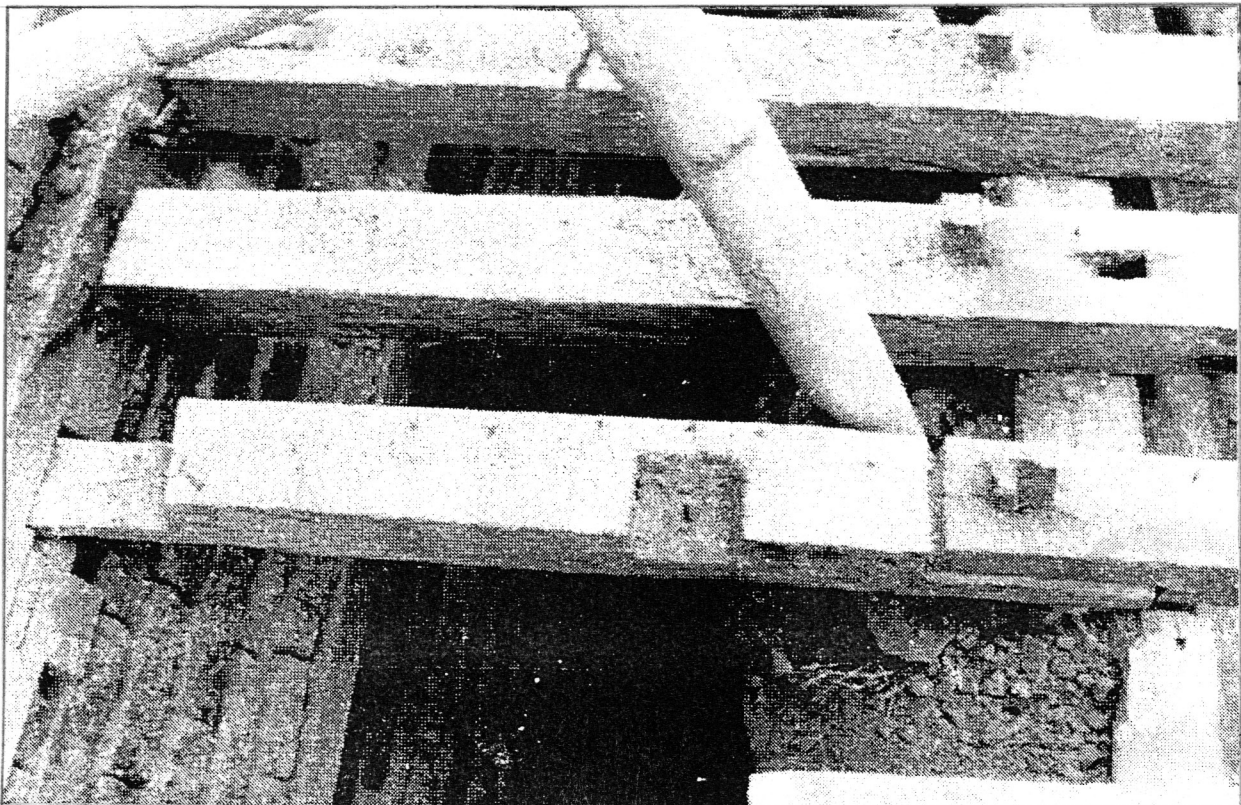
**Timber joinery from 1967 repairs at Radha Krsna Temple.**

Sloppy repairs and rebuilding in the last century have endangered many buildings. Above: where rafters meet upper walls of the temple, tenons have been drastically undercut, rendering the joint useless. Below: rafters (often made up of two lengths) are joined in a structurally irrational configuration: the lap joint is reversed, so that the lower length of rafter is held in place only by the small timber peg.

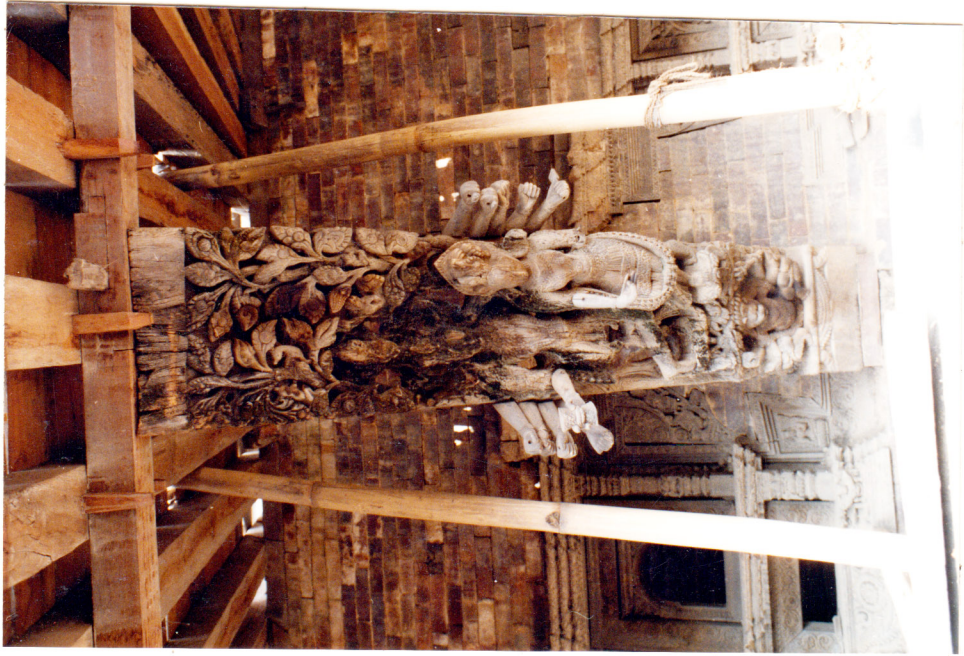
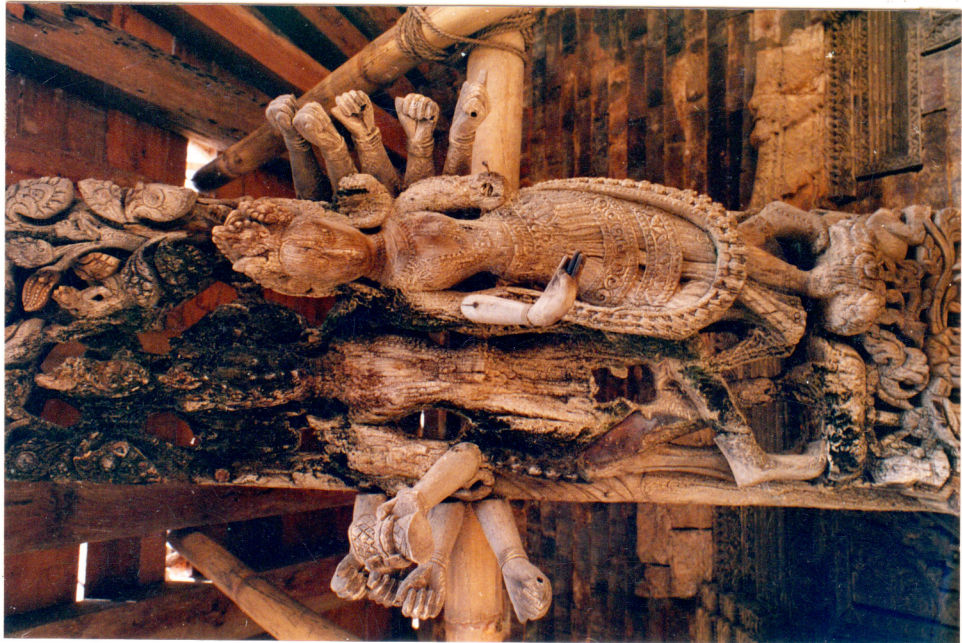
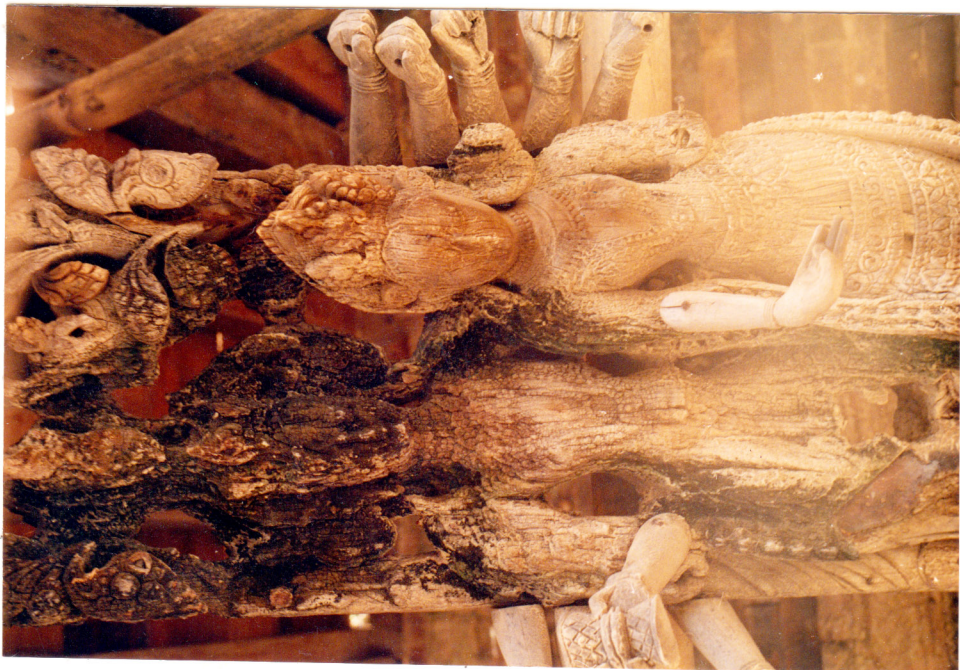
LOWER ROOF STRUT 107: DOCUMENTATION OF MILDEW AND WET ROT, MARCH, 1992.

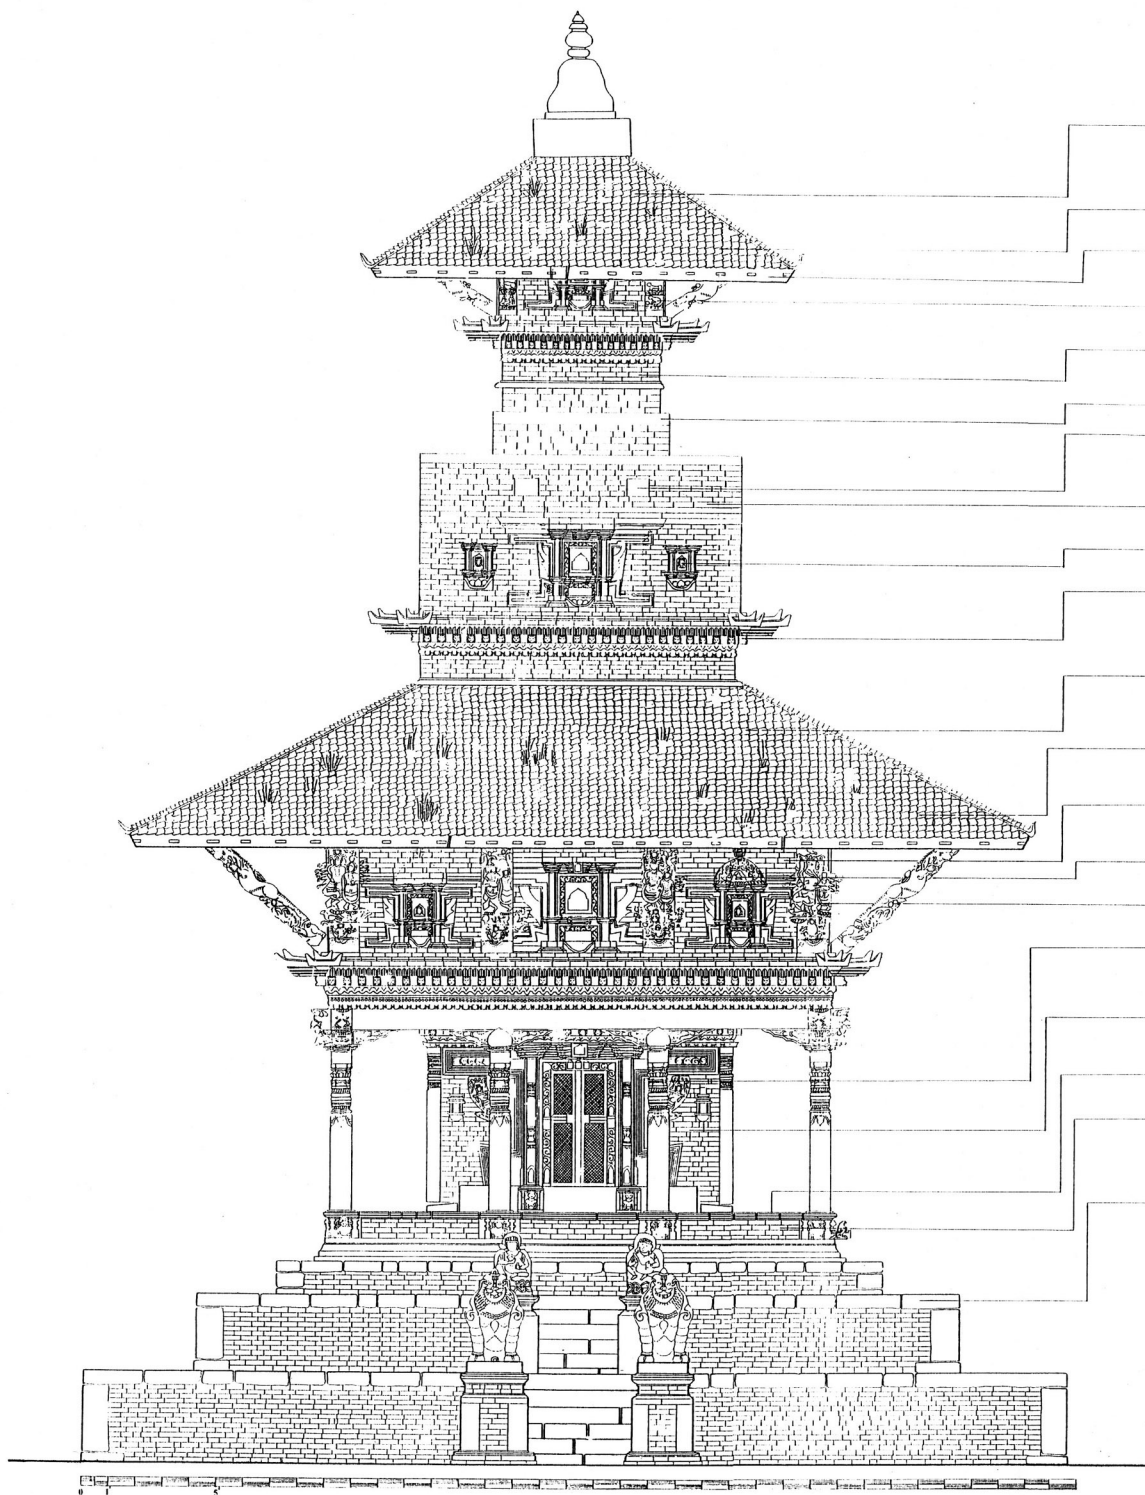
**GUARDIAN LION (LEFT):**  
**LICHEN GROWTH, FEBRUARY, 1992.**

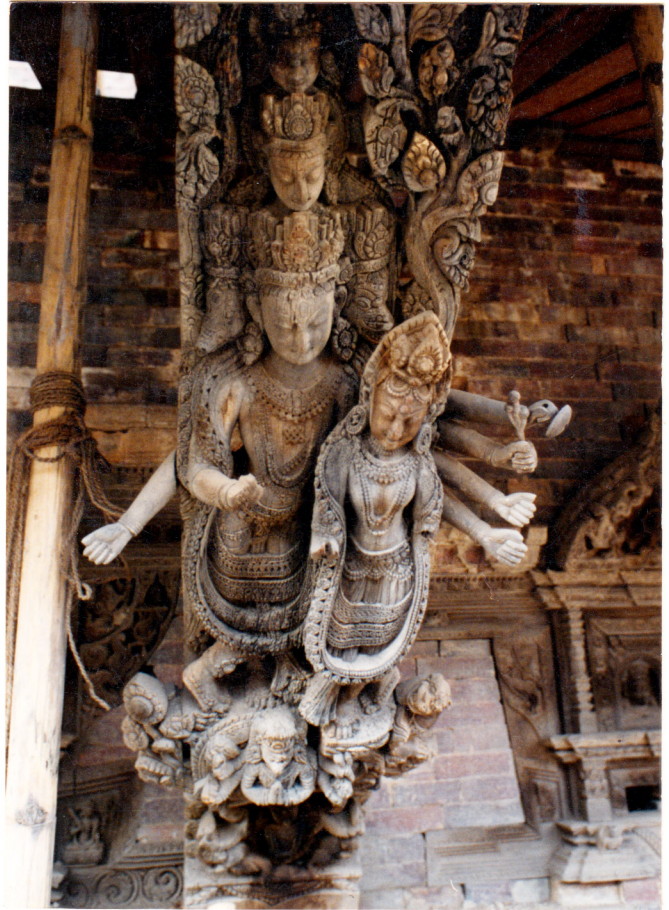
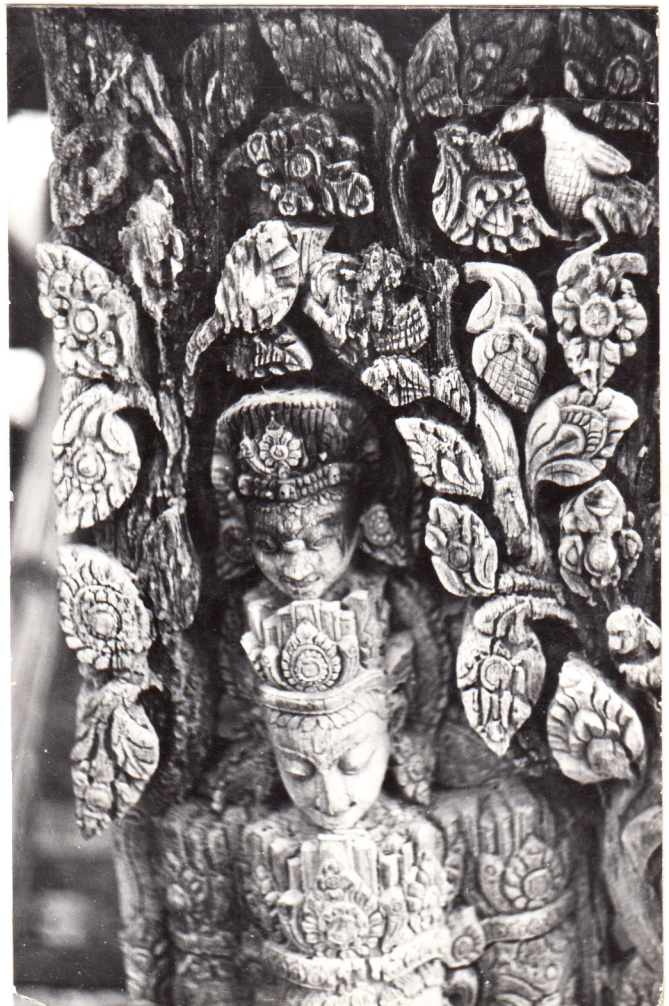
**BOTTOM ROOF  
STRUT: 103  
ELEVATION: EAST  
AGE: ORIGINAL (1668)**

- Hands : Male: Right 1 hand original, 3 misfitted, 2 lost; Left: 1 original, 5 misfitted;
- Female: Right 1 hand original; Left misfitted.
- Weapons of hands lost.
- Structurally o.k.
- Mildew problem is mainly on the lower figures and upper most head (App. 36sq. in.)
- Green mould is seen in some part of the male figures and uncarved top of the strut. App.80sq.in.
- Drapery is lost.
- Some 1"x 3"x 8" piece is broken off at top-most end of the strut.

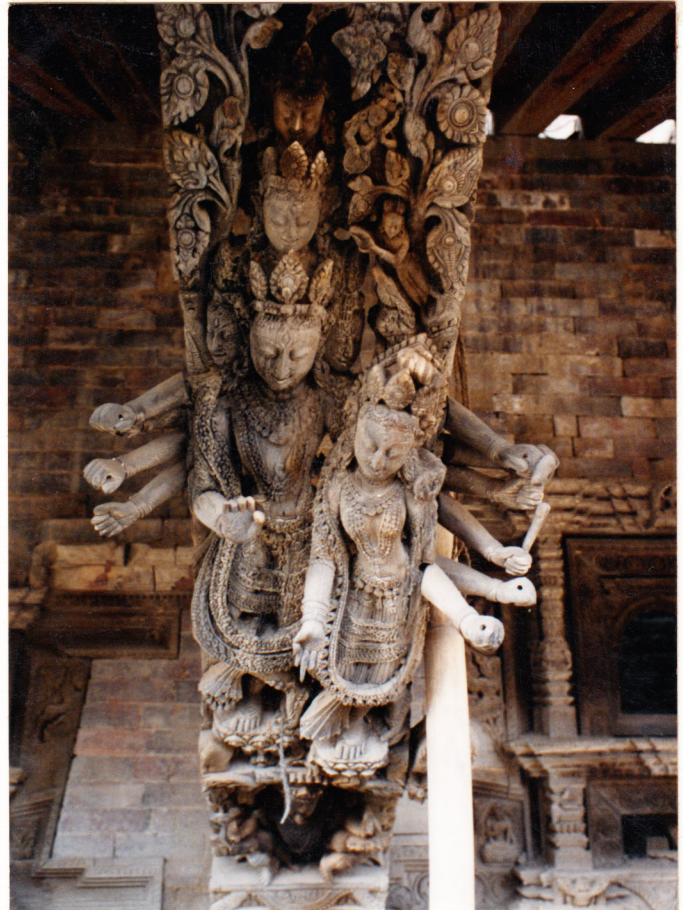
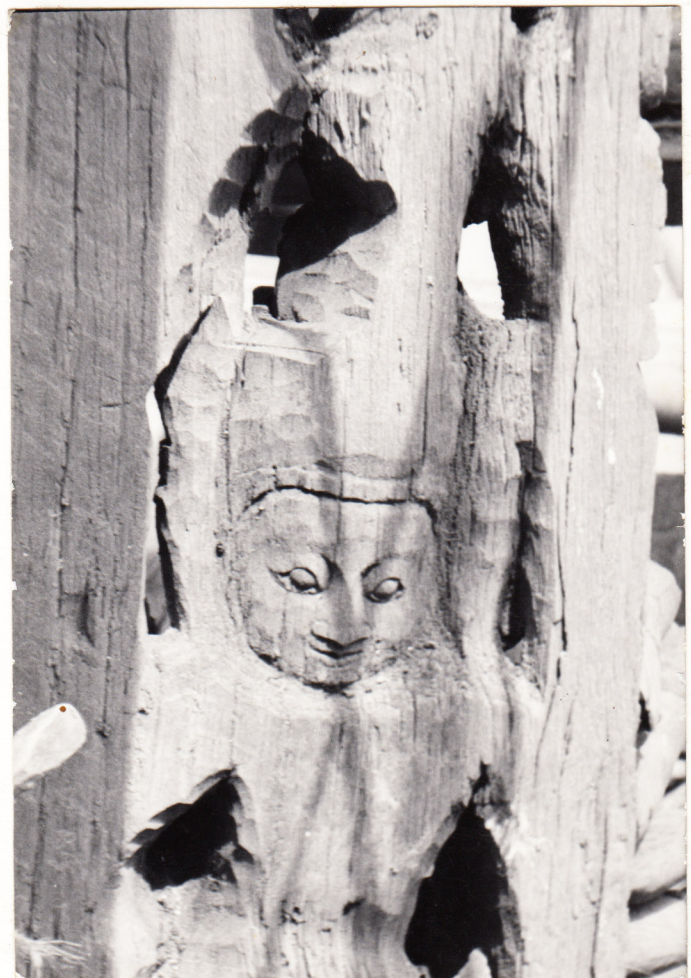
**BOTTOM ROOF  
STRUT: 104  
ELEVATION: EAST  
AGE: ORIGINAL (1668)**

- Structural condition is good.
- Mildew problems on leaves, tiny monkey, on female face ornaments of female figure as well as on the base scene. (App.1sq.ft.)
- Hands- Male-Right; 2 original hands, 3 misfitted, 1 lost; Left; 5 original hands, 1 misfitted. Female- both original, fingers are broken on both hands.
- Right side drapery is lost, left intact.
- Male figure's right leg is loose, because of timber shrinkage.

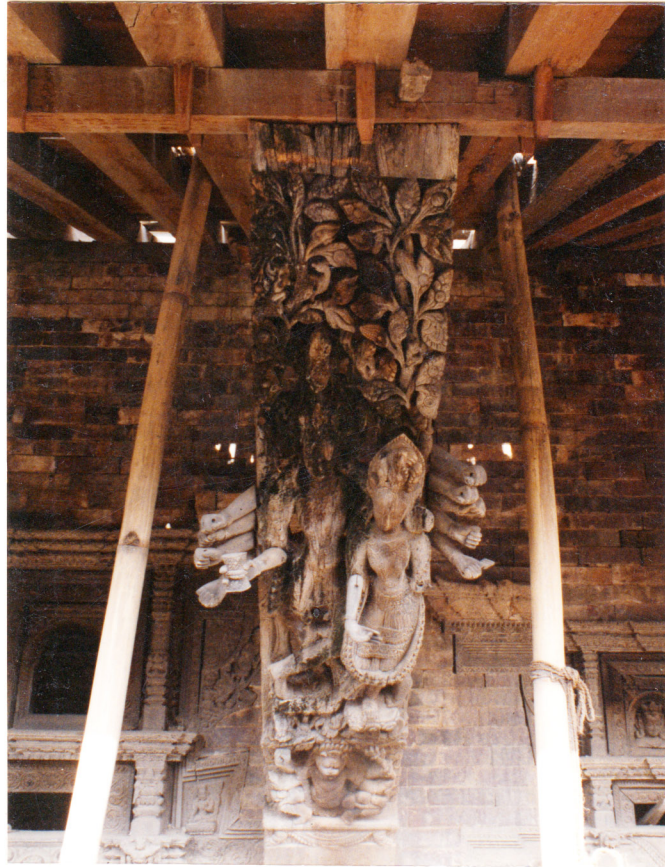
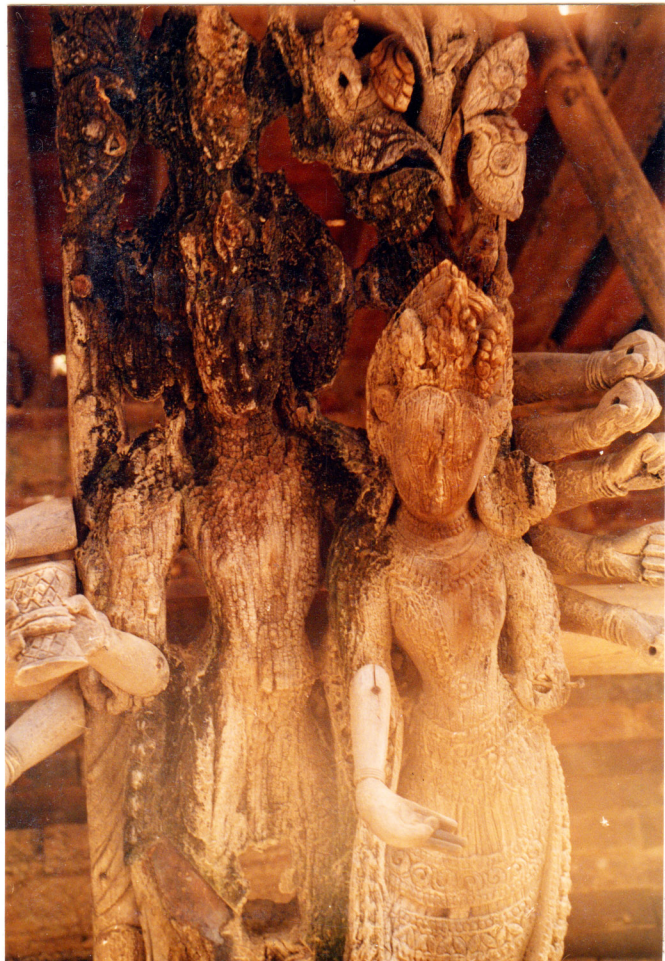
**BOTTOM ROOF  
STRUT: 108  
ELEVATION: SOUTH  
AGE: 1967**

- Structural condition is good.

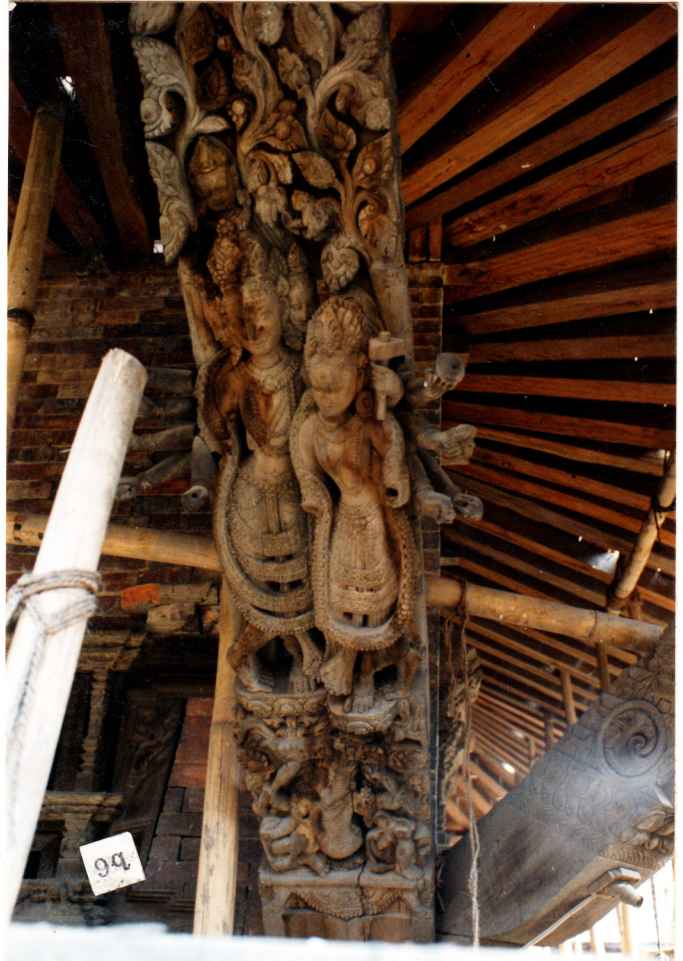
**BOTTOM ROOF**  
**STRUT: 112**  
**ELEVATION: WEST**  
**AGE: ORIGINAL (1668)**

- Head, hands, weapons, and drapery are lost. (Above head all the part are lost, 29" upper portion is lost.)
- Strut has been stored on the ground at the back of Sattal beside Swatha Narayan Temple.
- Structurally condition needs closer study to determine how extensive denaturing from wet rot has penetrated.

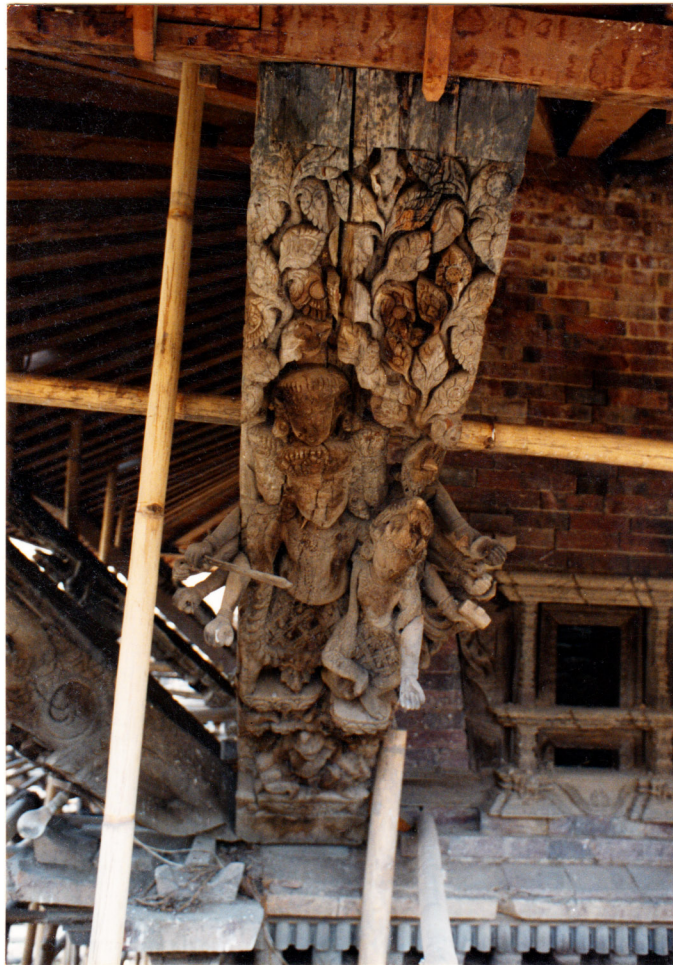
**BOTTOM ROOF**  
**STRUT:116**  
**ELEVATION: NORTH**  
**AGE: ORIGINAL (1668)**

- Structural condition is good.

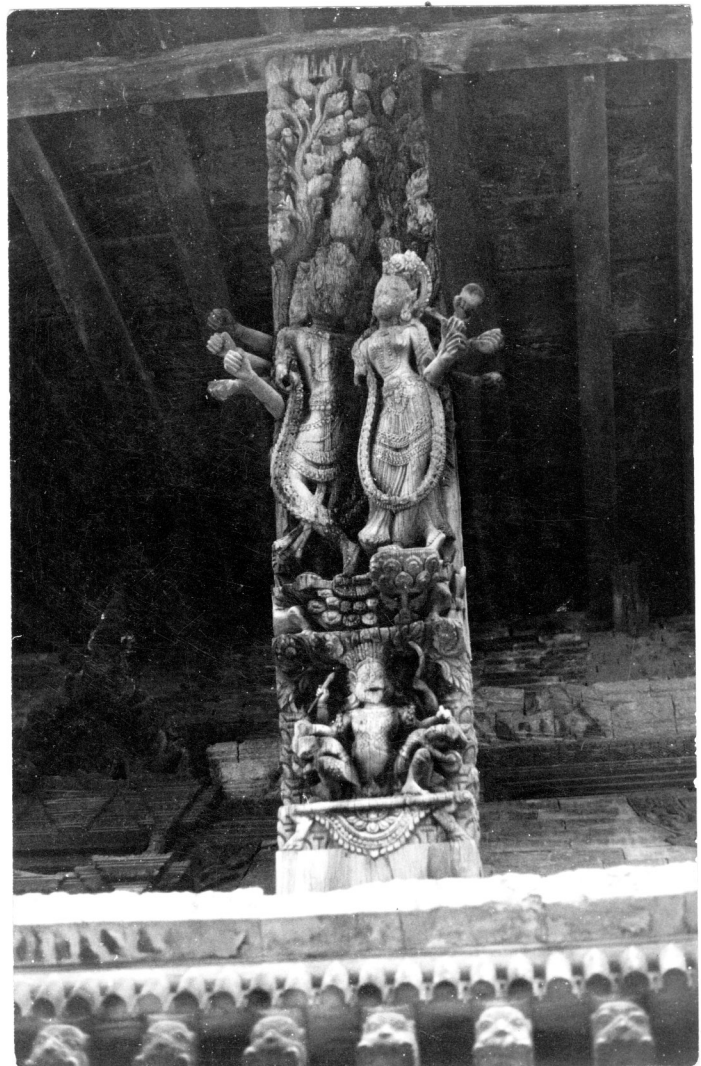
**BOTTOM ROOF**  
**STRUT:119**  
**ELEVATION: NORTH**  
**AGE: ORIGINAL (1668)**

- Structural condition good.

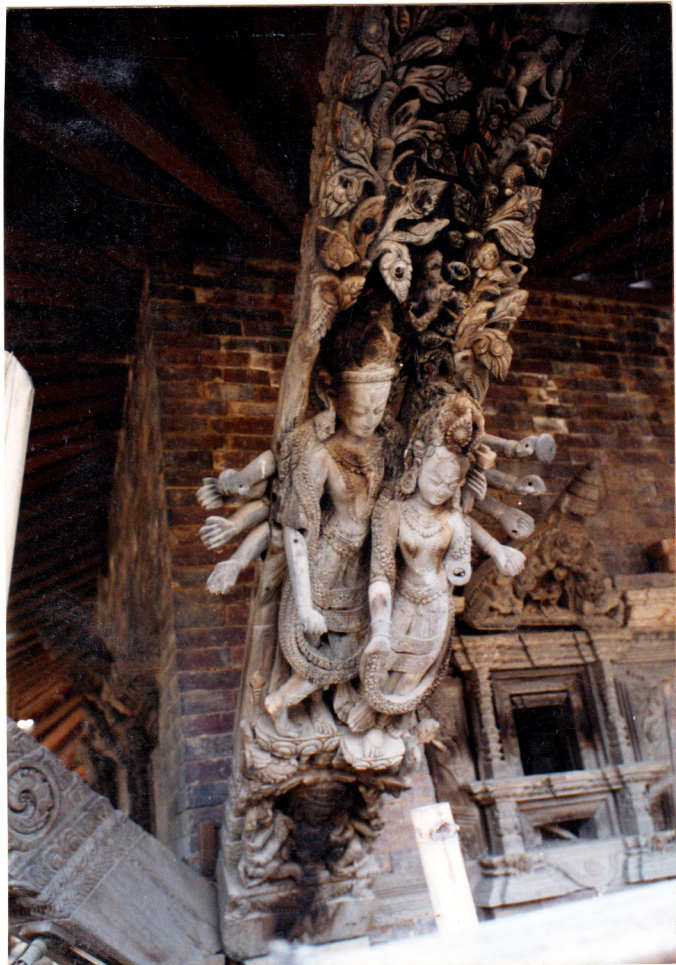
**BOTTOM ROOF  
CORNER STRUTS:  
105, 110, 115, 120  
AGE: ORIGINAL (1668)**

- All four corner struts are structurally sound.
- Mildew problems mainly on the base scene with few patches on the body of the main figures and on the Garuda mounts.

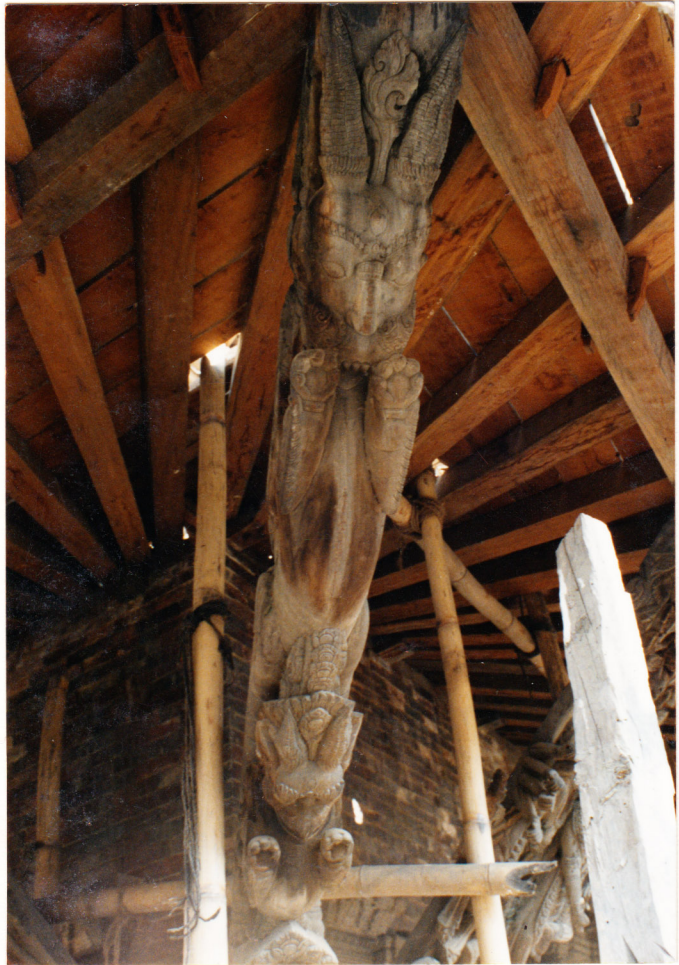
**MIDDLE ROOF  
STRUT: 201  
ELEVATION: EAST  
AGE: 19th C.**

**CONDITION:**  
-HANDS: eight hands (all lost).  
- Mildew problem on leaves, crown and face.  
- Structurally o.k.  
- All hands lost.  
- Draperies also lost.

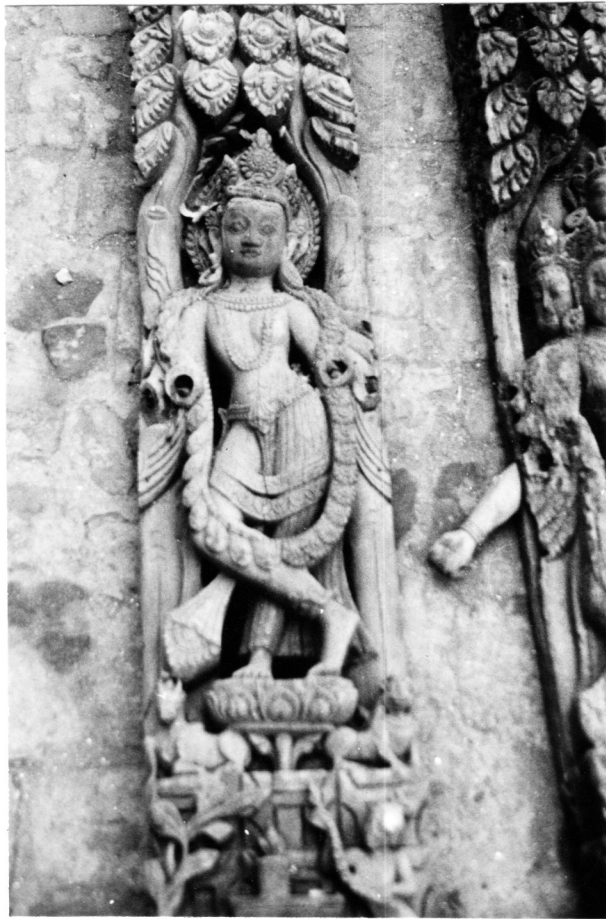
**MIDDLE ROOF  
STRUT: 202  
ELEVATION: EAST  
AGE: 19th CENTURY**

**CONDITION:**  
- Mildew problems on leaves and face.  
- Structurally o.k.  
- All hands are lost.  
- Drapery also lost.

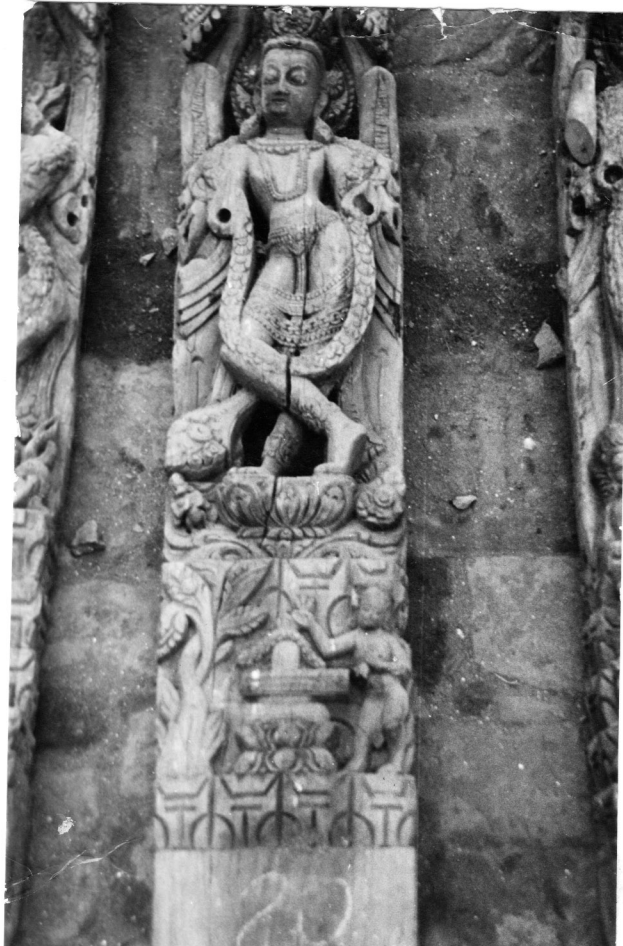
**MIDDLE ROOF**  
**STRUT: 203**  
**ELEVATION: EAST**  
**AGE: 19th CENTURY.**

- Surface decoration and ornaments have been removed.
- One portion has broken off (App.3"x 6"x 2") at the top of strut, but not structurally threatening.
- All the hands lost.
- Draperies also lost.

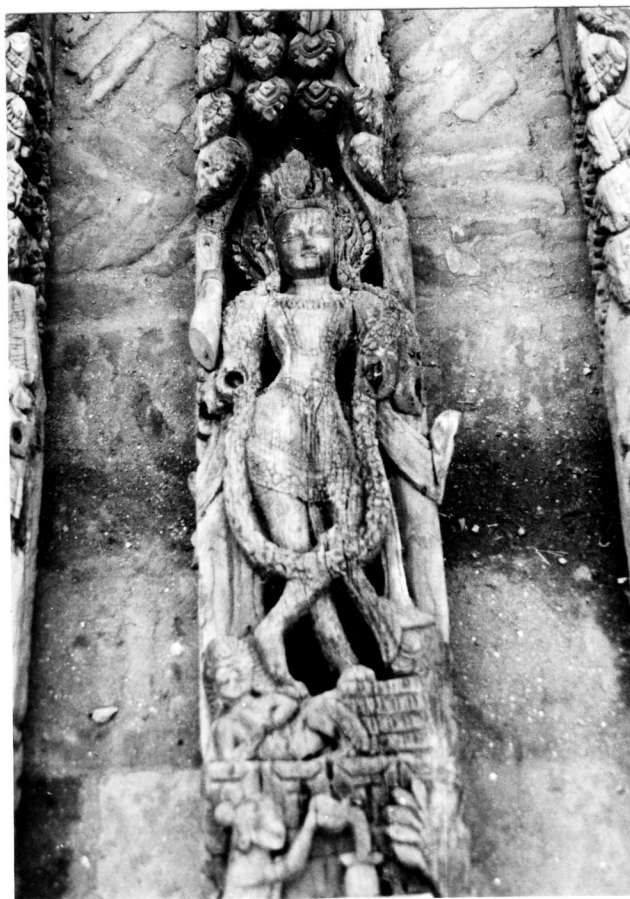
**MIDDLE ROOF**  
**STRUT: 204**  
**ELEVATION: EAST**  
**AGE: 19th CENTURY**

- Structural condition is good.
- All hands lost except one which is not joined hand.
- Draperies are also lost.

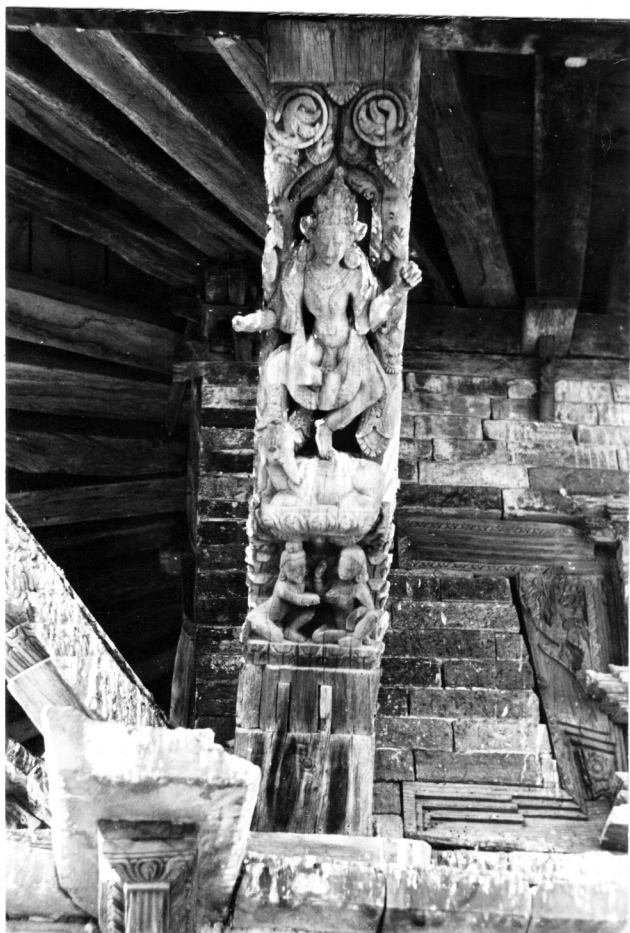
**TOP ROOF  
STRUT: 304  
ELEVATION: EAST**

**CONDITION:**  
- Structurally sound.  
- Scoured by wind and rain.  
- All hands are lost.  
- Stained by pigeon guano, scoured at back as well. Typical of all upper roof struts.
