**RADHA KRISHNA TEMPLE**  
**SWATHA TOL, PATAN**

**HISTORIC STRUCTURES REPORT**  
**MARCH, 1992**

**ERICH G. THEOPHILE**  
**ROHIT K. RANJITKAR**  
**KATHMANDU VALLEY PRESERVATION TRUST**  
**IN COLLABORATION WITH**  
**HIS MAJESTY'S GOVERNMENT**  
**DEPARTMENT OF ARCHAEOLOGY**

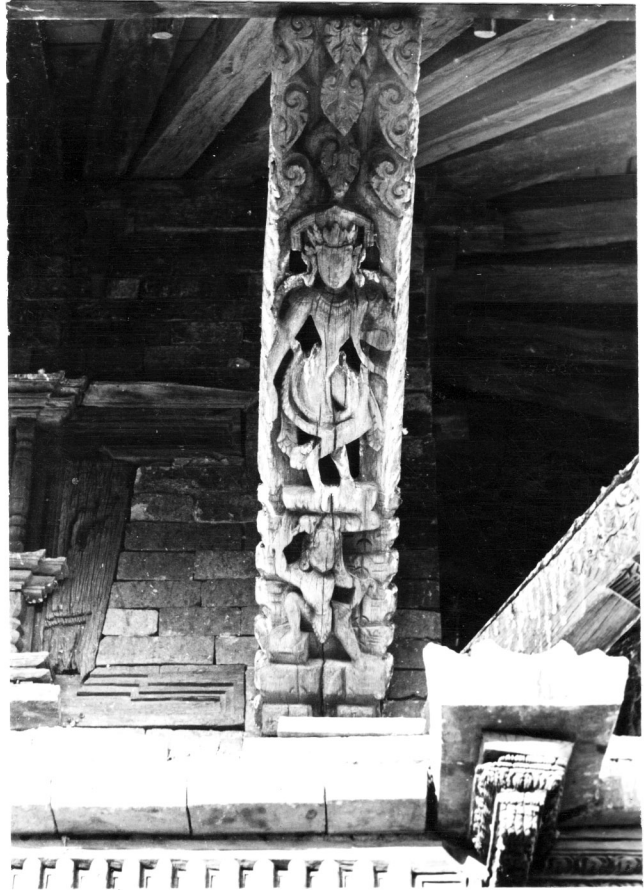
**TOP ROOF  
STRUT: 305  
ELEVATION: SOUTH  
FROM ANOTHER TEMPLE  
AGE: 19th C.**

**CONDITION:**  
- Structurally sound.  
- All hands are lost.  
- Stained by pigeon guano.  
- Added timber at base. See notes #301.

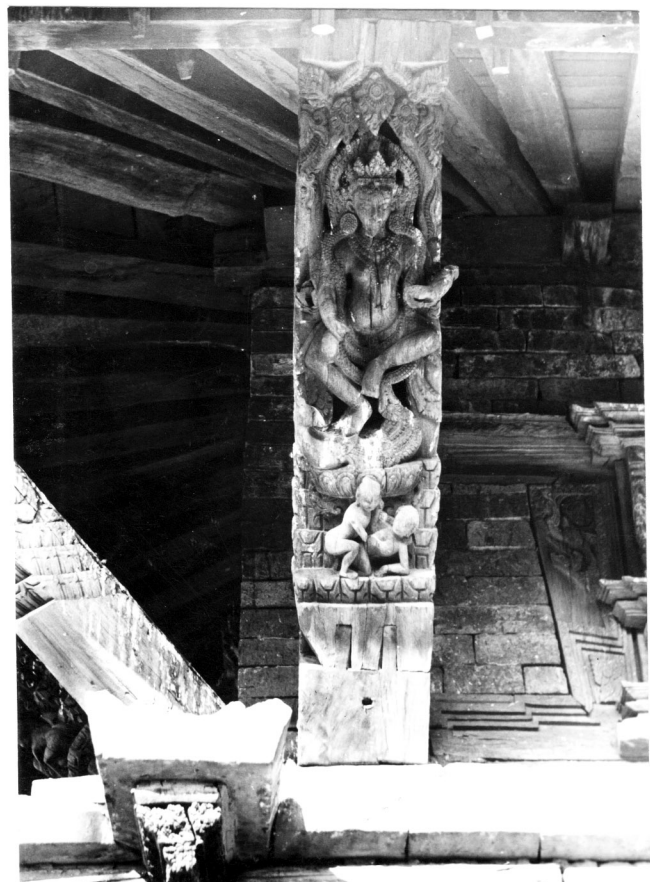
**TOP ROOF**  
**STRUT: 307**  
**ELEVATION: WEST**  
**FROM ANOTHER TEMPLE**  
**AGE: 19th C.**

**CONDITION:**  
- Structurally sound.  
- Seasoning crack (vertical) lower 2/3 of strut.  
- All hands are lost.  
- Stained by pigeon guano.  
- Added timber at base. See notes #301.
