THE PATAN ROYAL PALACE RESTORATION AND CONSERVATION PROJECT

## SUNDARI COK

CONDITION REPORT  
OF THE  
WOODEN CARVED ELEMENTS IN THE COURTYARD

JULY 2007

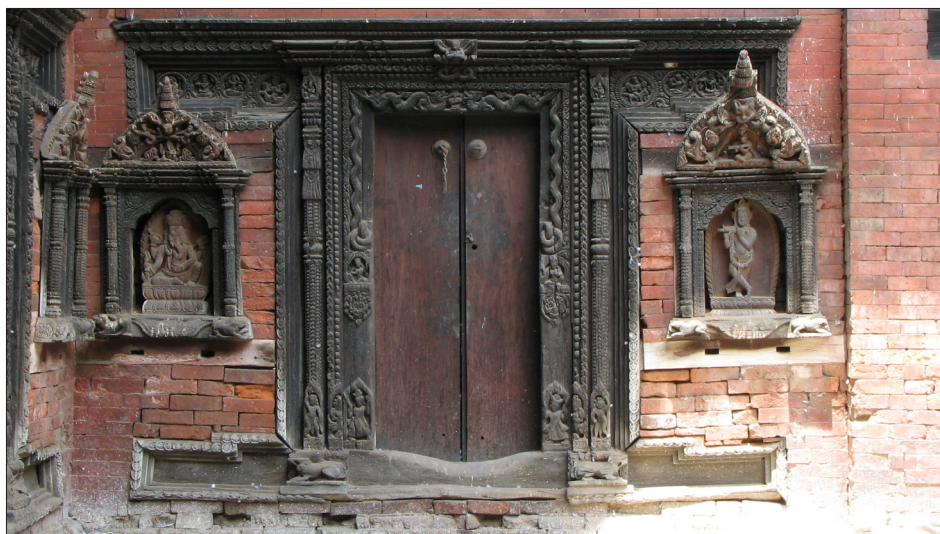
### 2.5.D.01

The structure is in fair condition. Elements of the outer frame at the doorsill are missing. The whole threshold of the door has weathered with the wood more eroded at the centre and there are breakage at the heads of the carved lions. There several breakages namely one at the ritual pot on the left jamb, one at the end of the cornice on top of the door and another at the bottom of the outer frame at the projecting end of the lintel. Lower portion of the entire construction has bleached up to the 14th layer of brick from below. The joints are not properly fitted and are open. Minor cracks are visible in the left inner jamb.

The entire carved outer frame element at the base of the threshold needs to be replaced and carved with lotus leaves pattern copied from the original remaining detail. The vertical element of the outer frame on the left projecting end of the door sill has to be readjusted.

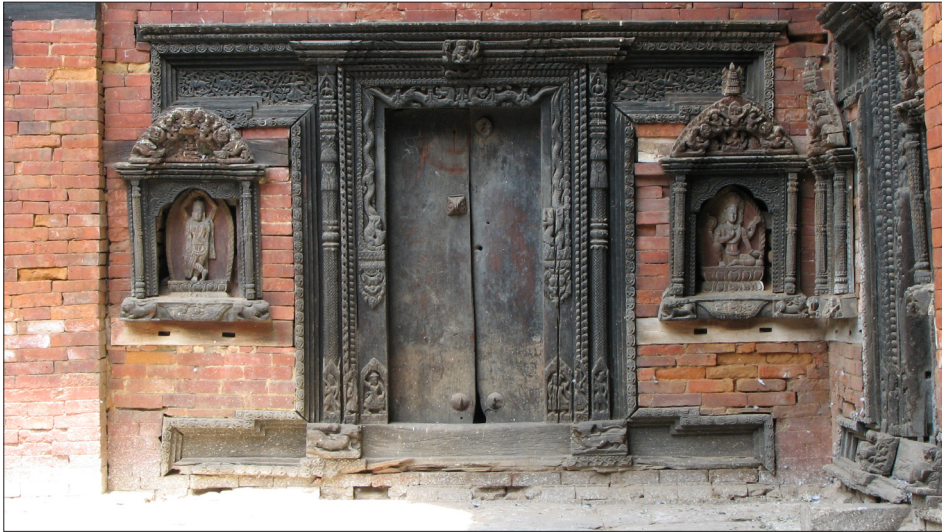
**2.5.D.02** Door frame-original / authentic, Shutters-original

The structure is in fair condition. The entire outer frame at the sill level has 80% breakages and elements at the left portion are missing. Both bases of the pillars are heavily weathered making the carvings unrecognizable. The left door shutter has a major breakage. There is a large vertical crack on the left inner jamb

The bottom section of the outer frame has to be replaced with a new one with detail copied from the existing design on the frame. The left vertical element of the outer frame at the threshold has to be readjusted.

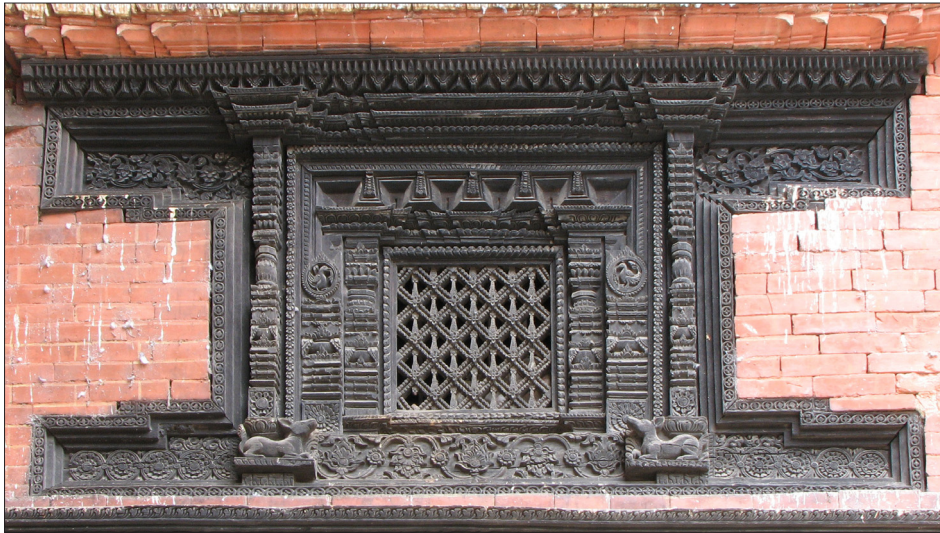
| | | <p><b>Conditions</b></p> <p>Construction is in a good condition. The entire construction is original including the lattice. The sill show a large horizontal crack which extends to its projecting ends. 25% of the the mouse tooth pattern has breakages.</p> <p><b>Recommendations</b></p> <p>Only cleaning of the elements is required. The window should be cleaned with the method described at the end of the report.</p> |

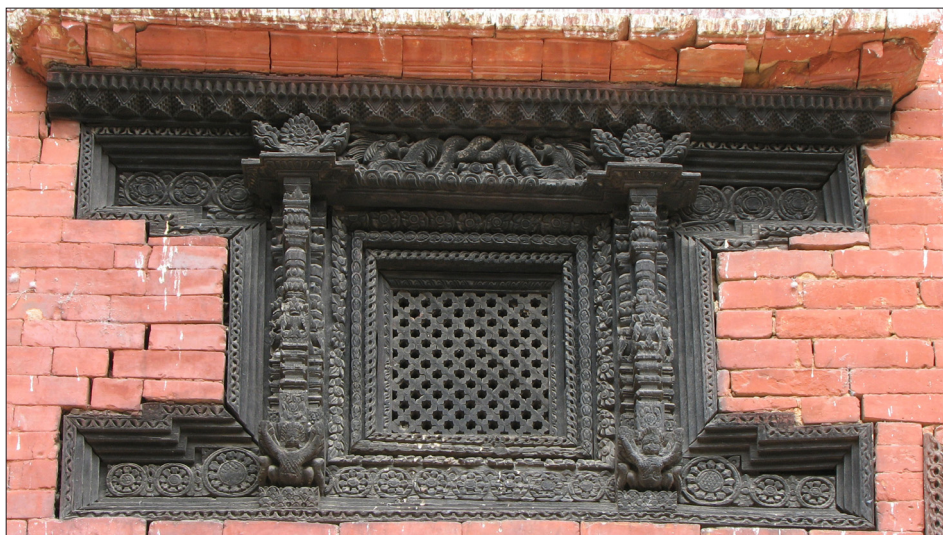
## 2.5.W.02

The structure of the window is in a good condition. However, the lower portion of the sill and the inner frame have weathered 40%. Cracks are evident in the sill. The left projecting end at the base has given in under the pressure of the brick work and has slightly deformed.. Studying the pattern of lattice in the window symmetrical to this one on the same facade (which is more elaborately carved), we can say that this lattice is not original and was added only after the earthquake.

One alternative is to retain the existing latticework, since it has some history attached to it. Another option is to recarve the latticework with reference to the authentic one in the 2.5.W.04. The deformed section of the projecting sill needs to be readjusted.

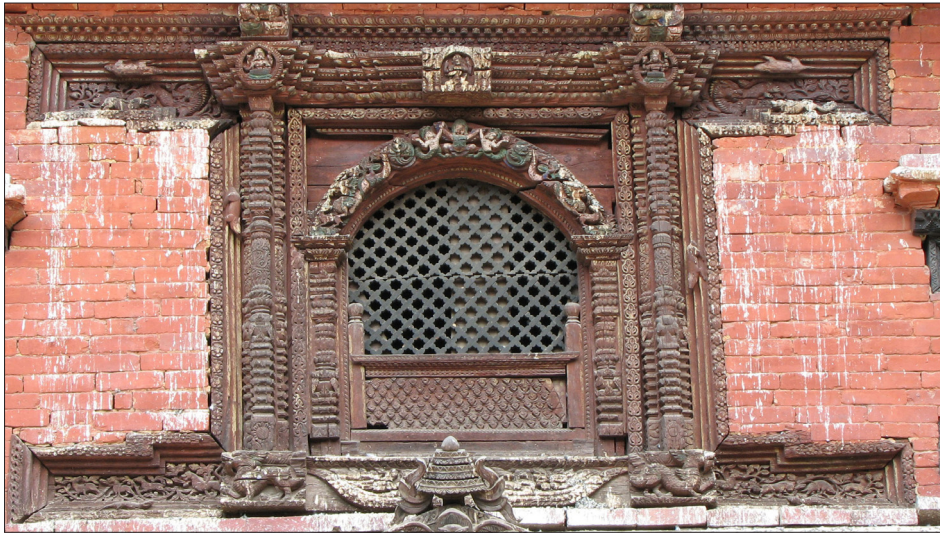
| <b>2.5.W.03</b> | Frame-Original, Shutters are lost and replaced with lattice |

The structure is in a good condition. The frame is authentic but the shutters are lost and has been replaced with two plain pieces of lattice. This has been crudely nailed from inside. There is a large horizontal crack in the left projecting lintel. Likewise, similar cracks are visible at the pillar bases. Lower section of the sill and the projecting ends have weathered. The vertical member of right end of the outer frame at the sill is larger than the other sides and was probably replaced. Both bases of the inner supports are missing. Latticework in the corners above the round arch has been replaced with plain planks. Studying the similar windows in other facades, one can conclude that the window apron too was changed. A coat of paint covers the wood.

Replace the vertical member of right projecting sill of the outer frame with a new one carved with the original lotus flower motif. Recarve new carved bases for the inner support in the traditional pattern with reference to the bases at 2.7.W.03. Recarve the diagonal lattice for the corners above the arch, the apron as well as the shutters taking into account the details in 2.7.W.03.

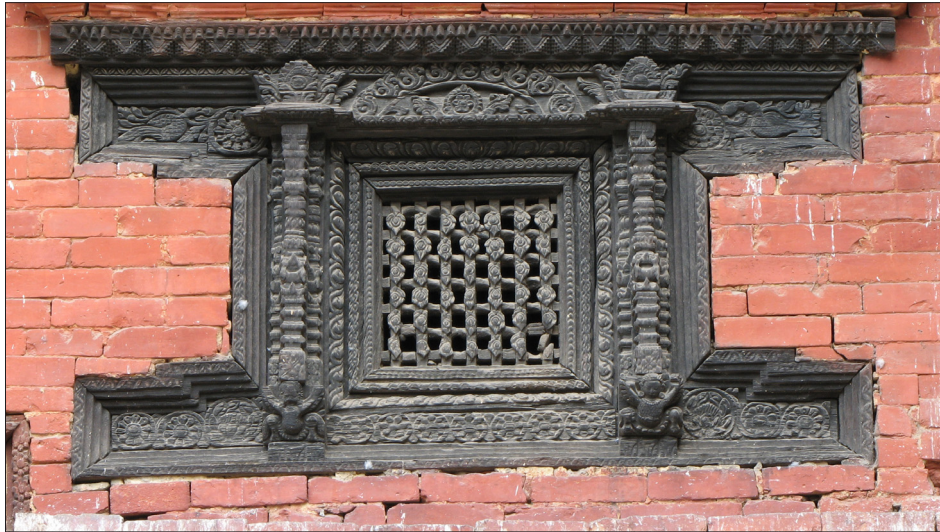
## 2.5.W.04

The structure is in a good condition. However, 60% of the window frame have slight weathering. Weathering is seen in the outer frame, lower section of the sill and at pillars. The about 3 inches of left vertical component of the lattice has broken. There are 40% breakages at the mouse tooth pattern.

The damaged piece from the vertical member of the lattice needs to be repaired. Cleaning of the elements should be carefully done using first a dry brushing and with the help of scalp hard and dried dirt should be removed

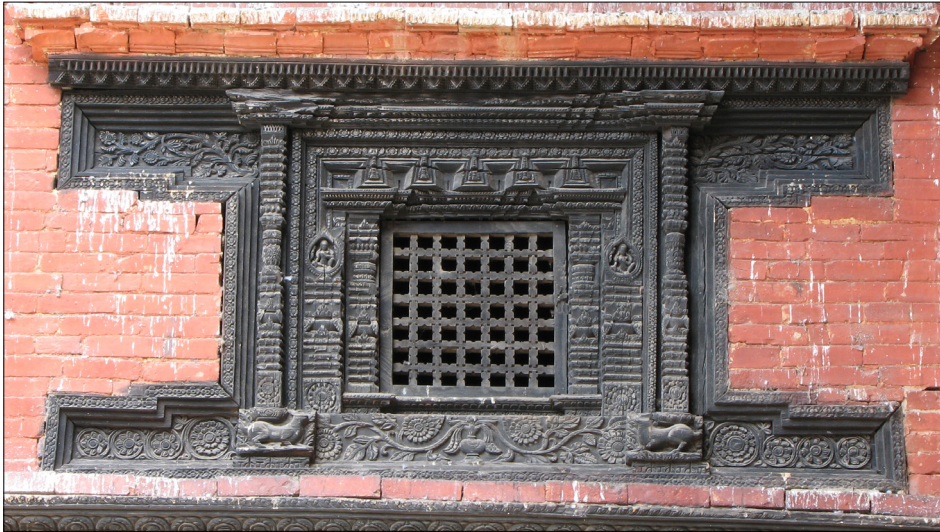
## 2.5.W.05 Frame-Original, Lattice added after the earthquake

The structure is in a good condition. The right part of the kulan above the pillar of the cornice is 80% damaged. About 1 feet long horizontal cracks isvisible in the inner frame at the nose pattern and a crack is also seen in the left projecting lintel. The lattice work is not authentic and has been added later only, studying its crude construction.

One alternative is to retain the existing latticework, since it has some history attached to it. Another is option is to recarve the latticework with reference to the authentic one in the 2.5.W.01.

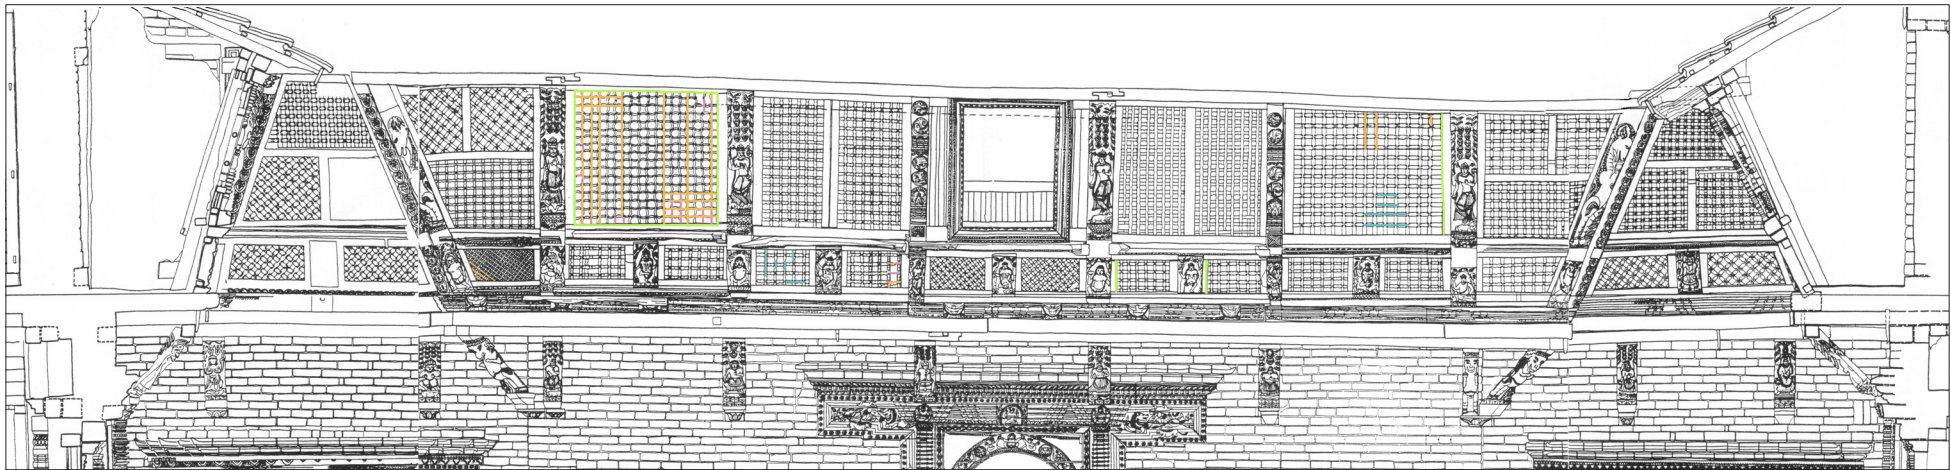
- 2.5.L.03 lattice seems original, but it doesn't fit into the frame. There are breakages on the vertical lattice support. A part at the bottom on the right is damaged and vertical and horizontal parts are missing. The frame is not original and probably made for this damaged lattice course where the lattice is broken. There are no slots to fix the lattice into the frame which is the case in traditional design.

- Completely replace this unauthentic lattice work with a copy of 2.5.L.03, which appears to be an authentic one.. Install it in a new frame done in traditional style with niches to hold the lattice

- Completely replace this unauthentic lattice work with a copy of 2.5.L.03. Install it in a new frame done in traditional style with niches to hold the lattice

- Repair and stabilize the old lattice and replace the missing parts. Make holes for fitting the lattice into the frame.
- Completely replace this unauthentic lattice work with a copy of 2.5.L.03. Install it in a new frame done in traditional style with niches to hold the lattice

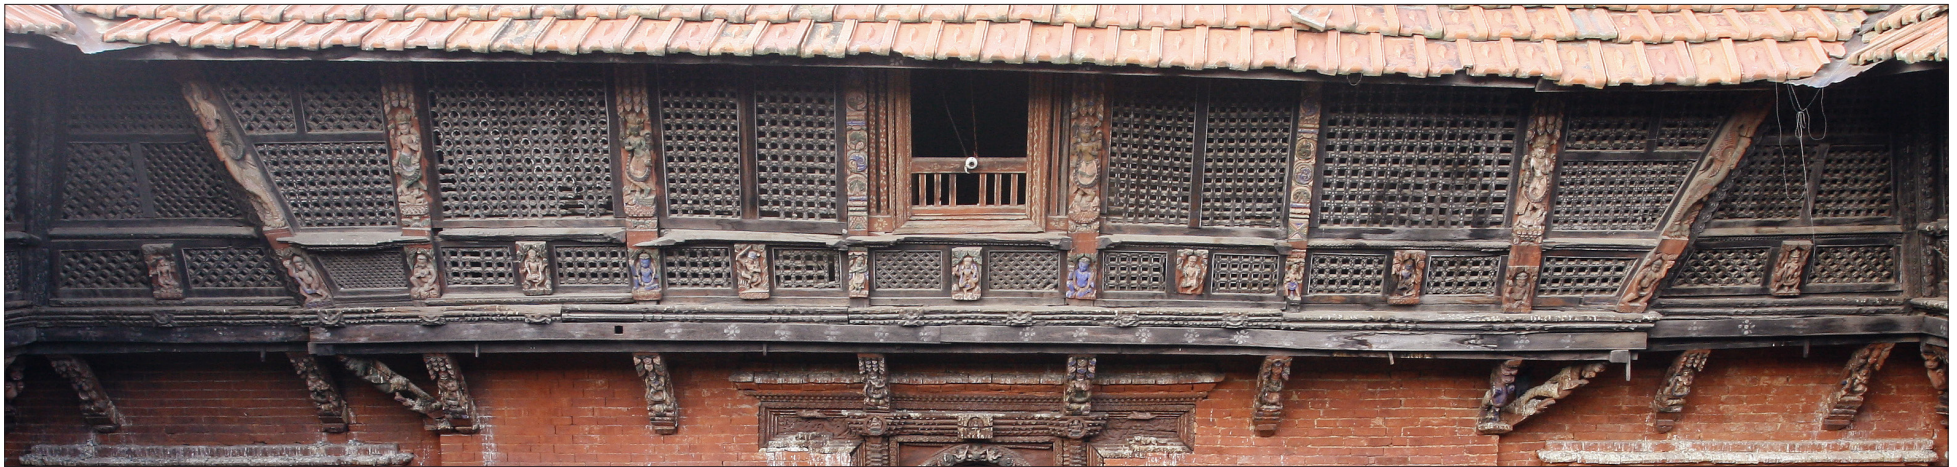
2.5.L.10 lattice is authentic but has no carved frame work, some of the bottom members are damaged. The frame is not fitting into the area between the struts

2.5.L.11 lattice is not authentic and has no carved frame work. There are breakages on the bottom at the right corners due to rotten elements, some of the vertical members are missing

2.5.L.12 lattice and the frame are not authentic. It is severely rotten on the backside. One vertical member is missing and some horizontal elements are damaged.

2.5.L.13 lattice is not authentic and has no carved frame work. But it is in good condition

Replace the frame as well as the lattice with new ones copied from 2.5.L.10, an original one

Refit and stabilize the lattice in the frame and recarve the missing parts

Replace the frame as well as the lattice with new ones copied from 2.5.L.10

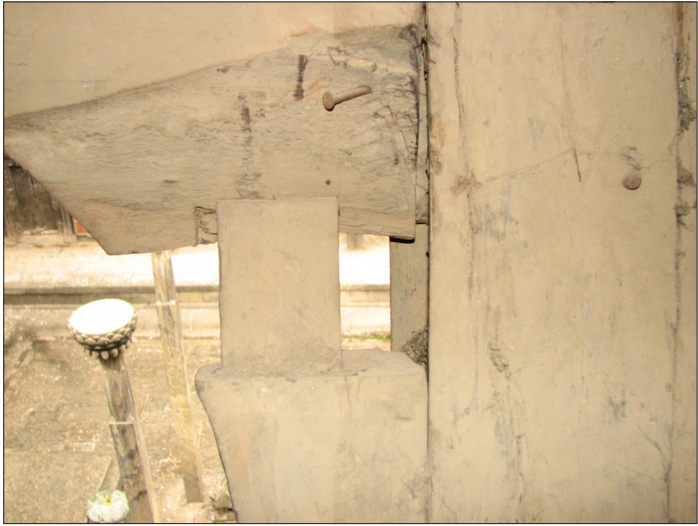
*damaged frame joint at 2.5.W.06*

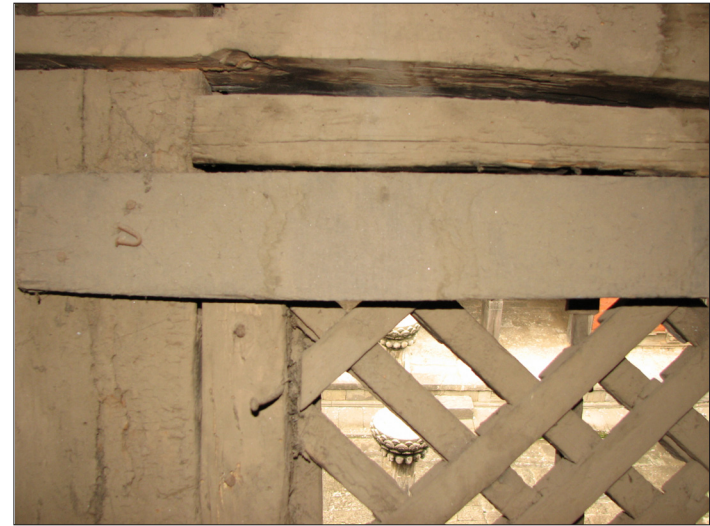
*low grade repair at the frame work 2.5.*

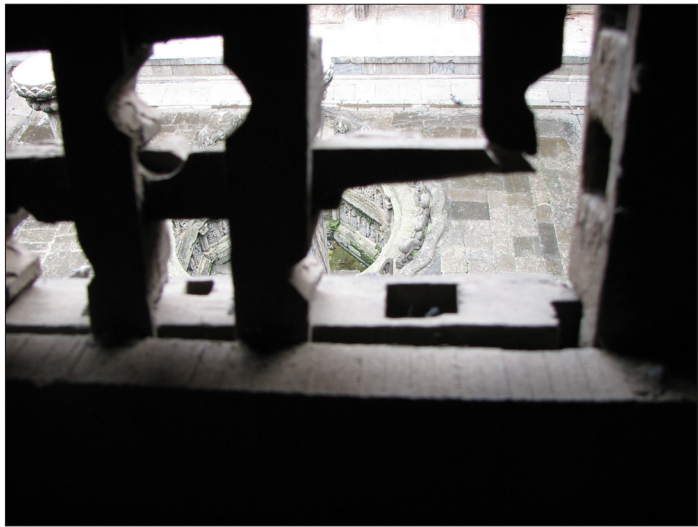
*damaged lattice 2.5.*

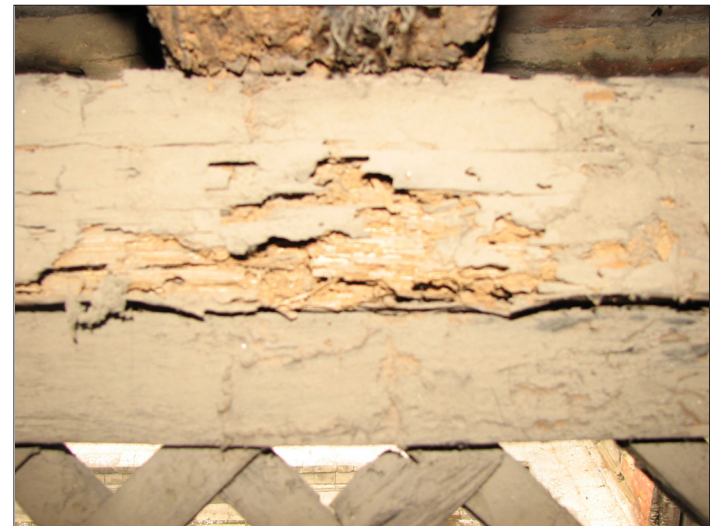
*rotten decay at 2.5.*
