# INDRAPUR TEMPLE

KATHMANDU DURBAR INITIATIVE 2000-2004

## FINAL REPORT

ROHIT RANJITKAR \* RAJU ROKA  
KATHMANDU VALLEY PRESERVATION TRUST  
DECEMBER 2002

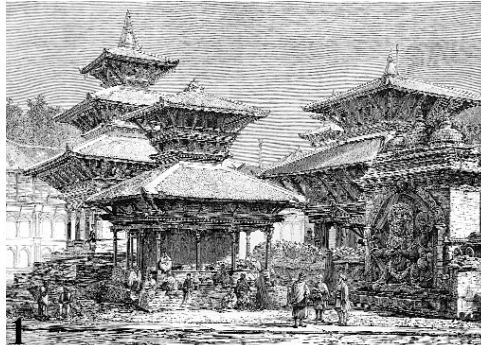
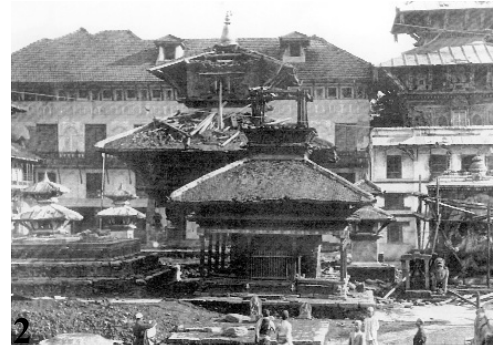
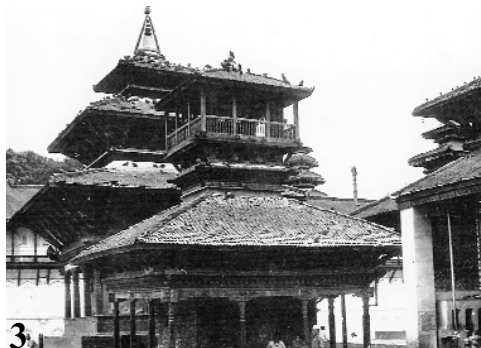
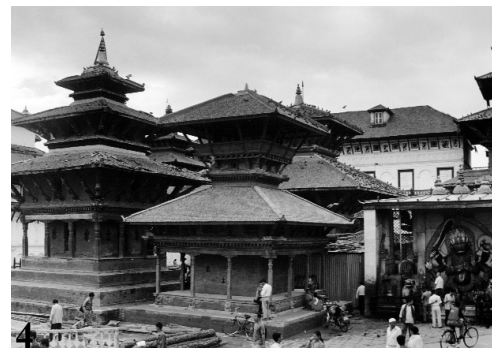
*1. A sketch by Lebon before the 1934 earthquake, which was evidence of historical configuration. 2. A photograph showing the condition of the monuments after the great earthquake. 3. The figure of Indrapur Temple in an altered form, restored shortly after the earthquake. 4. The recently restored Indrapur Temple in its historic figure.*

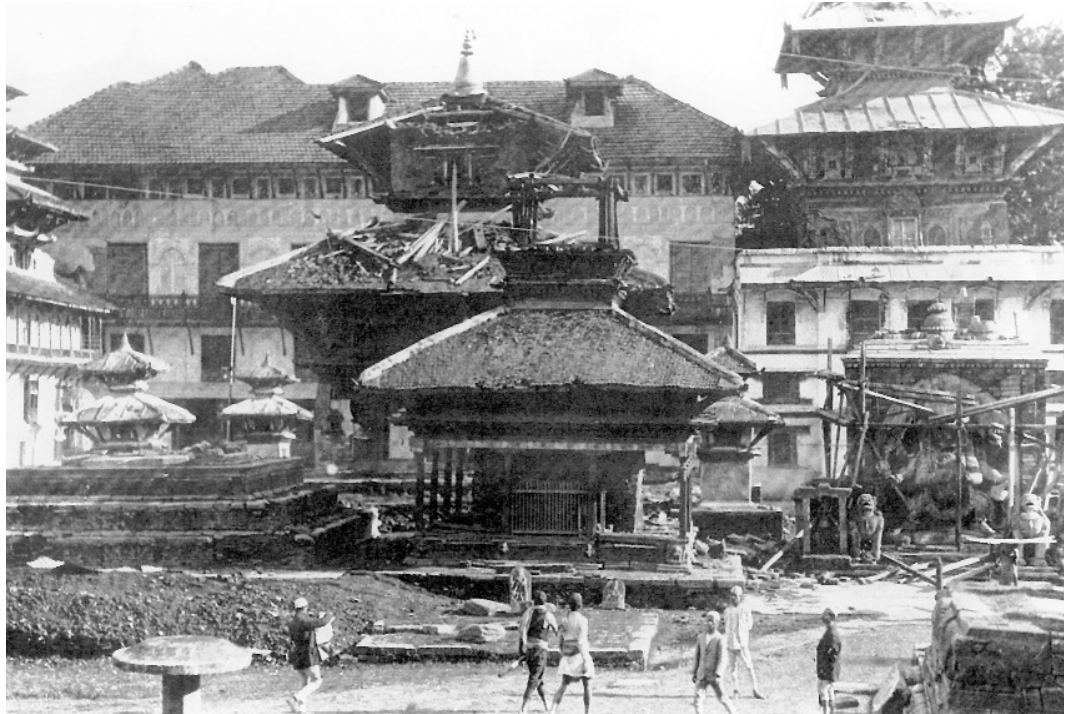
The great earthquake of 1934 devastated the Narayan Temple leaving only the plinth, while partially damaging Jagannath and Indrapur Temples.

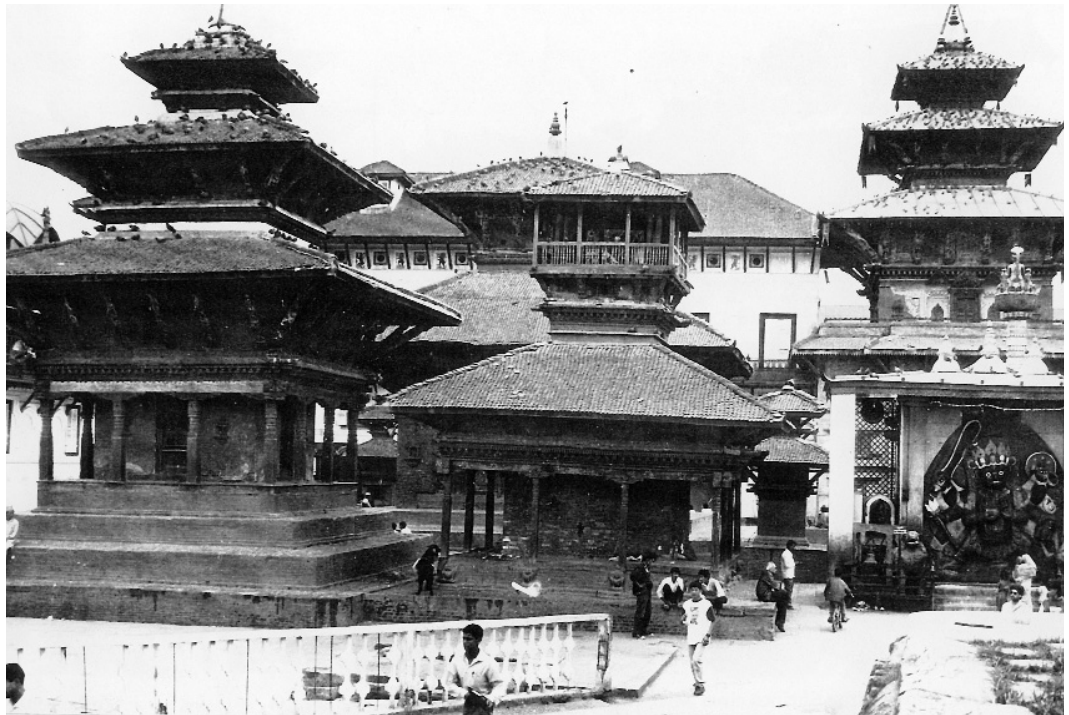
A contemporary view (1995), compared with previous post-1934 earthquake. After the earthquake the upper tower of the Indrapur Temple was completely restored in a different configuration.

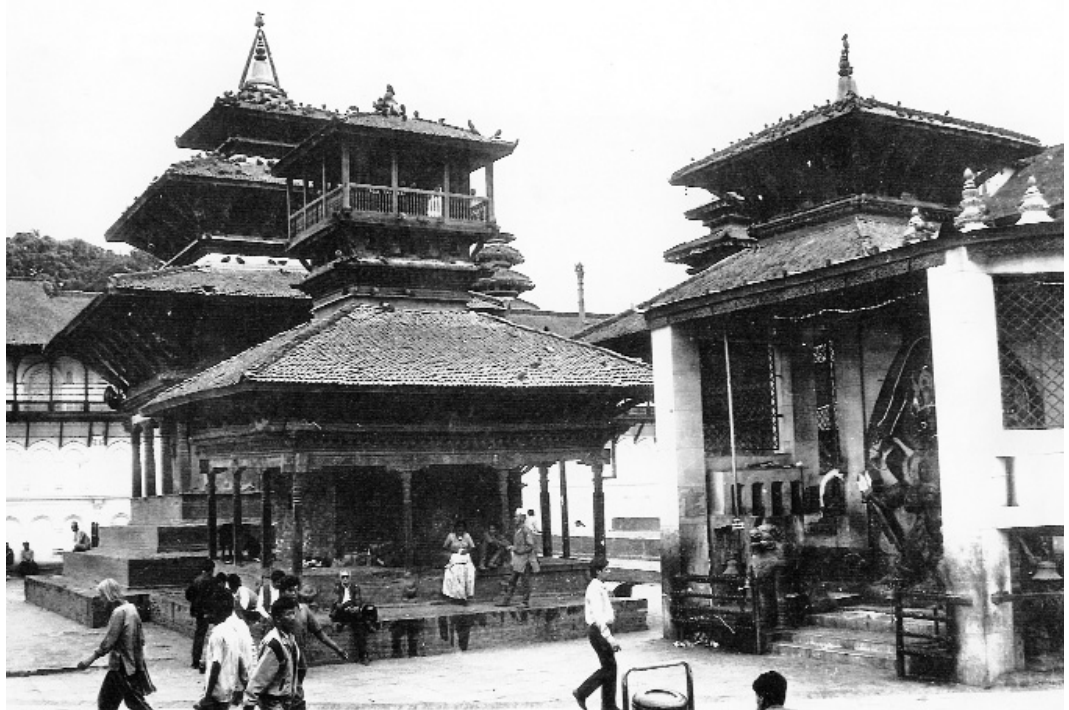
A view of Indrapur Temple before the initiation of restoration work in September 2002.

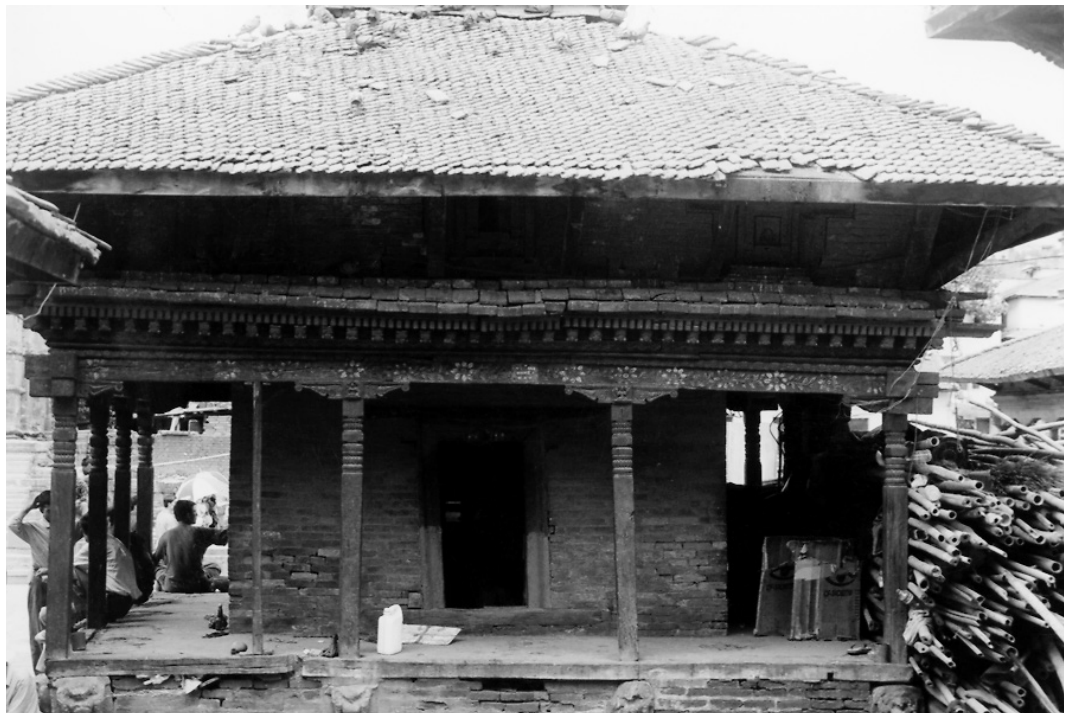
A southern view of the Temple showing the poor condition of the arcade and lower roof.

The roof was completely reconstructed using new (*sal*) timber members. Before the reconstruction work began the roof was in inadequate condition. But as the mud bed and roof tiles (*jhingati*) were removed for repair, we found that none of the timber members were reusable.

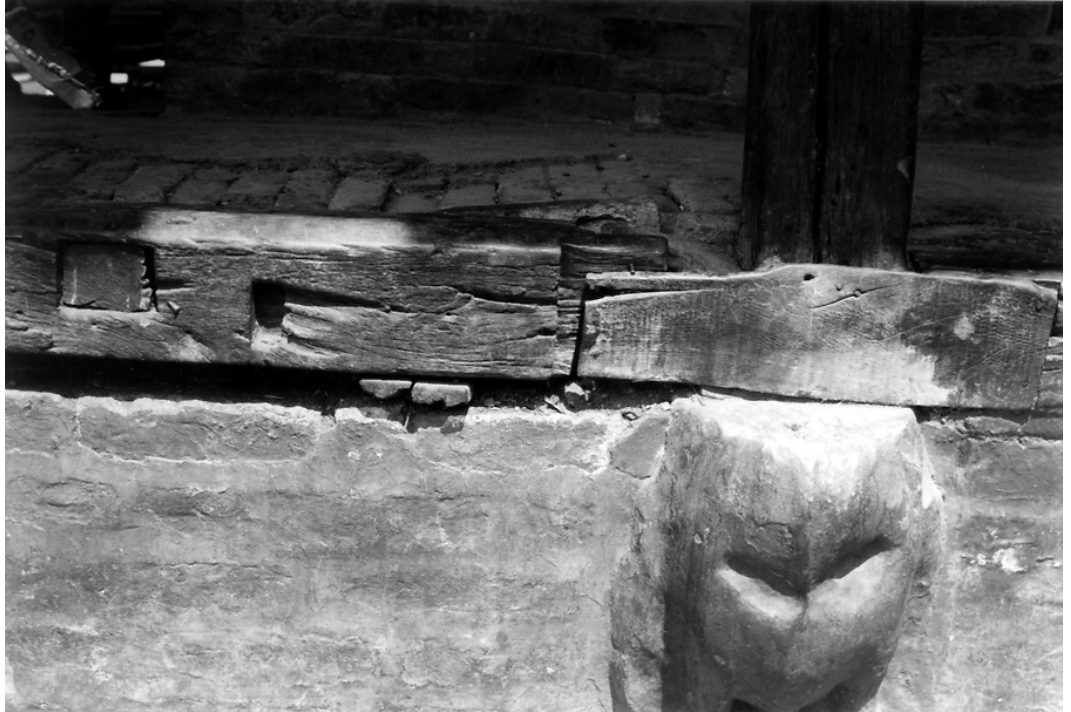
Damaged condition of *lakasi* (base of arcade pillar).

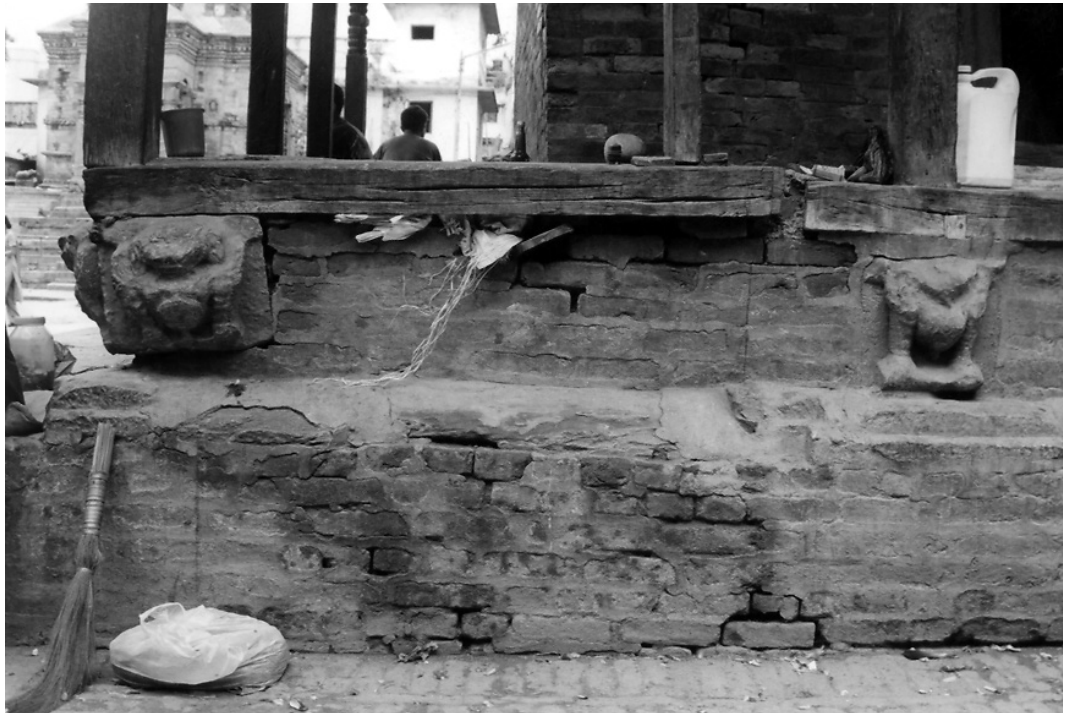
Damaged condition of the plinth level wall where the outer plinth does not exist.

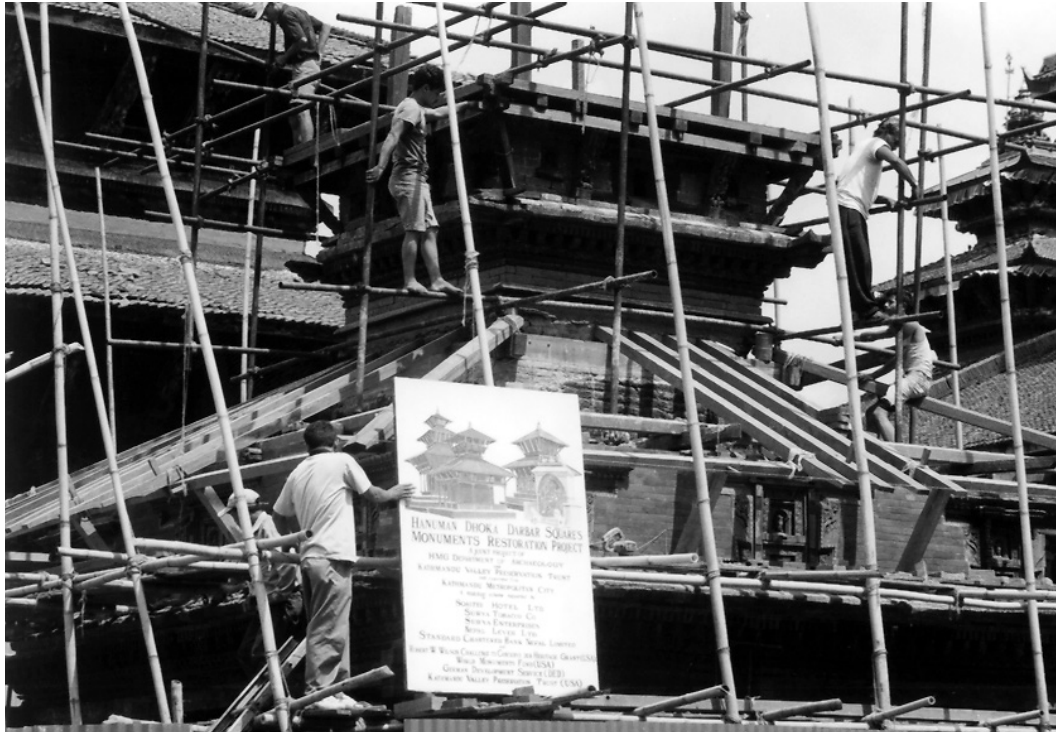
Upper tower dismantled to restore the historical figure.

After 1934 the tower was not reconstructed in its historic form using original elements. New carvings and timber components were based on the visual documentation of other buildings from the same period.

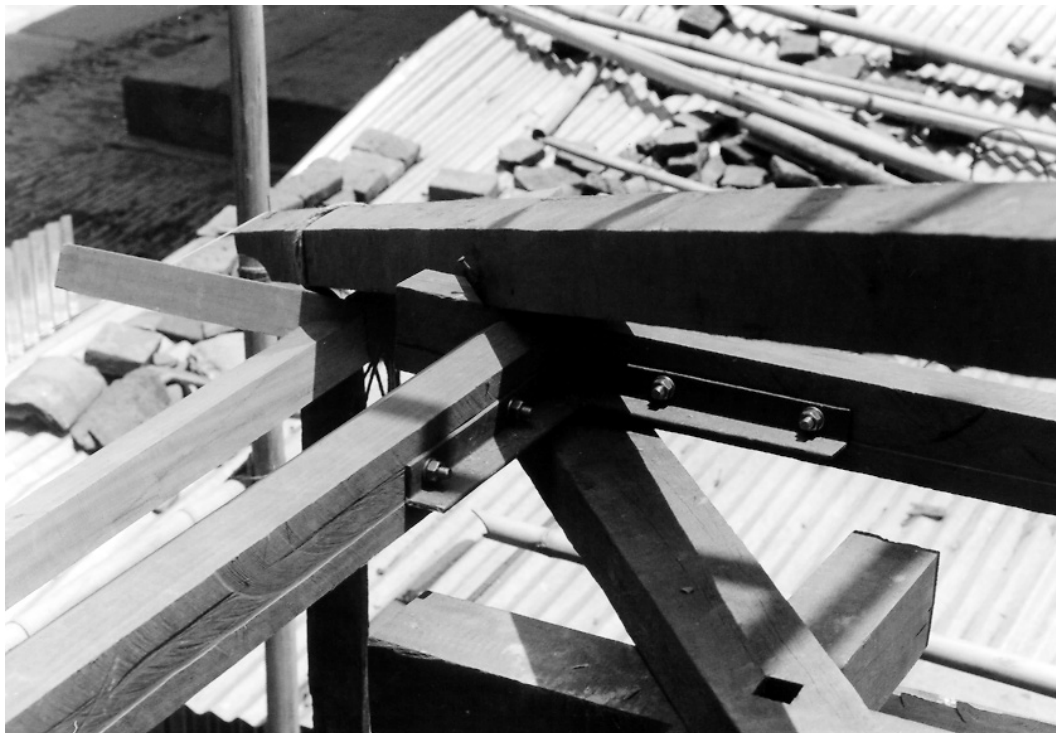
On the steel angle, nuts and bolts are used at the joint of the purlin, tying them together acting as one unit in the event of a seismic movement.

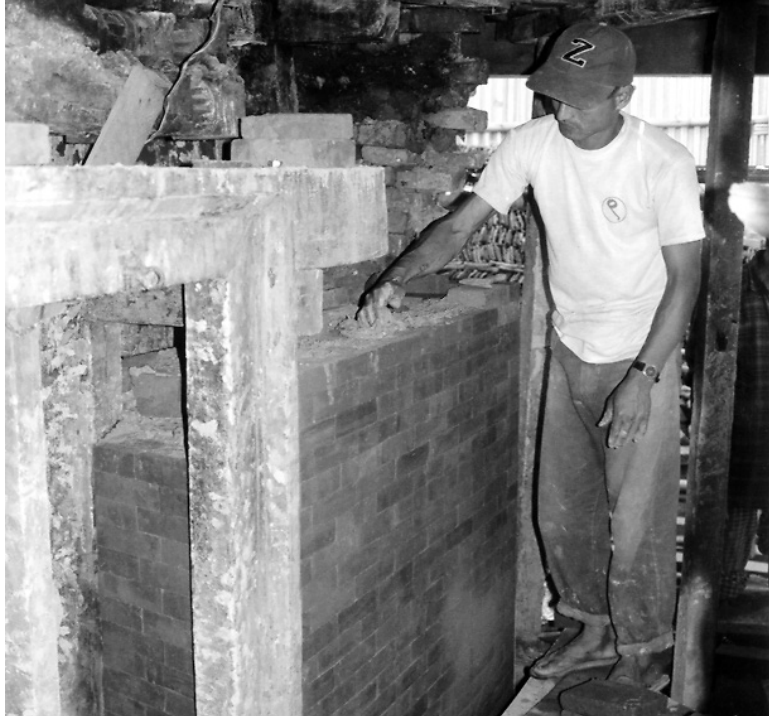
Rebuilding of a masonry wall on the ground floor sanctum with traditional brick (*dachi-apa* and *ma-pa*) which improves brick bonding.

In the proposed planning we had thought of repairing the damaged area of the wall, but when the damaged area was dismantled, we found that the wall was greatly damaged inside. Therefore, the wall was completely reconstructed using traditional brick (*dachi-apa* and *ma-apa*) in mud mortar at the ground level as well as the first floor outer wall. Four load bearing timber posts were replaced on four corner of the ground floor wall.

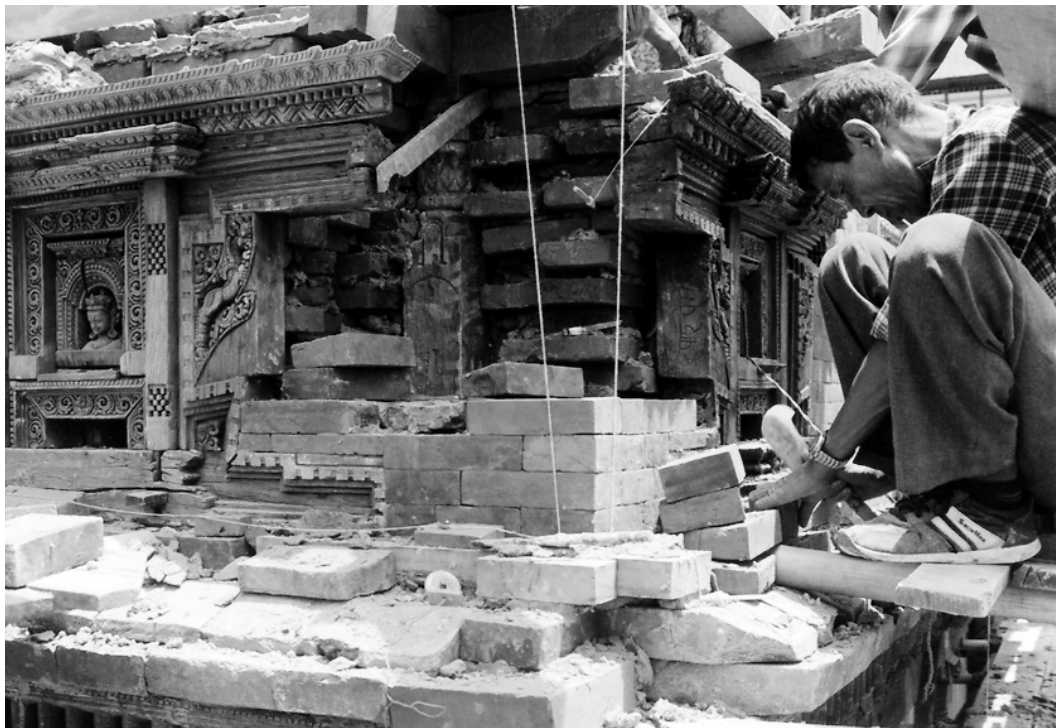
Rebuilding of the outer masonry wall on the first floor level in traditional brick (*dachi-apa* and *ma-pa*) incorporating the historical carved window.

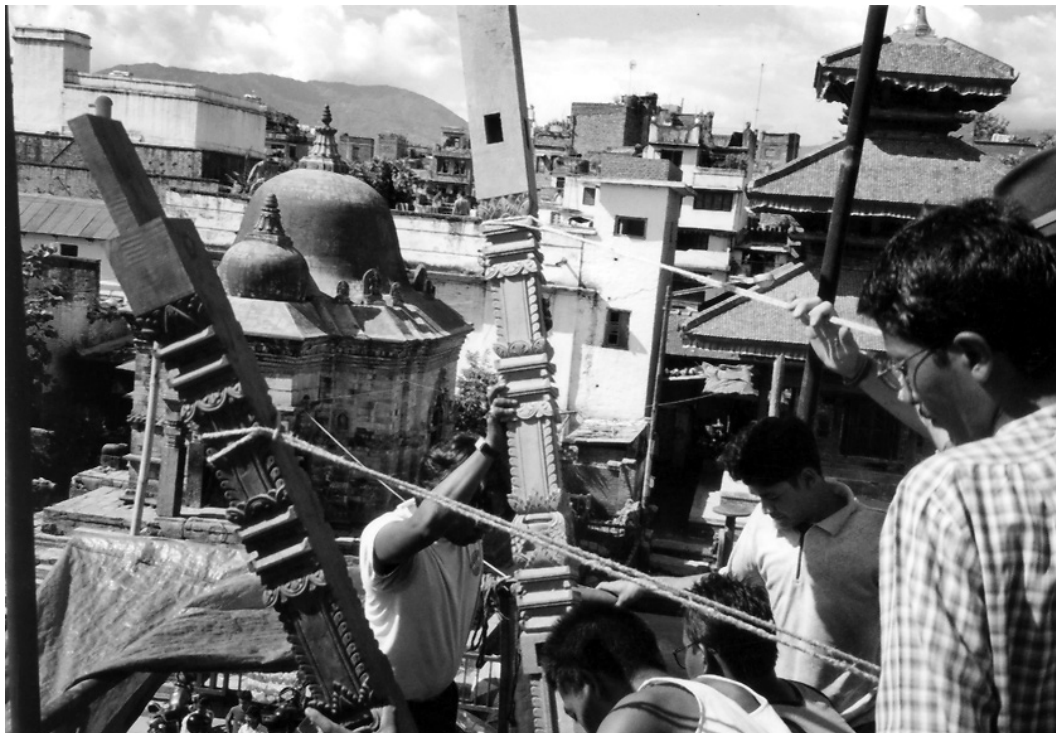
New carved inclined struts are in the process of installation on the upper tower.
