# KAL BHAIKAV

KATHMANDU DARBAR INITIATIVE

## FINAL REPORT

ROHIT K. RANJITKAR\* LUMANTI JOSHI  
**KATHMANDU VALLEY PRESERVATION TRUST**  
MAY 2005

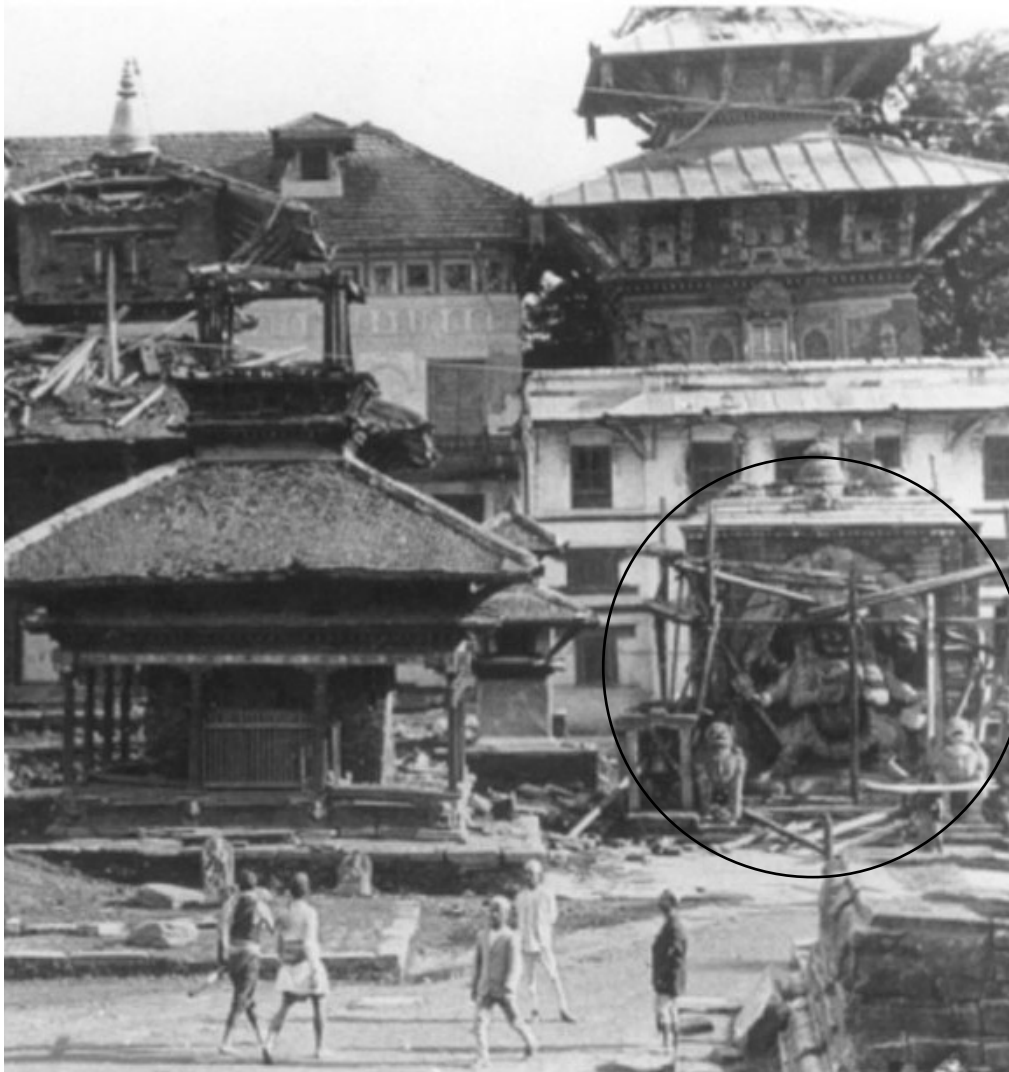
**left:** The great earthquake of 1934 devastated almost all of the temple structures in the Kathmandu Darbar Square. The upper level of the shrine including the cornice and the pinnacles had collapsed. This was not restored according to the historic configuration during the repair done in 1936, thus completely altering the original configuration of the shrine. *Photo courtesy: Manju Rana.*

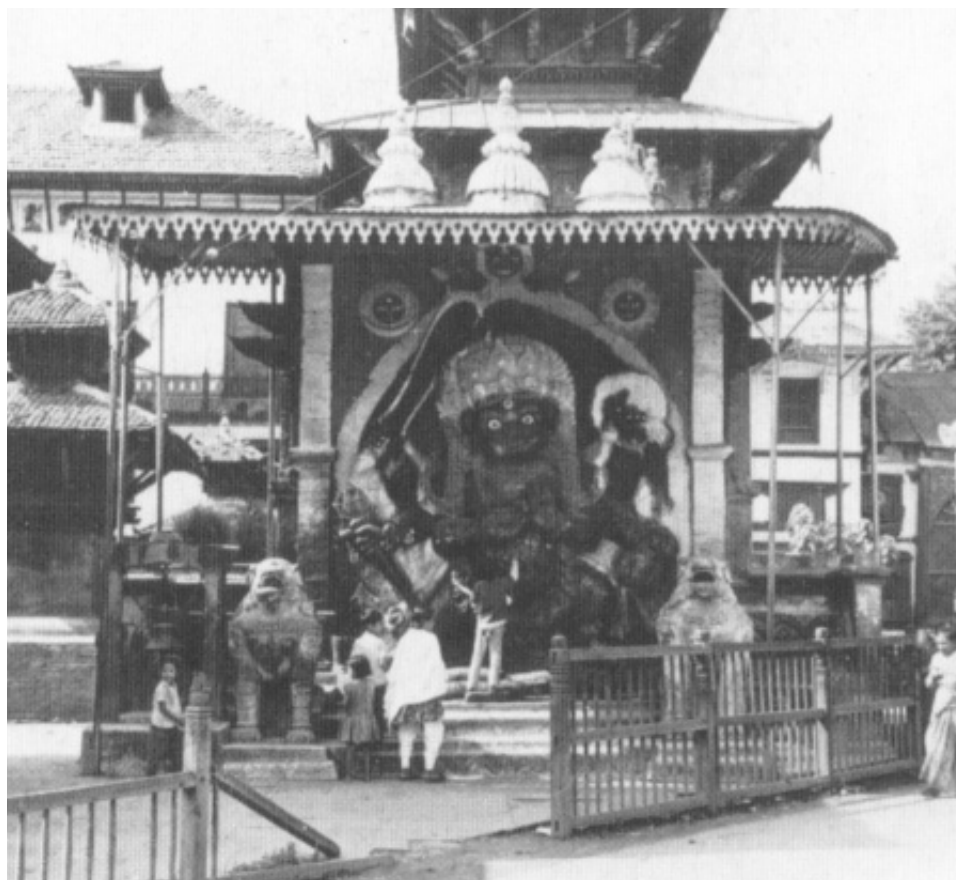
**left:** The roof structure with corrugated zinc sheets, supported by G.I. pipes was propped on top of the shrine. Photo courtesy: “Inventory of Kathmandu Valley: 1971”, published by UNESCO.

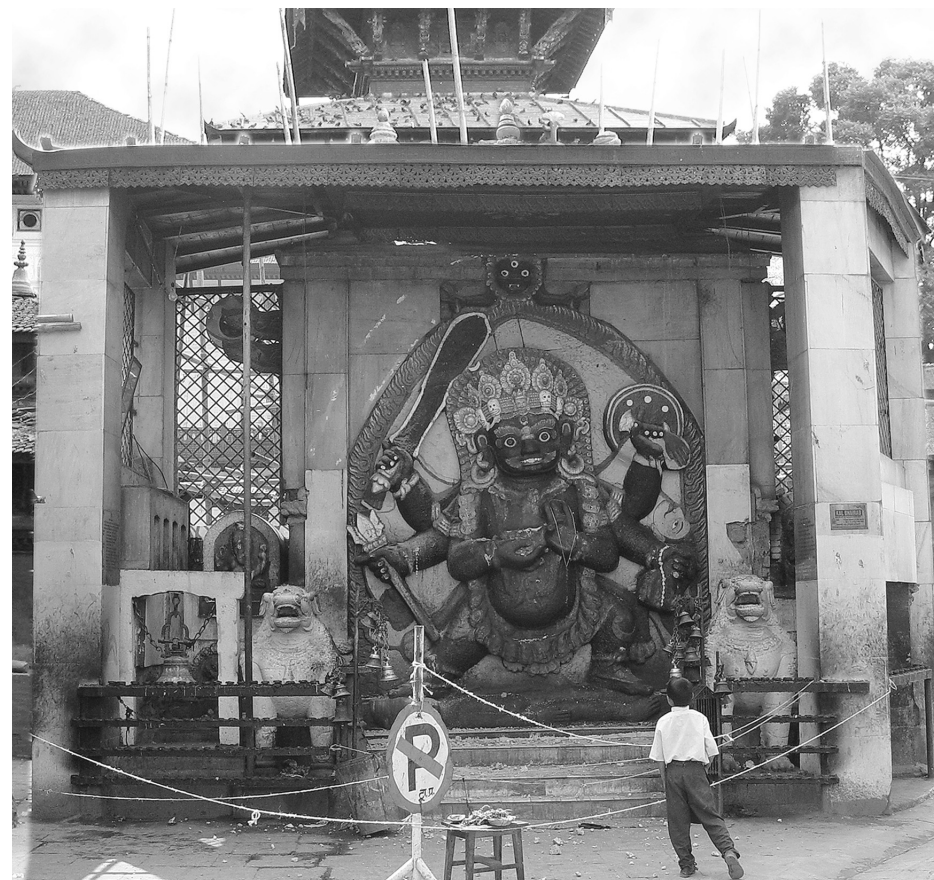
**right:** Kal Bhairav as it stood in December 2003, just before the commencement of restoration. The original form of the shrine was totally lost under the layers of votive offering donated to it. The marble clad concrete pillars supported the heavy metal roof above the shrine. Photo: Raju Roka, December 2003.

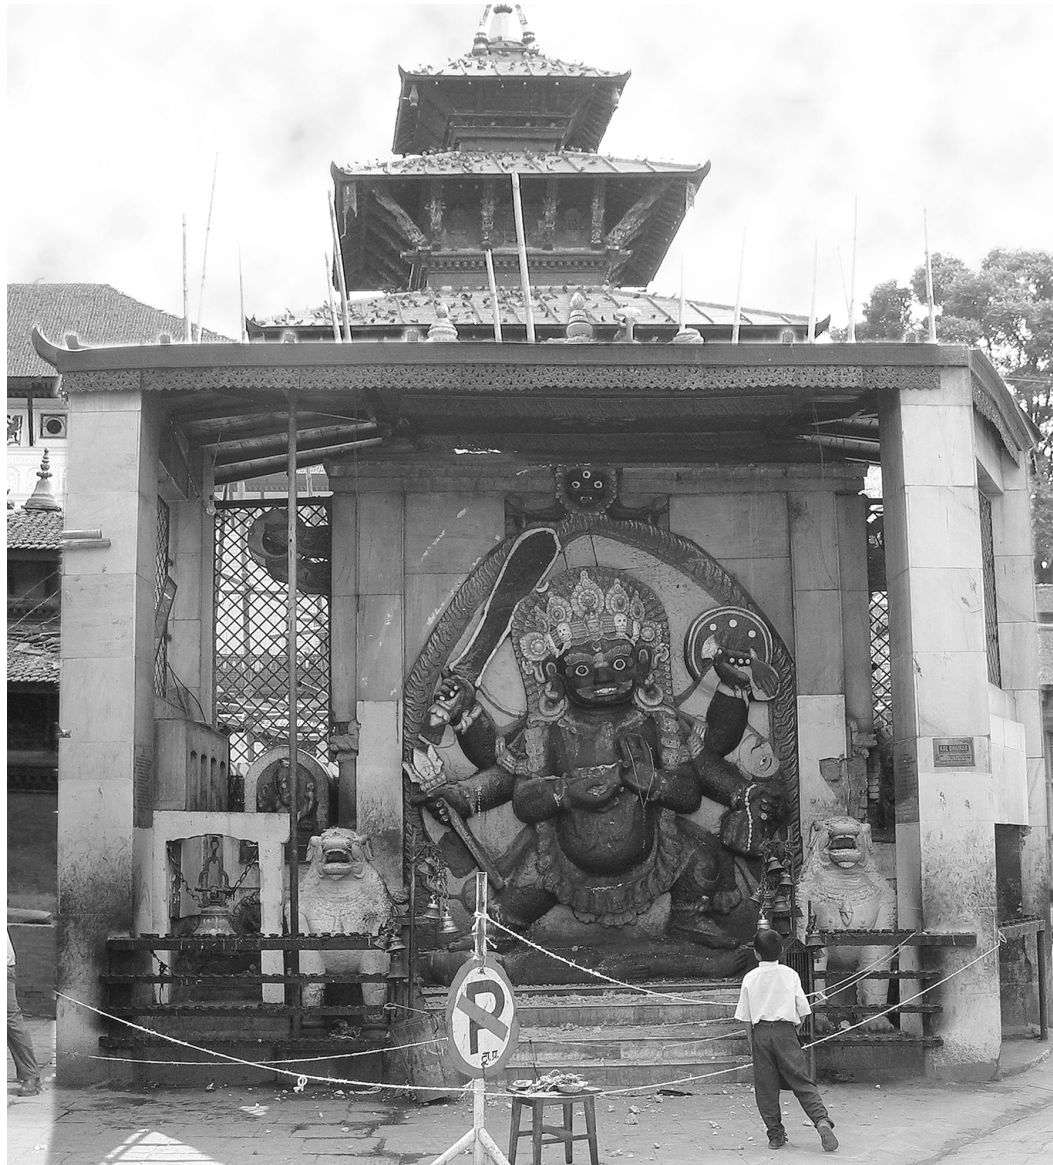
**left:** Kal Bhairav in December 2003, before the restoration project was initiated. Photo: Raju Roka, December 2003.

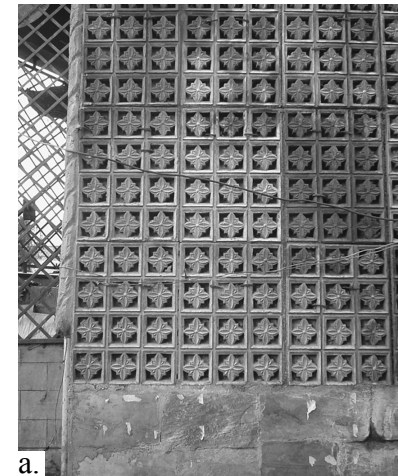
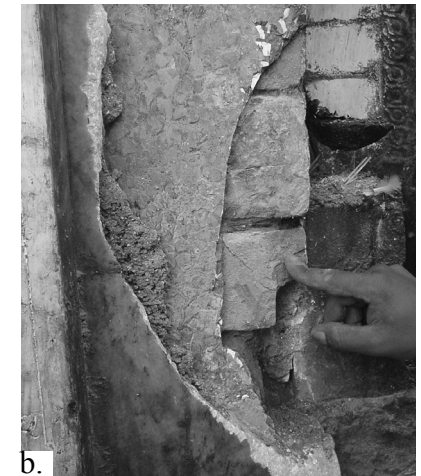
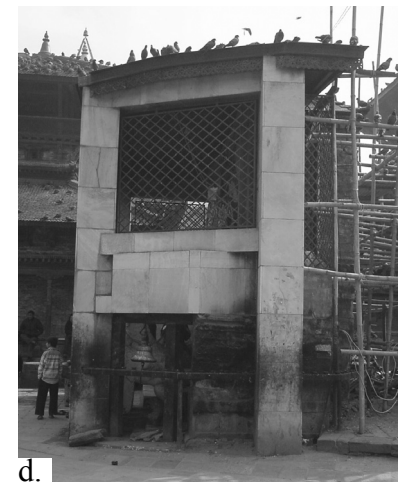
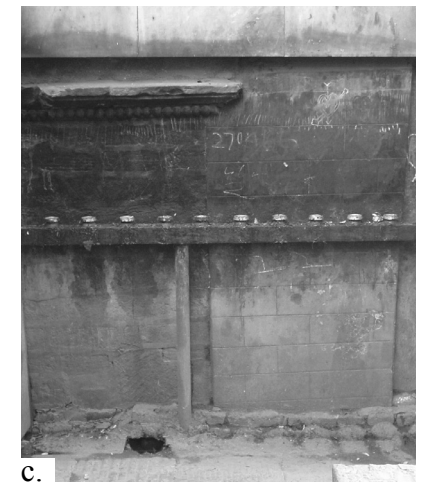
**above (clockwise direction):** **a.** The original fabric in the back facade was hidden below newly added layer of precast cement mesh. **b.** When we removed the marble slabs near the main image, a new layer of mosaic chips was revealed. This layer was probably added in 1970's. **c.** The height of the side walls were raised using brick masonry and marble slabs to accommodate images donated to the shrine by the devotees as votive offering. Note the original side wall with its cornice detail. **d.** The west facade with marble slabs. Photos: Raju Roka, December 2003.

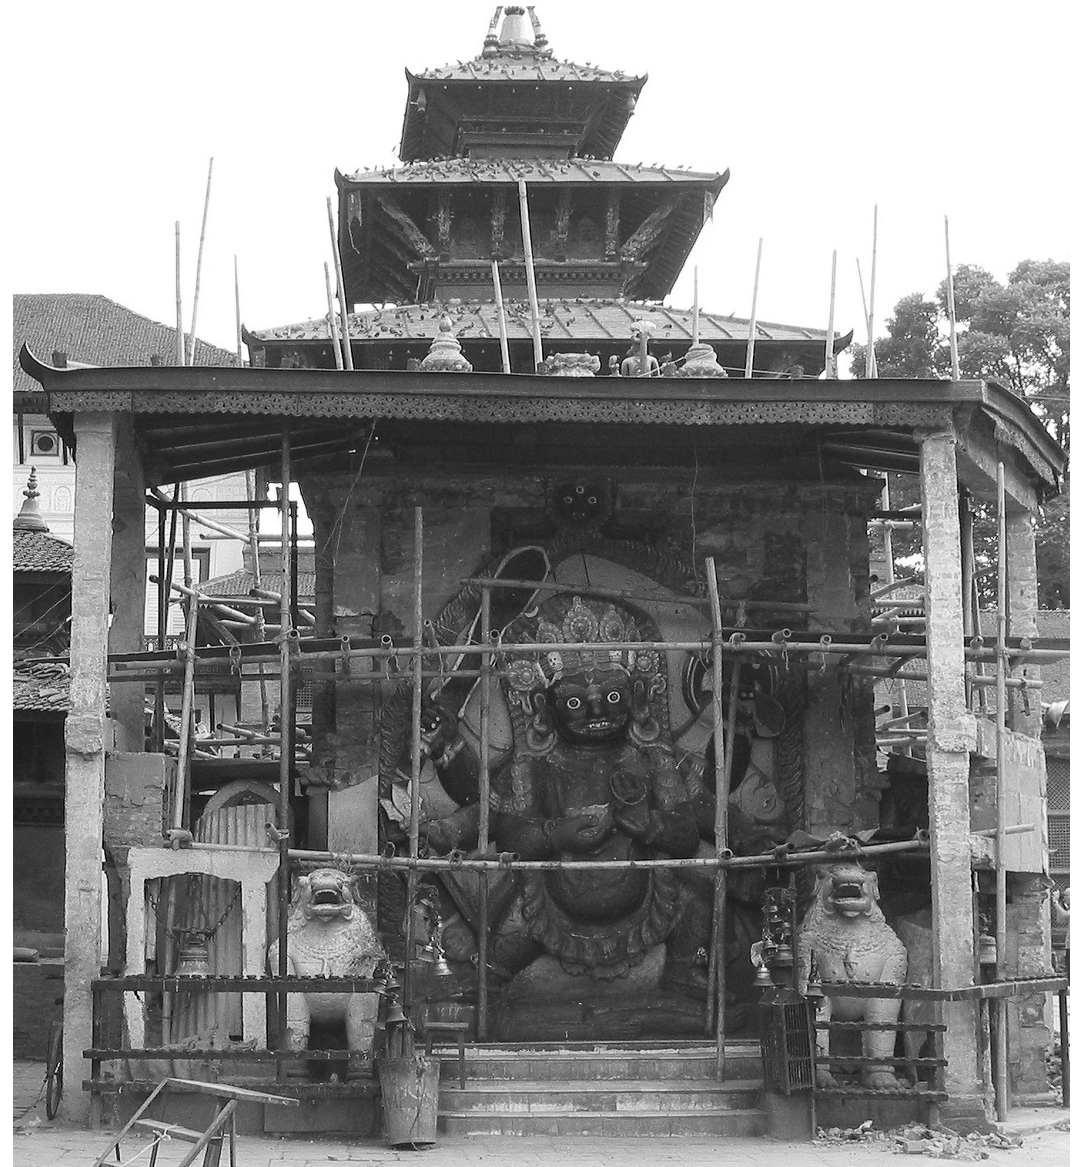
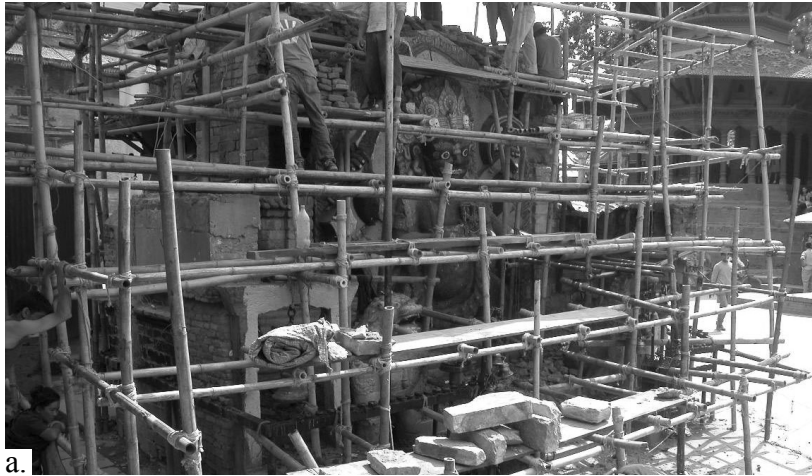
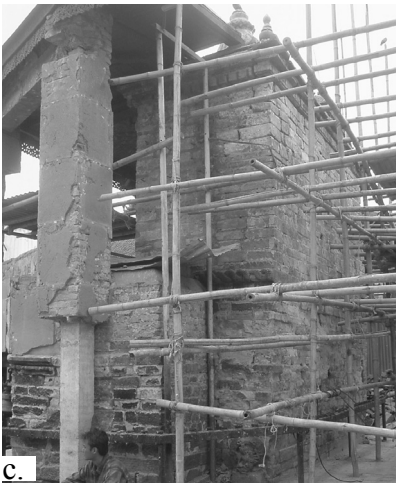
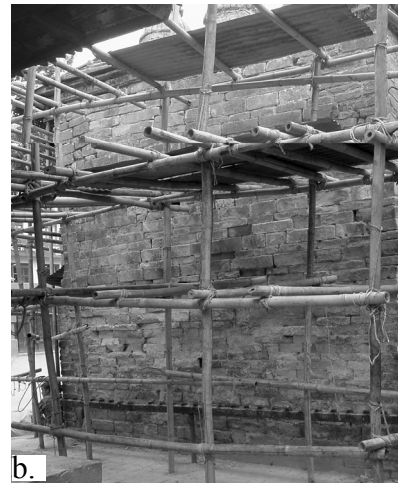
**right:** Removal of marble slabs and other recent layers revealed the extent of damage done to the shrine which we had not anticipated before. Much of the original fabric was found in poor condition and important details such as the tympanum was totally lost. *Photo: Raju Roka, January 2004.*  
**above (clockwise direction):** **a.** Kal Bhairav under scaffolding. **b.** The back wall had tilted 4" from the plumb line and the stone work was damaged because of cement used to fix the marble slabs and pre-cast cement blocks. **c.** Side wall after marble slabs were taken off. The modern additions also included the cement pointing on the joints. The wall was patched with cement plaster in many locations. *Photos: Raju Roka, January 2004.*

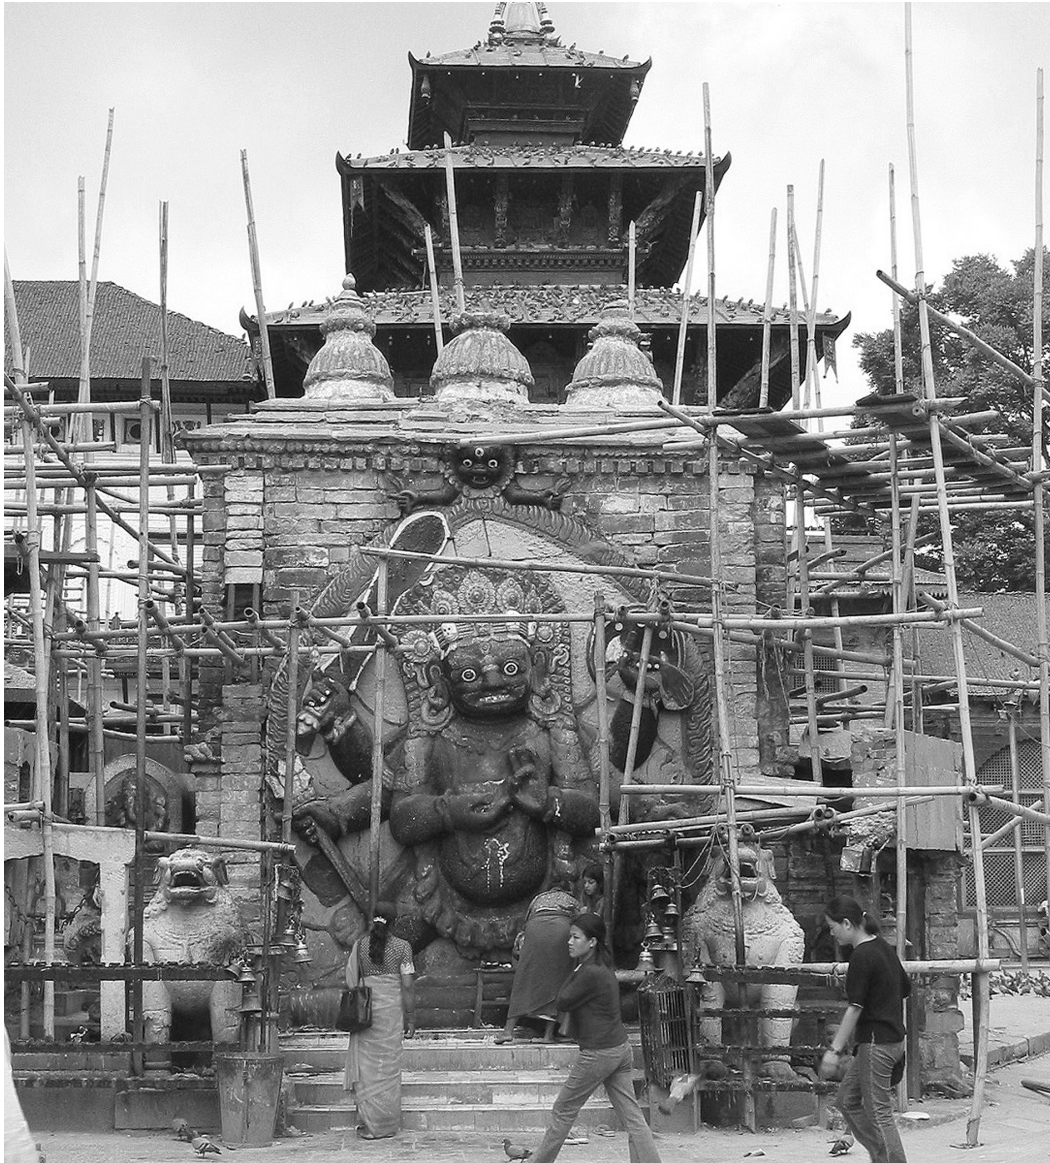
*left:* Much reduced and simplified version of the original structure was exposed when modern layers were taken off the shrine. Most of its significant details were either incomplete (pinnacle), reversed, damaged (cornice details) or lost (tympanum and the pillars). During the restoration, these details were recarved on the basis of the historical photographic documentation. *Photo: Raju Roka, February 2004.*

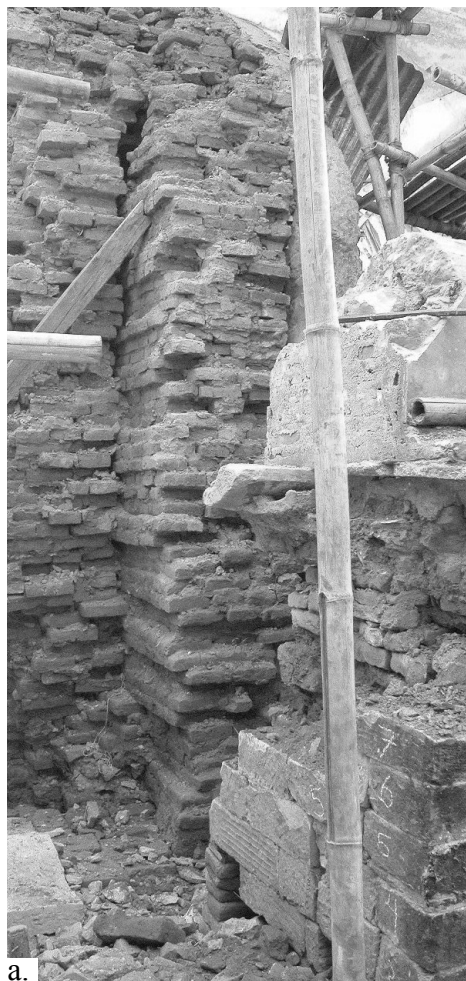
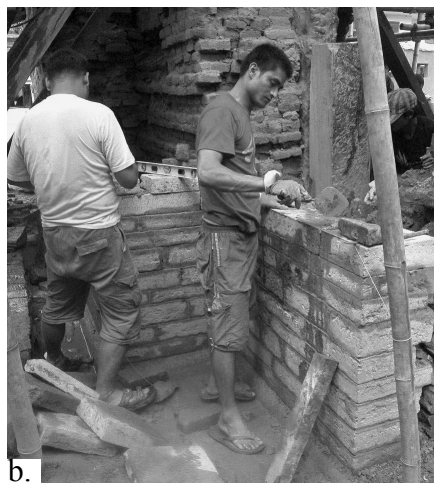
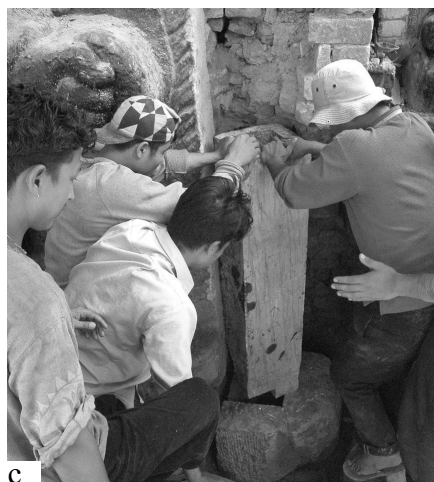
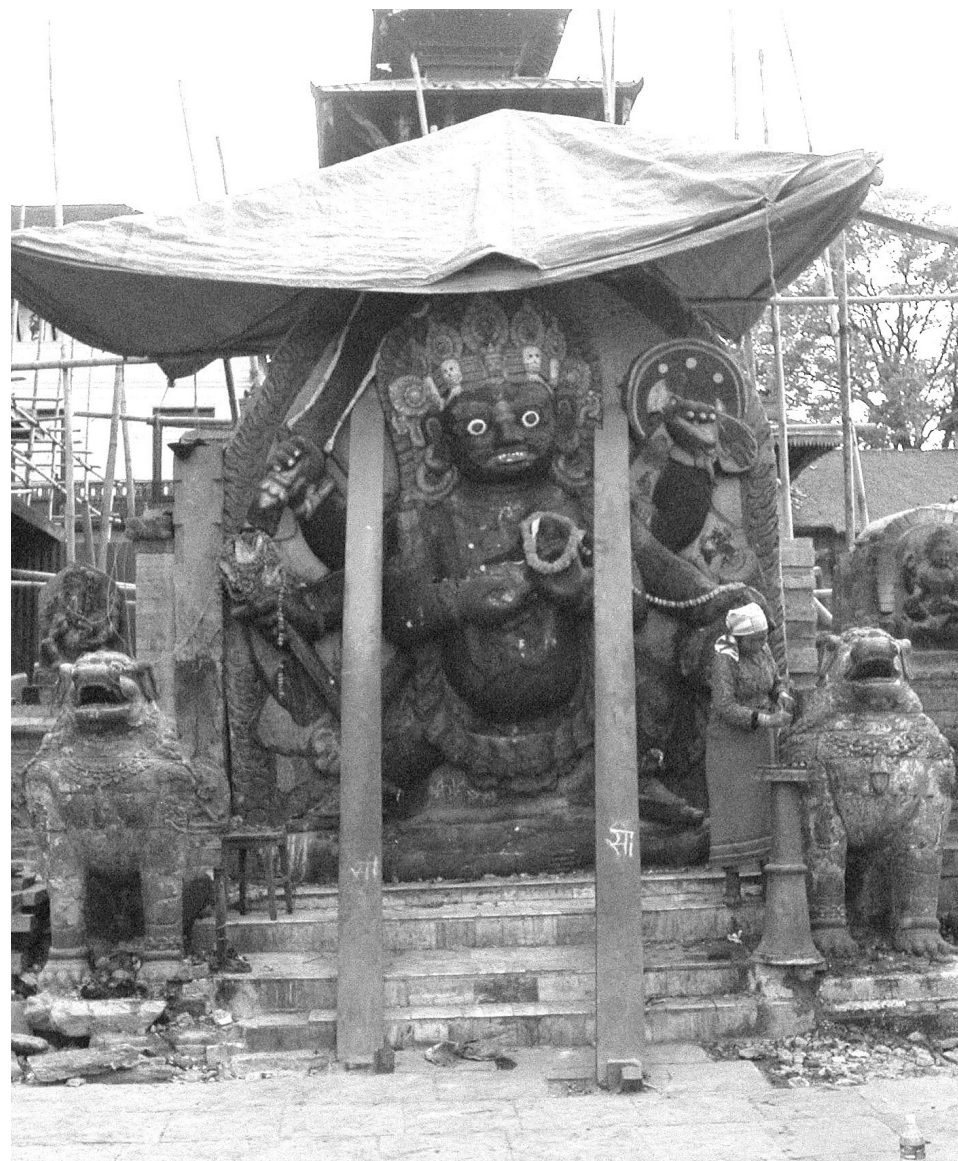
**right:** The principal image being stabilized after the back wall was dismantled. Photo: Raju Roka, August 2004.  
**above (clockwise direction):** a The core wall of the frame constituted of two layers of brick masonry. The outer layer, a new addition, was constructed as the structural reinforcement for the original layer. Photo: Badri Juwal, March 2004. b. The outer wall being reconstructed with stone blocks as the old stone wall had deteriorated completely. Some of the original stone blocks, which were in good condition, were reused. Photo: Badri Juwal, March 2004. c. The column base for the tympanum being installed in its position. Photo: Badri Juwal, August, 2004
