# The Jalasayan Narayan Pokhari Restoration

Hanuman Dhoka Durbar Museum Development Committee  
Kathmandu Durbar Square, UNESCO World Heritage Site

Historic Structure Report/ Conservation Notes

July 2013

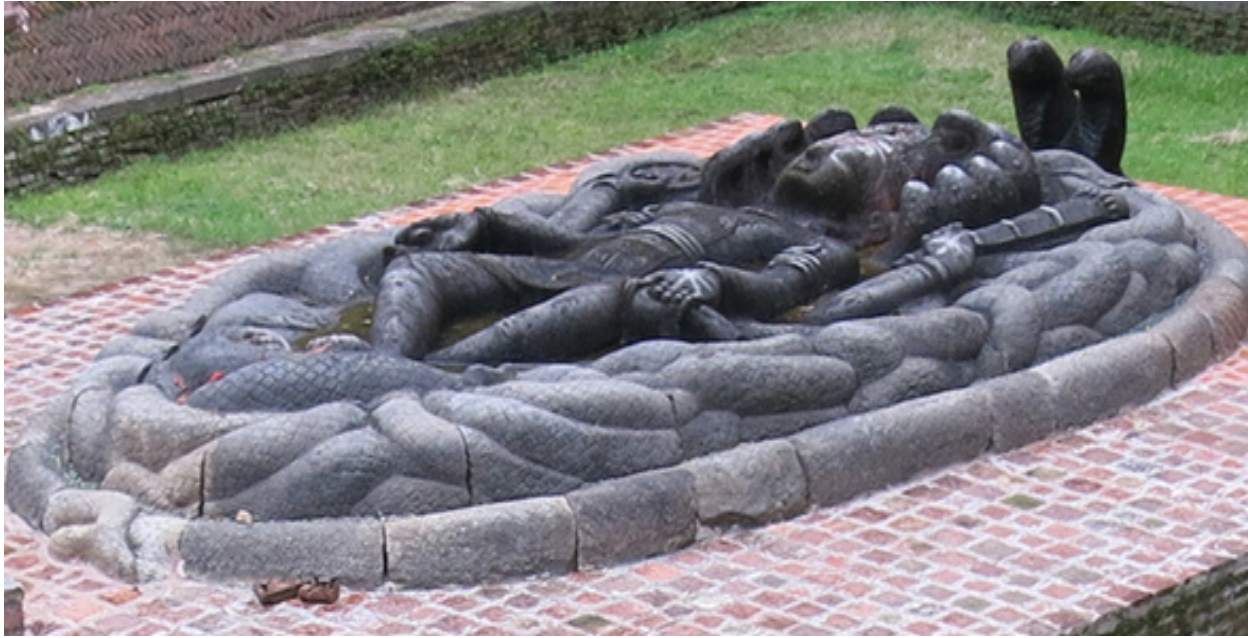
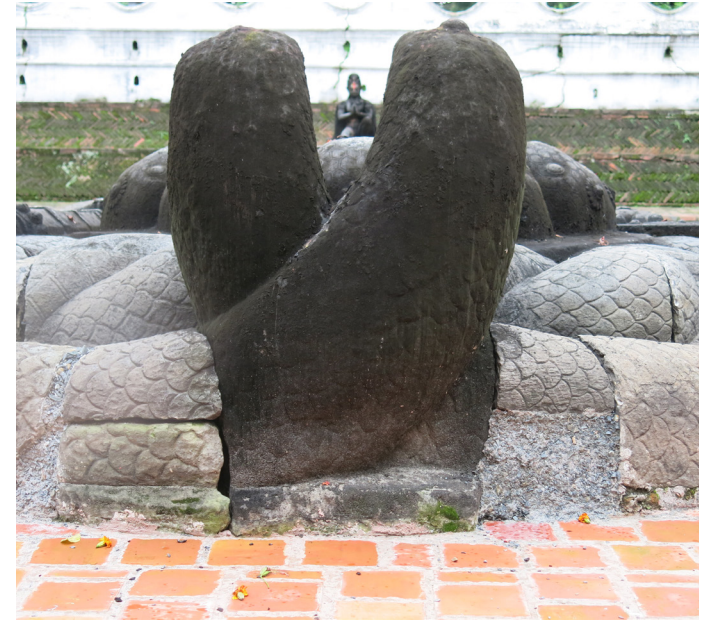
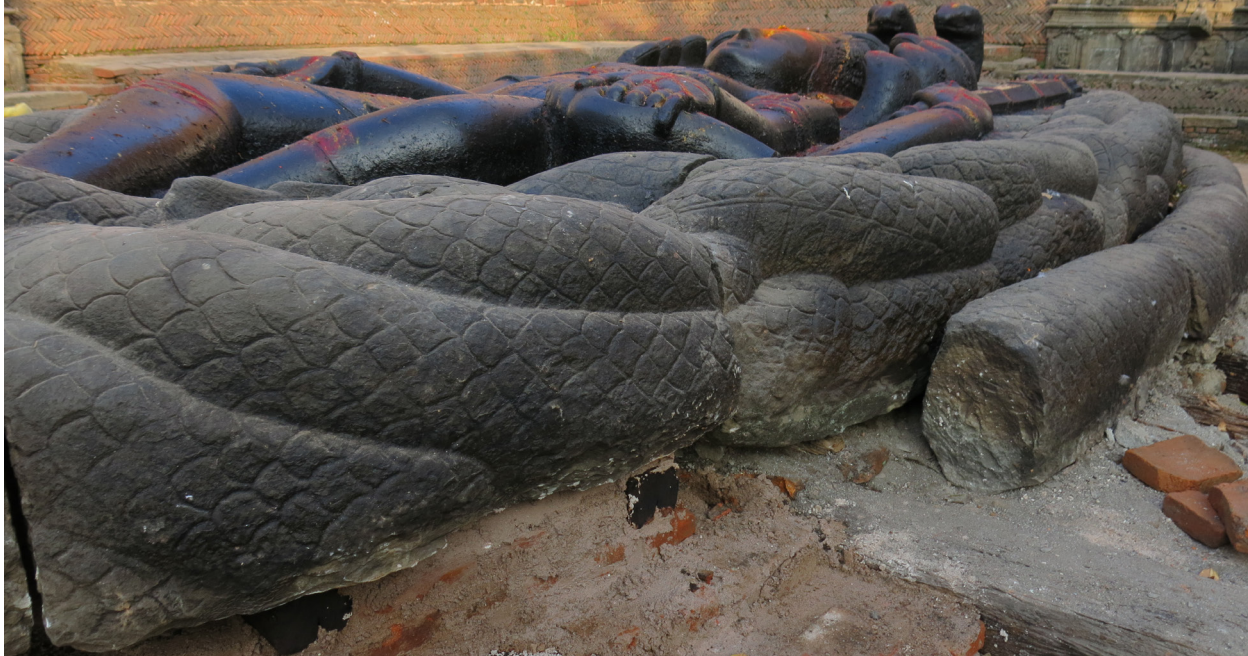
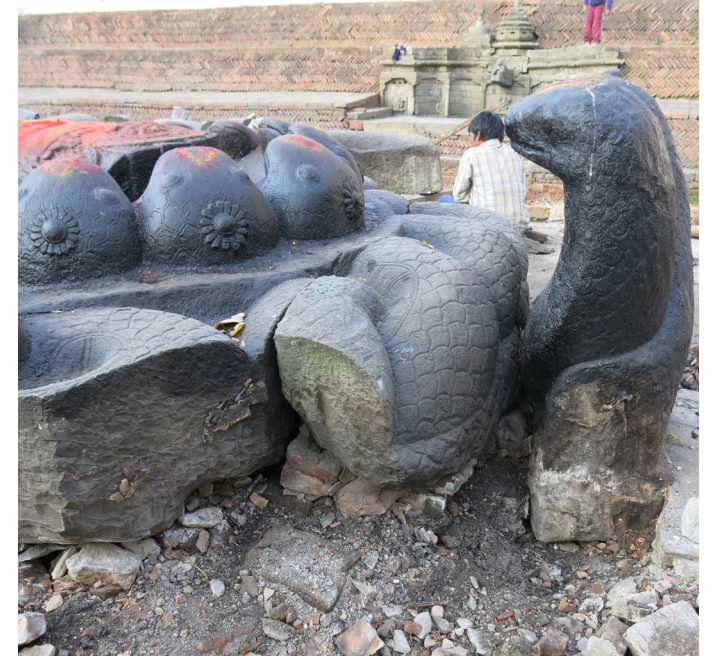
*Top left: Existing condition. Body of two standing heads in the periphery of the main shrine and the other eleven snakes.*

*Top right: The standing snake does not match the joints with other small parts.*

*Bottom right: Standing heads have no proper link between the other snakes as well.*

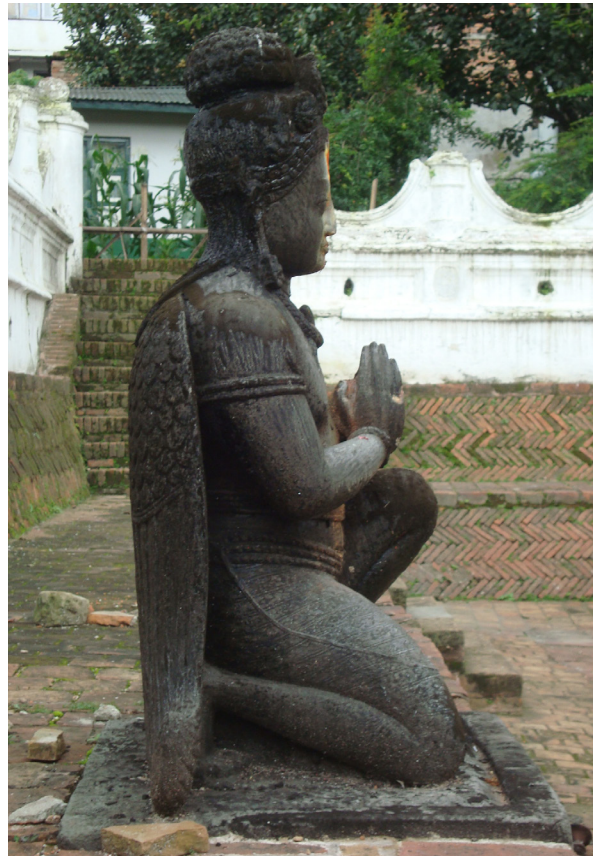
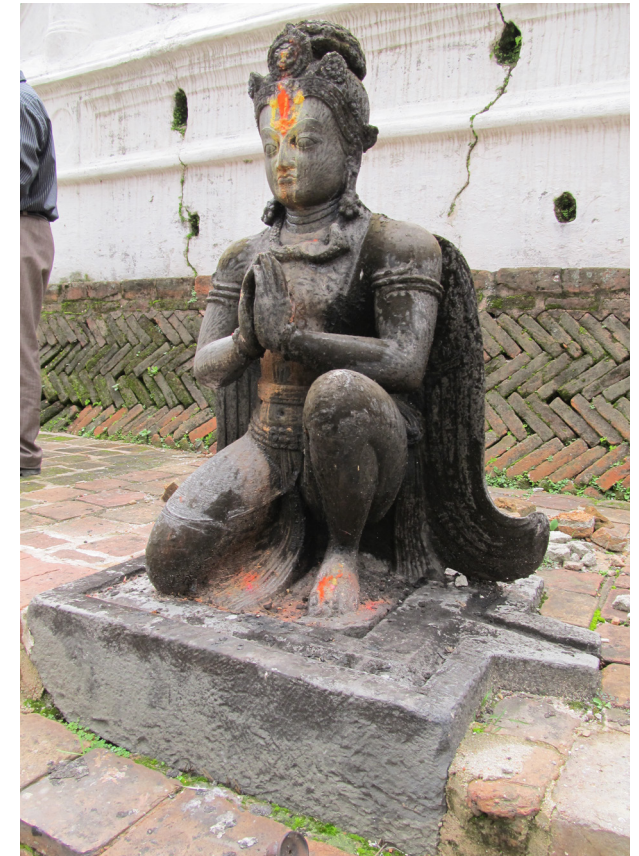
*Top: Timber members were kept below the stone images to stabilize the weight of the stones from settlement. Almost all of the timber elements were in very bad condition and some of them were completely rotten. There was no proper base for the stone pieces. During excavation, only rubble was found beneath the stones.*

*Side and general view of Garuda located on the western side of the Jalasayan Narayan. The Garuda is in excellent condition, no damages were found in this statue.*

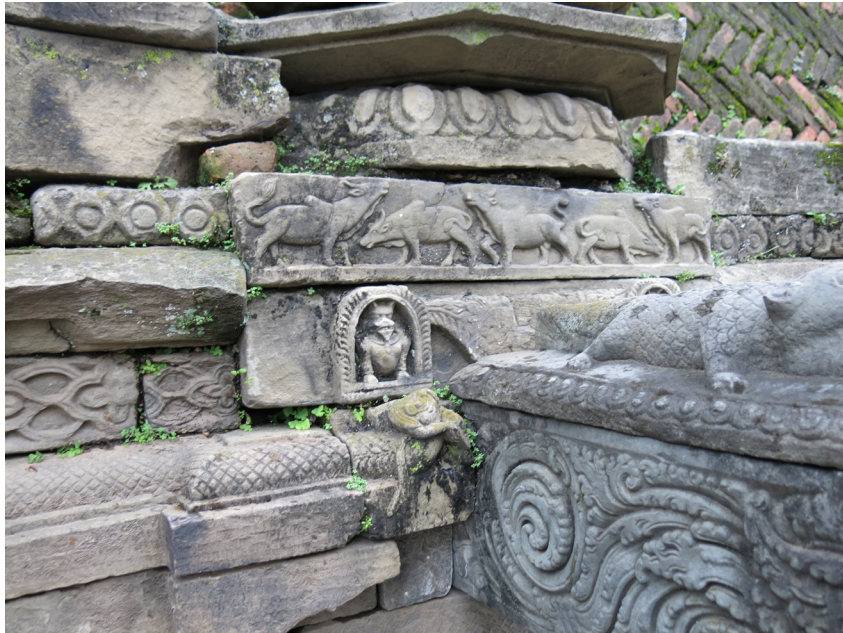
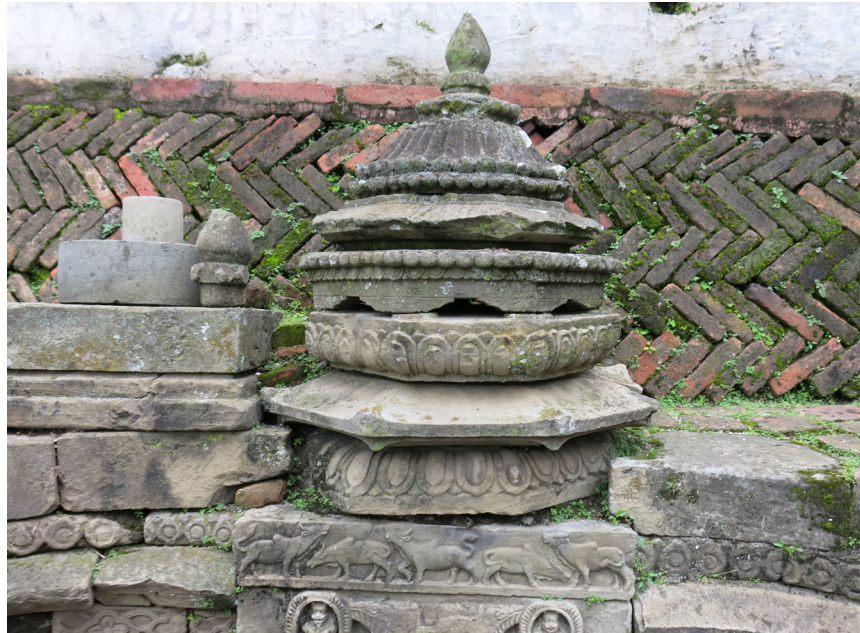
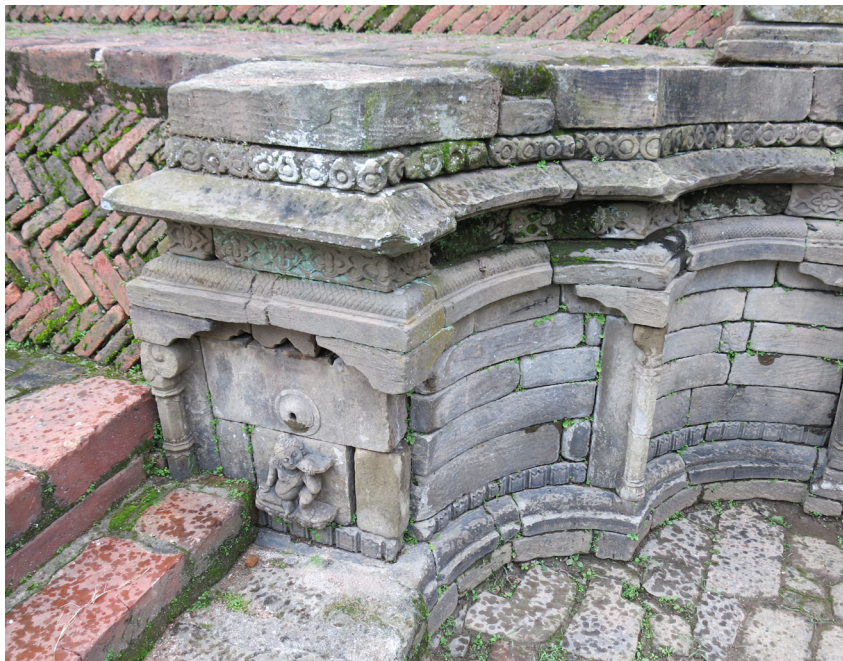
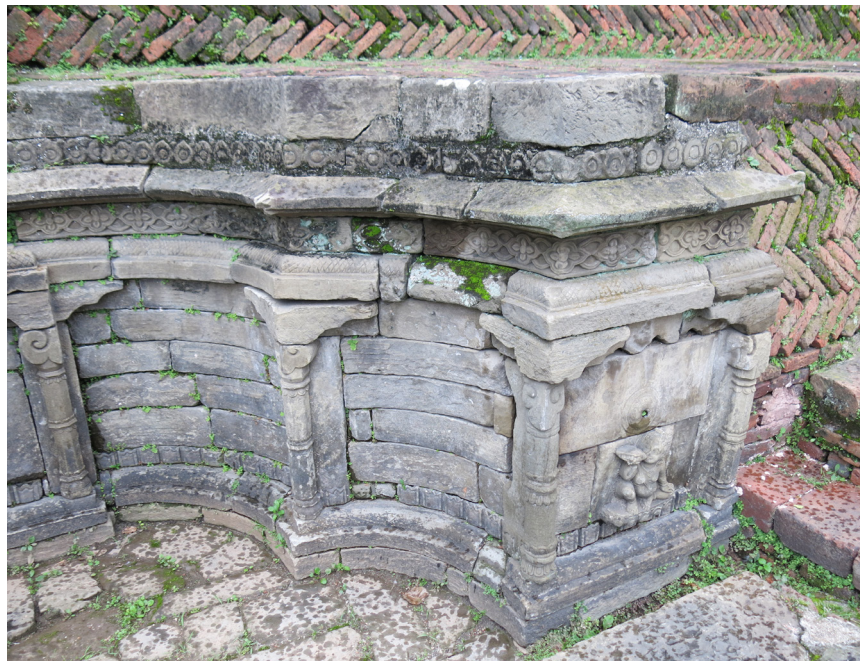
*Top photos: Heads of Nagkanya on both side of the hiti is broken. Some sections from the miniature shrine is missing. The stone pieces are not even stacked in the right order.*

*Bottom photos: One corner stone pillar on the left side is missing. Steps made from large brick are not built in its proper place, overlapping carved stone elements. But on other side still in proper location including drain for escape water from hiti.*

It is clearly visible from existing elements that some of the sections are missing from the back shrine. There are pin holes for miniature octagonal pillars on the lower base and a large part with capital (*meth*) was just put on top. Even one of the big piece is not in right order. It is recommended to make eight new octagonal pillars to restore the miniature shrine and put back stone pieces in historic configuration.

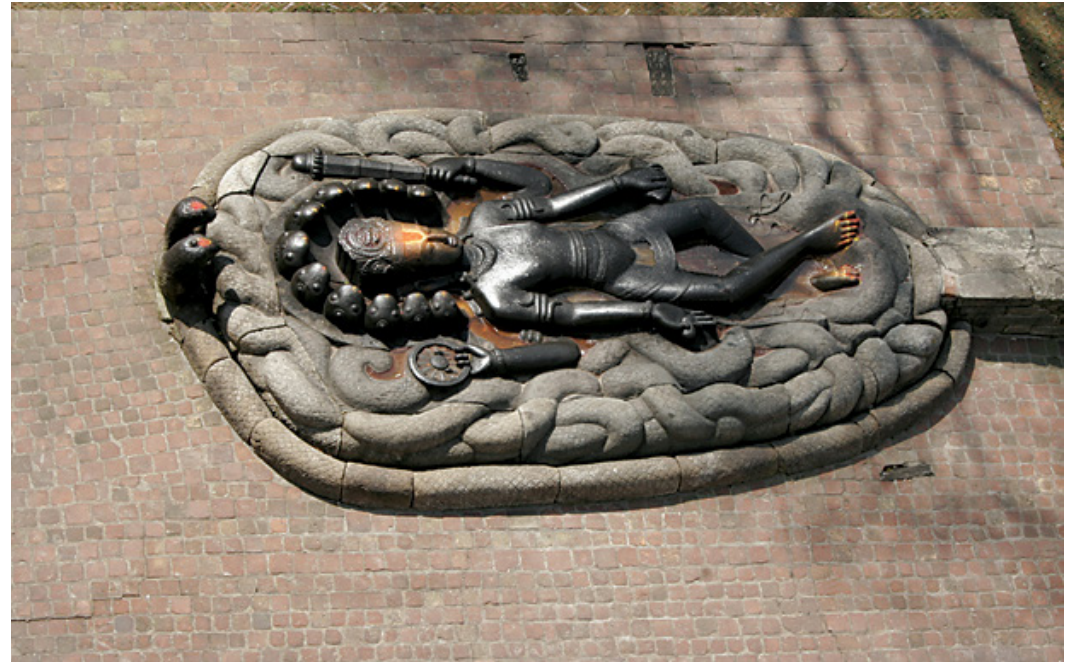
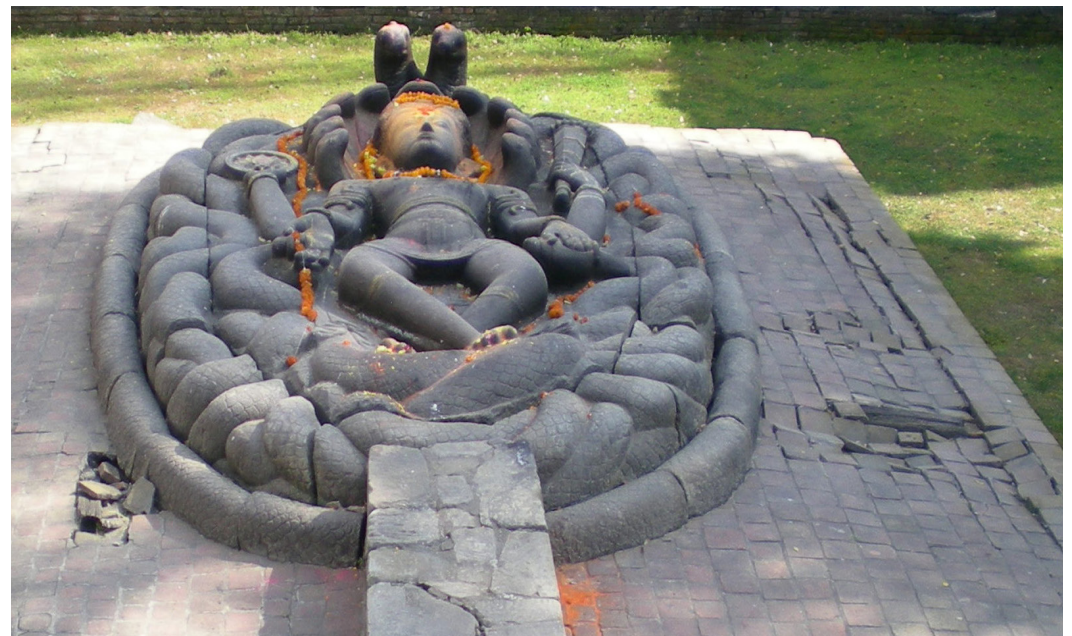
*Photo source: ECS Nepal, Jul., 2010.*

*Bottom: Those settlements were developed more on lower photograph. Settling of floor tiles allowed rain water to penetrate inside, so the damage is rapid. Photo: Nov., 2012.*

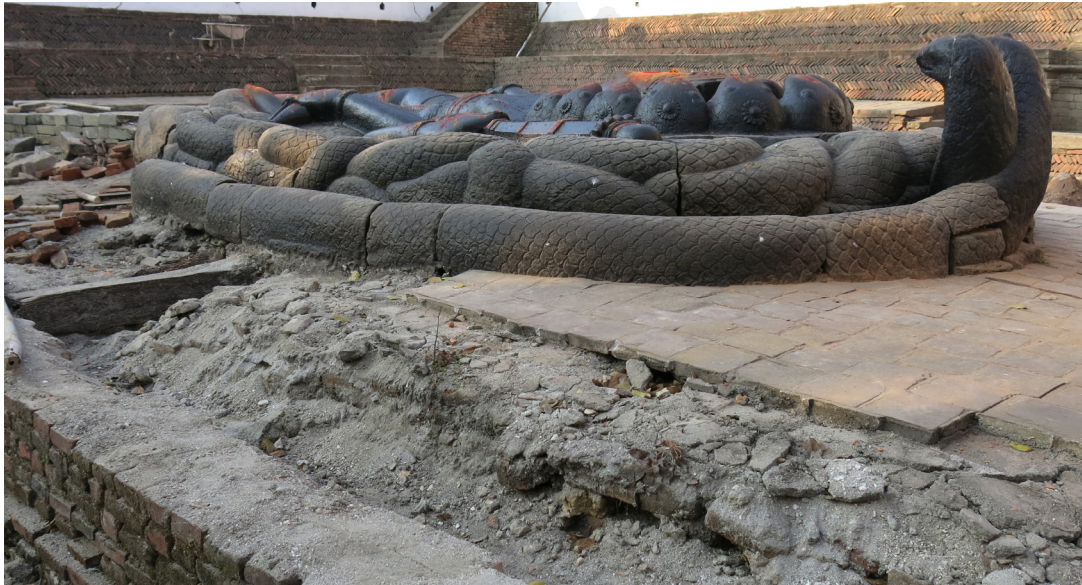
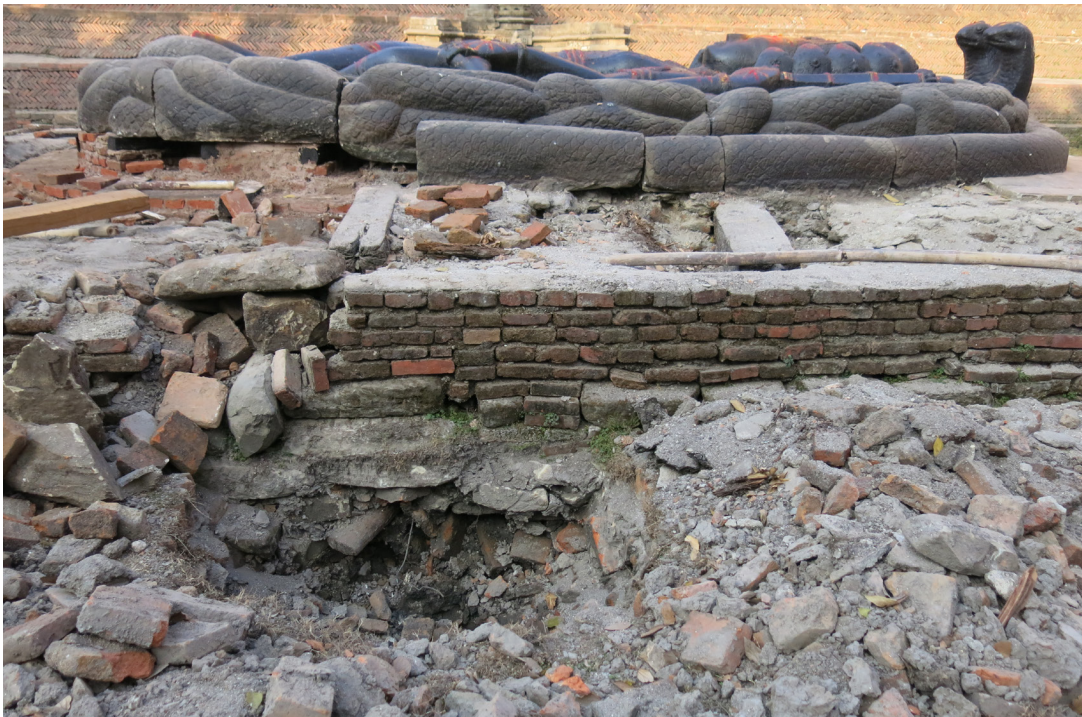
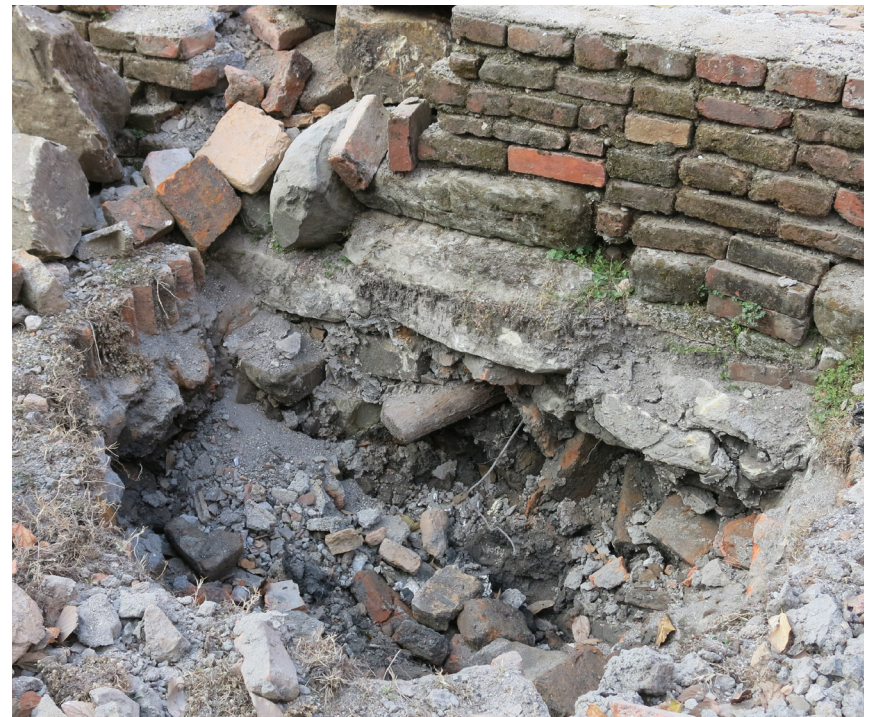
*Left: The inner section of the platform was not properly built with brickwork, mostly filled with rubble. Photo: May, 2013*  
*Bottom left: Excavation on south side of the platform.*  
*Bottom right: Detail of excavation. Below the pond surface, there were no proper foundation walls, only rubble mixed with stones. Photos: Jun., 2013.*

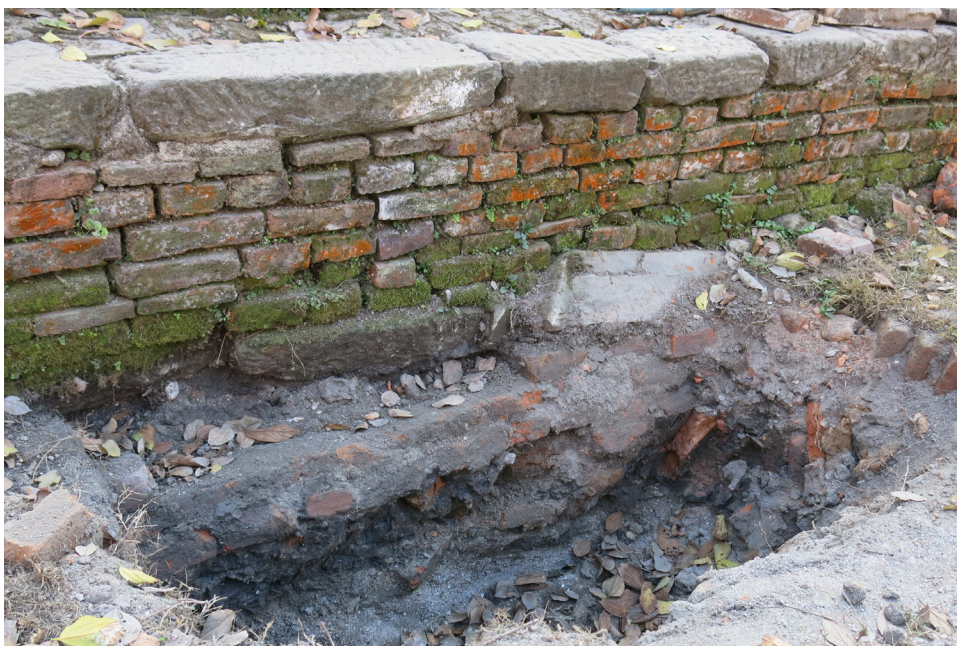
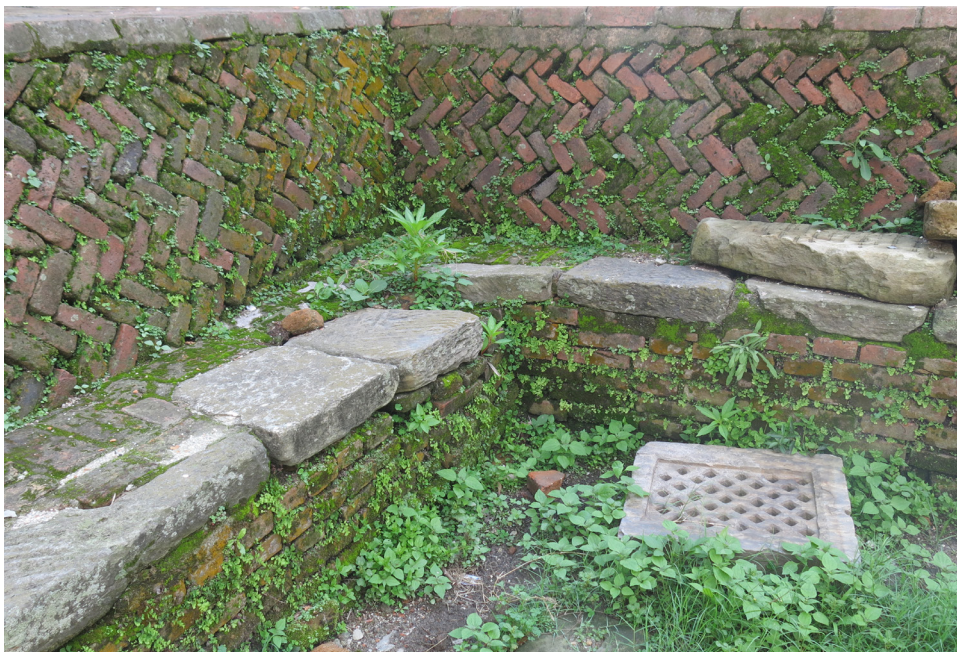
*Top: Lower plinth wall. When it was opened on South side, no proper foundation was found, only few layers of brick work. Photo: Jan., 2013.*

*Bottom: South East corner of lower plinth. Edge stones are fitted irregularly and corner stones are of different heights. Photo: May, 2013.*

On this level, plinth walls need to be rebuilt to introduce a waterproofing membrane and black soil to prevent water leakage, since it is not possible to bring the water table back up. Historically the wall was obviously built in mud mortar, which lacks tight joints, allowing seepage to travel to the pond. But the situation is different now. Instead of catching water from the ground we have to seal the holes from leakage. It should be built in lime surkhi mortar with the proper foundation.

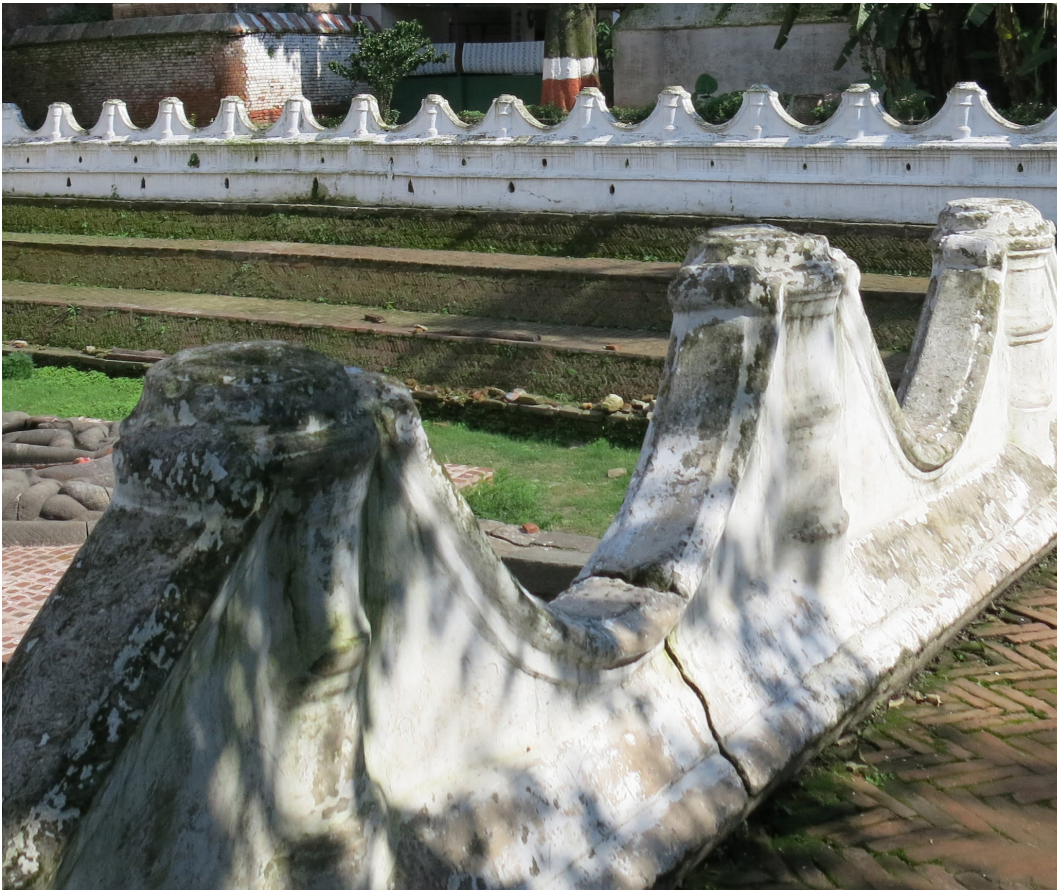
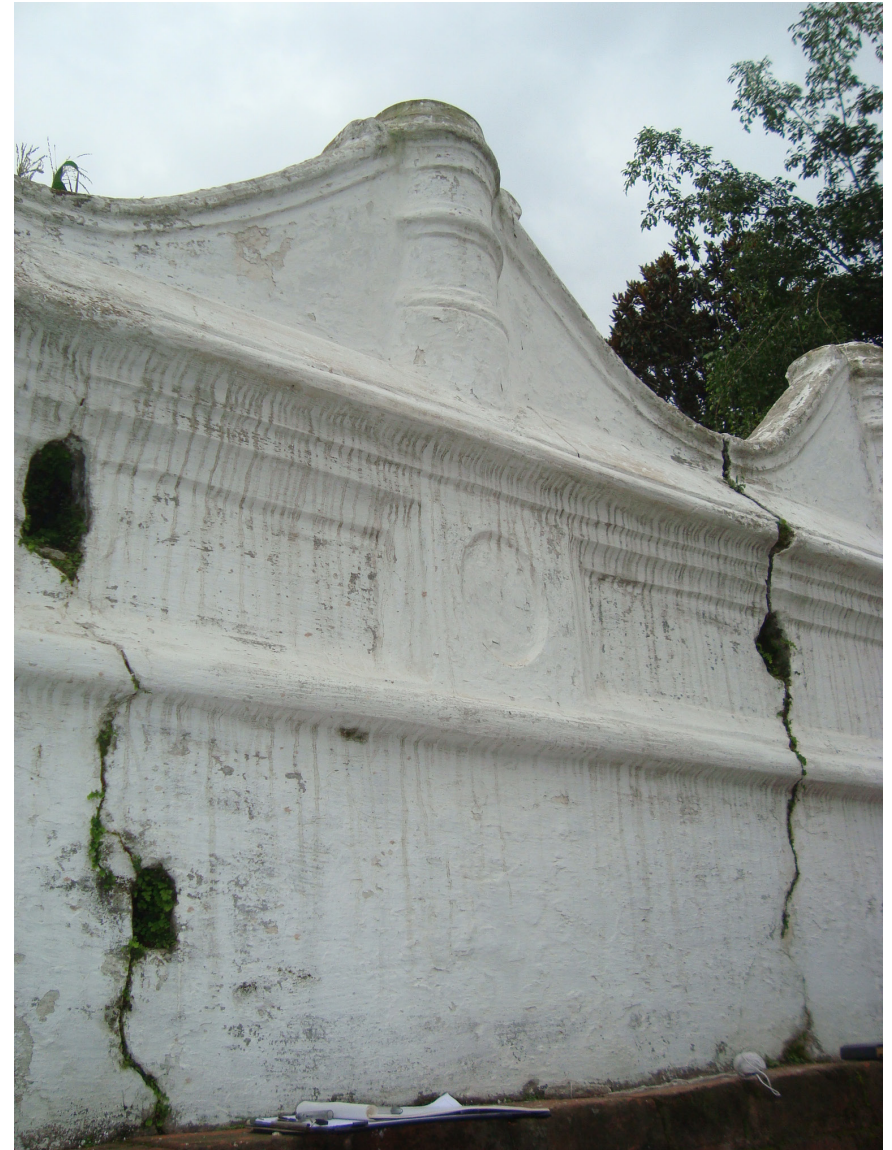
*Left: Upper parapet, North. This is the only large section that is missing. Photo: Jan., 2013.*

*Right: North Entrance to the pond. Stucco plaster is broken off on the pillar and large vertical cracks are also visible. Recent repair work shows superficial beautification rather than the restoration of broken areas to increase the stability of the structure. The stucco plastered area was whitewashed and damaged elements were not replaced. Photo: Jul., 2013.*

Damaged bricks will need to be replaced in lime surkhi mortar. About 6 feet of the north parapet is lost, and will need to be rebuilt by craftsmen who are able to replicate the historic design. Few bricks are damaged in some places, which need to be replaced in lime surkhi mortar.

Some areas of the plaster work are broken. These areas need to be replastered in lime surkhi mortar to match the historic surface. It is strongly recommended to use the lime surkhi mortar as per the traditional technique. Lime stones need to soak in water at least for month to get proper strength.

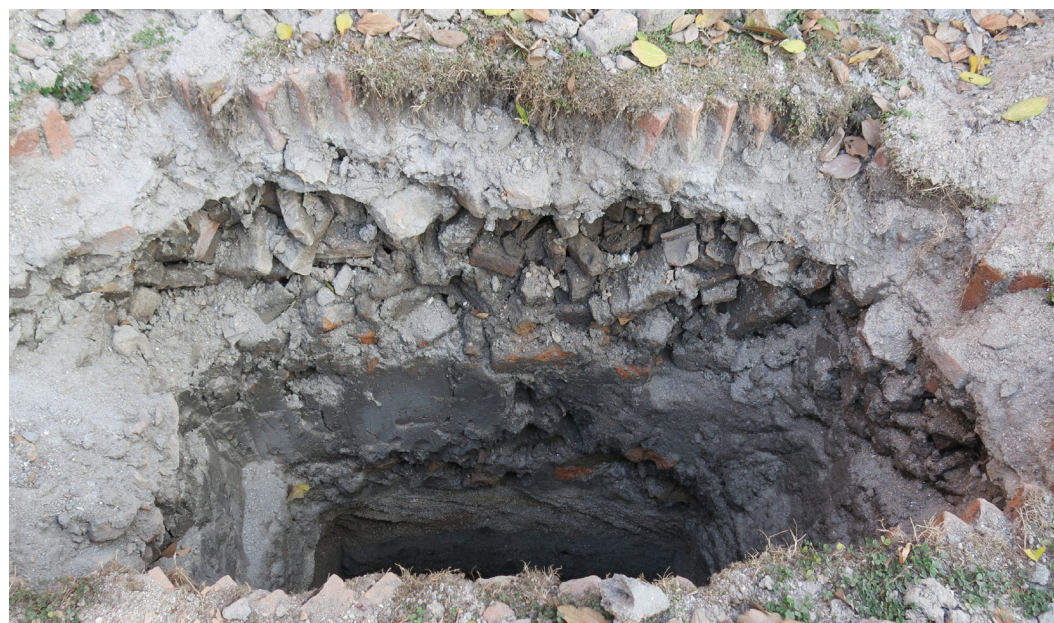
*Trench was excavated to examine the condition of the pond. There was no virgin soil found up to 5 feet trench. About 2 feet was only rubble filling, and some soil was found below that, but again some brick bats are mixed with mud.*

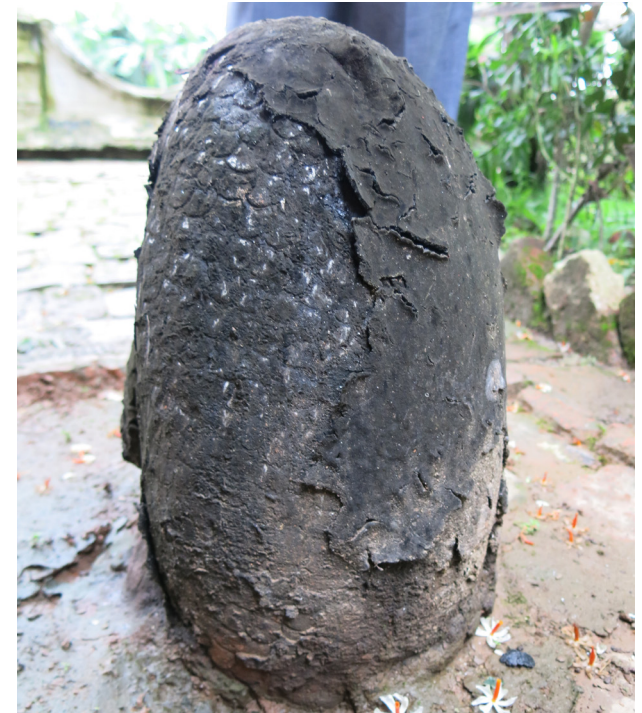
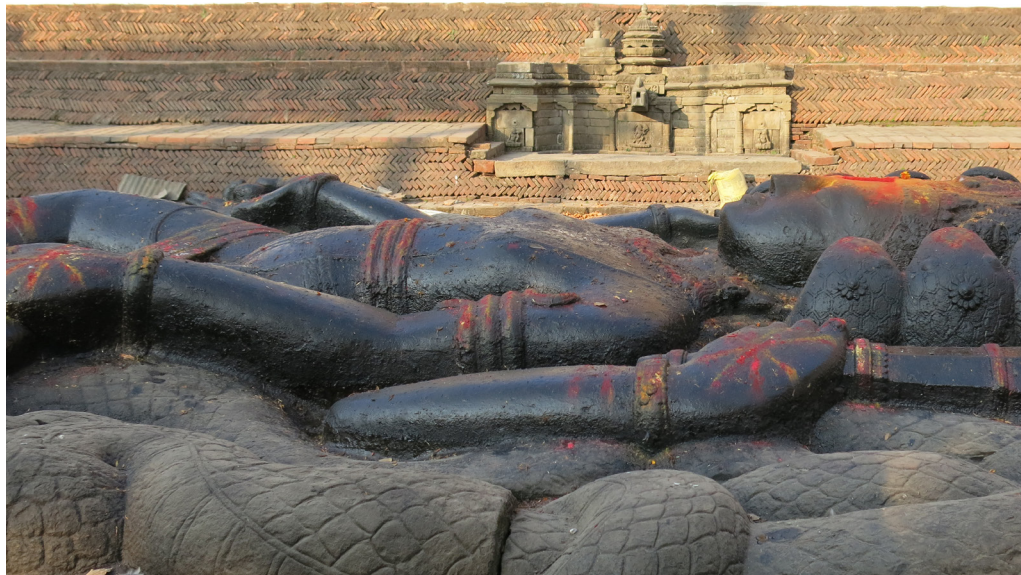
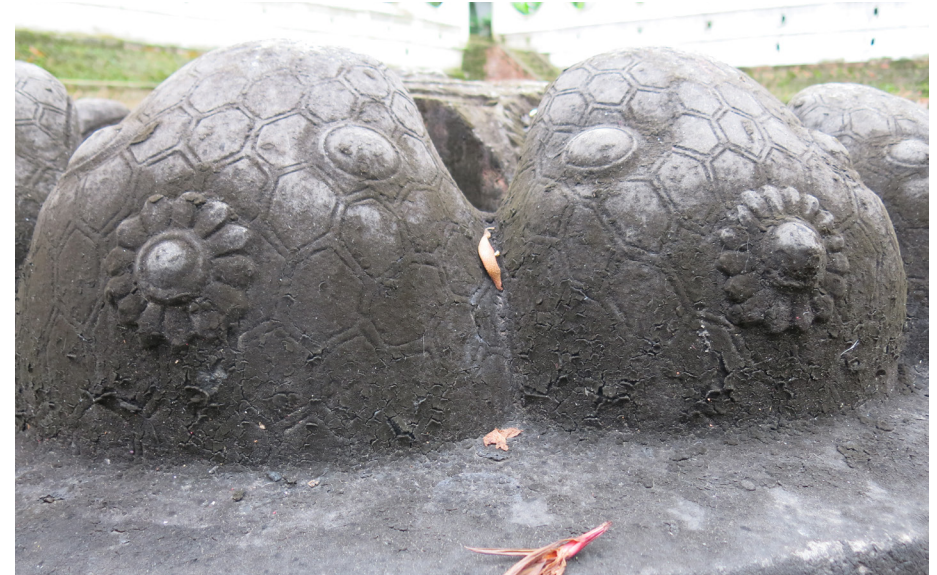
*Right: Many layers of oiling made thickness of dirt on stone surface, which after certain period peeling out from the stone surface. If stone is hard, might not make any damage on stone surface. It will be more of esthetical problem.*

*Bottom left: Top: Photo was taken just after oiling of the main stone image. This is ongoing tradition, might be since few generations or centuries, which is not easy to stop. But certainly due to hard stone this won't make damage in short period. Photo: Jan., 2013.*

*Bottom right: Oiling on top surface washed out quickly by sun and rain, compare to vertical sides. Photo: Jun., 2013.*

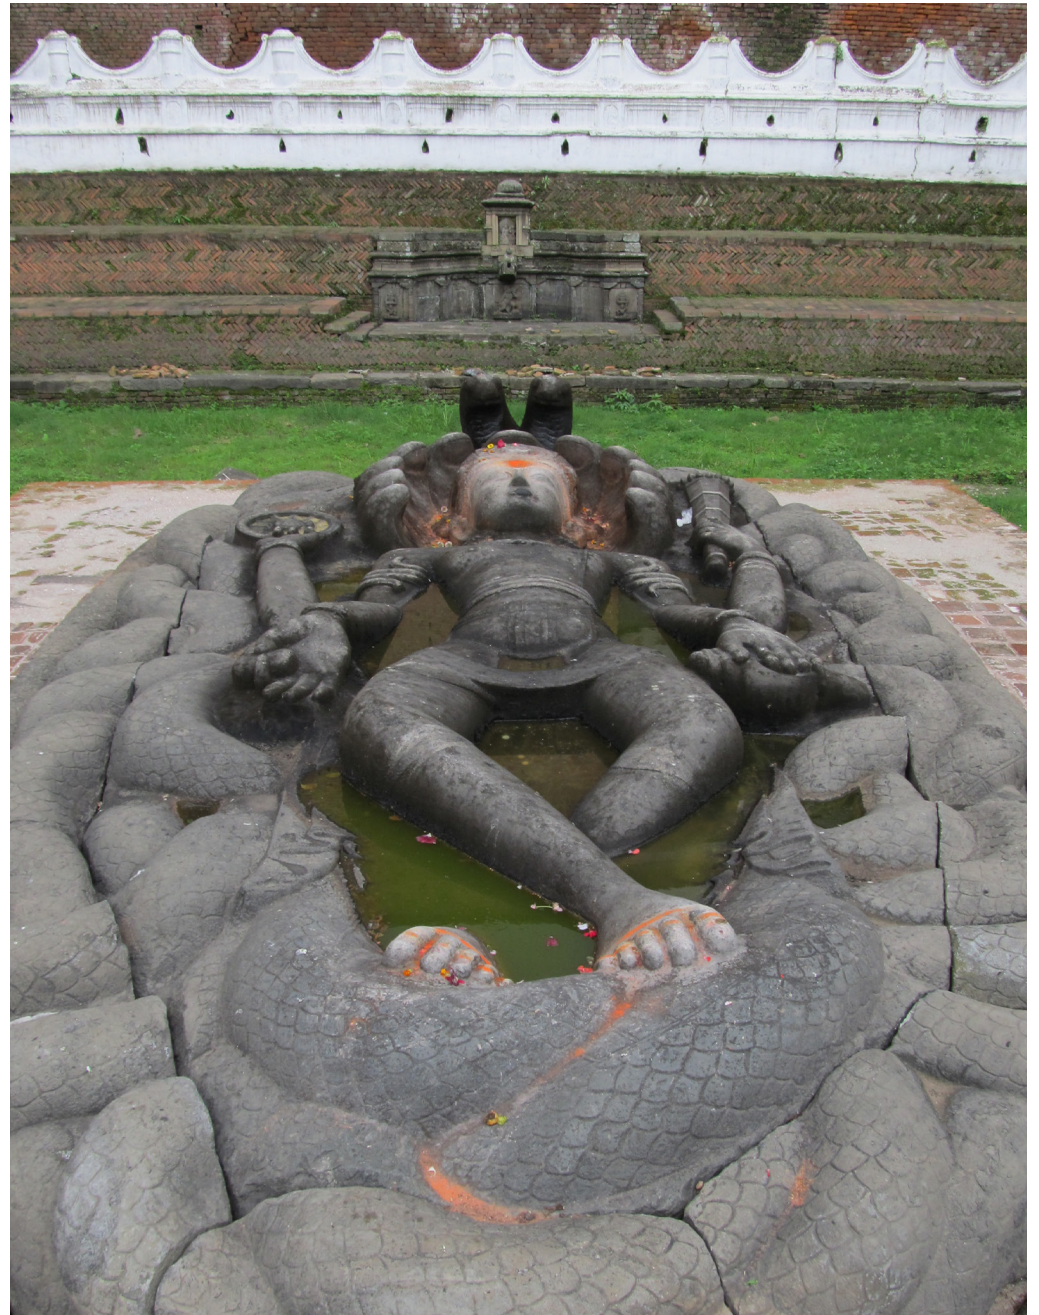
Pools of water form on the sculpture after rainfall in few places, which might adds to the damage in the long run. The only way to solve this problem is to make a drill hole to drain water from these areas, but it is not recommended to make any such interventions to the historic image. But of course some one can take out water by some utensils/ jug as a maintenance measure and wipe it out.

*Top and right: Water was trapped in many places on main shrine, made from single stone, which dries out only by evaporation. Photo: Jul., 2013*

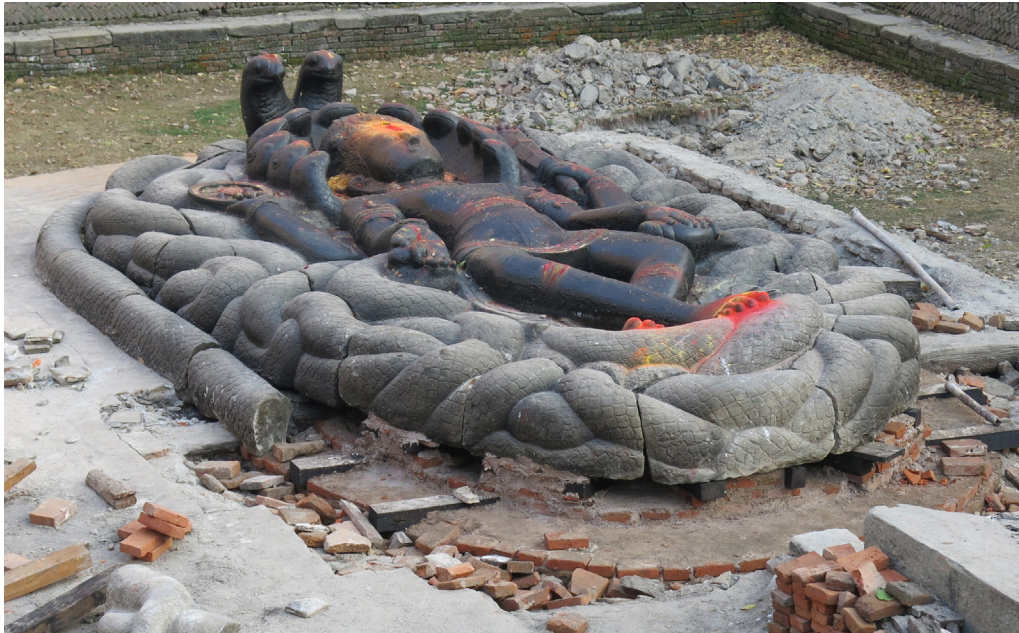
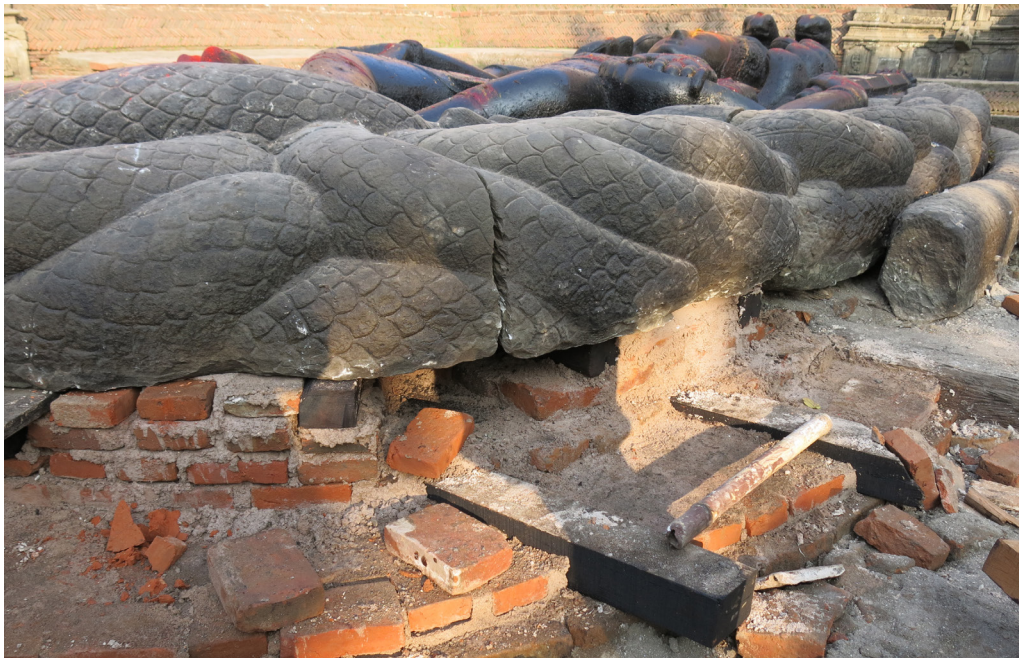
*Top: Replacement of rotten timber beams beneath the main shrine, made from one large piece of stone. Photo: Jan., 2013.*

*Bottom: Brick work in lime surkhi mortar to make solid base for main shrine after installation of timber beam. Photo: Feb., 2013.*

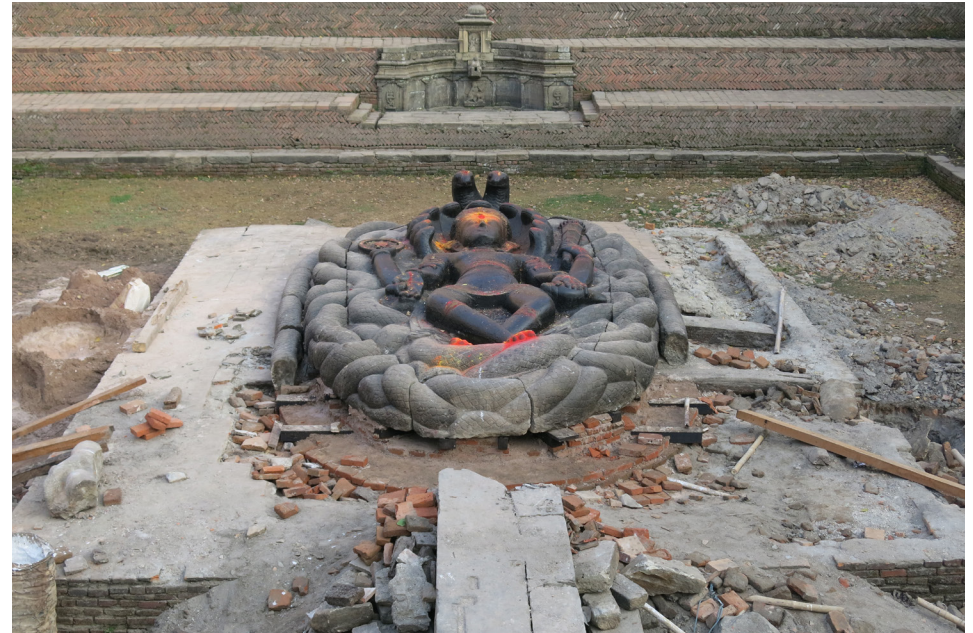
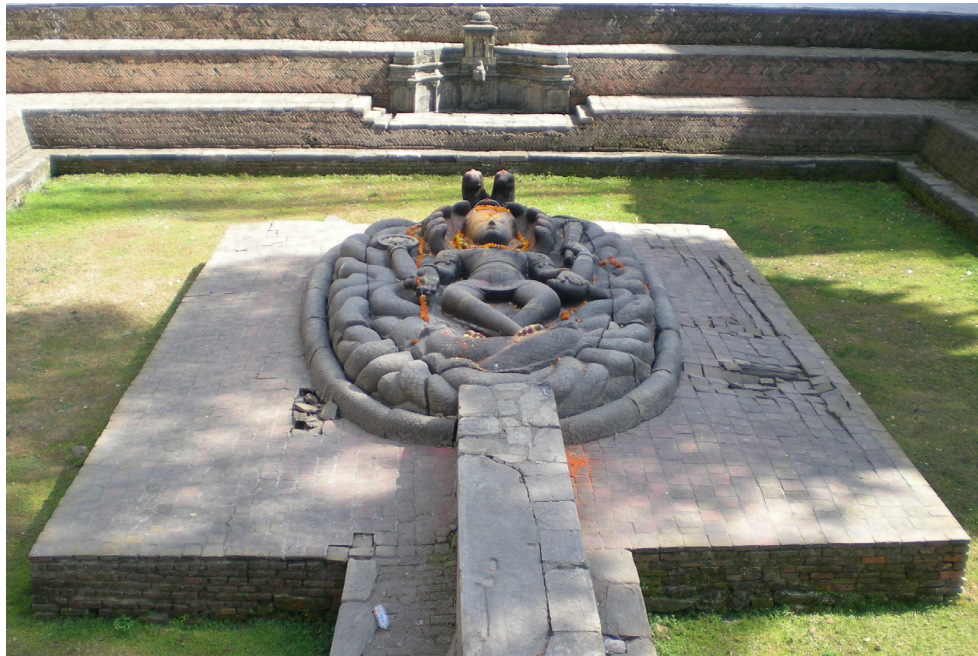
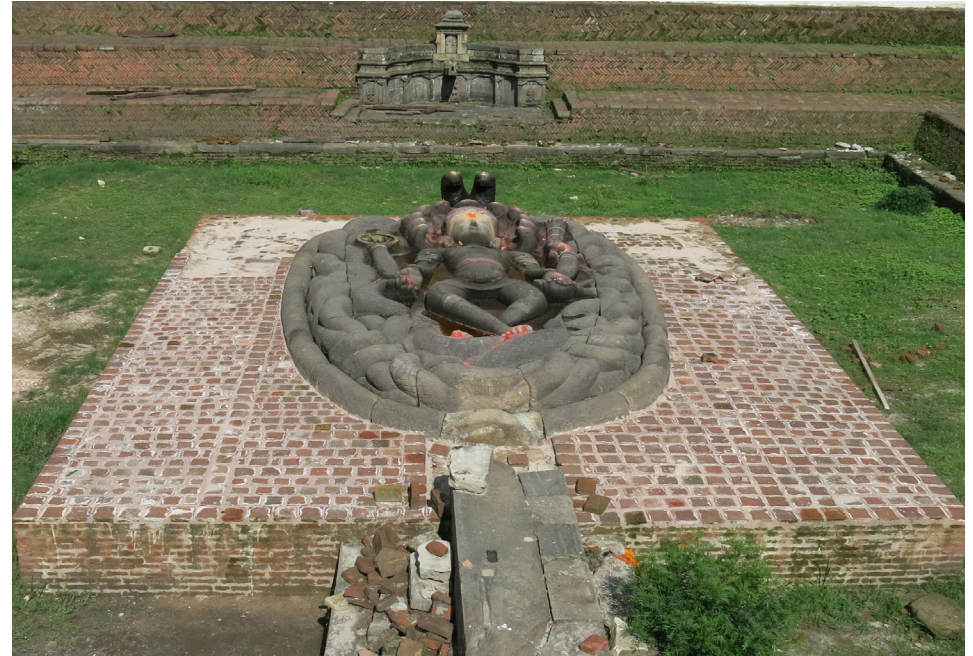
*Top right: After building brick work below stone image. Photo: Feb., 2013.*

*Bottom right: After tile pavement on the platform. Photo: Jul., 2013.*

Below the stone image, all the infill on the platform was replaced with brickwork in lime surkhi mortar during replacement of damaged timbers to prevent from settlement, already executed as an emergency measure in May-June, 2013.

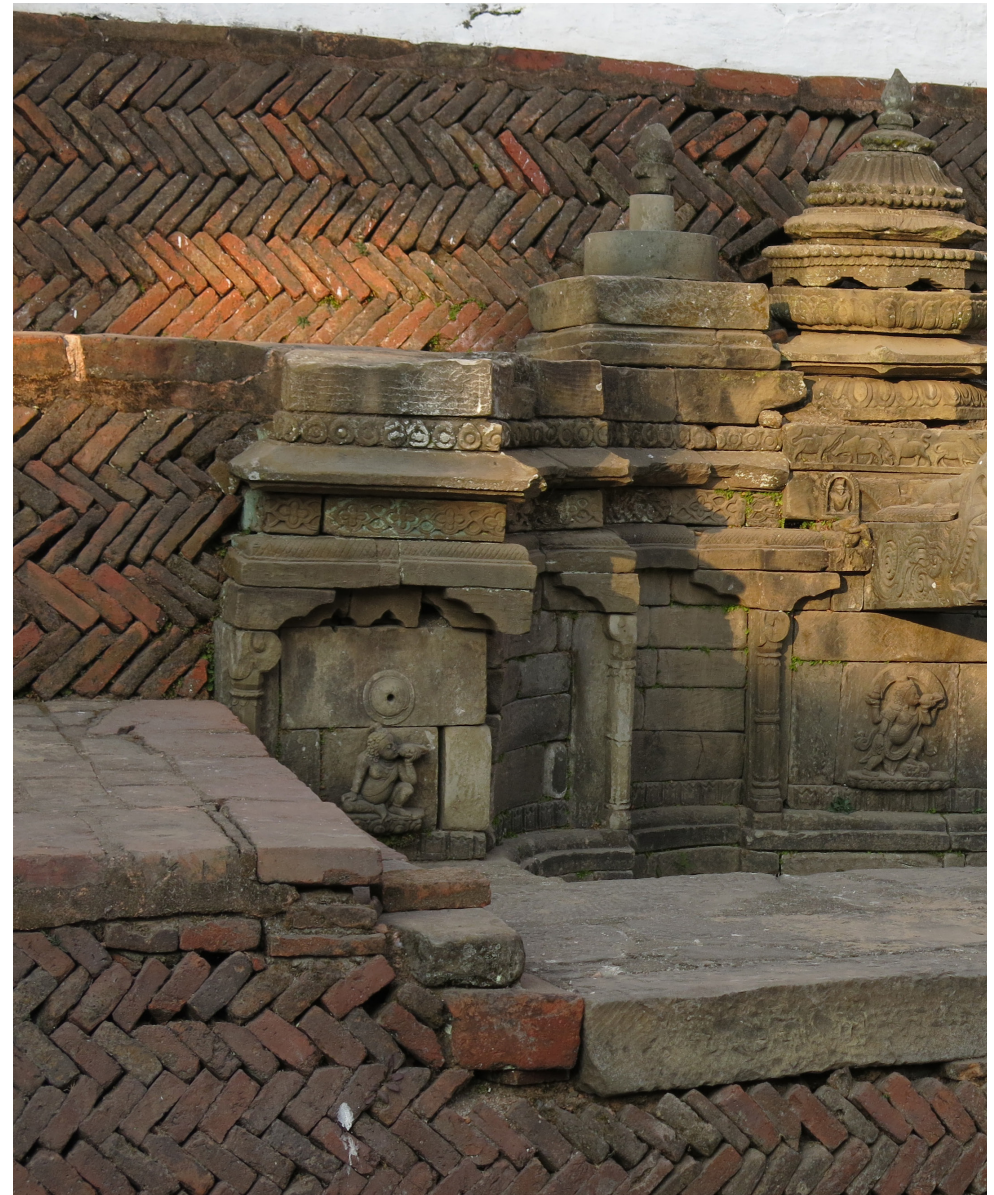
*North Hiti. Few bricks in fish tail pattern were missing behind the centre of the hiti on 4th level, on the left side of the hiti on the 3rd level and just below the steps on 2nd level plinth. Photo: Jan., 2013.*

Most of the areas on all three levels of plinth wall need only minor repairs. In some places, bricks are missing the fish tail pattern. It is recommended to put back missing bricks, which will prevent more bricks from falling. Bricks need to be matched depending upon the plinth level.
