# The Jalasayan Narayan Pokhari Restoration

Hanuman Dhoka Durbar Museum Development Committee  
Kathmandu Durbar Square, UNESCO World Heritage Site

Historic Structure Report/ Conservation Notes

July 2013

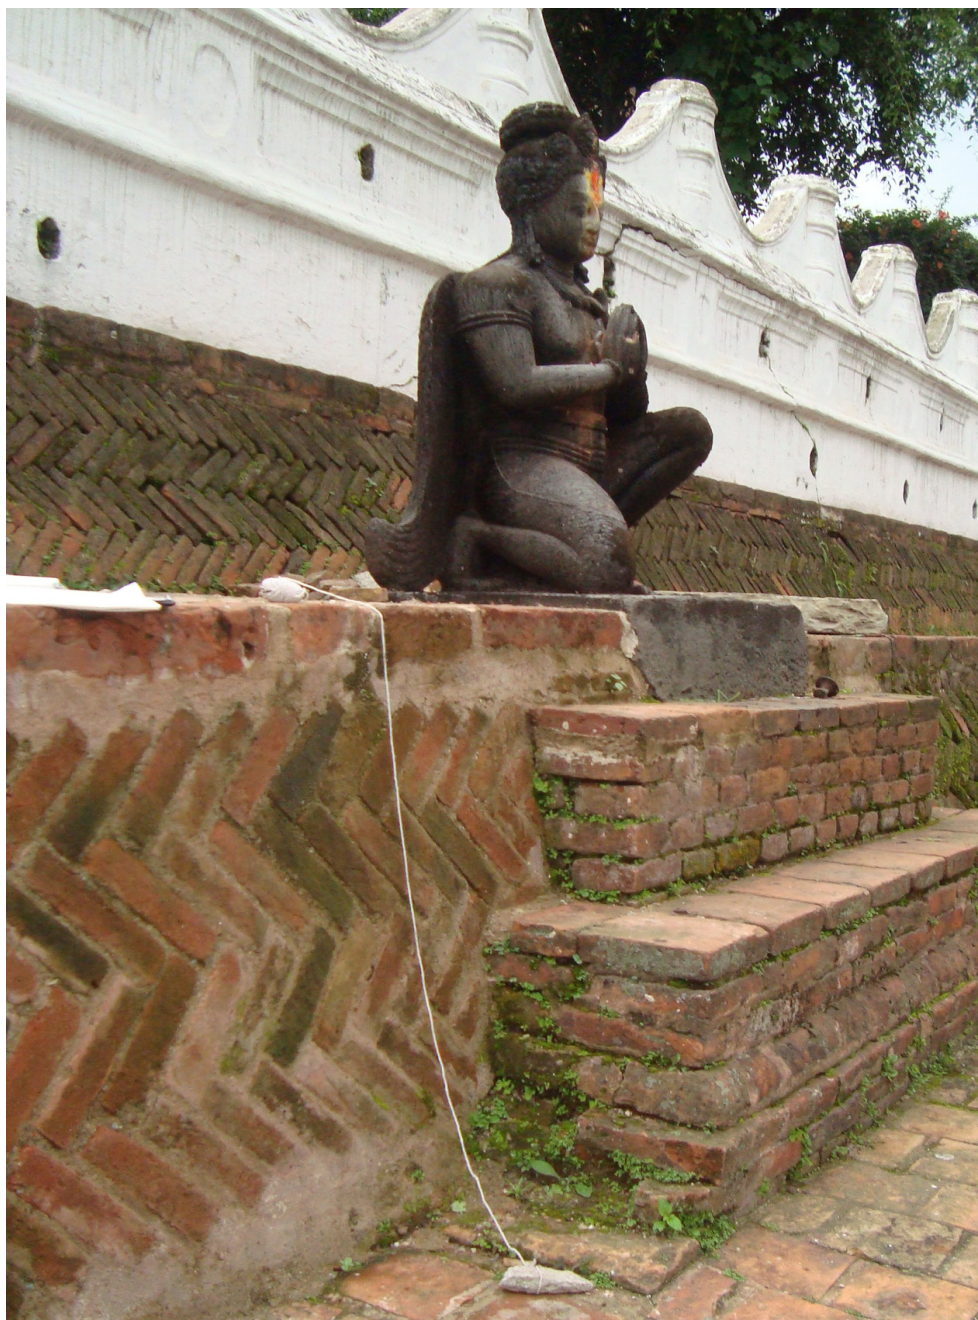
*A small section of 3rd level plinth was repaired recently in lime surkhi mortar on the right side of the Garuda. Lime surkhi mortar was rendered heavily on the joints and does not match the older sections, built in mud mortar. Three sides of the base is sunken on the 3rd plinth, which is logical to lift to make the stone base visible from all four sides. Photo: Jun., 2013.*

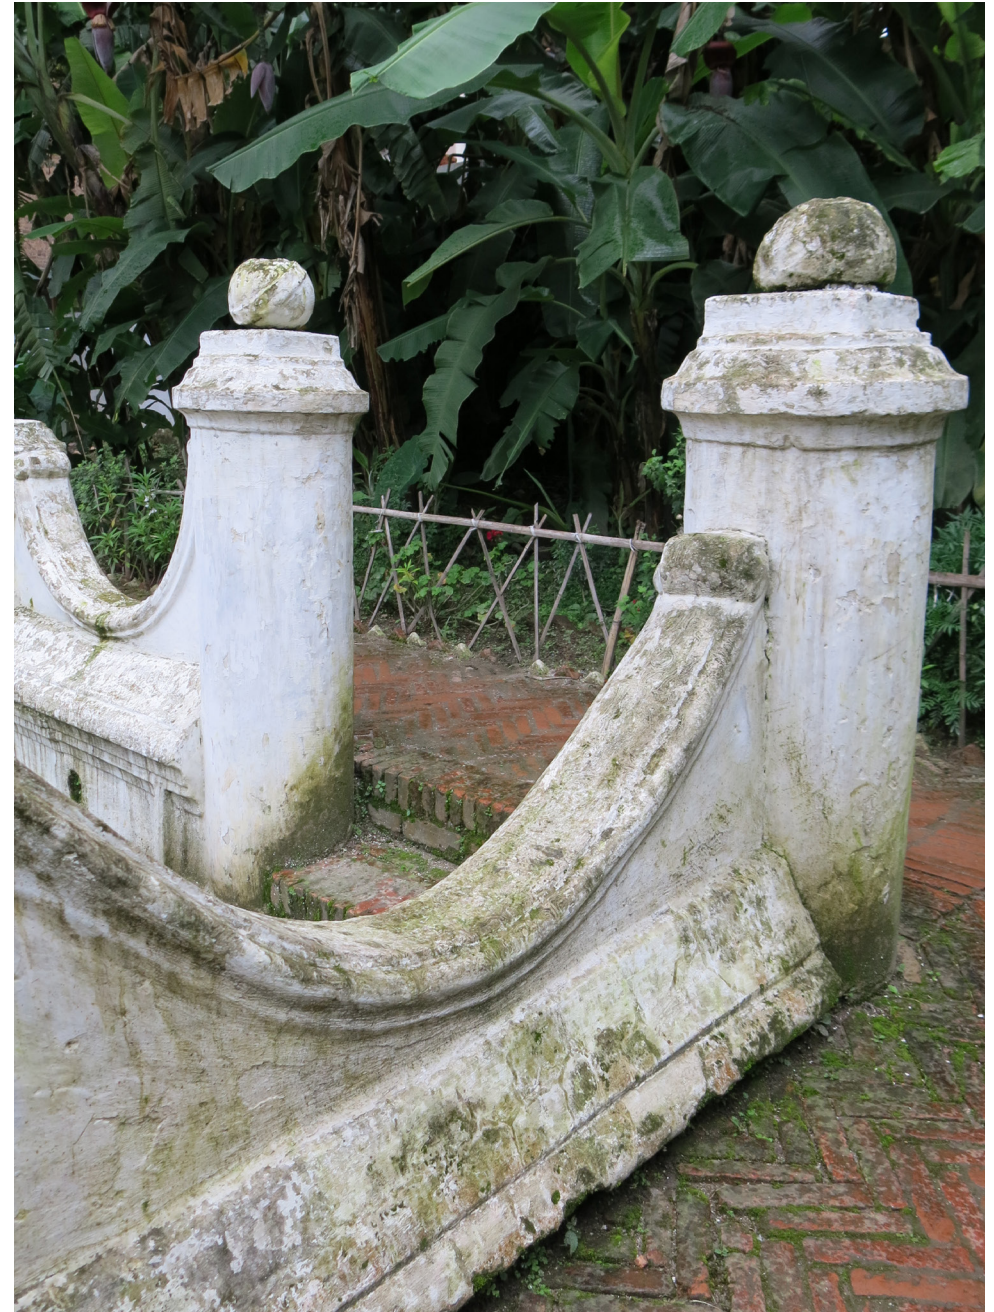
*One of the top of the pillar ornament on the south stair should be reproduced to match the existing pillar on the other side. Photo: Jul., 2013*

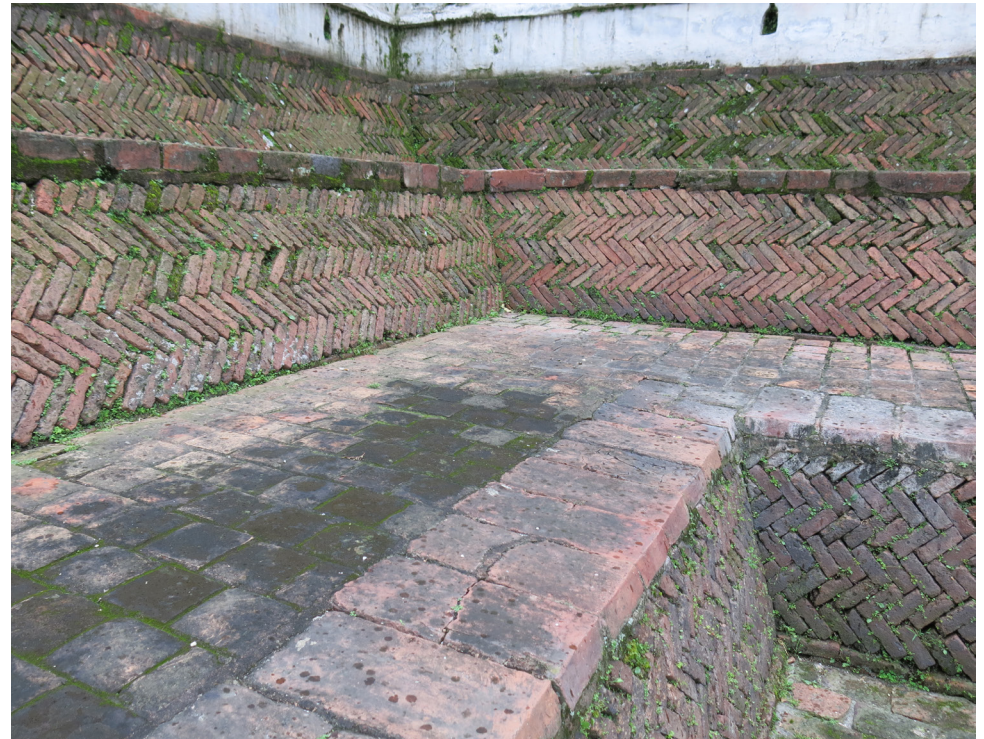
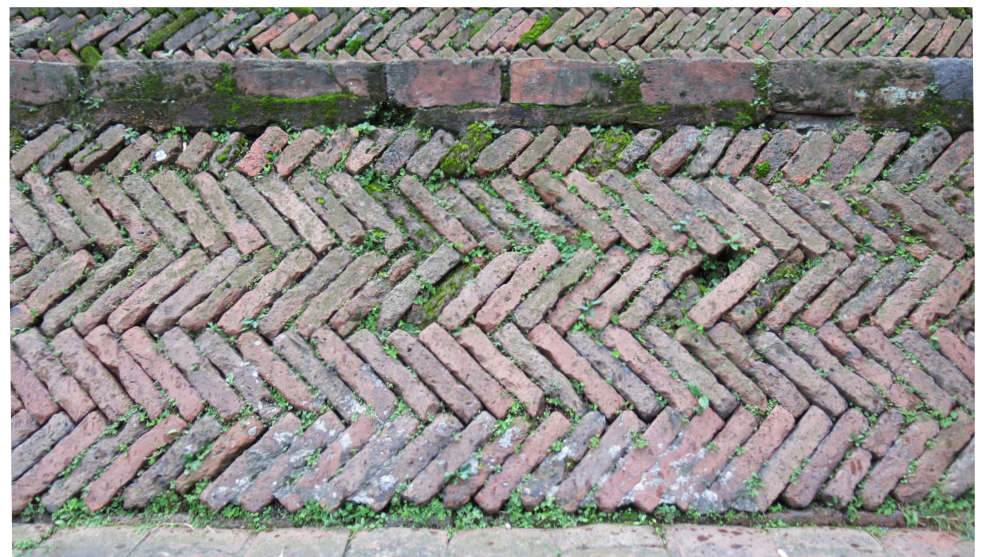
Bottom right: 3rd level with straight edge bricks, which need to replce as 2nd level.

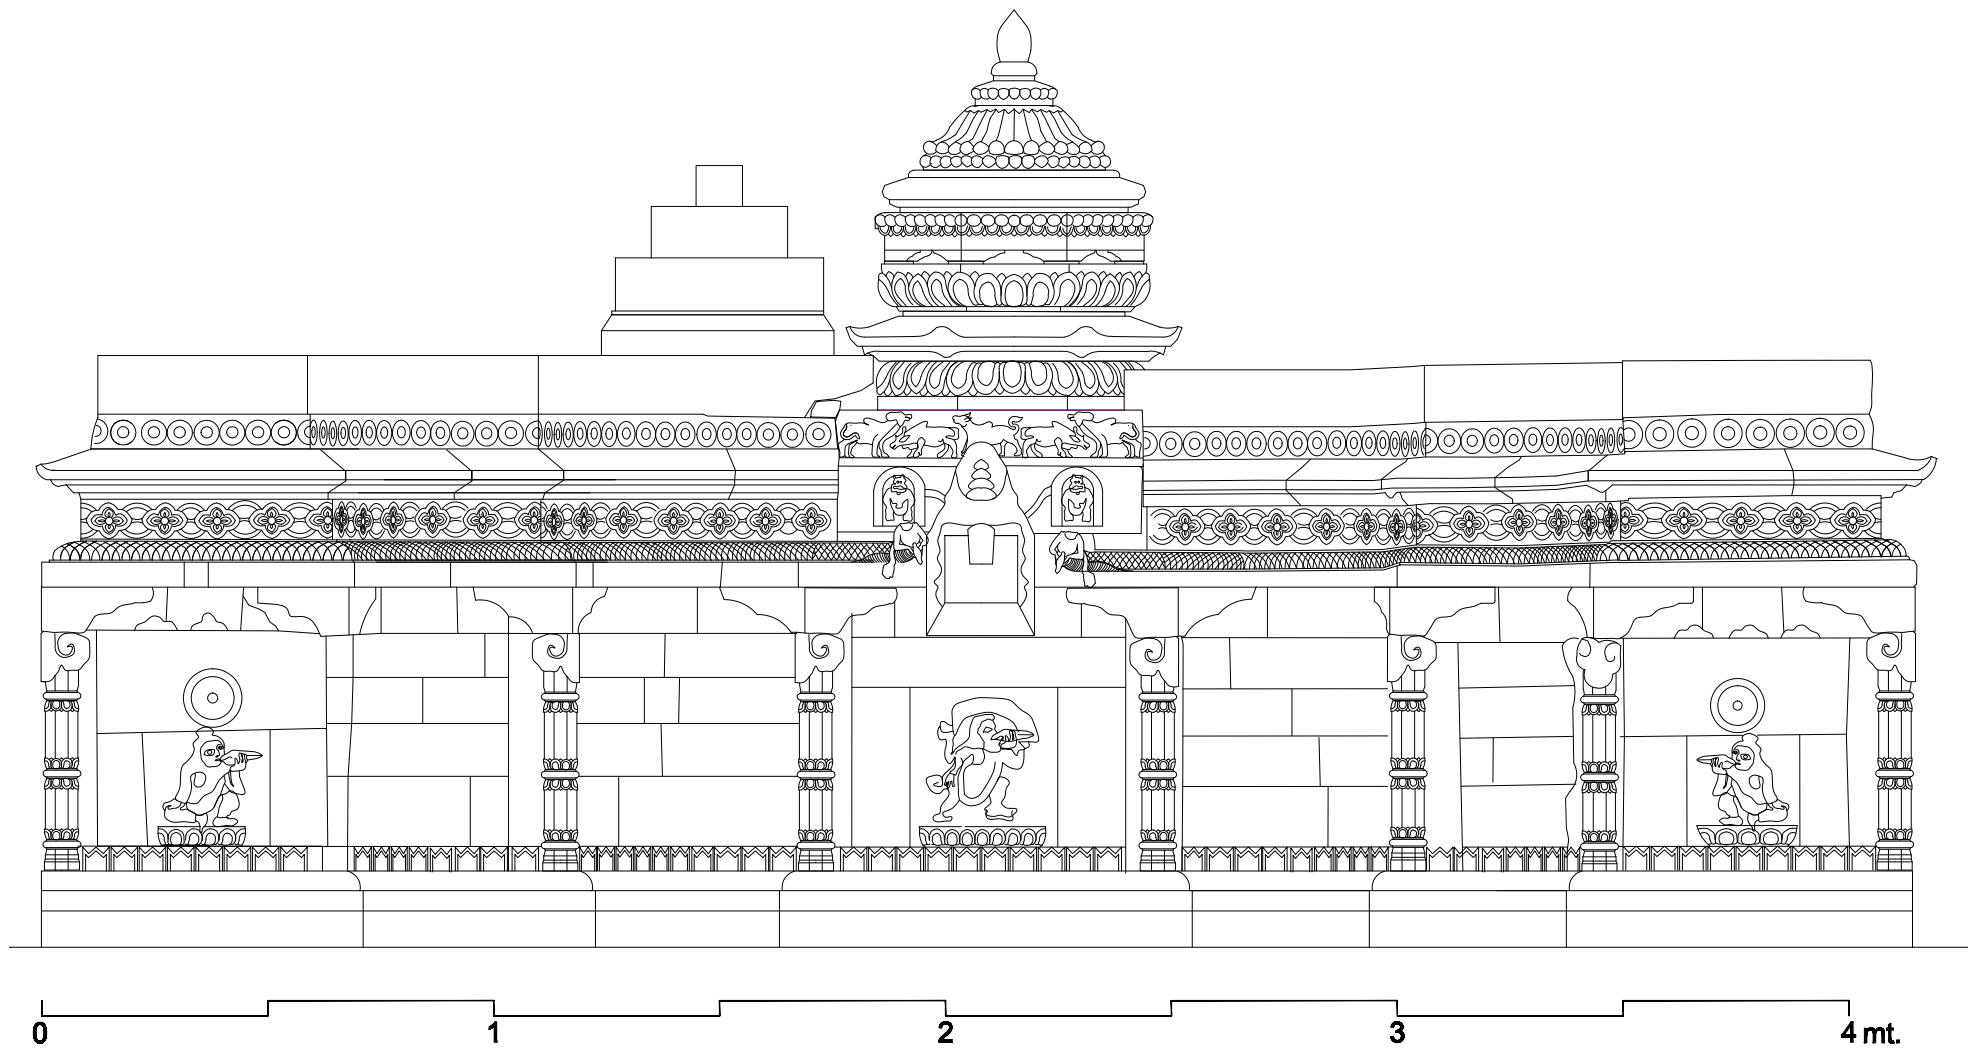
*East Hiti; existing condition.*

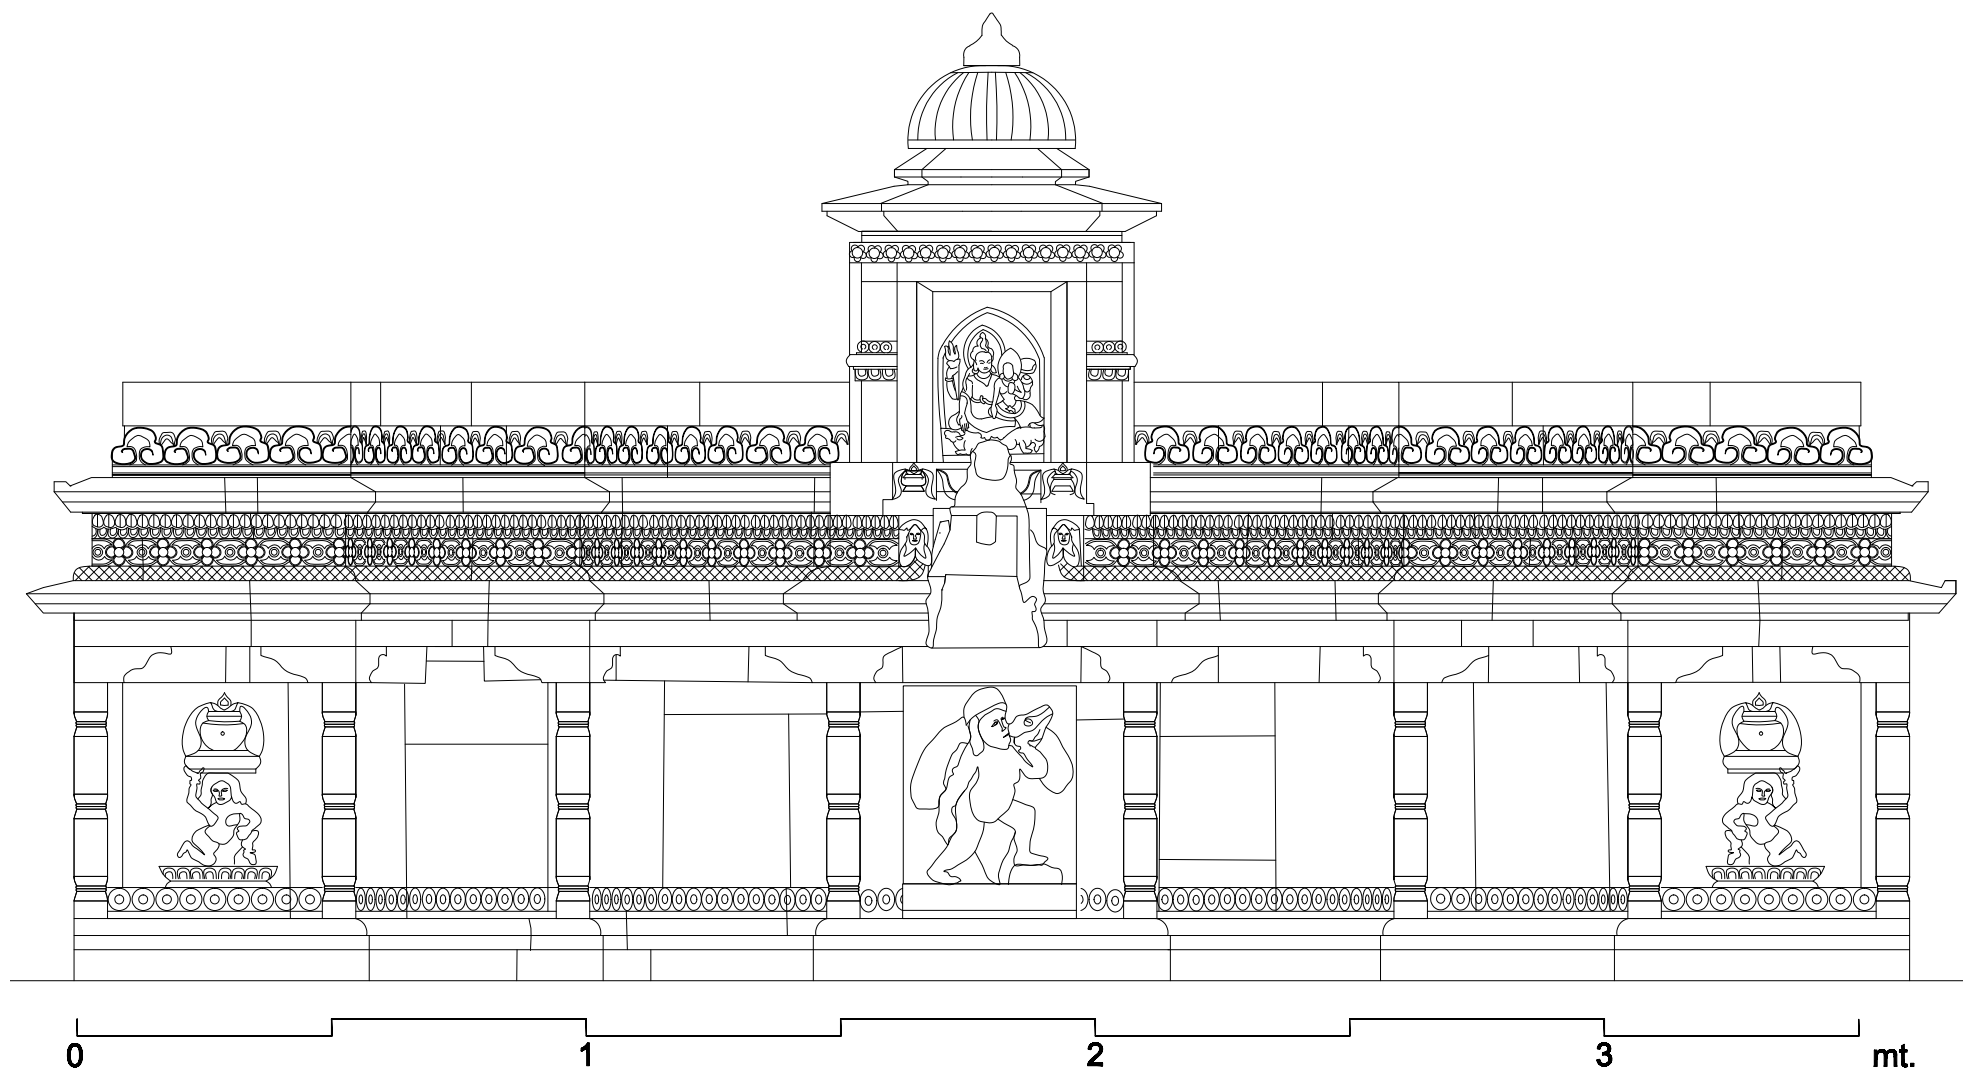
*East Hiti; existing condition.*
