# SULIMA RATNESVARA TEMPLE

SULIMA, PATAN

HISTORIC STRUCTURE REPORT

ROHIT RANJITKAR AND ERICH THEOPHILE  
KATHMANDU VALLEY PRESERVATION TRUST

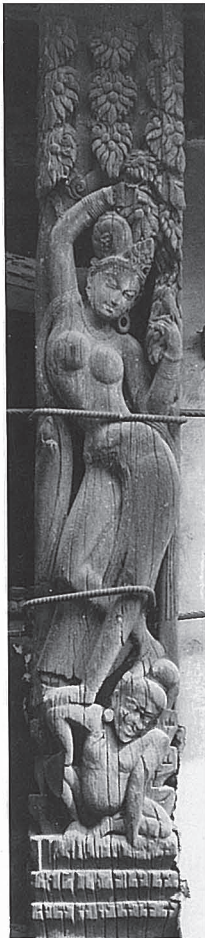
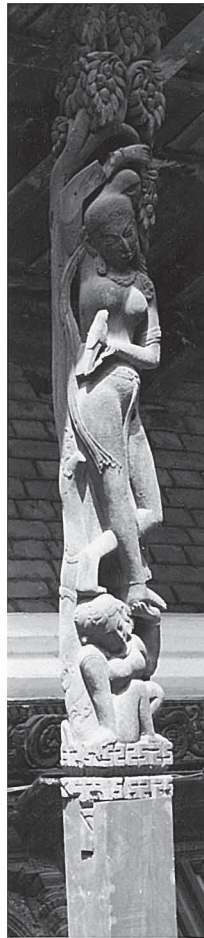
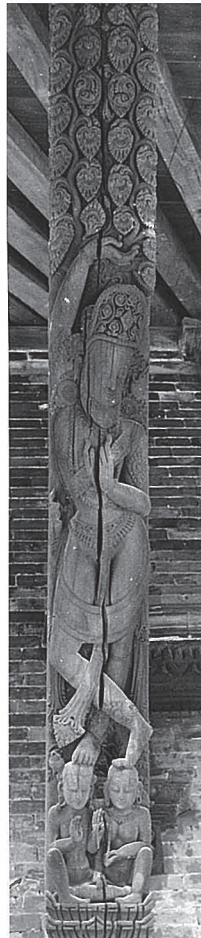
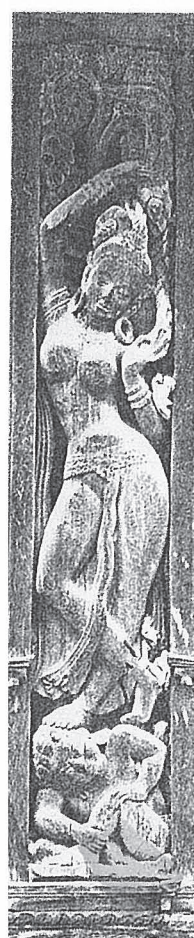
*Struts of similar age and style from different buildings. From left to right: Tyagah Chapah, Uku Baha, Indraesvara Mahadev, Yetkha Khwapa Chhe.*

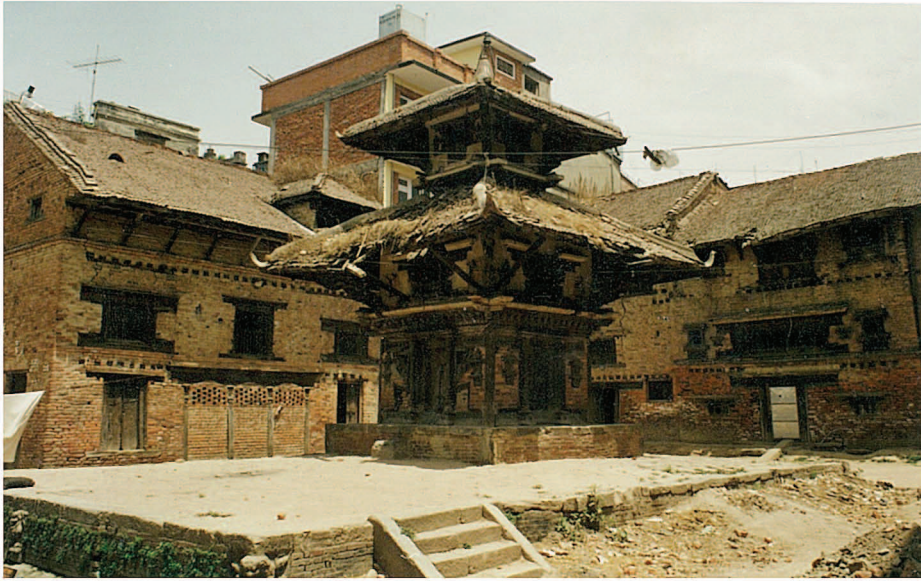
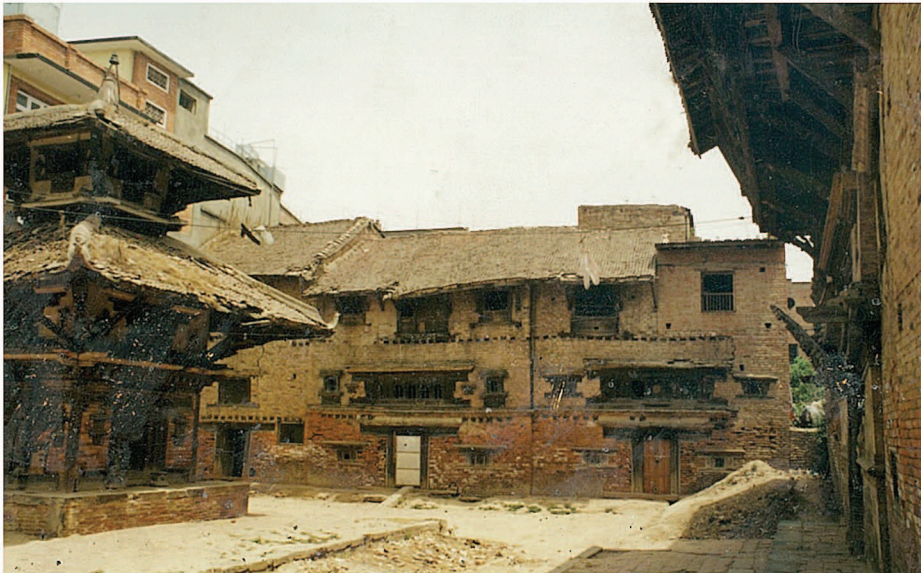
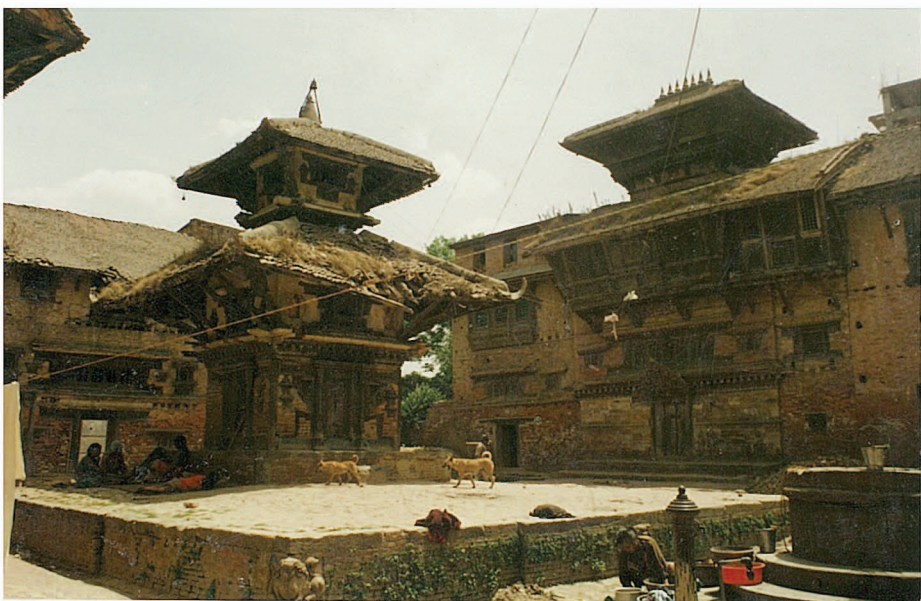
*Buildings around the Ratnesvara Mandir. Five years ago the historical buildings of Sulima Square were intact. Since then, many have been replaced by modern concrete structures. Lost houses are shown in red. Photo: 1993.*

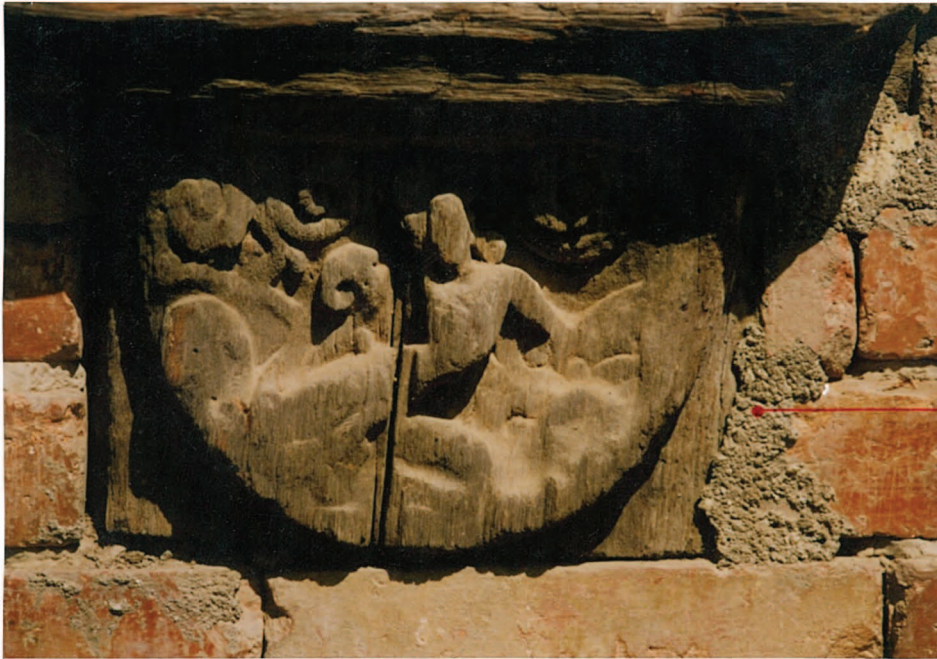
*Recent sloppy cement  
patching by locals covering  
timber elements.*

*Recessed and keyed surfaces  
of the original window which  
suggest an original plaster finish*

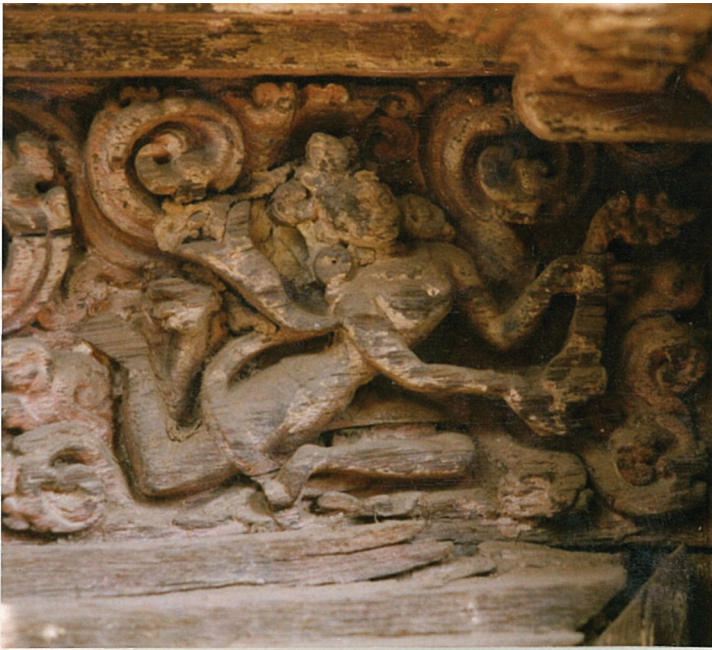
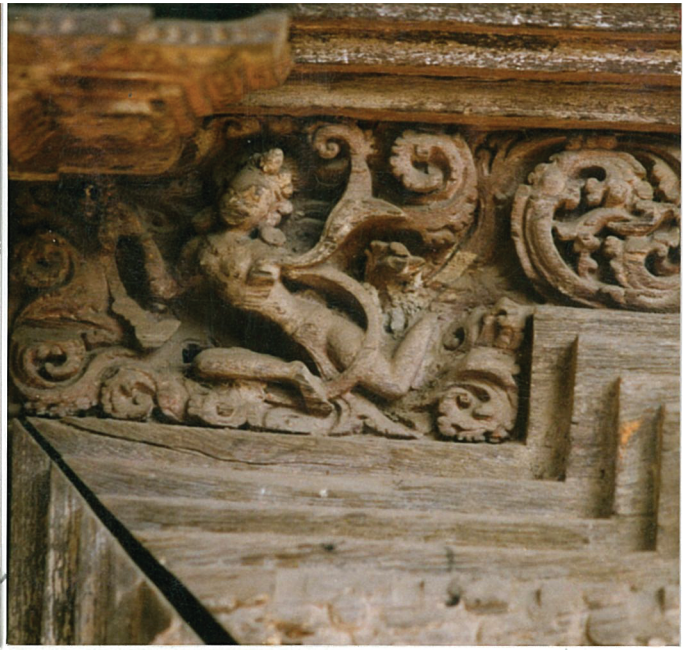
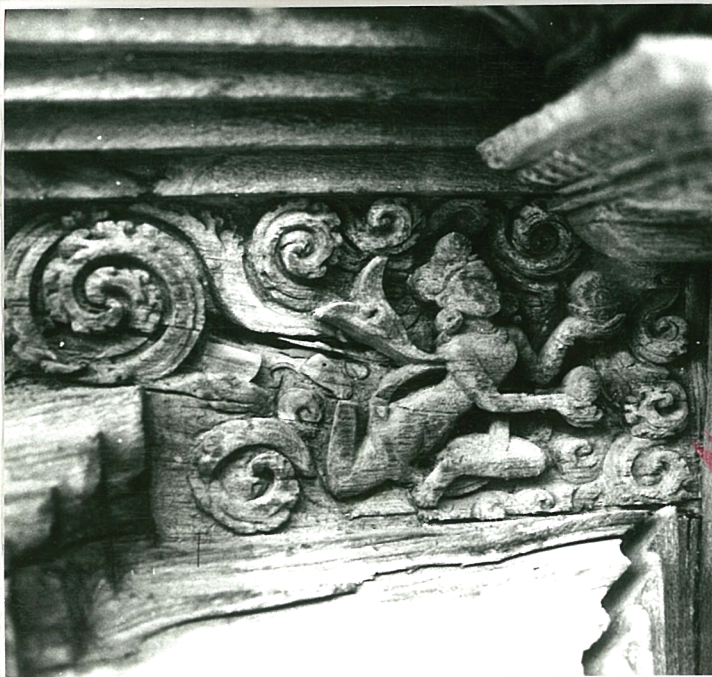
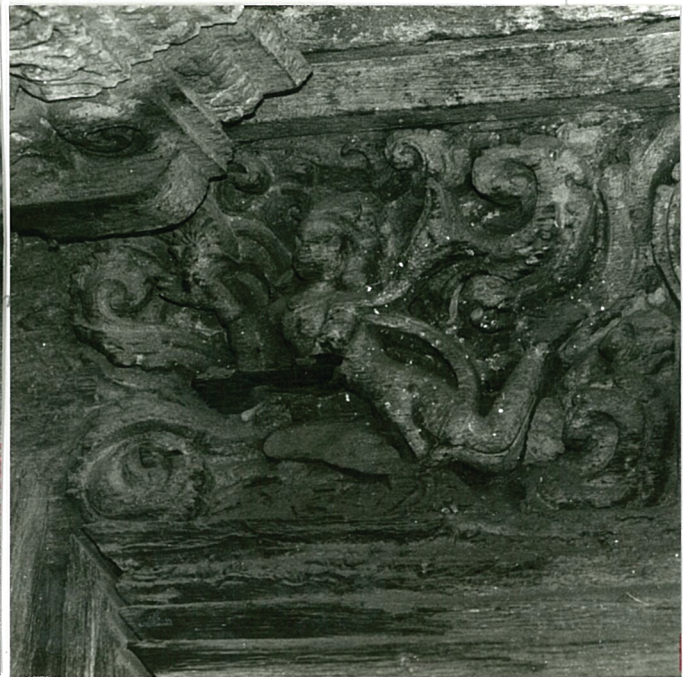
Detail of the upper level  
extended door lintel showing  
winged figure "Apsara". Top  
photo from front west facade.  
Bottom from east facade.

Facing page: Detail of the  
upper level extended door  
lintel showing winged figure  
"Apsara". Top photo from  
north facade. Bottom from  
south facade.

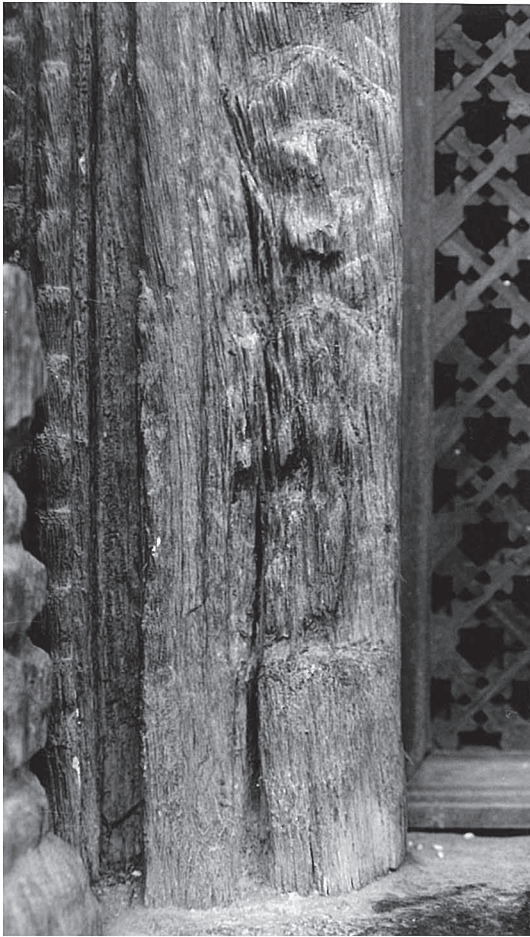
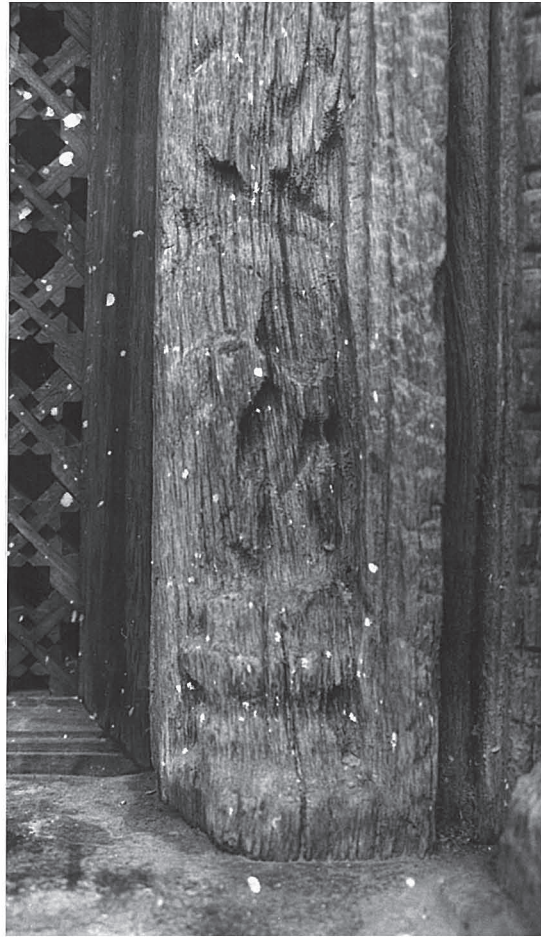
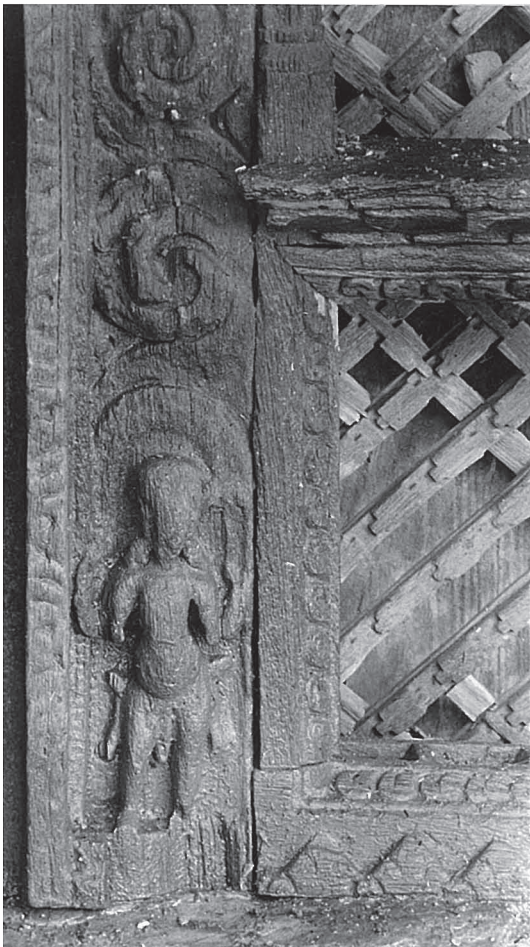
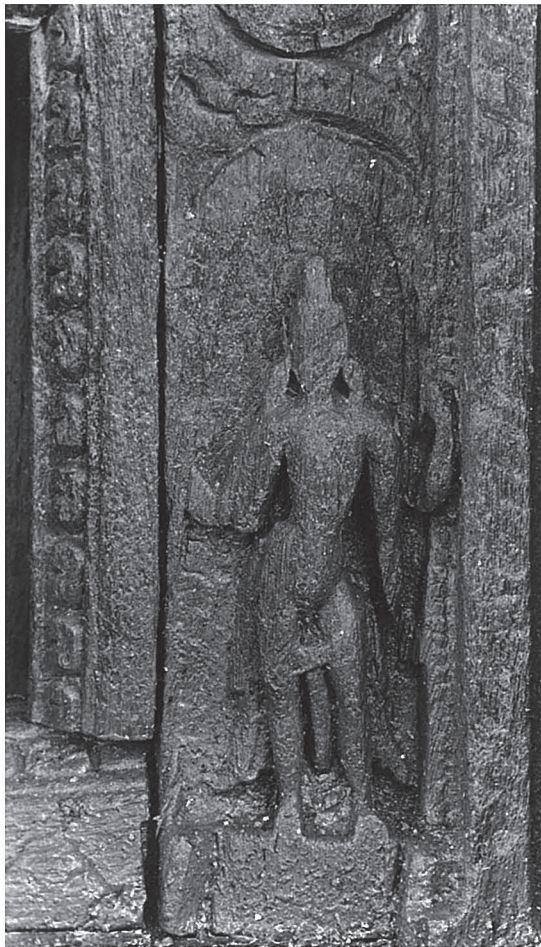
*Lower parts of the door surrounds with small deities as a base of the vertical frame.*

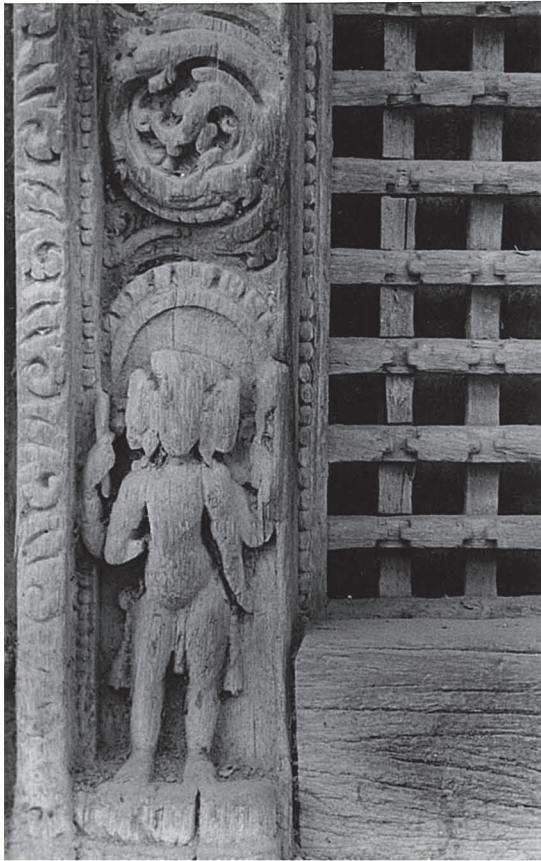
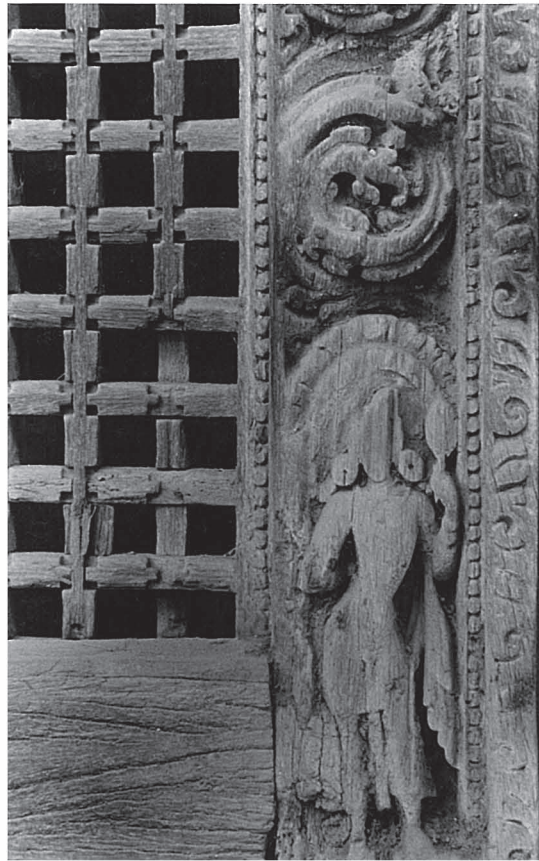
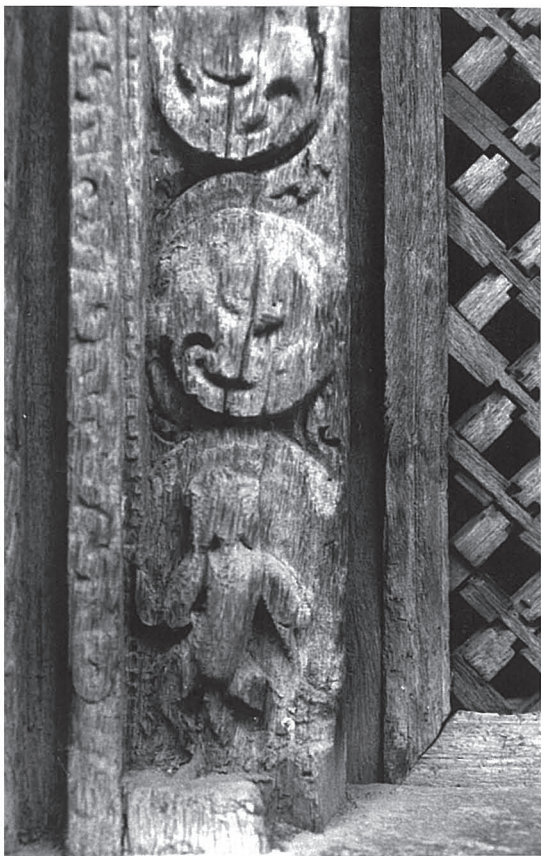
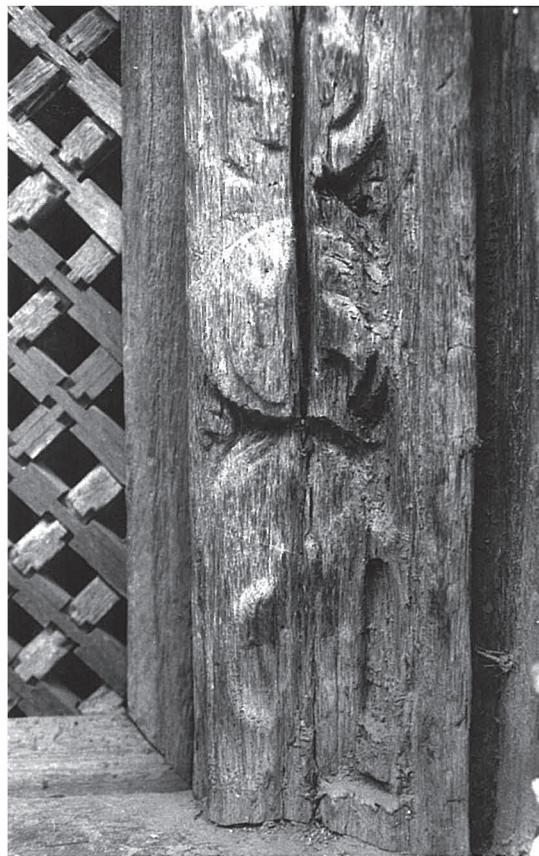
*Lower parts of the door surrounds with small deities as a base of the vertical frame. Top: three headed icon (unidentified) and Shiva Pratihara on north door frame. Bottom: three headed figure (unidentified) and Shiva Pratihara on south door frame.*

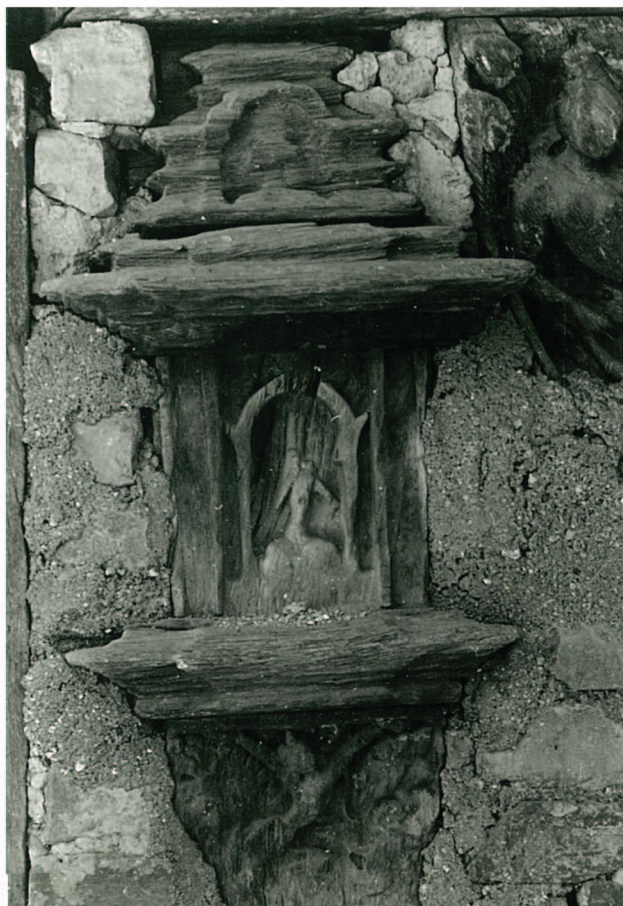
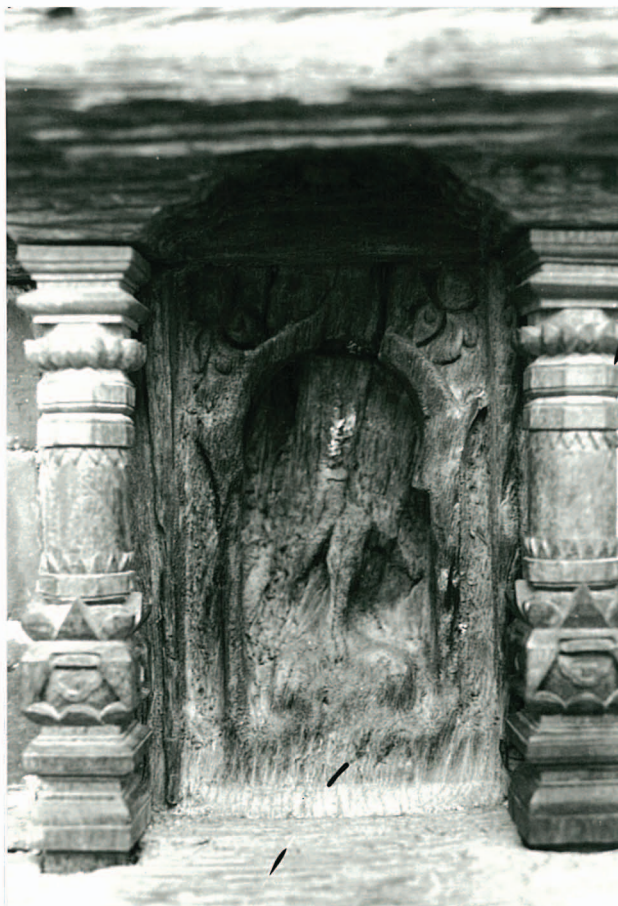
Left: Blind window from front west facade left side. Blind window is worn too much, so it is almost impossible to identify the main figures on it. Lower figure in blind window is "Ghandharva". Right: detail of main icon of the blind window.

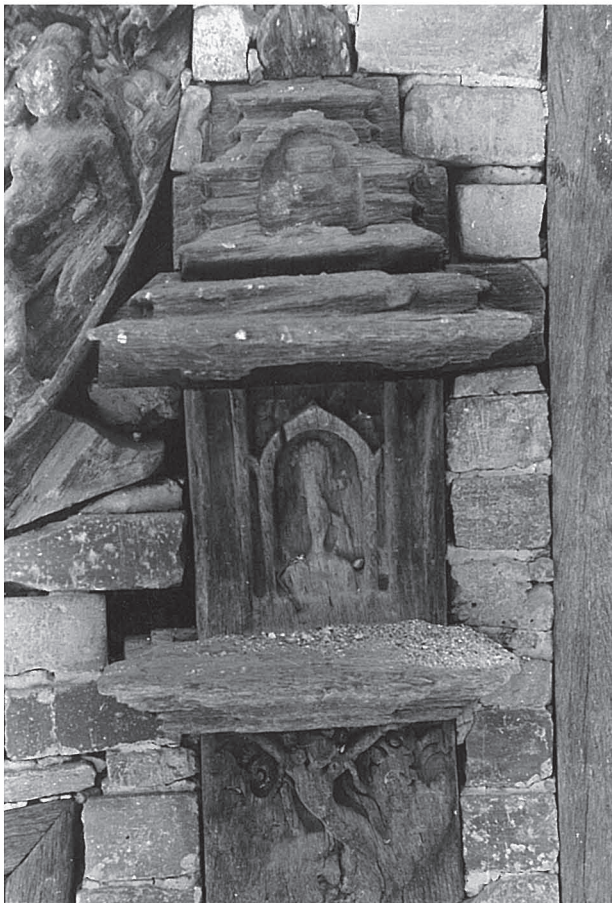
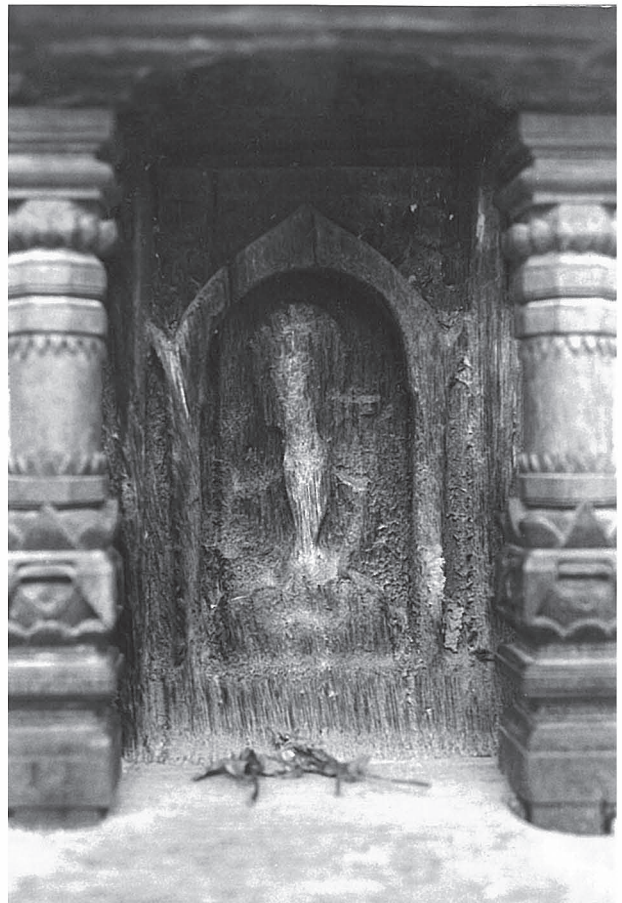
*Left: Blind window from front west facade right side. Main figure of this blind window is also impossible to identify. Right: detail of main icon of the blind window.*

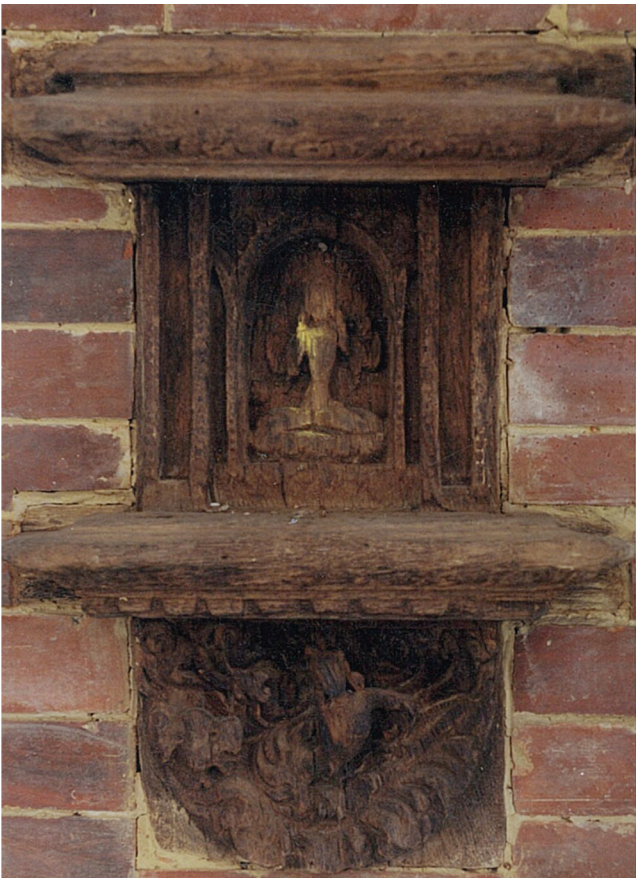
*Left: Gahjhya, blind window from ground level, north facade left side. Main figure is not identifiable and as on other blind windows, lower part is a "Ghandharva". Right: detail of the gahjhya.*

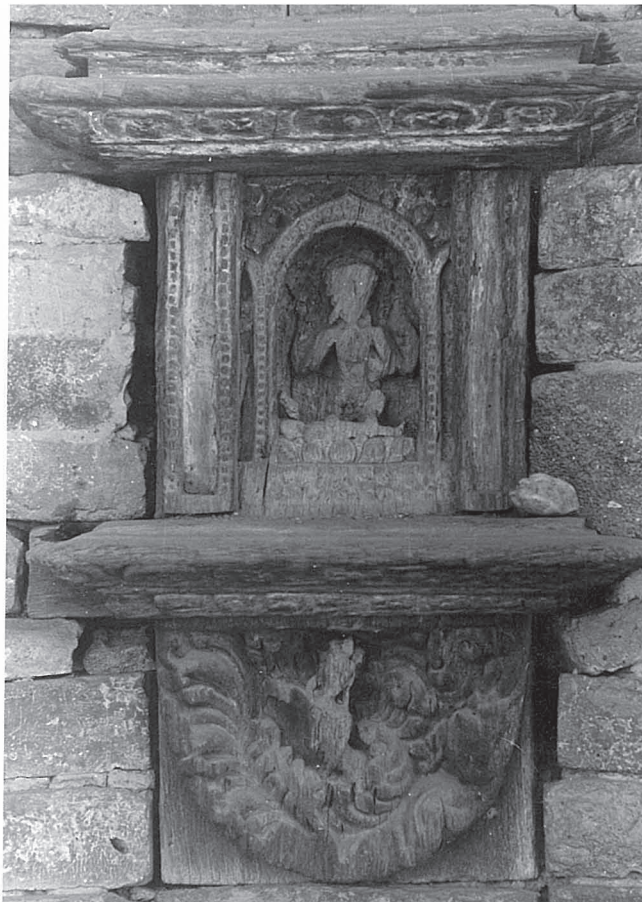
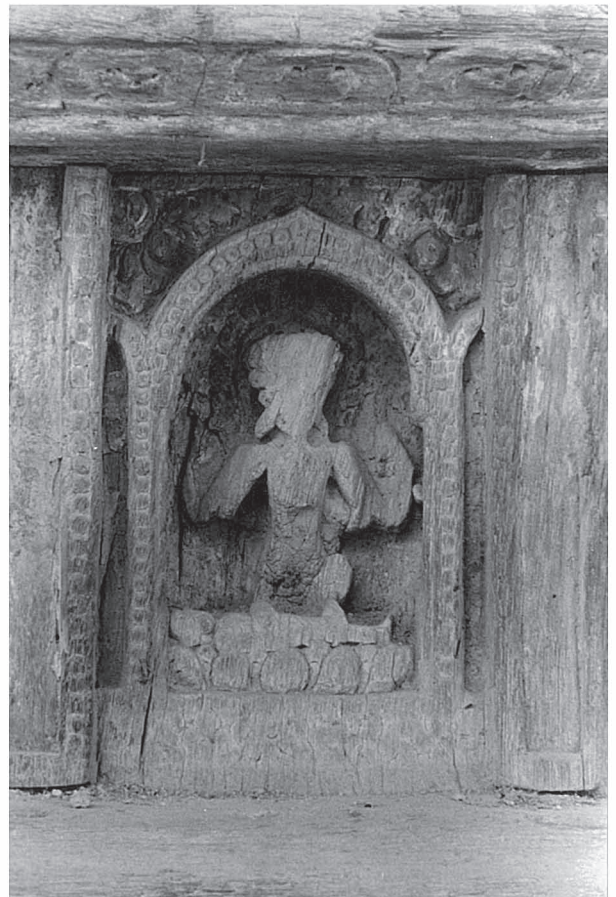
Left: Gahjhya, blind window from ground level, north facade right side. Main figure is "Garuda" carrying a human figure and, as on other blind windows, lower part is a "Ghandharva". Top part of the blind window about 1/3 and small timber posts are lost. Right: detail of the gahjhya. Garuda, vehicle of Narayan as a main figure inside the frame.

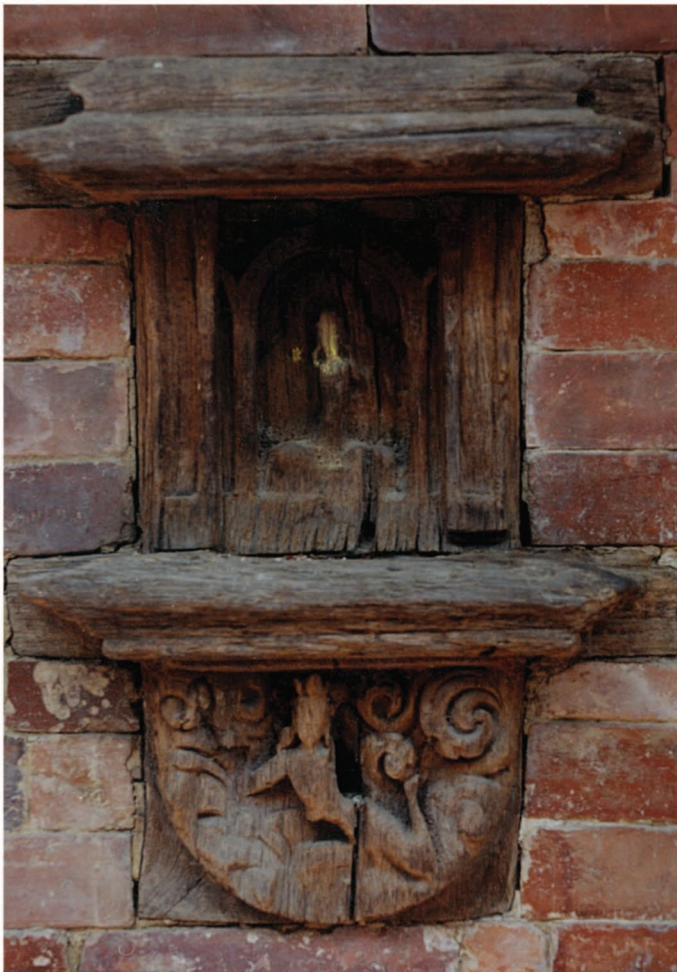
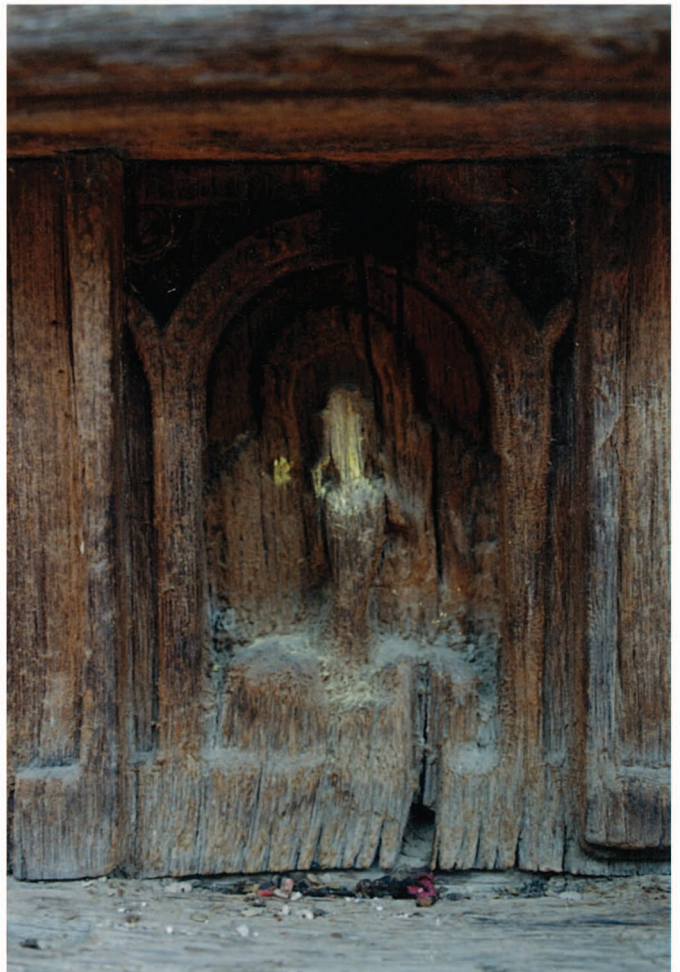
*Left: Gahjhya, blind window from ground level, south facade left side. Main figure not indentifiable, lower part is a "Ghandharva". Right: detail of the gahjhya.*

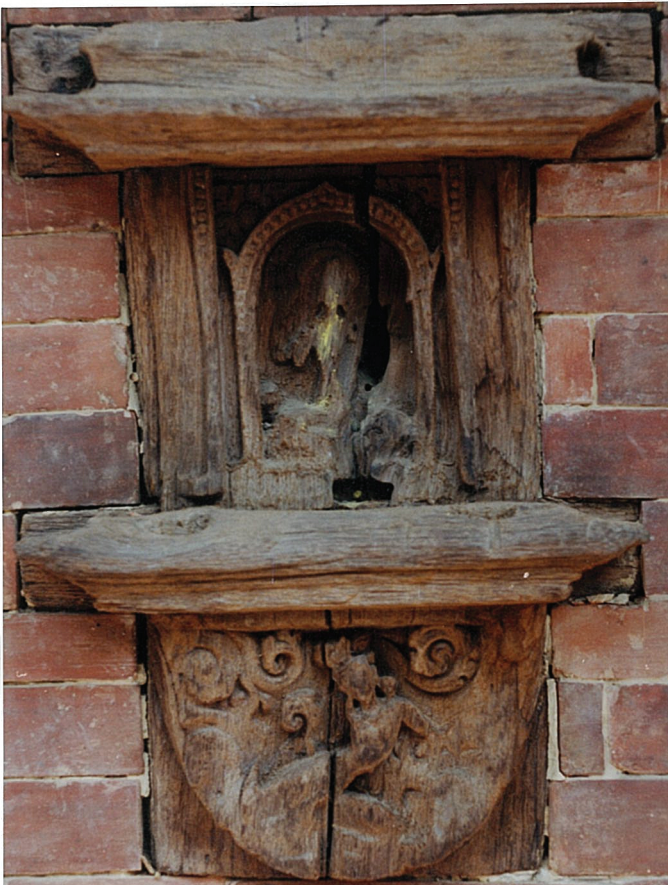
Left: Gahjhya, blind window from ground level, south facade right side. Main figure not indentifiable, lower part is a "Gandharva". Right: detail of the gahjhya.

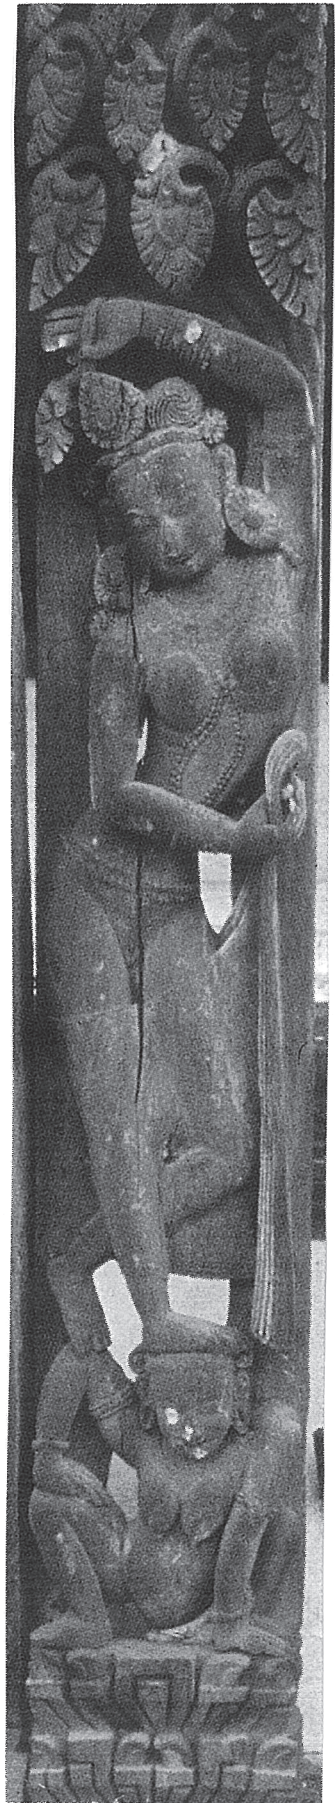
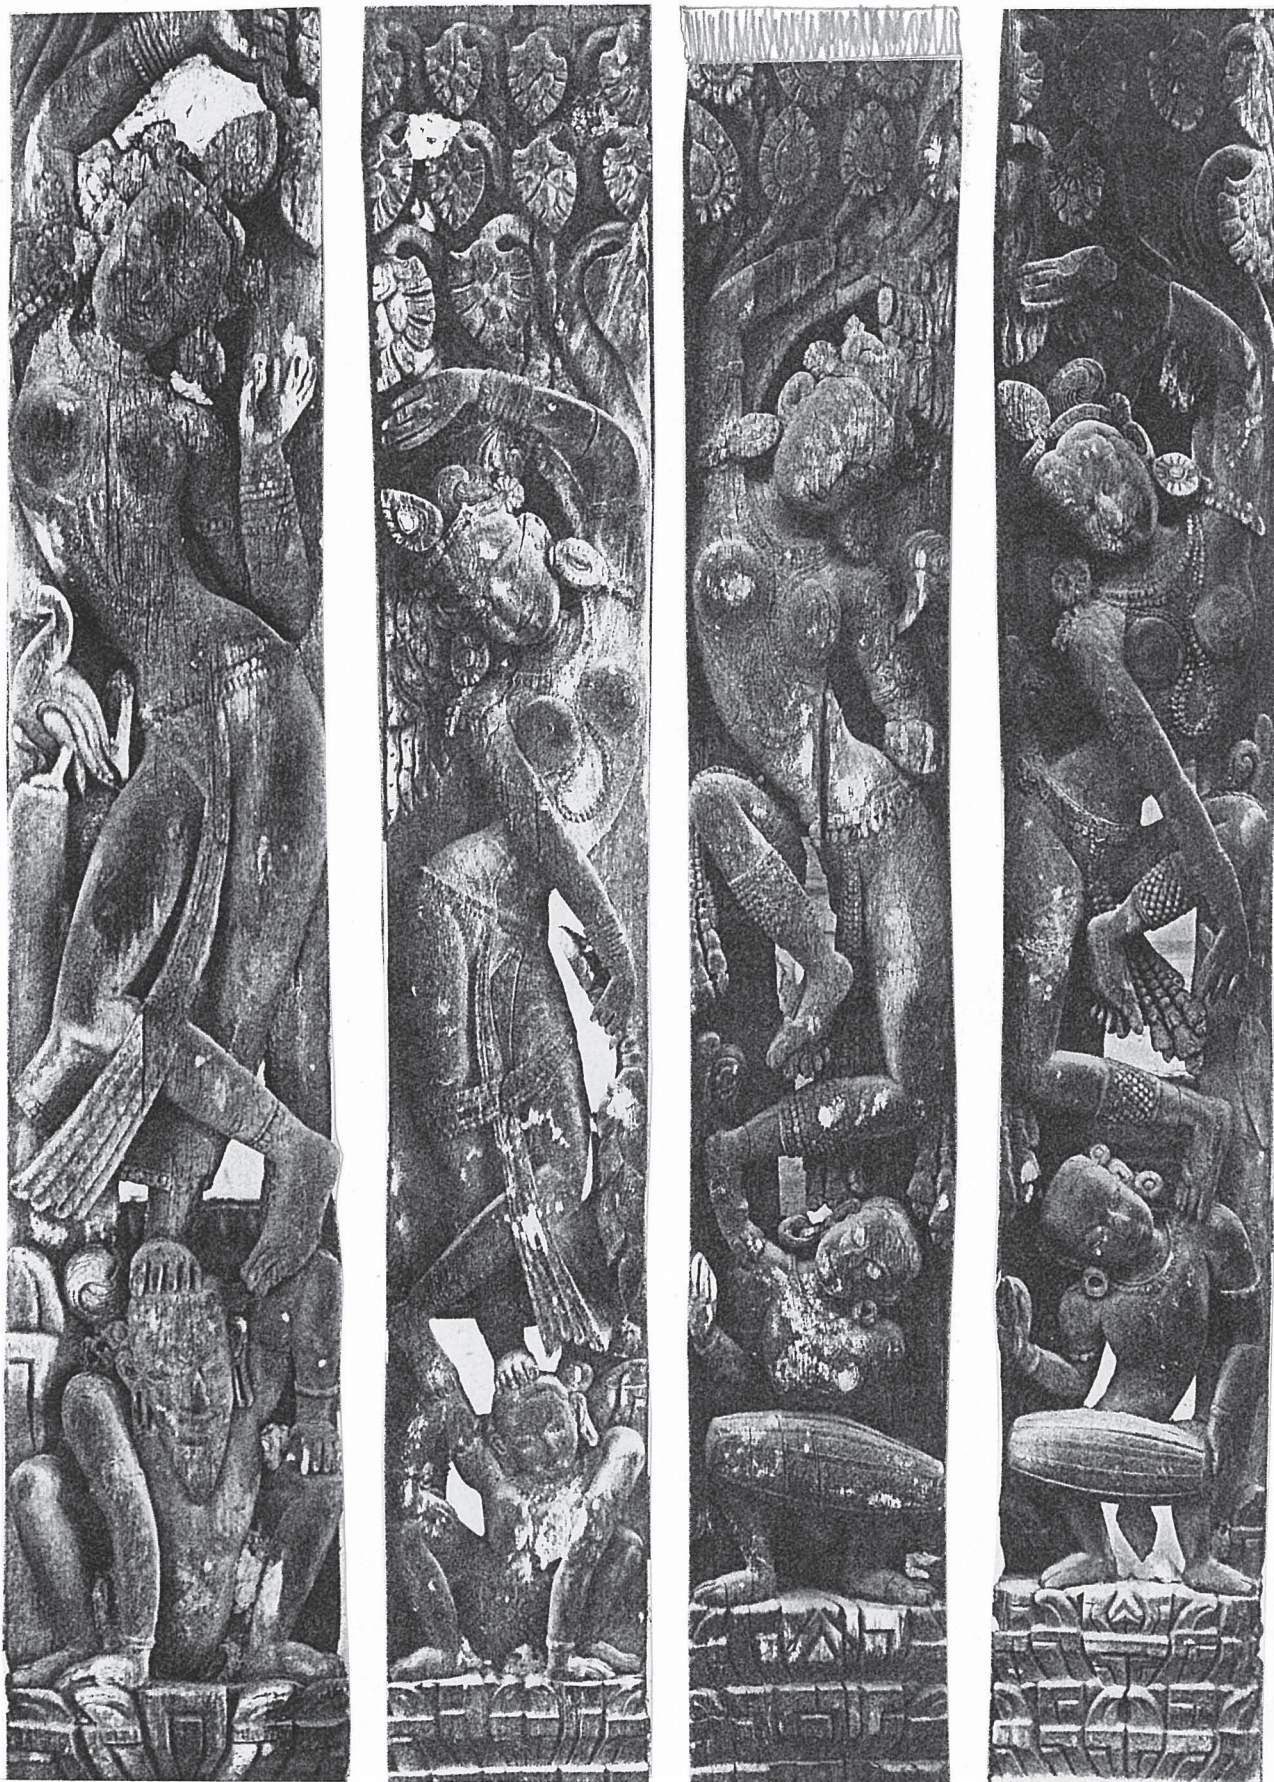
*Facing page and above: Historical original (?) struts from the lower roof, which were lost about two decades ago. Photo: M. Slusser, 1980.*

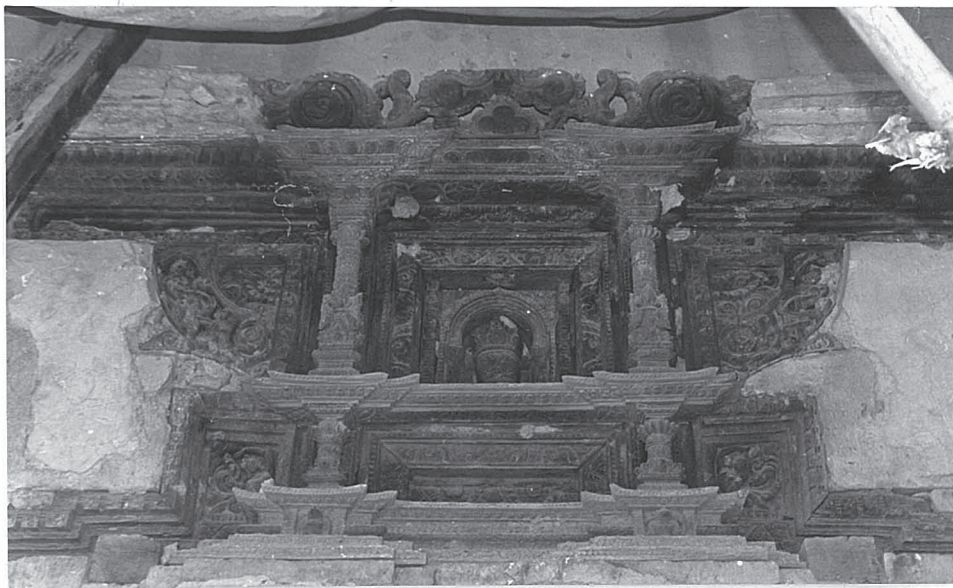
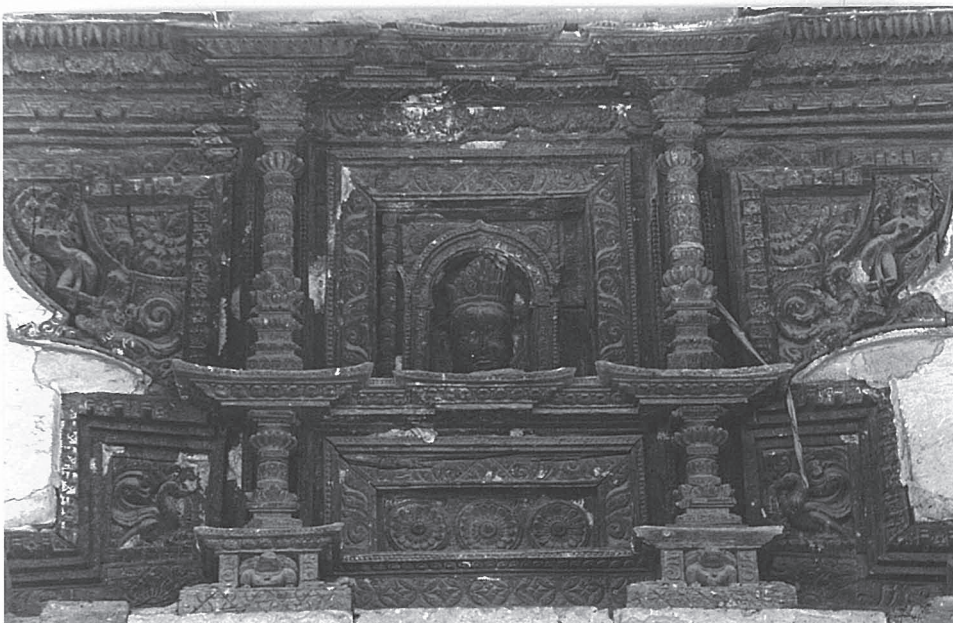
Windows of front and back facades.

Typical locations of decorative and iconographic carvings: extended carved lintel, free-standing posts in front of the door frame, inset decorative panels below the window lintel, decorative bracket figures defining quarter round panels, and decorative panels above the door sill.

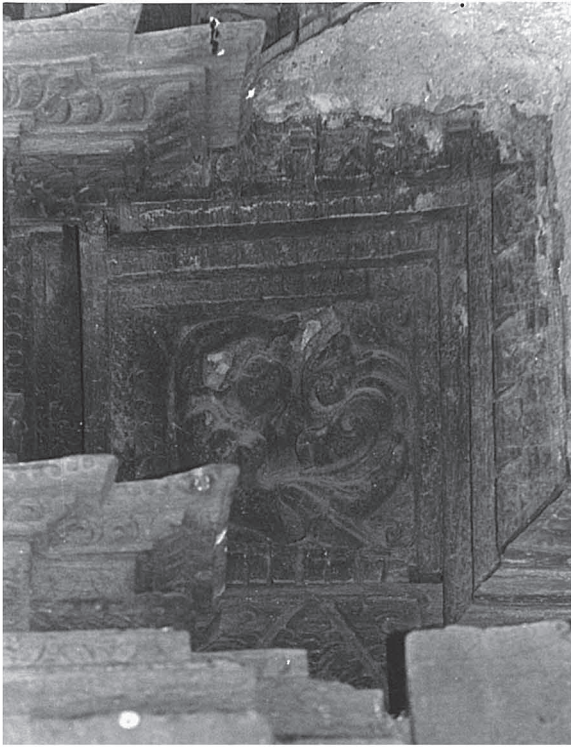
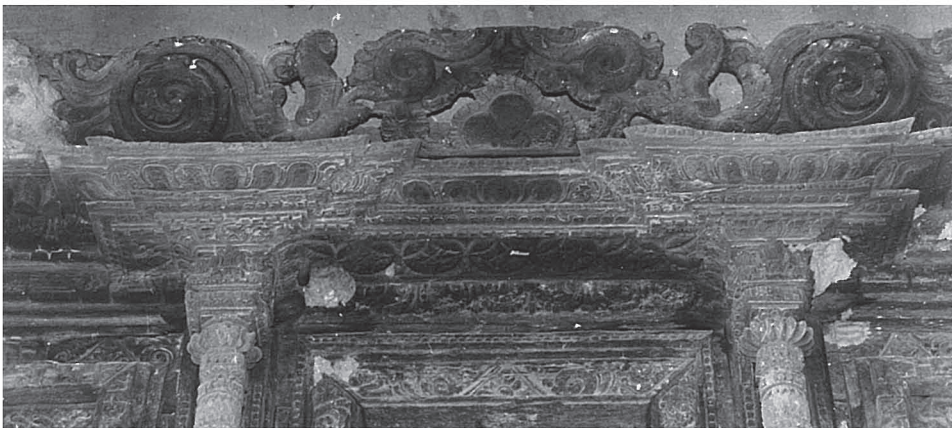
Top: detail of the extended window sill showing gandharava. Middle: torana fragment above central window, principal facade. Bottom: documentation of fragment for study purposes. Drawing, Bijay Basuala.

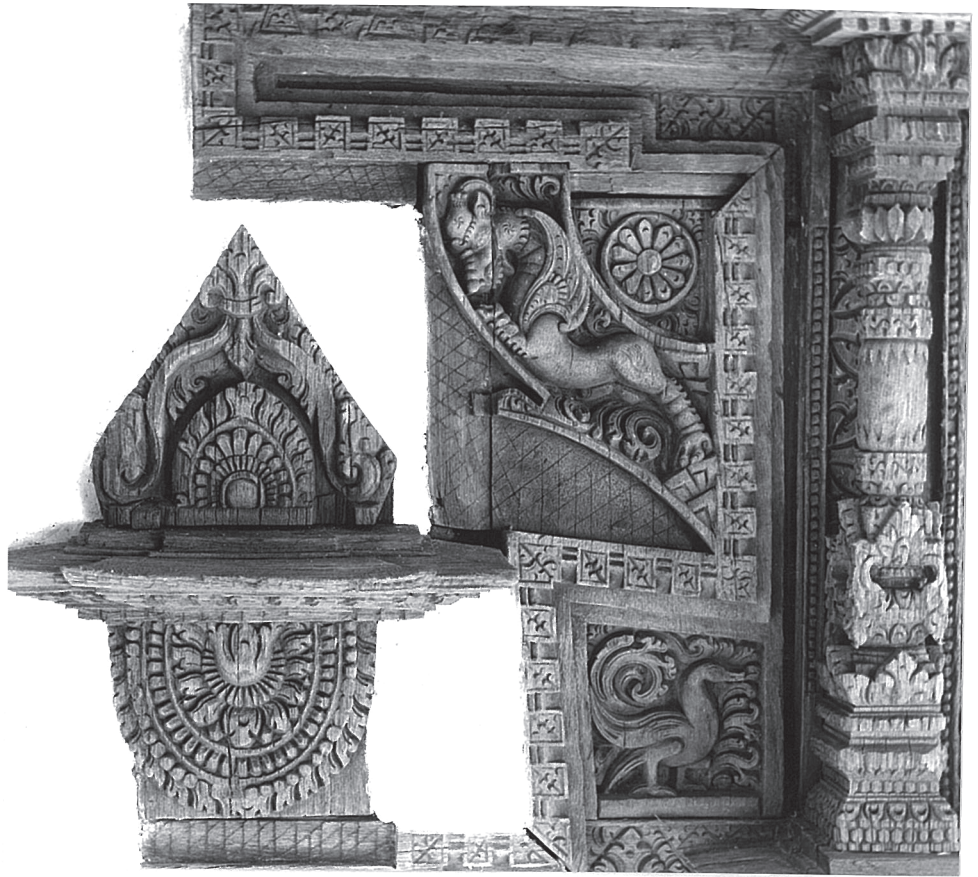
Right: detail of central window and ghajhyah. Bottom: drawing of front facade central window. Drawing, Bijay Basuala. Facing page: detail of central opening, a typical repeating detail.

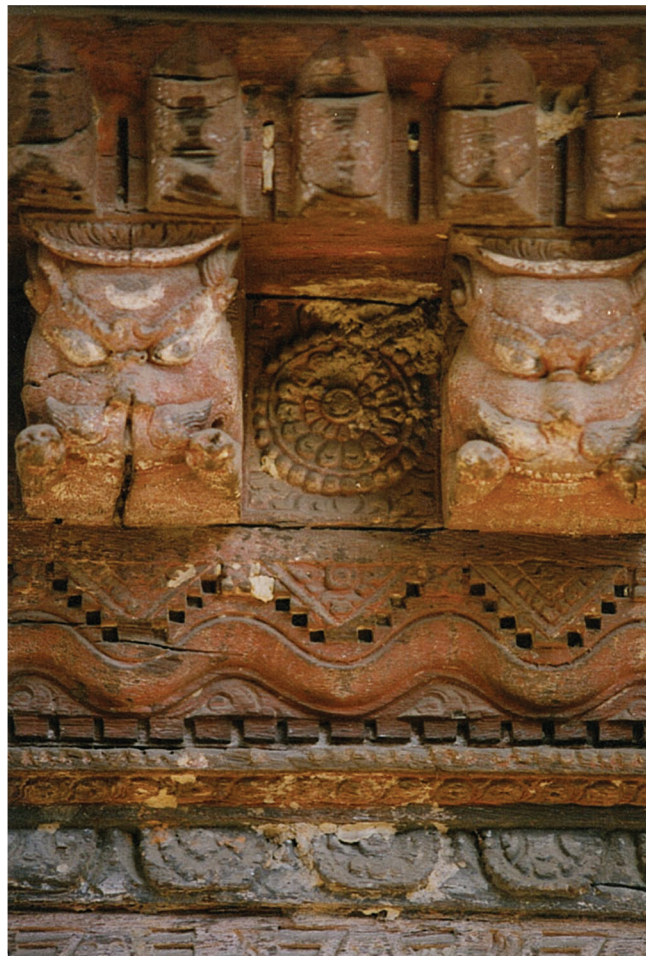
*Cornice detail,  
floral design inbetween lion heads.*
