# SULIMA RATNESVARA TEMPLE

SULIMA, PATAN

HISTORIC STRUCTURE REPORT

ROHIT RANJITKAR AND ERICH THEOPHILE  
KATHMANDU VALLEY PRESERVATION TRUST

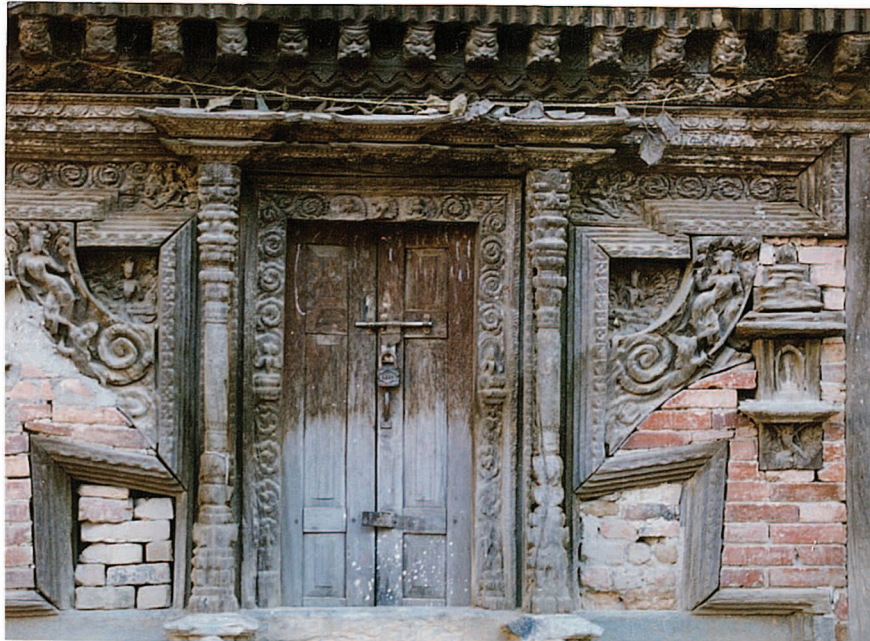
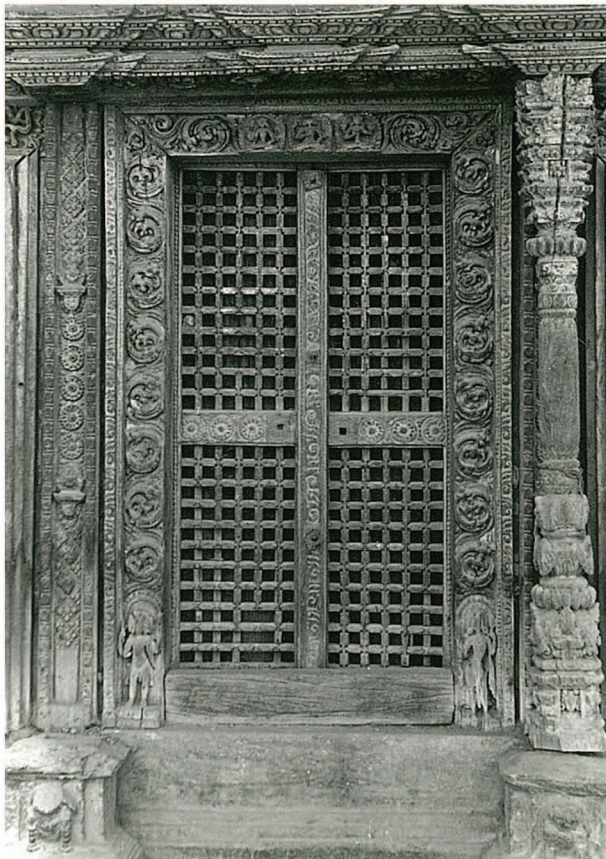
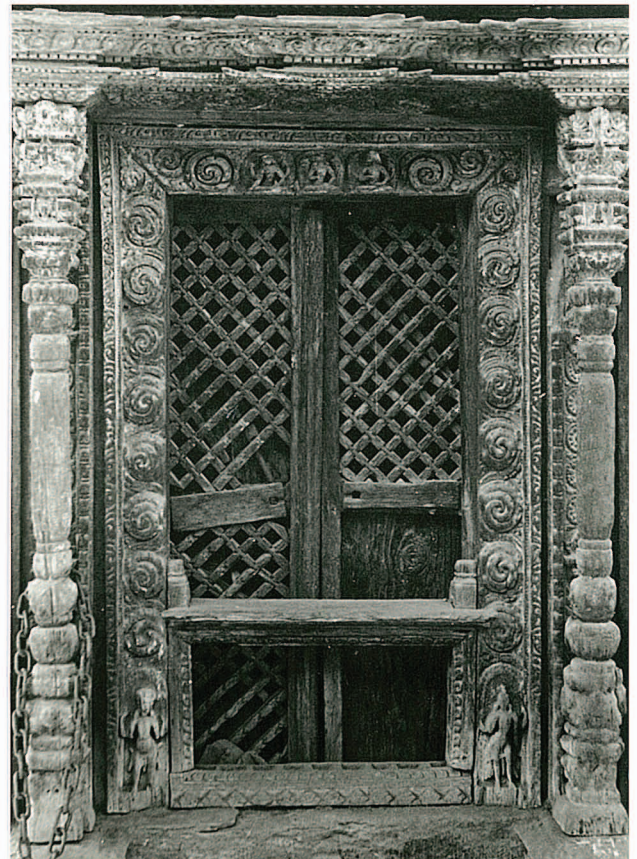
*Ground floor doorways.*

*Top: front west side door. Original door was replaced with this modern door for security. Lower inset decorative panels of the door are lost, filled with sloppy brickwork. Bottom left: north side door, only door with carvings on the door shutter frames too, which seems oldest door among the others. Condition of the door is also better than other side doors, only a small piece of lattice at the left panel is broken. Bottom right: west side door is the worst compared to other sides.*

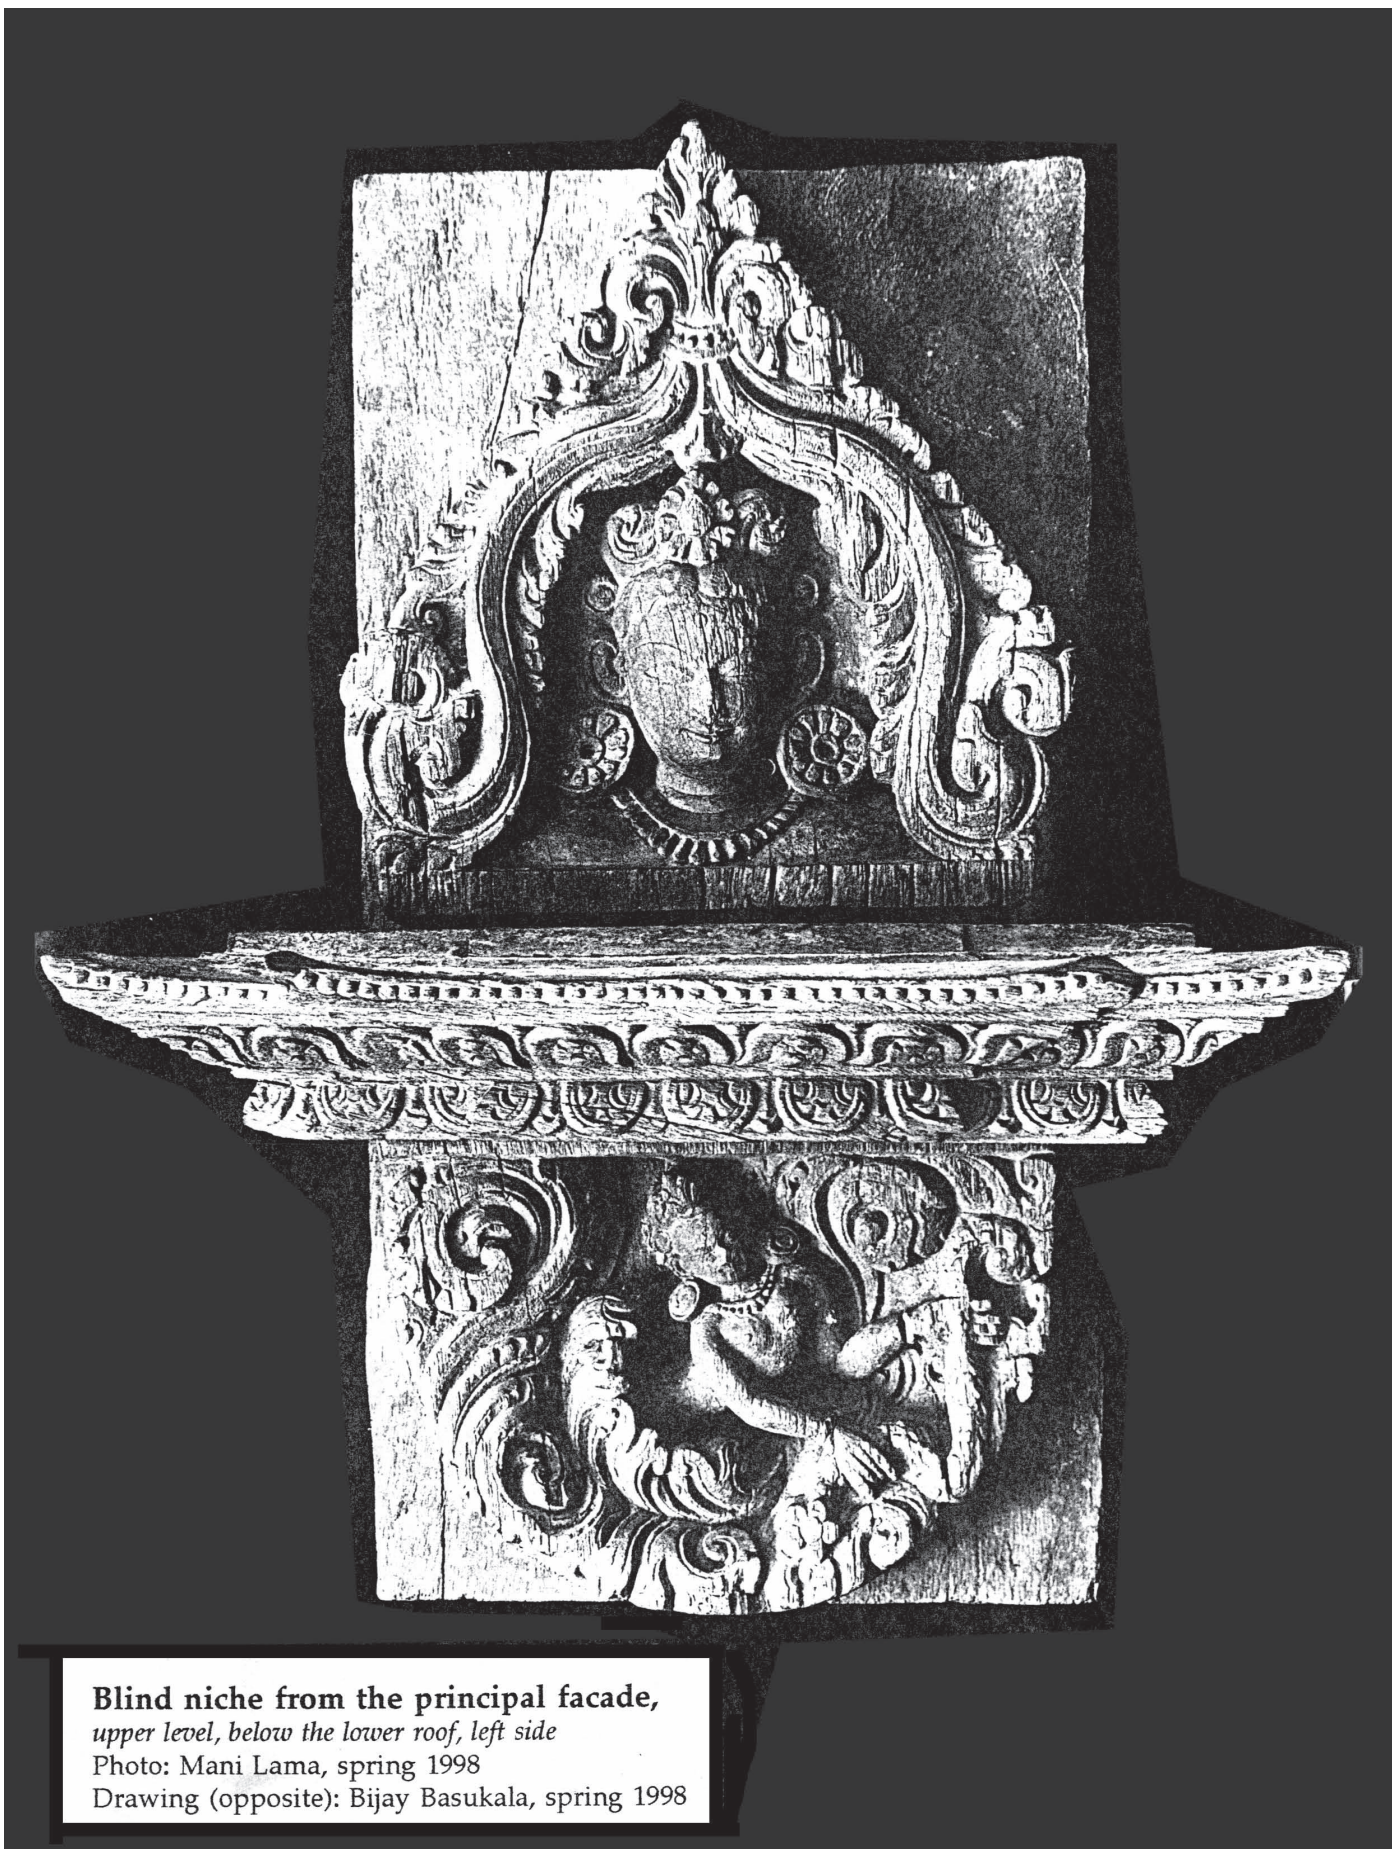
**Blind niche from the principal facade,**  
*upper level, below the lower roof, left side*
