## **APPENDIX A**

### **PROGRESS REPORT**

## **PATUKVA AGACHE :**

**New timber structure for seismic improvement**

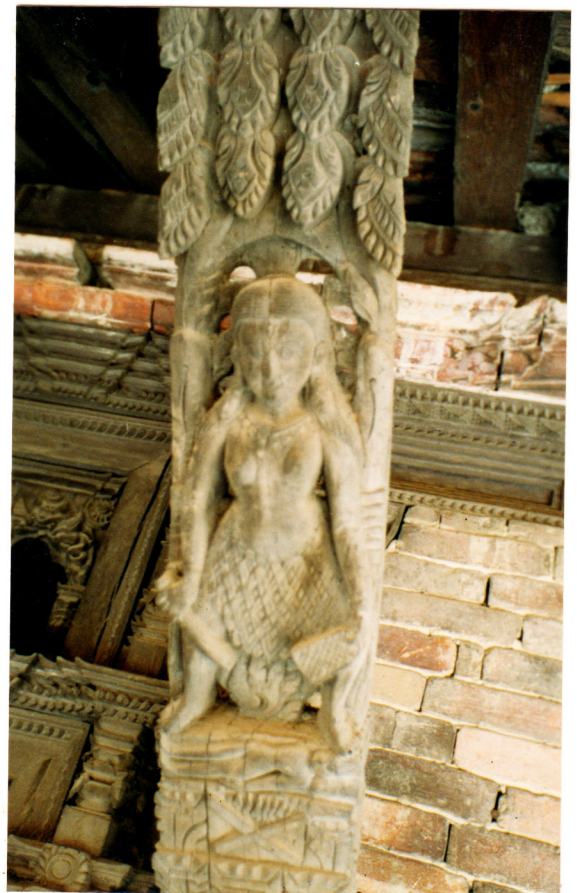
**BOTTOM ROOF**

- structural condition good
- Top 3" and 1/3 part of right side of strut is damaged due to wet rot.

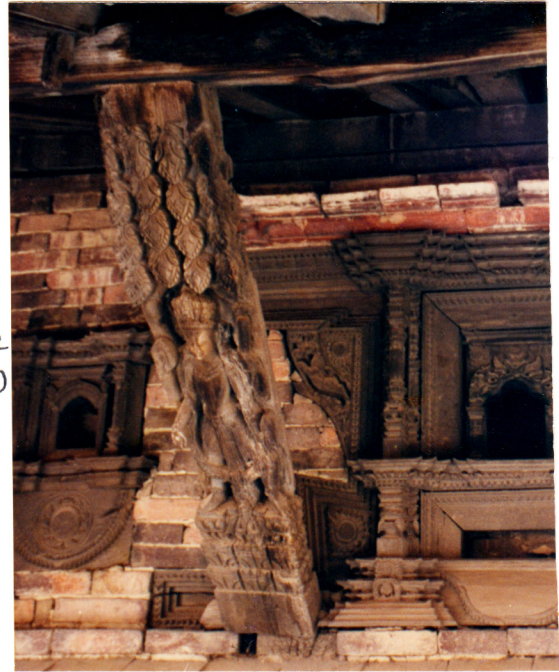
**BOTTOM ROOF**

- structural condition is o.k.
- Top right side (2" X 6") damaged by wet rot.
