# RESTORATION OF PATAN ROYAL PALACE COMPLEX

MUL CHOWK, KOT PATI, STONE GATES

**PHASE I - FINAL REPORT**

KATHMANDU VALLEY PRESERVATION TRUST

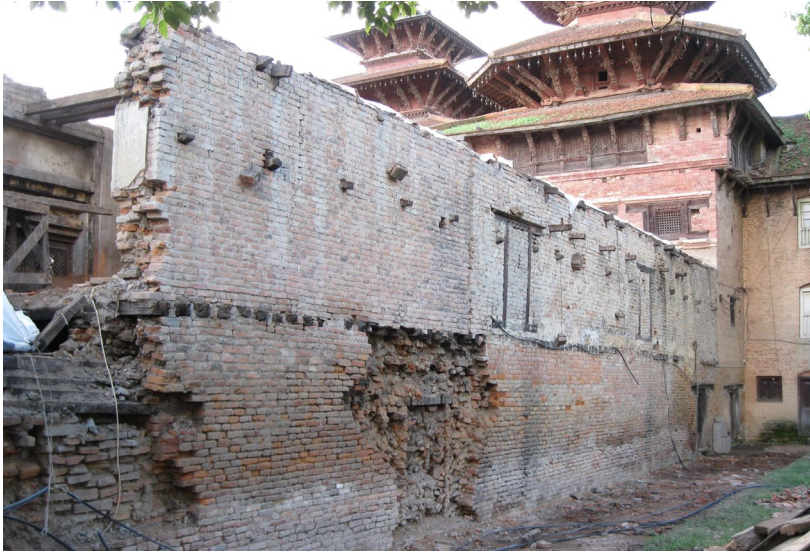
May 2010: East wing brick wall during deconstruction.

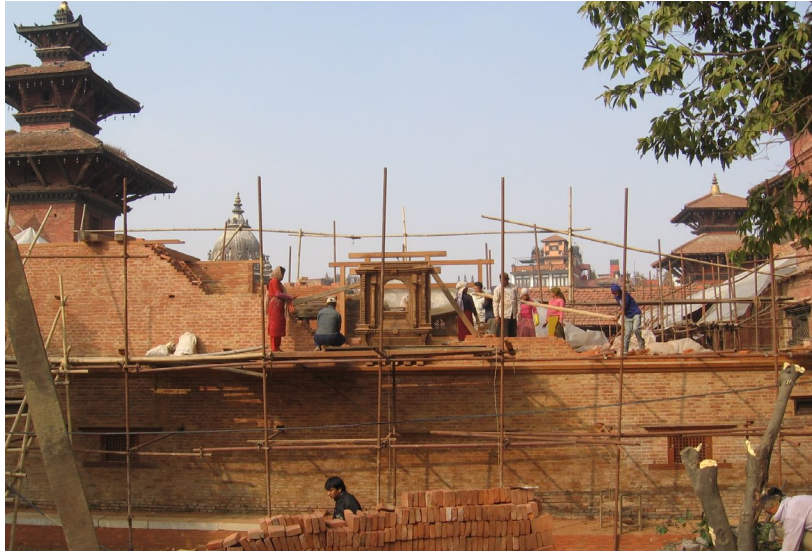
June 2011: Reconstruction of the east wing façade.

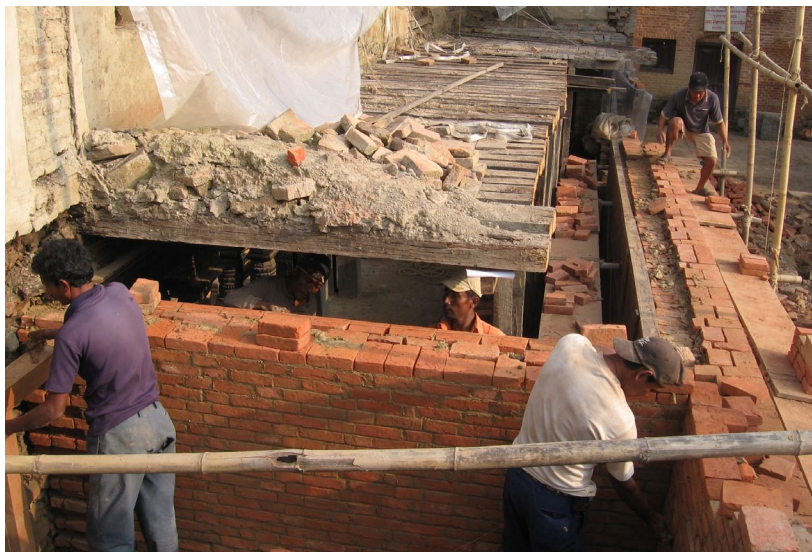
June 2011: Rebuilding the partition wall on the east wing ground floor using traditional *ma-apa* bricks in mud mortar.

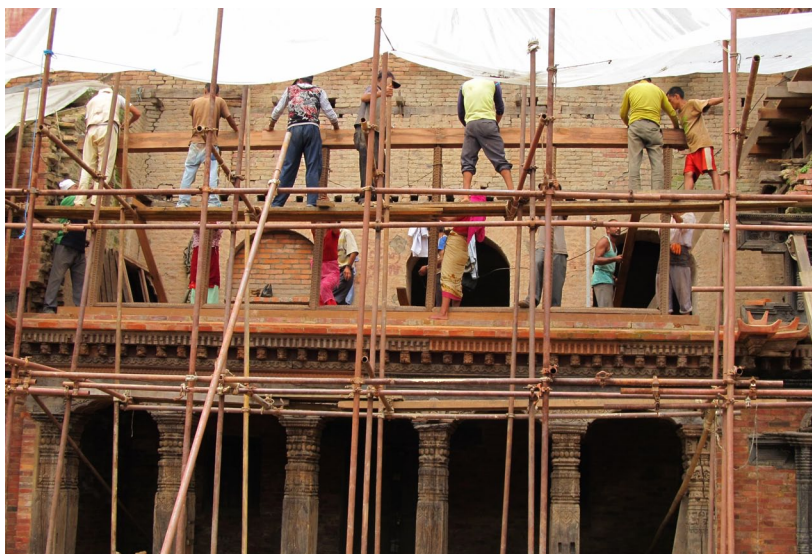
July, August, September 2011: Rebuilding the north wing façade.

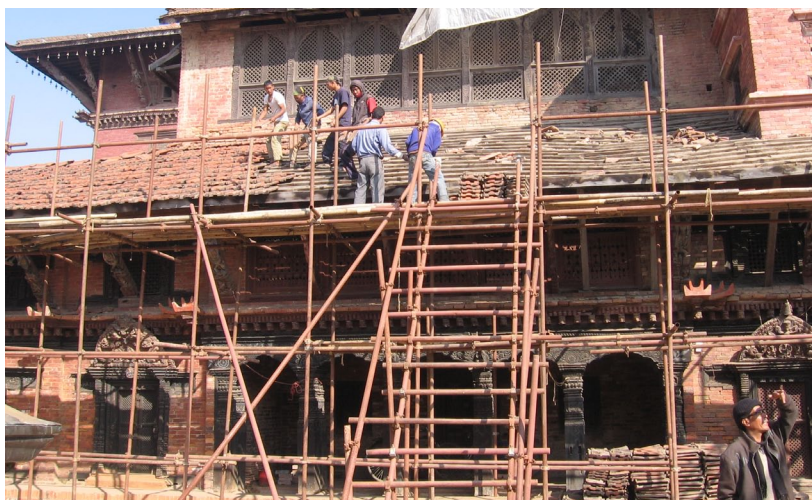
August 2010, March 2010, January 2011:  
Removing the existing roof structure  
from the east, south and north wings.

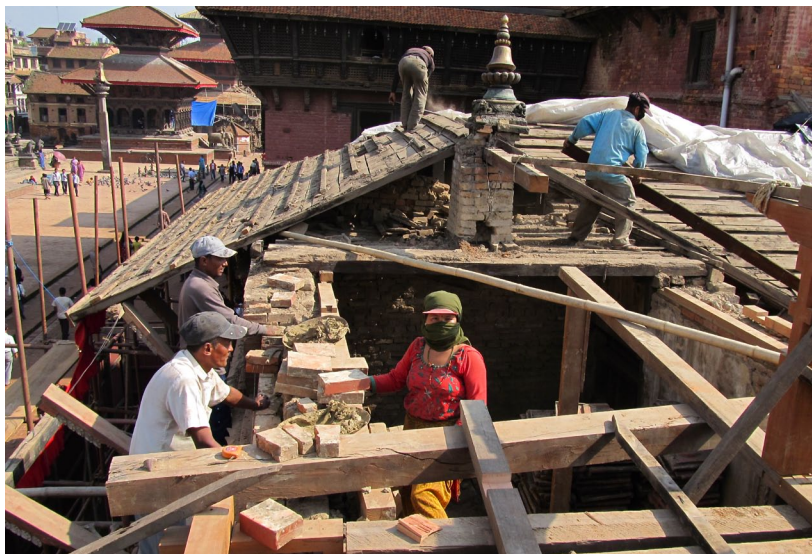
June 2011, August 2011: Removal of roof structure from the west wing.

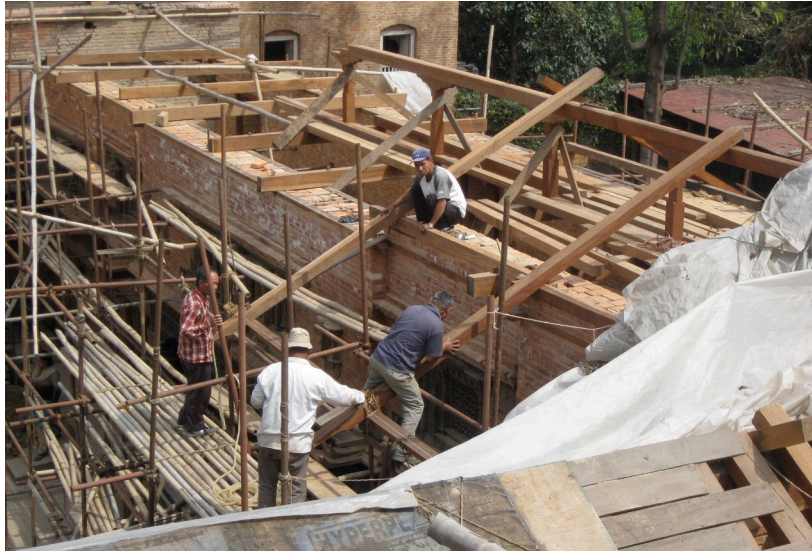
March 2011: Installation of roof timber structure on the east wing.

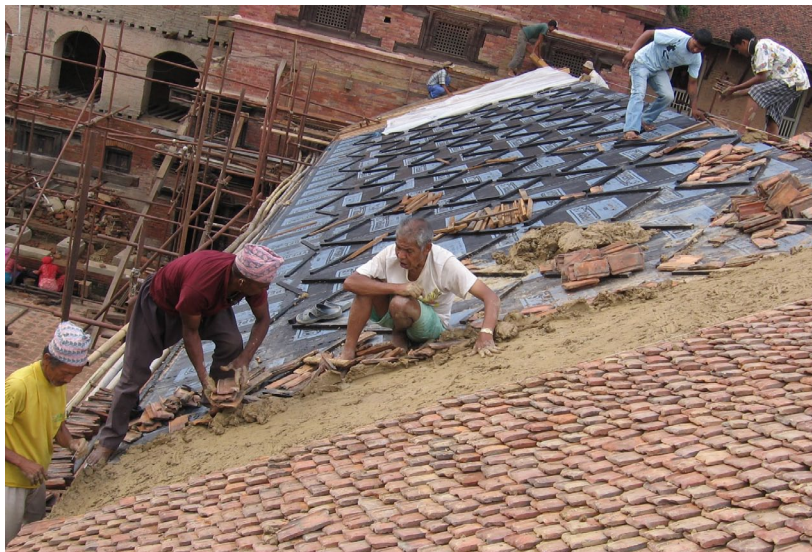
June 2011: Laying traditional roof tiles (*jhingati*) on a mudbed over the waterproof membrane on the east wing roof.

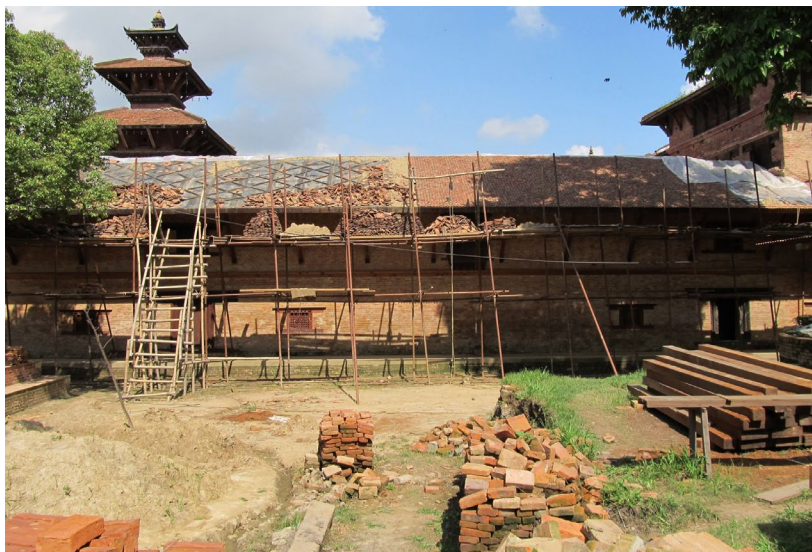
July 2011: East façade of the east wing during installation of roof cover.

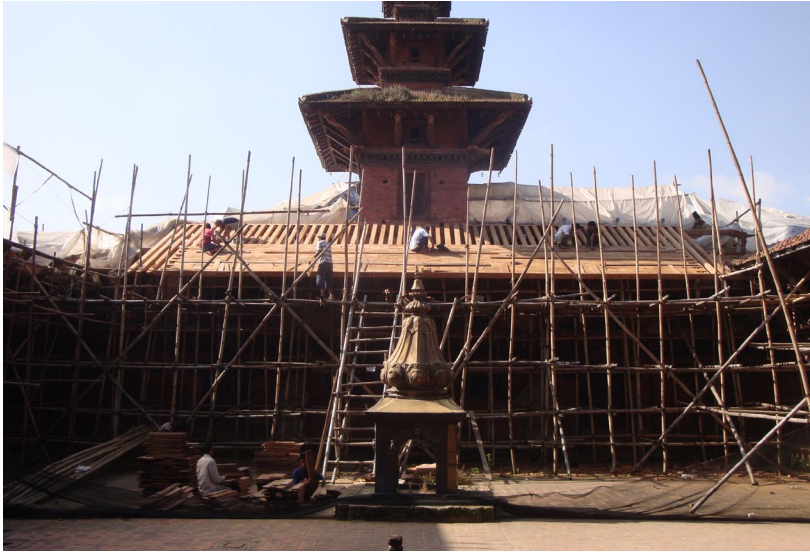
January 2011: Installing hardwood and plywood planking on the timber joists of the south wing.

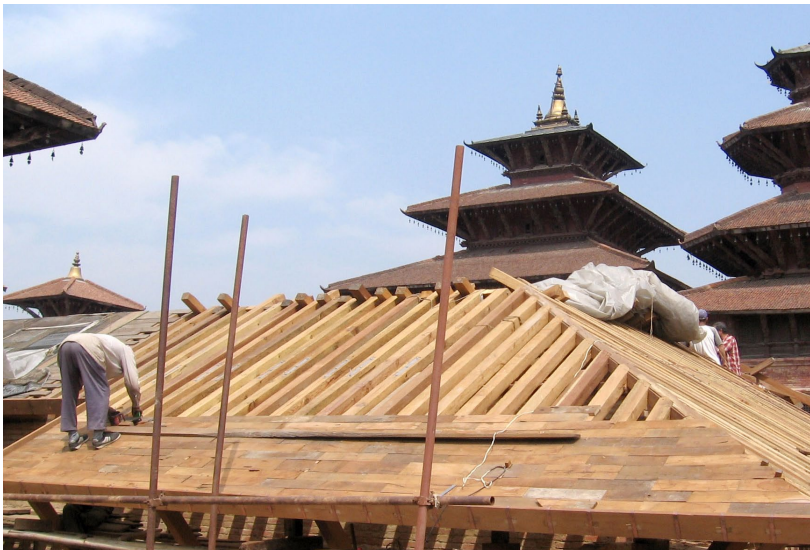
March 2011: Detail of *sal* hardwood planking on the south-east corner.

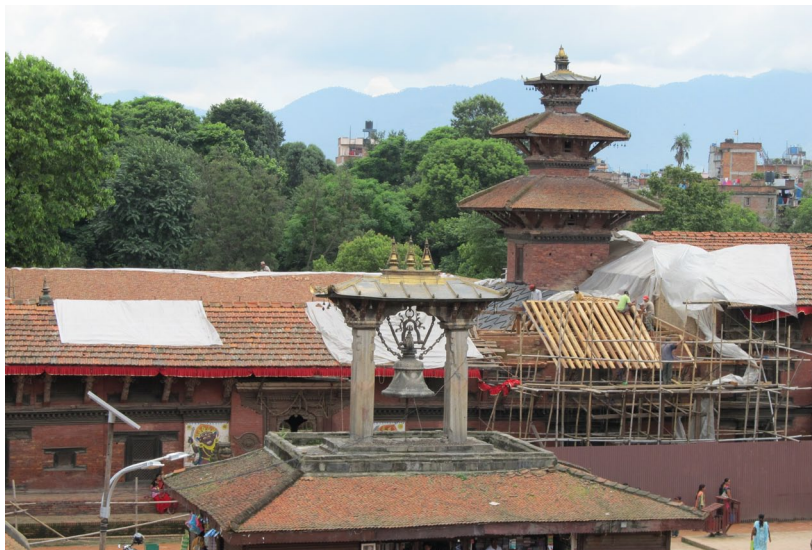
July 2011: Installing new timber joists on the west wing roof.

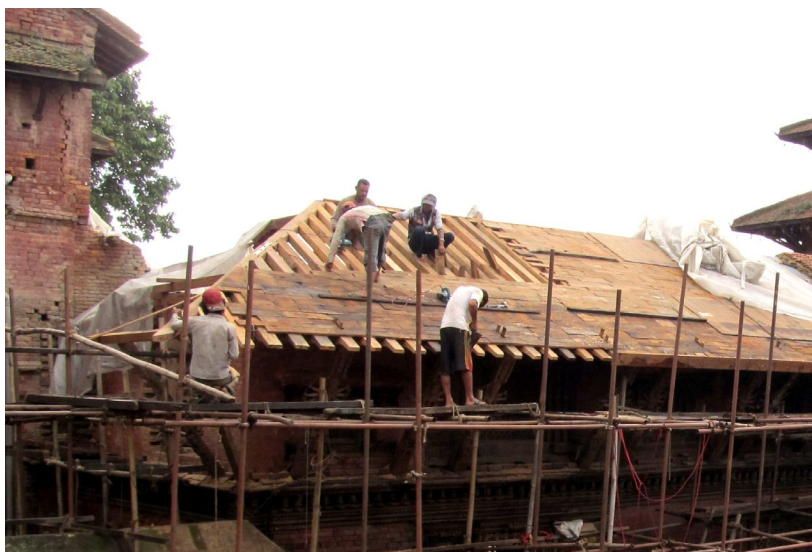
September 2011: Uniting roof timber elements on the northwest corner.

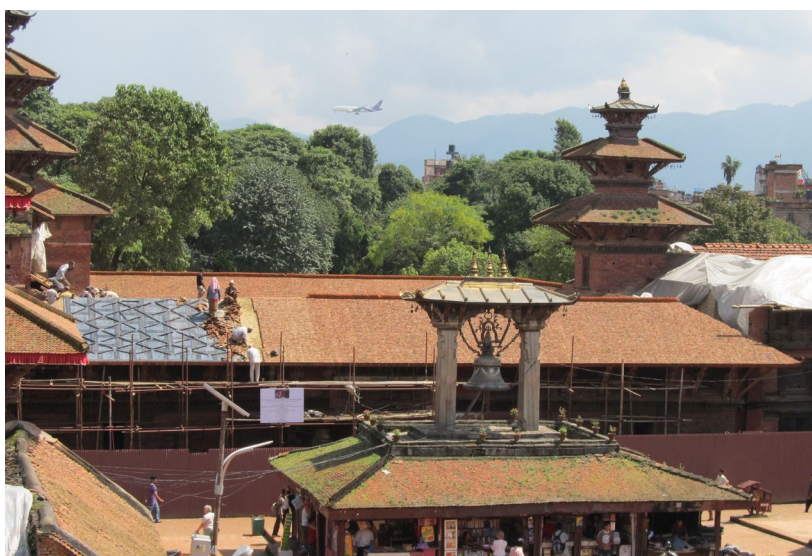
September 2011: Installation of traditional *jhingati* roof tiles on the west wing roof.

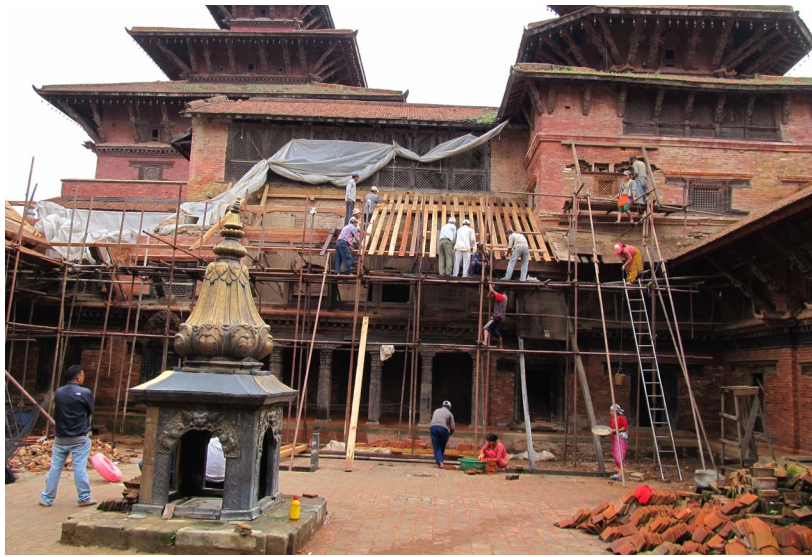
September 2011: Installing new timber joists on the north wing roof.

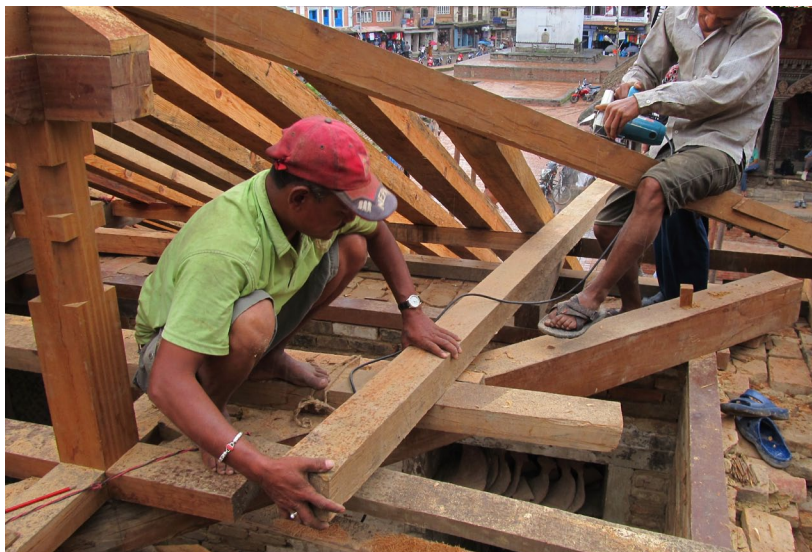
September 2011: Detail of traditional timber joinery for the roof structure on the northwest corner.

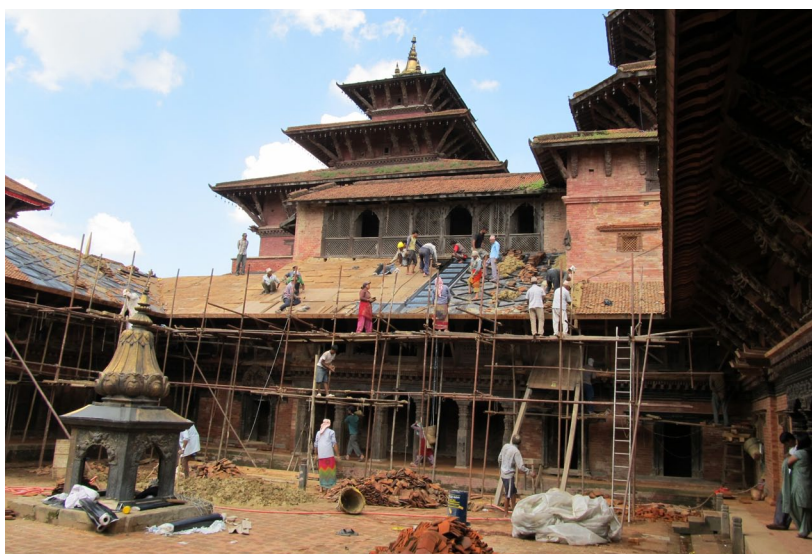
September 2011: Placing a waterproof membrane over the hardwood planking.

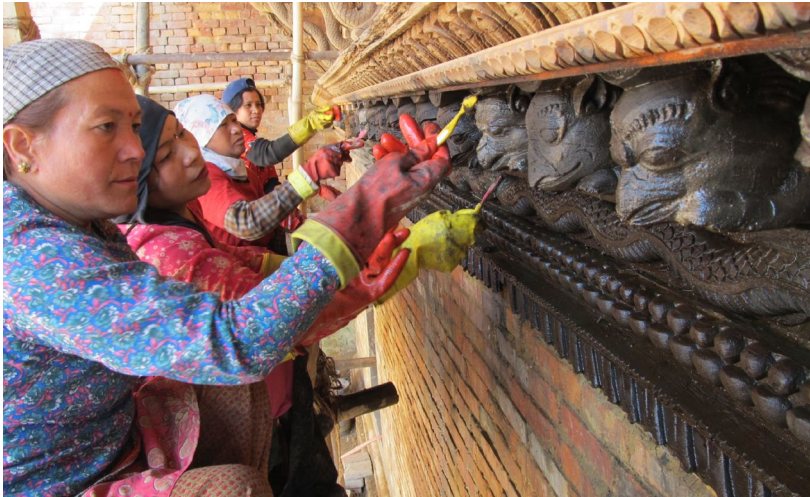
March 2012: Women cleaning existing timber cornice in-situ using plain water and caustic soda.

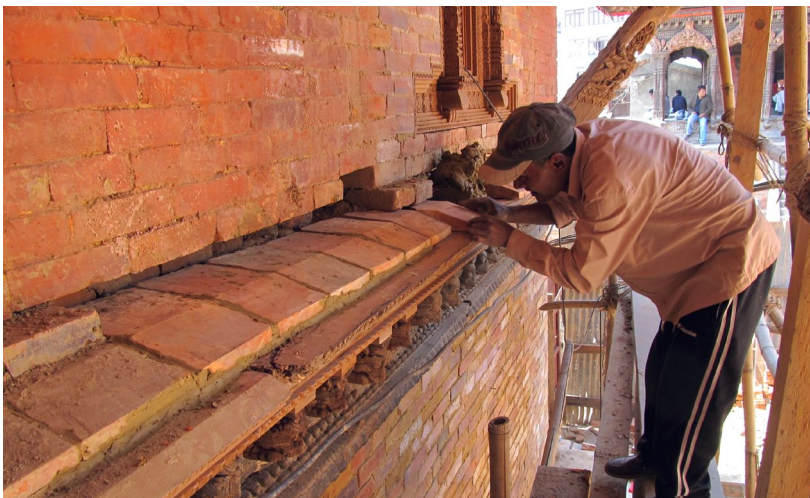
March 2012: Mason building brick cornice over timber cornice.

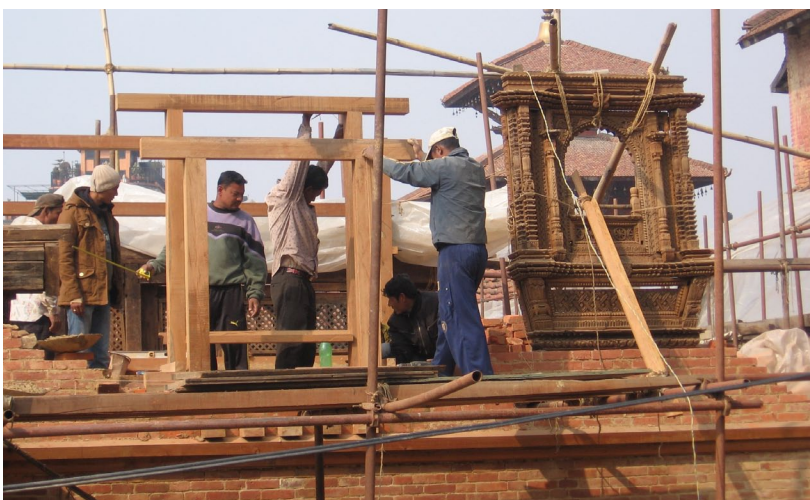
January 2011: Placing new inner window frames for the salvaged window brought from a house in Sundhara, Patan.

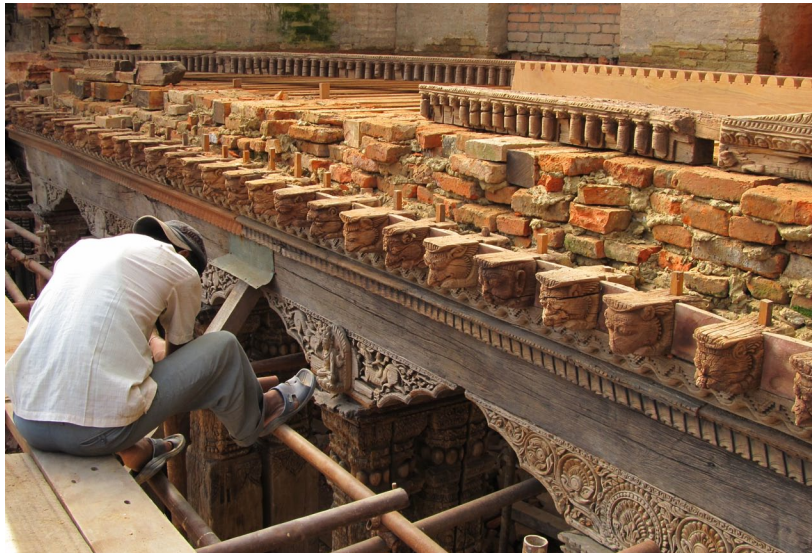
July 2011: The lion heads on the timber cornice were cleaned and reinstalled.

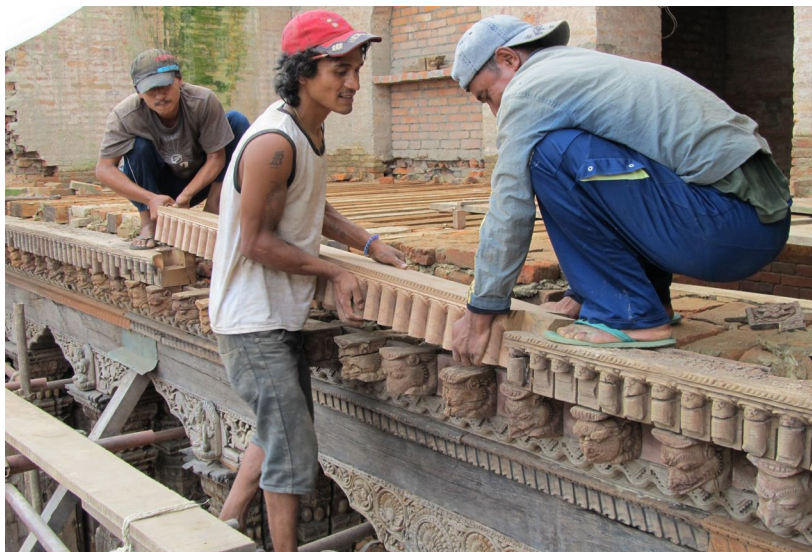
July 2011: Lost timber dental cornices were refabricated and installed above the lion heads using traditional timber joints.

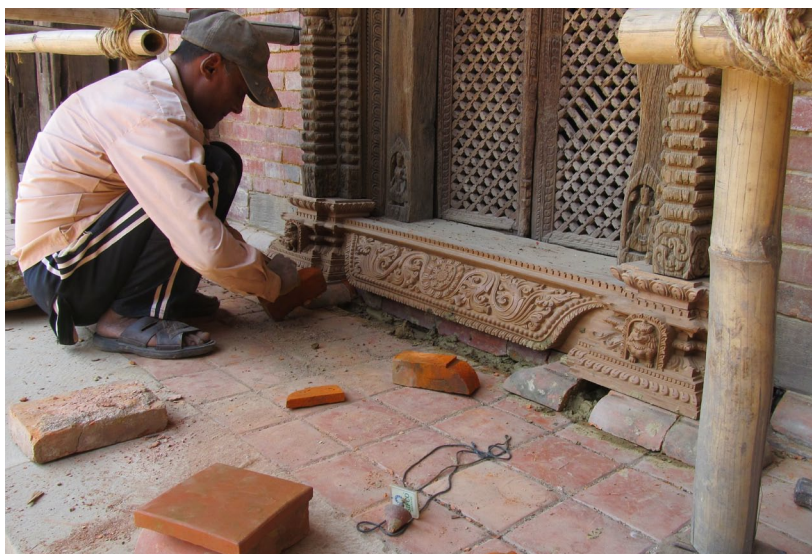
May 2012: New door jamb bases were installed where old ones were missing.

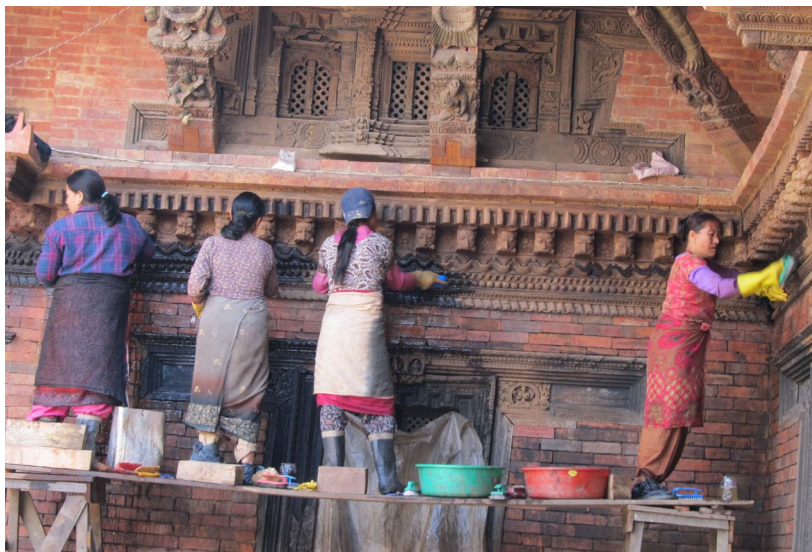
December 2010, September and October 2011: Removing black paint from pillars and cornices using water and caustic soda.

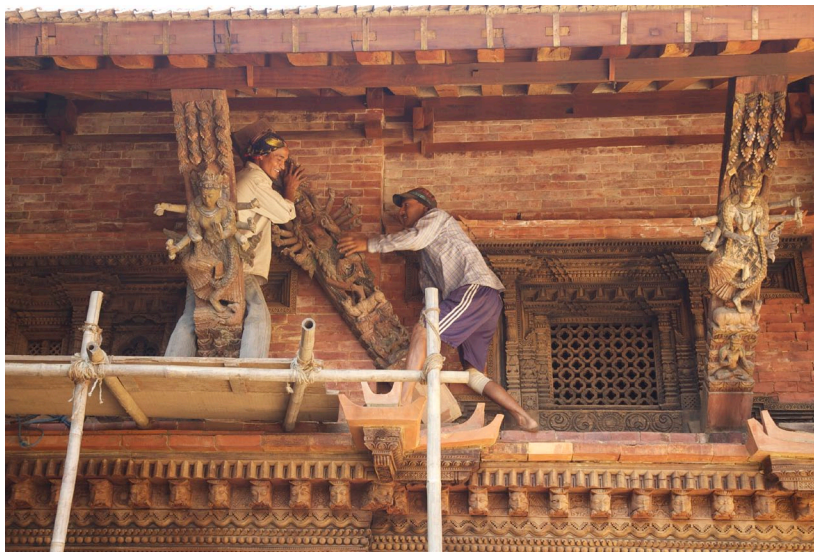
October 2011: Removing roof struts for cleaning and repair.

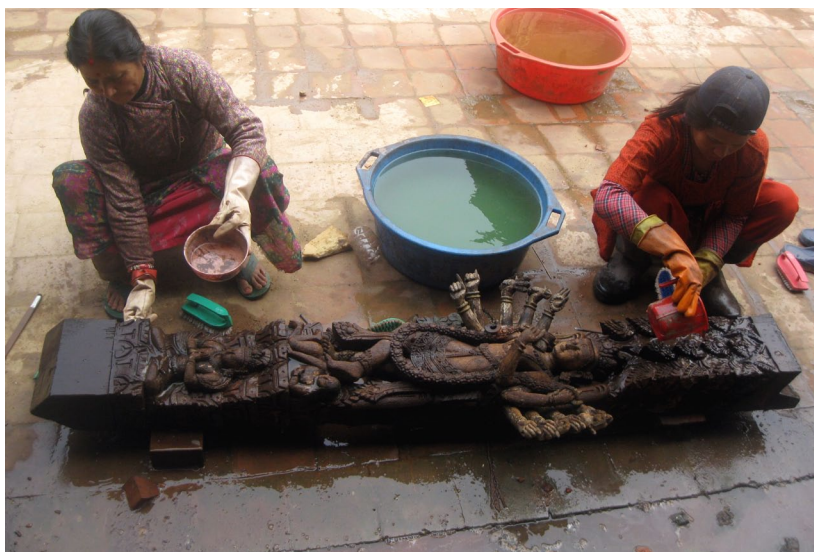
October 2011: Cleaning a roof strut after removing paint.

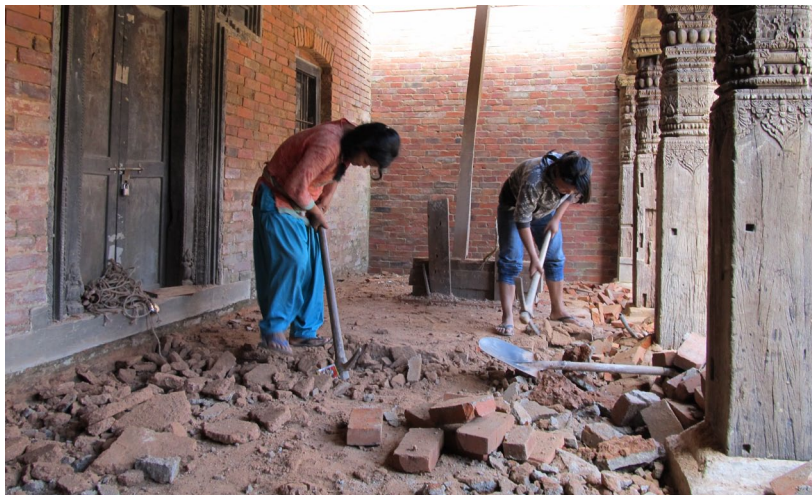
July 2011: Floor levels of the rooms north of the arcade on the north wing were lowered to match the historical level.

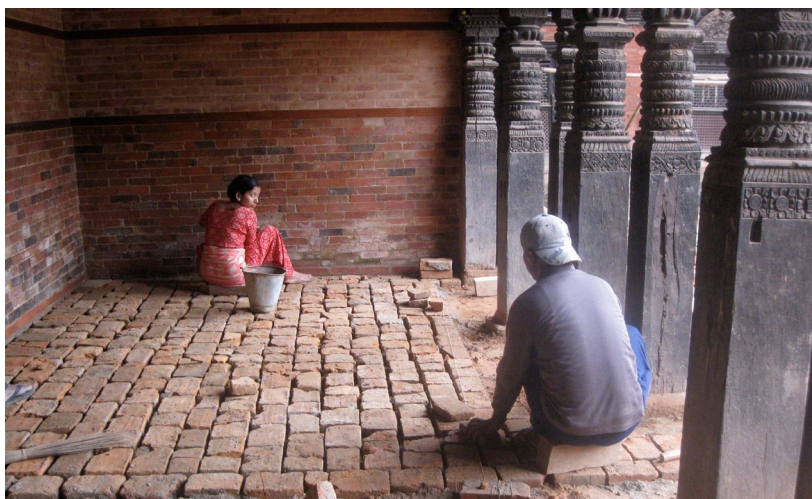
August 2011: Flat brick soling was installed on a sand bed.

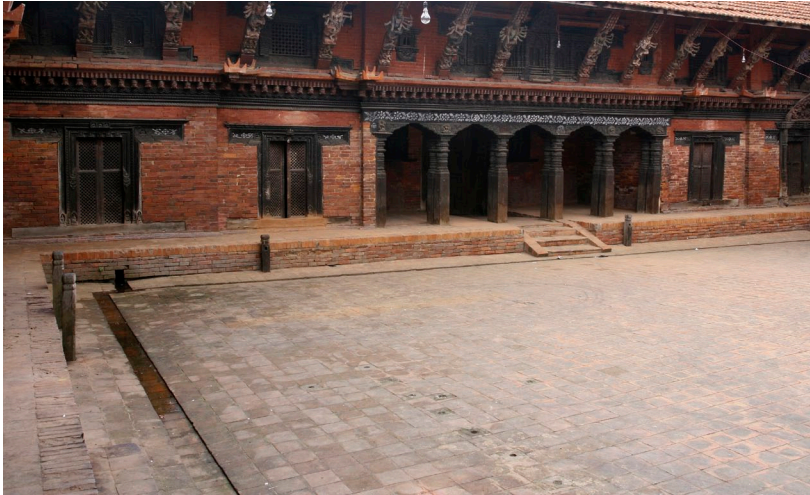
October 2006: Courtyard before excavation.

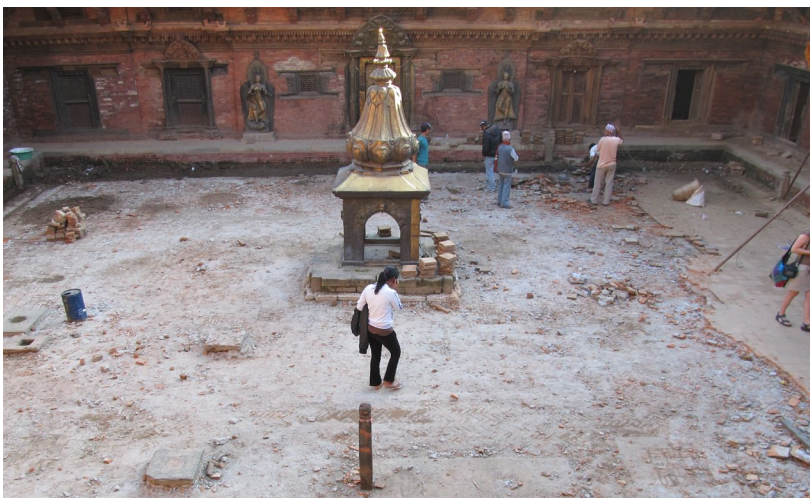
The Mul Chowk courtyard paving was thought to be at the correct level. However, after the removal of the 1972 paving laid in cement mortar, the original on-edge brick paving was found at a historic level 5 inches below. A similar situation was discovered at the three open arcades on the ground floor, where the raised floor levels had caused damage to the historic pillars. This is why all floors were completely rebuilt at the correct level using traditional materials. These unexpected discoveries meant that more time and energy had to be spent on adjusting the level of the courtyard.

January 2012: Courtyard during excavation.

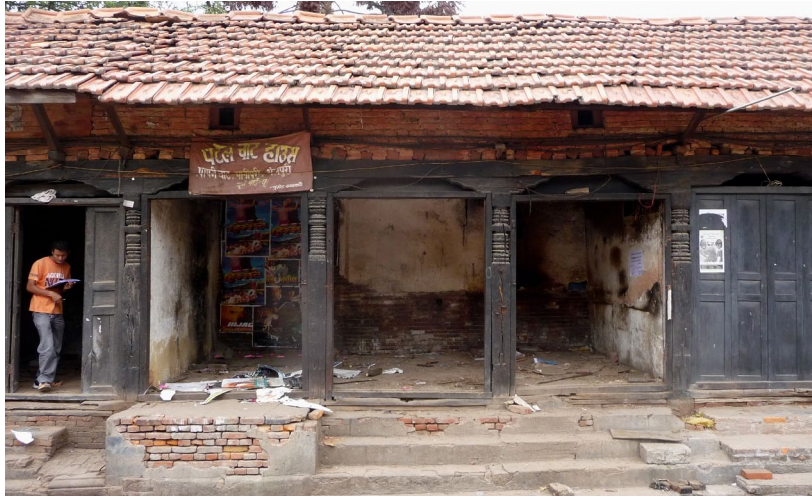
- The existing Kot Pati needed to be almost completely dismantled as it was in a highly dilapidated condition. The existing redundant partition walls and horizontal ceiling planks were removed.
- Missing or damaged stone pavement, plinth edges, and mouldings were recreated following existing historic examples.
- The historic plinth was completely re-built along the face of the Pati using edge stones and telia tile.
- After removing the cemented paving, the floor of the Pati was repaved with traditional floor tiles (*chikah-apa*) in lime *surkhi* mortar.
- After removing the existing roof structure, a new roof structure was reconstructed with new closely-spaced timber joists in the traditional configuration.

June 2009: Existing front and back elevations of Kot Pati before restoration.

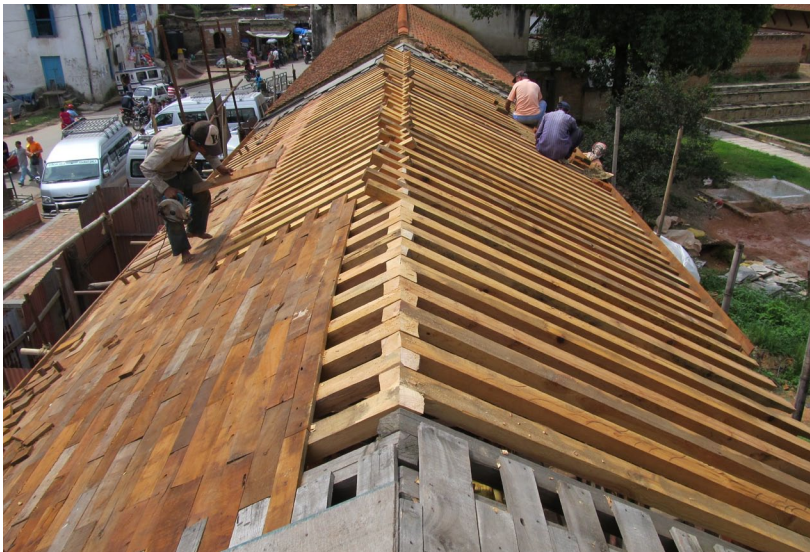
The initial restoration plan foresaw the reuse of about 30% of existing joists for reconstruction of Kot Pati roof. However, after removal and analysis of all the joists, it was discovered that they were not reuseable. The joists had been damaged beyond repair due to water leakage from the poorly constructed modern tile roof. For this reason, new timber joists were used for the Kot Pati roof structure.

August 2012: Installing hardwood and plywood planking over the rafters.

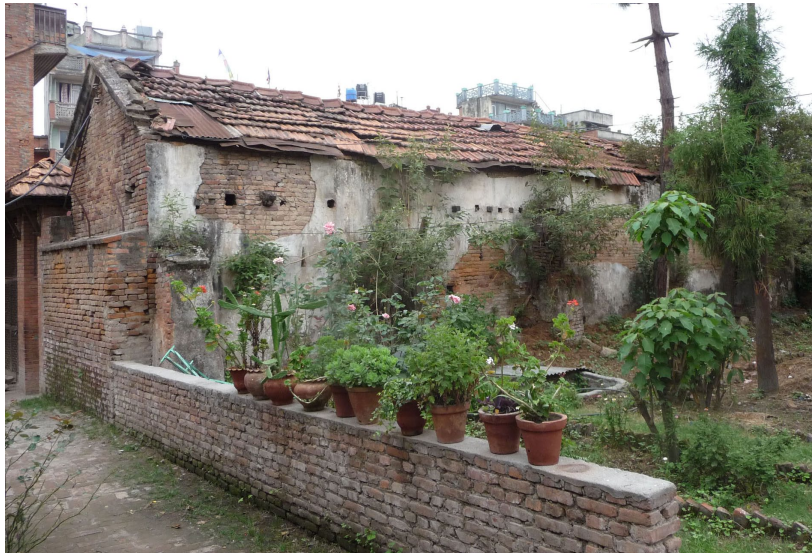
June 2009: Back façade of Kot Pati before restoration.

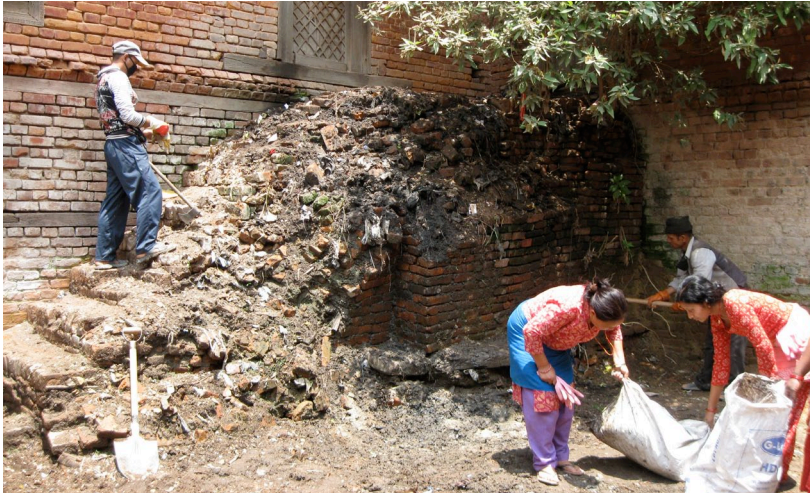
May 2011: The courtyard filled with junk was cleaned before restoration began.

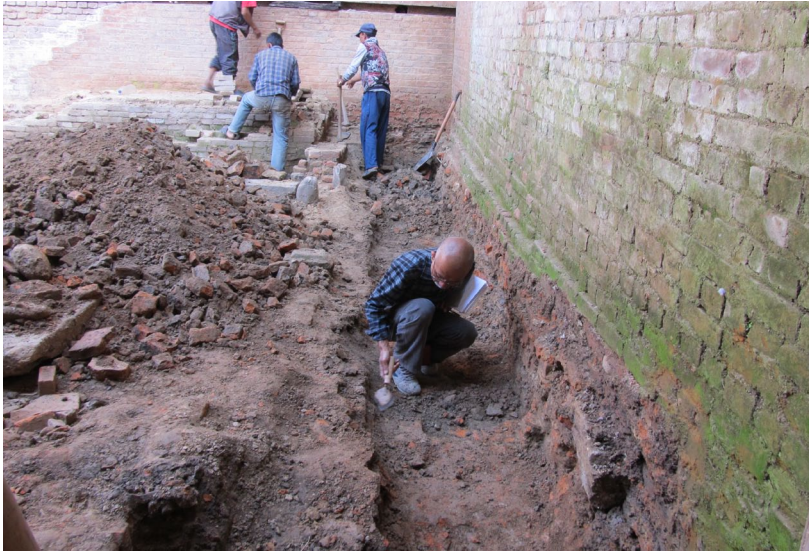
February 2012: Excavating the courtyard to remove the foundation of the existing dilapidated plinth.

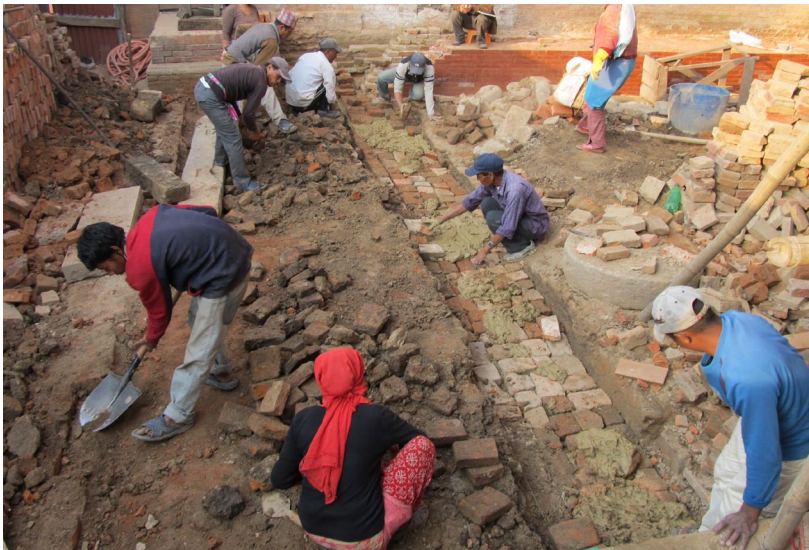
March 2012: The foundation of the principal wall running along the Darbar Square was excavated and built up again to ground level using yellow mud mortar.

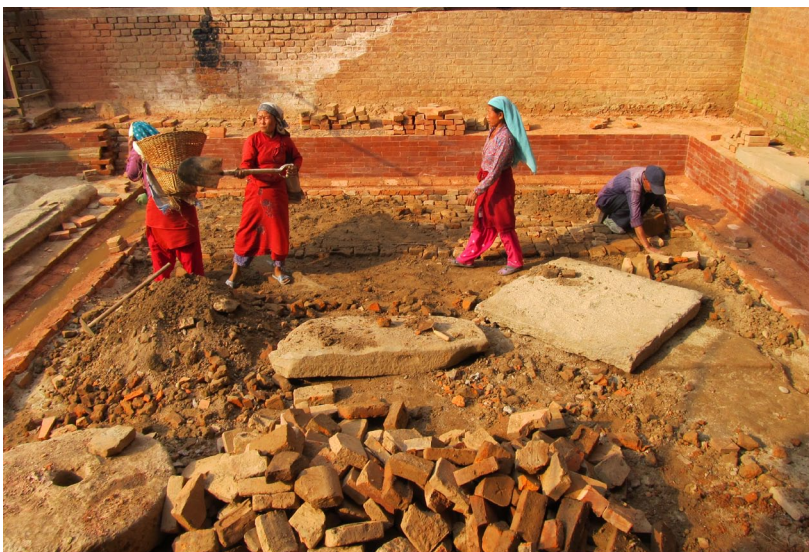
March 2012: Debris was removed from site, and flat brick soling was done on the courtyard.

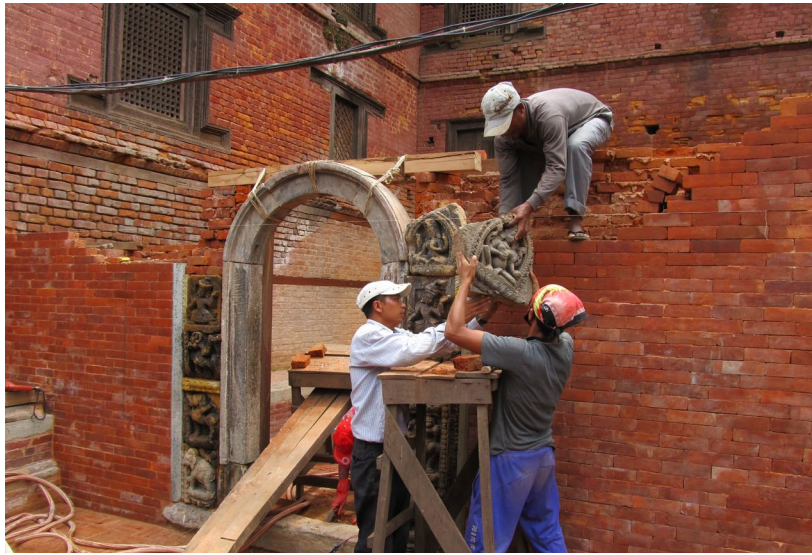
June 2012: The gate was rebuilt using the repaired stone statues and traditional bricks in lime and brickdust (*surkhi*) mortar.

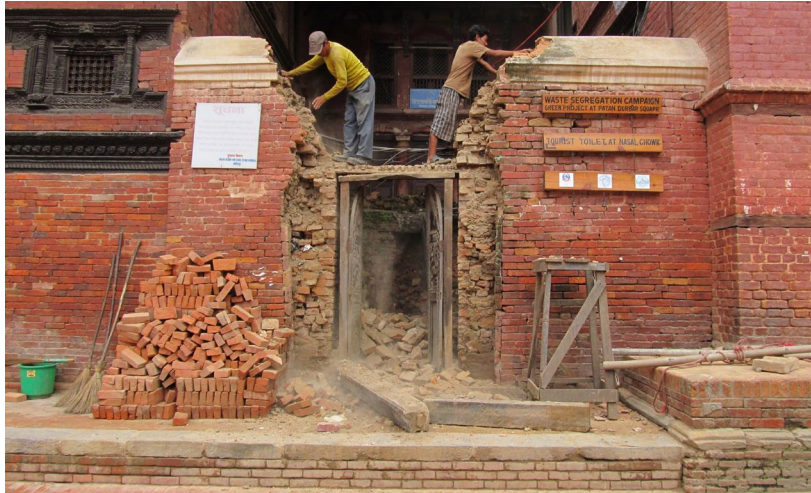
July 2012: Dismantling the dilapidated brick wall surrounding the stone gate.

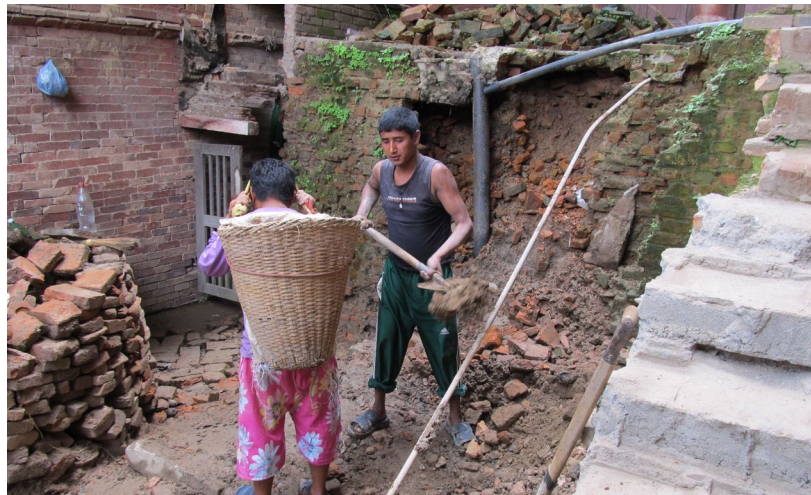
July 2012: Debris being removed after excavation of the pavement.

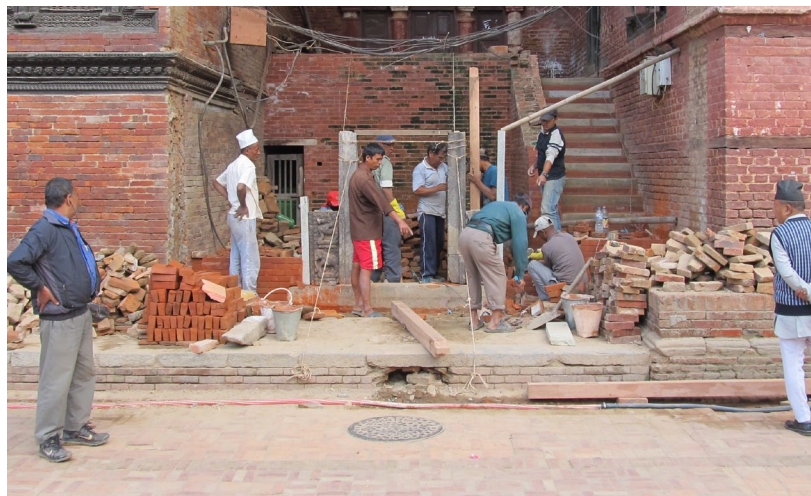
October 2012: Building the brick wall surrounding the gate using traditional *ma-apa* brick in lime *surkhi* mortar.

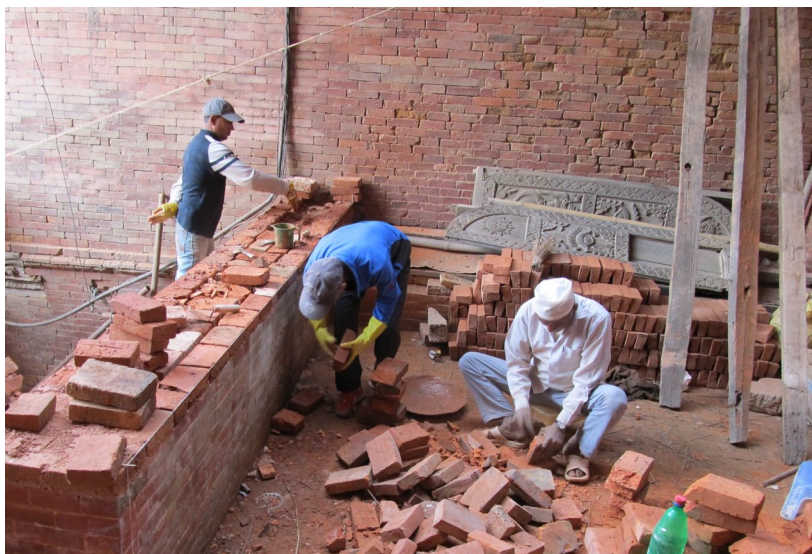
November 2012: Building the parapet wall.

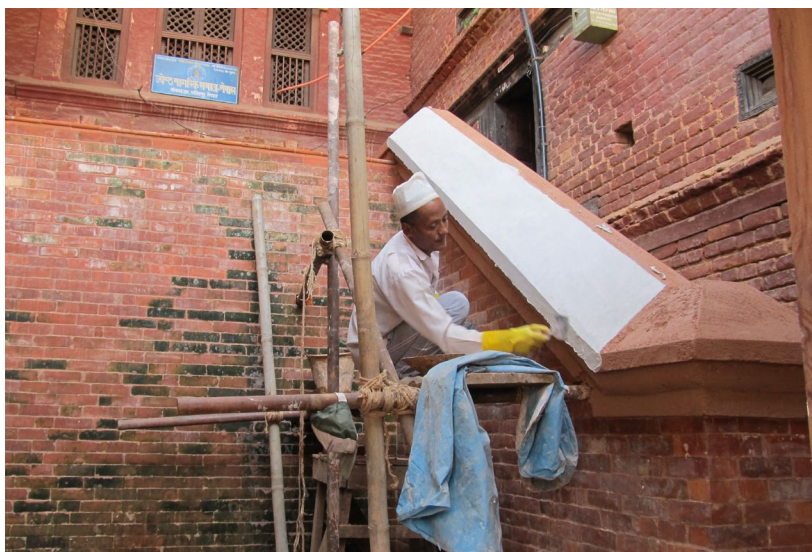
November 2012: Applying lime plaster to the parapet wall on the stone staircase.

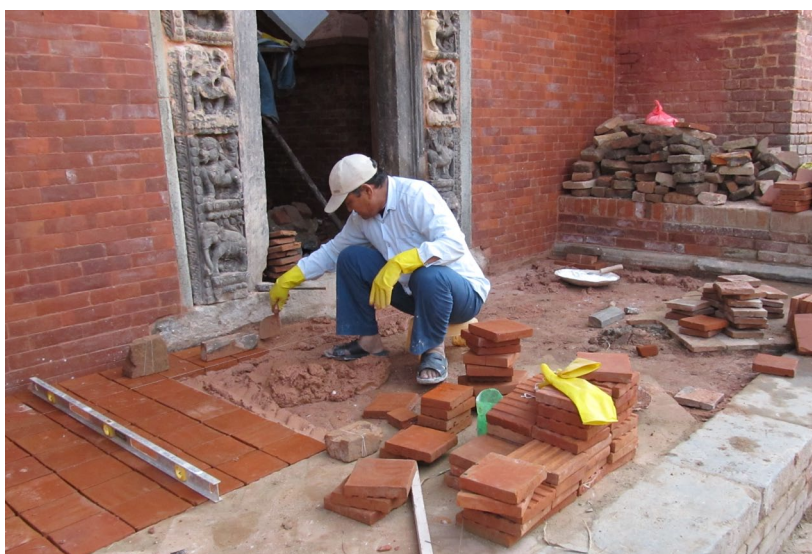
November 2012: Installing floor tiles (*chikah-apa*) in lime *surkhi* mortar in front of the gate.

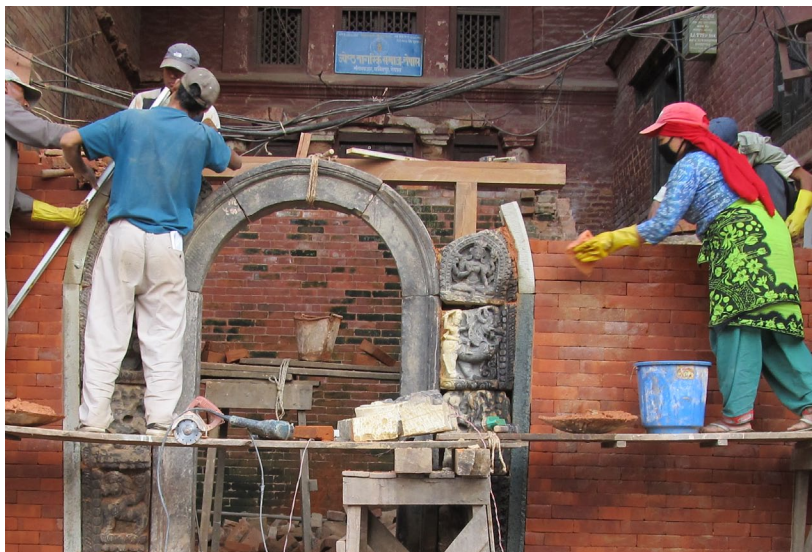
October 2012: The gate was rebuilt using existing stone statues and traditional bricks in lime and brickdust (*surkhi*) mortar.

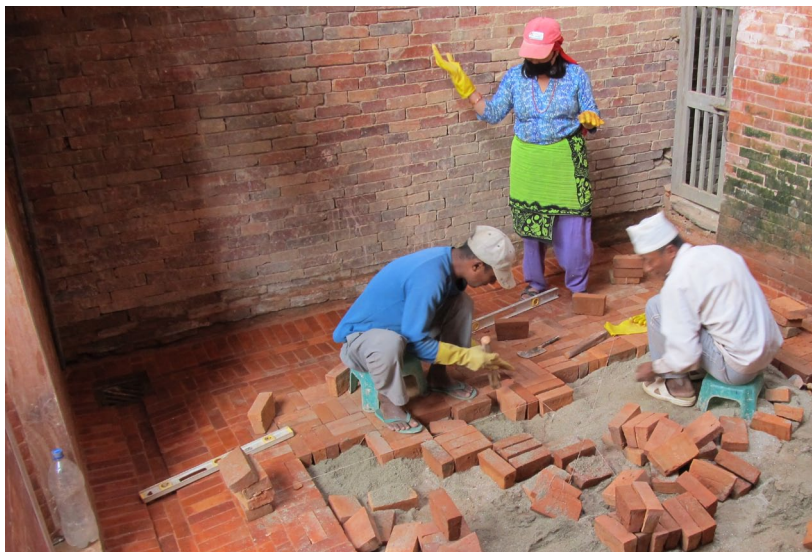
November 2012: Installing brick on-edge paving in the courtyard.
