**PATUKVA AGACHE**  
**PATUKVA TOL, PATAN**

**HISTORIC STRUCTURE REPORT**  
**JUNE, 1994**

**ERICH G. THEOPHILE**  
**ROHIT K. RANJITKAR**  
**KATHMANDU VALLEY PRESERVATION TRUST**  
**IN COLLABORATION WITH**  
**HIS MAJESTY'S GOVERNMENT**  
**DEPARTMENT OF ARCHAEOLOGY**

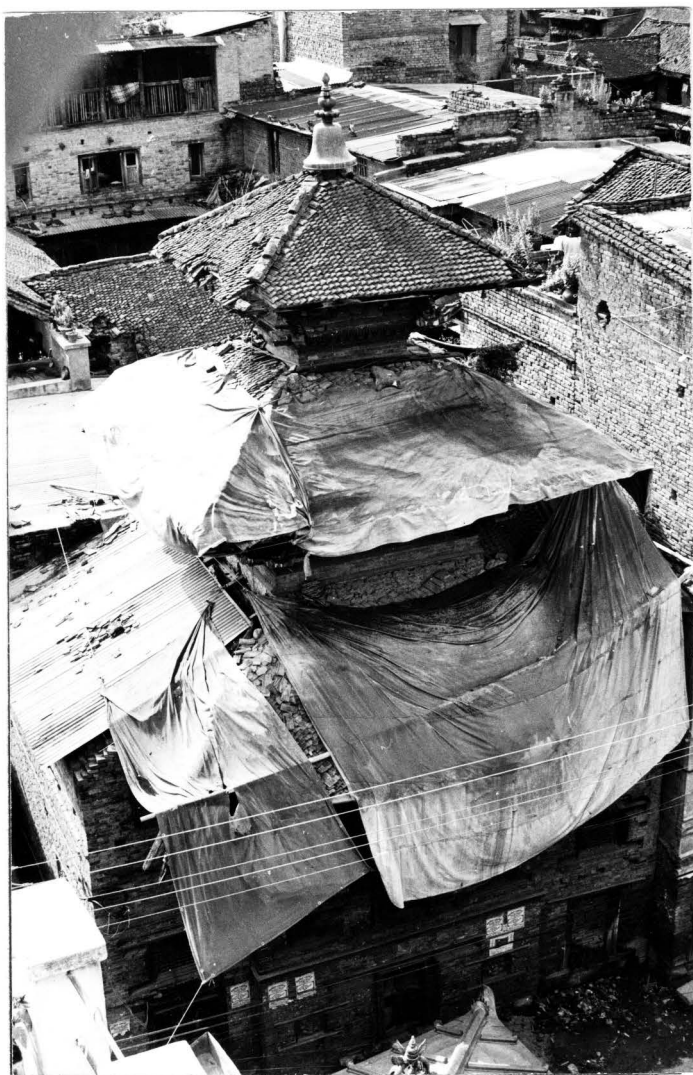
The Agache seen from the southeast, after emergency assistance by K.V.P.T. including tarpaulins on roof to protect building from monsoon rain, Spring 1992.

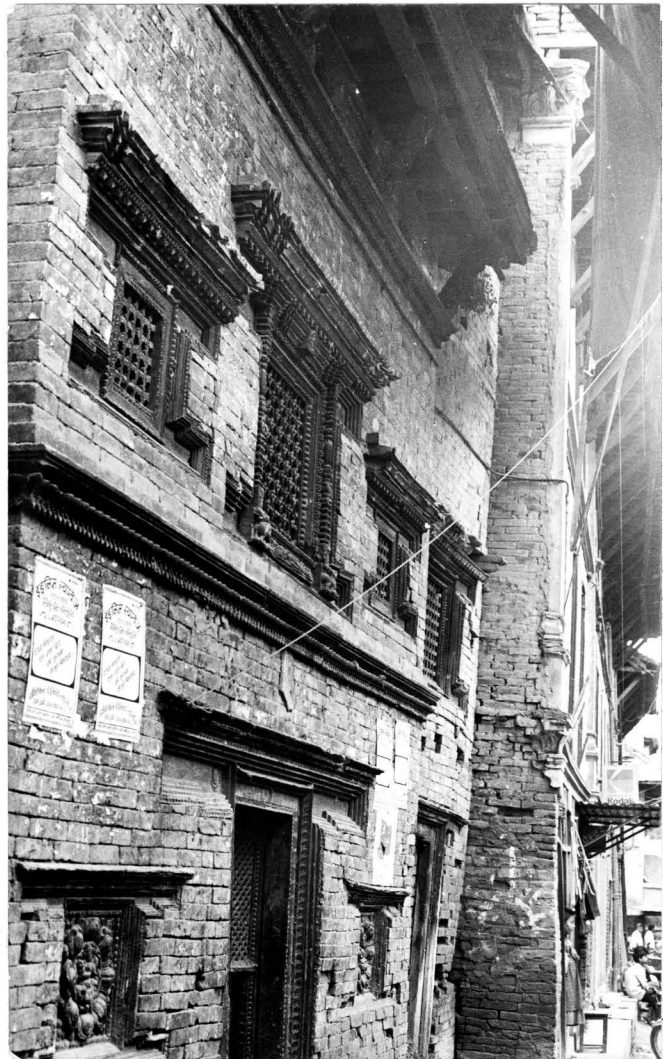
**One brick projection of central bay of the principal facade.**

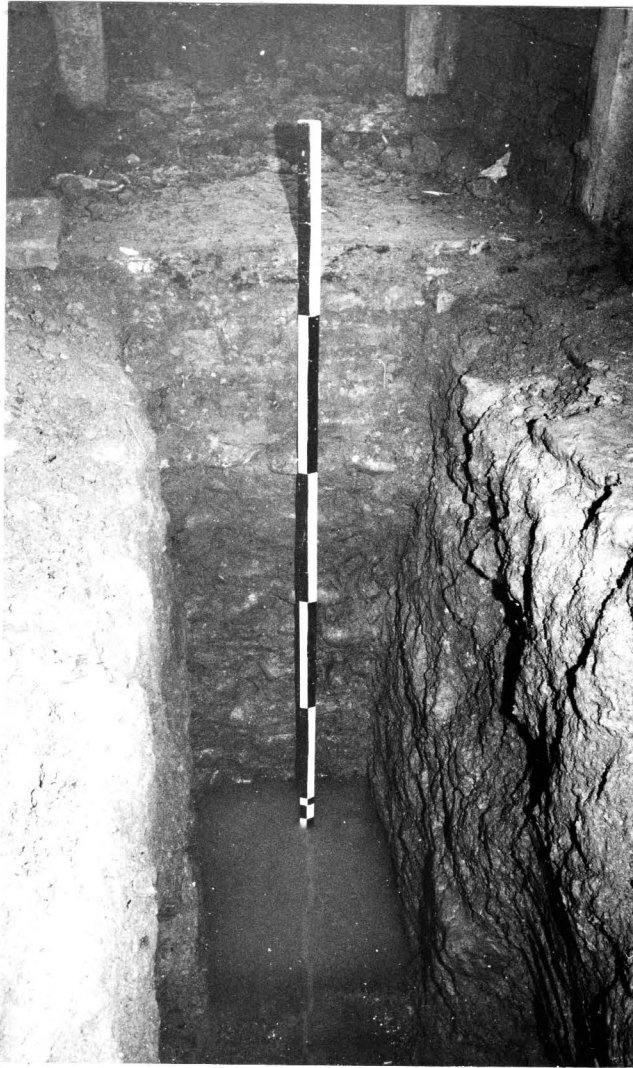
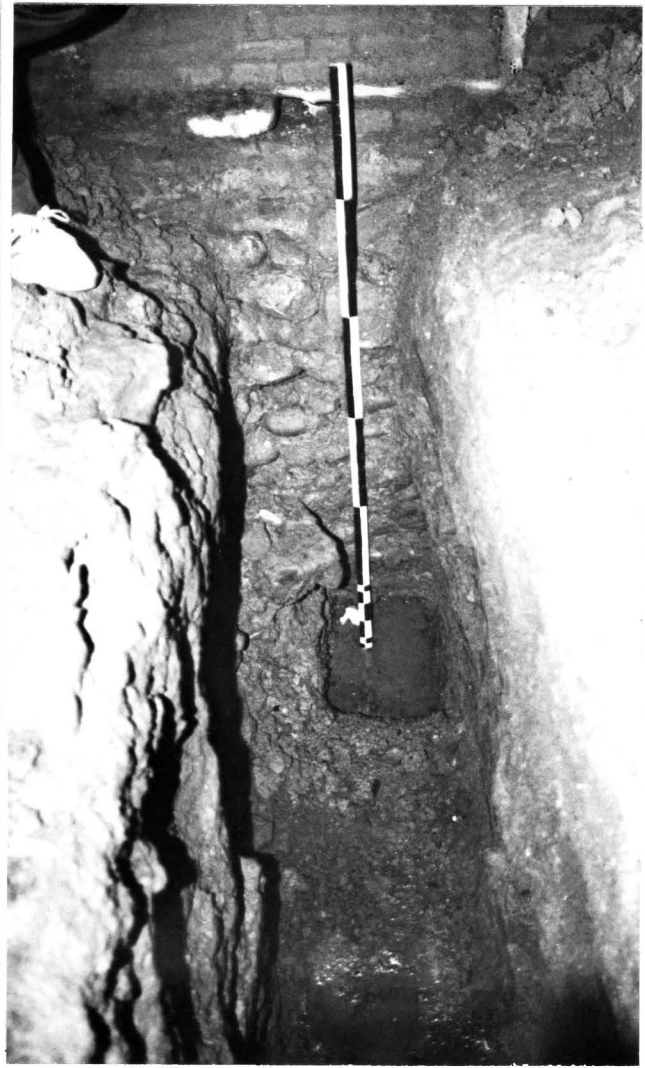
The foundation of the building appears to be in excellent condition, consisting of river stones laid in mud mortar total height 5'-1" to ground level. Excavation summer 1993. It is unclear why significant settlement of up to 6" has taken place in the tower area of the N-S wall facing back courtyard (called middle wall in text).

Excavation in two locations during summer 1993 determined the composition and condition of the foundation: it's height is exactly 5'0" from the bottom of the bricks above (ground level) to the bottom of the lowest stone below. The construction is of river stone (varying sizes approximately 9-12" diameter oval) laid in mud mortar, thickness of the stone foundation wall varies (front eastern wall: 4'3-1/2"; rear wall: 2'6"). Excavation has not been undertaken at the timber posts of the rear gallery in order to preserve adjacent historical tile pavement.

Settlement of the middle masonry wall has occurred only under the tower section of the building. Settlement varies from 7" maximum in the middle to 5" under the tower's north and south walls. No settlement is found at the end of this wall (outside central tower area). Settlement has been determined by comparative study of the wall plate levels.

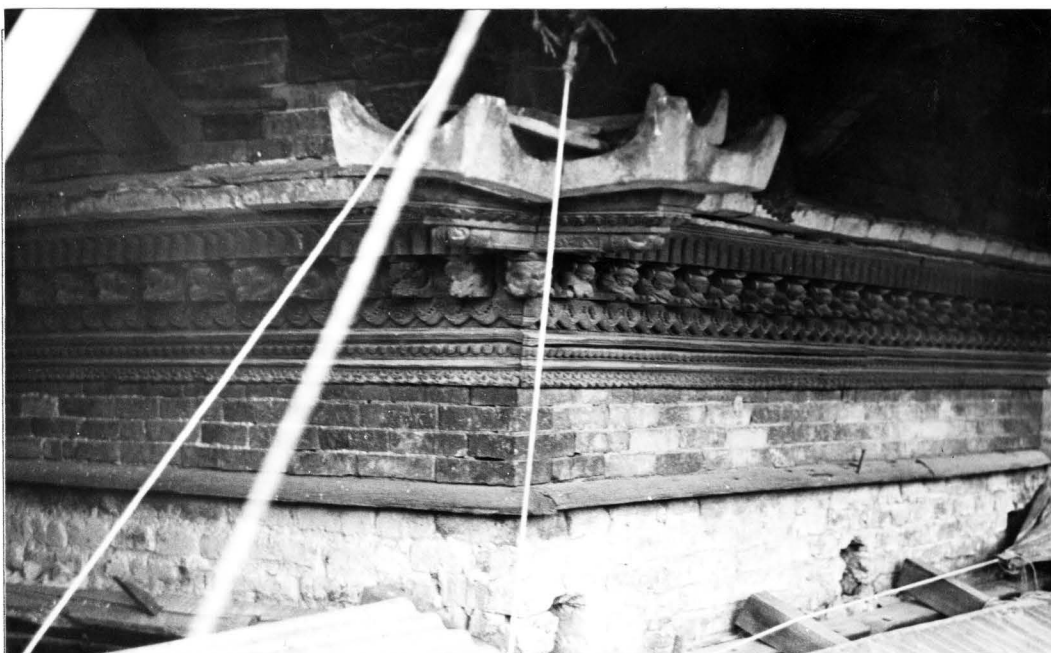
Upper level of rooftop pagoda shows daci apa framed by timber cornice pieces.  
Below common fired brick with visible mud mortar joints. All in excellent condition.

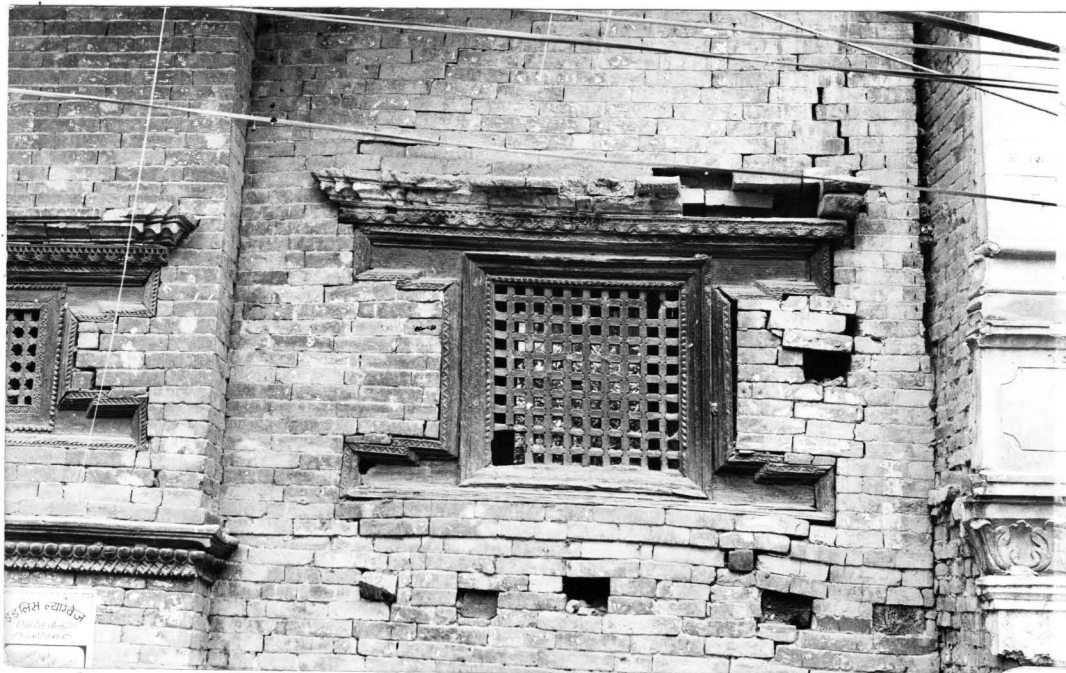
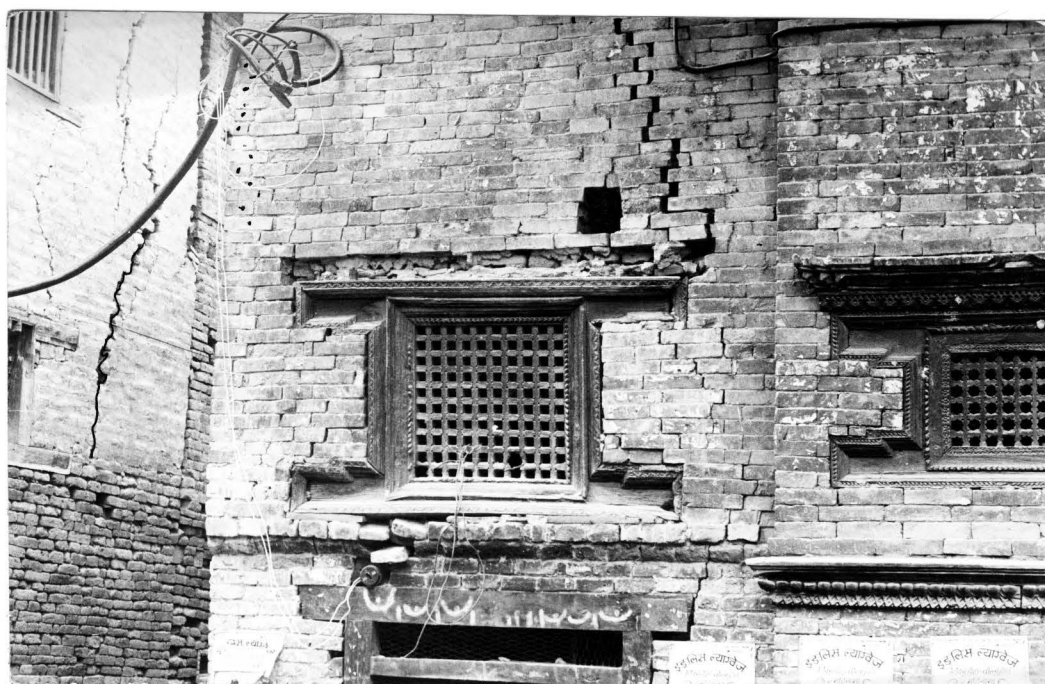
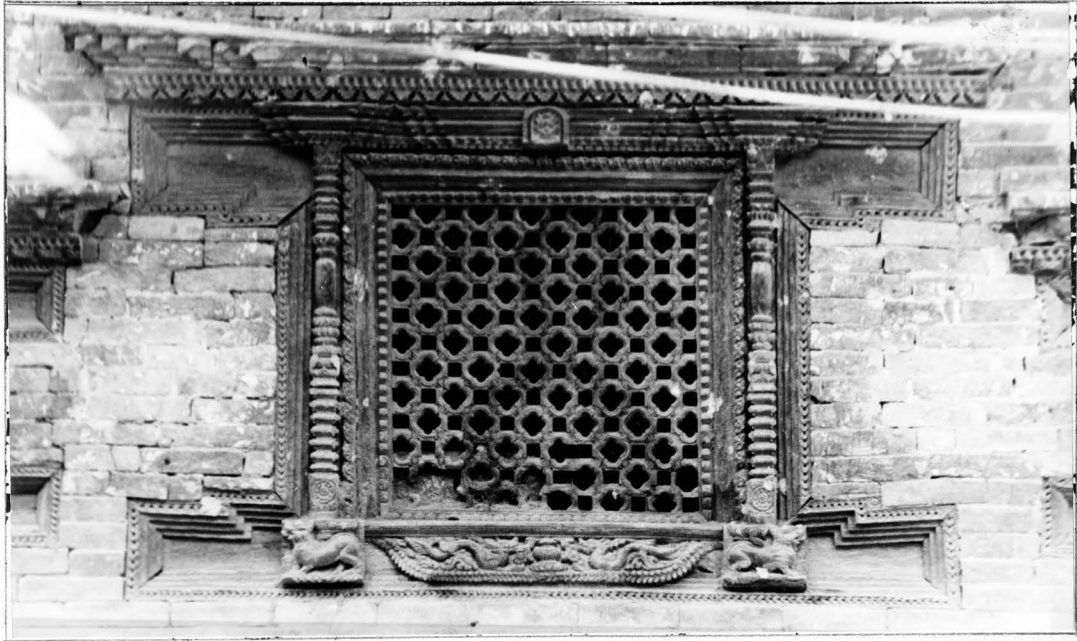
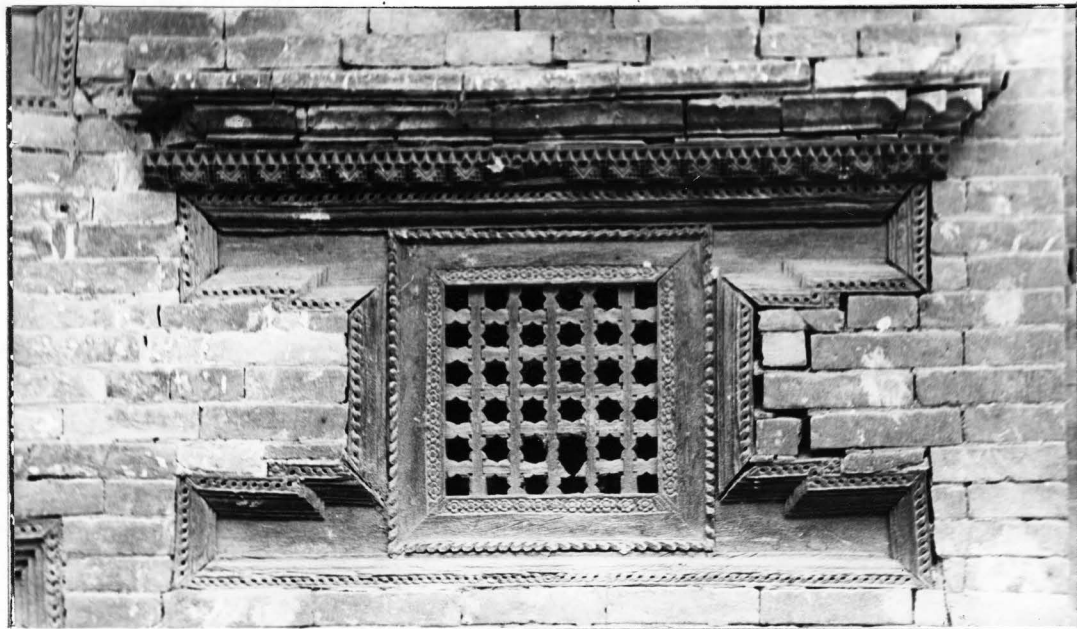
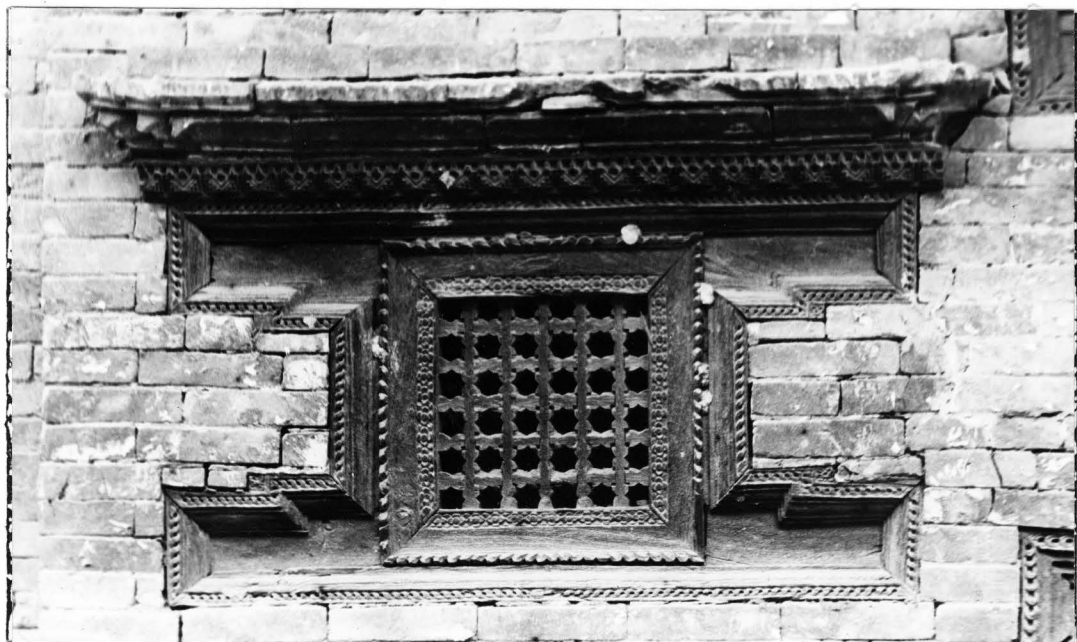
On the first floor, openings are in good condition except for missing brick cornice discussed under 5.02. Lattice work in the central and northern windows is damaged, approximately 6"x4" and 4"x4", respectively.

**This page: First floor windows north and south ends. Opposite page: central window first floor. above with north and south flanking units below, respectively.**

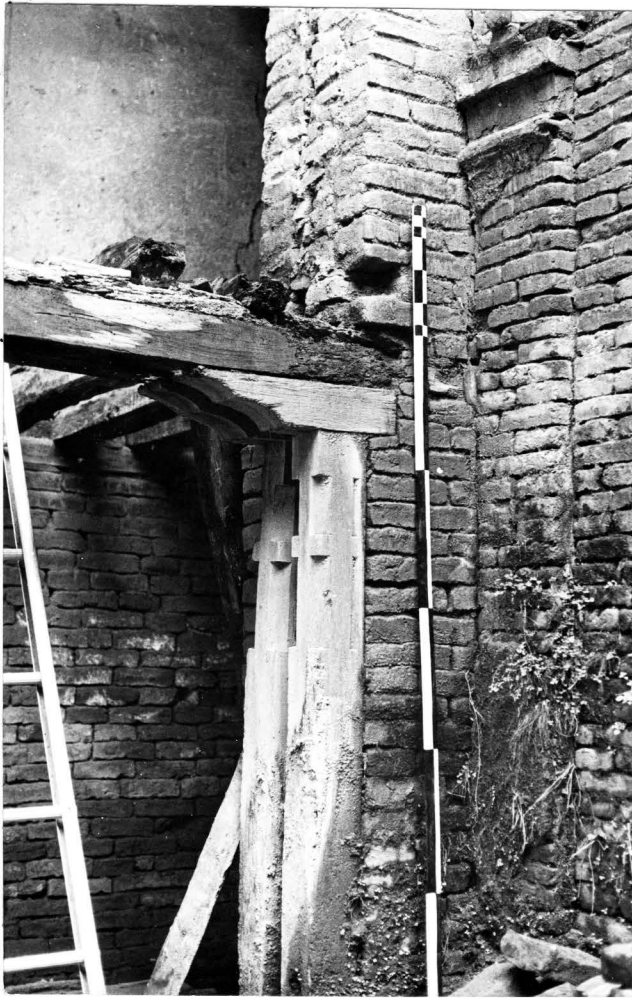
At the back elevation upper two floors (first and second floor) collapsed some five years back after several years of water penetration. Now only seven of the ground floor timber posts remain.

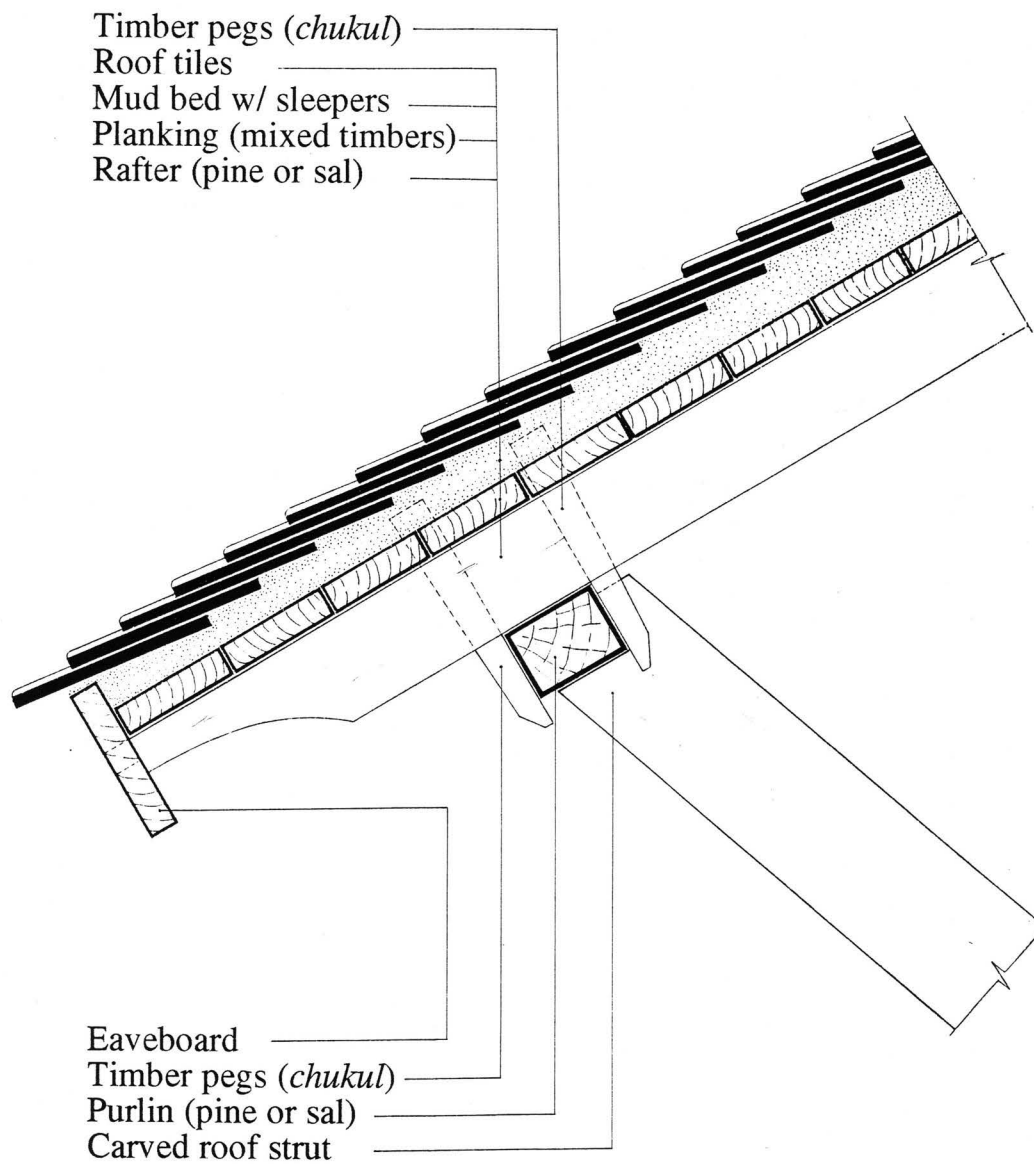
## THE "KEY" PROBLEM

An important conclusion after detailed study of the extant roof structure is that the traditional wooden peg (Newari: *cuku*, Nepali: *chukul*) inserted as a key at wall plate and purlin is a principal entry point for water into the structural timbers. The traditional detail uses the peg as a key into the mud layer above. Thus any damage to or movement of the rather loose roof tile (Newari: *Jhingati*) allows water to reach the mud and then penetrate into the cross grain of the rafter through this wooden peg. Moreover when the small timber peg deteriorates, there is nothing to prevent the heavy rafters from sliding off the masonry core structure--this is especially critical at purlin locations.

At almost all (approximately 90%) of these peg locations, structural deterioration and in particular enlarged holes of these pegs to as much as 3" square (300%) has led to structural failure of the joints. This failure pattern is exacerbated by general dampness transmitted by the timber lath beneath the mud bed. This scenario describes the loss of rafters above the bay window here as well as the majority of roof failures in Newar buildings, and in particular at our other recent projects, Radha Krishna and Uma Maheswar Temples.

*Section at roof overhang:  
as traditionally detailed*

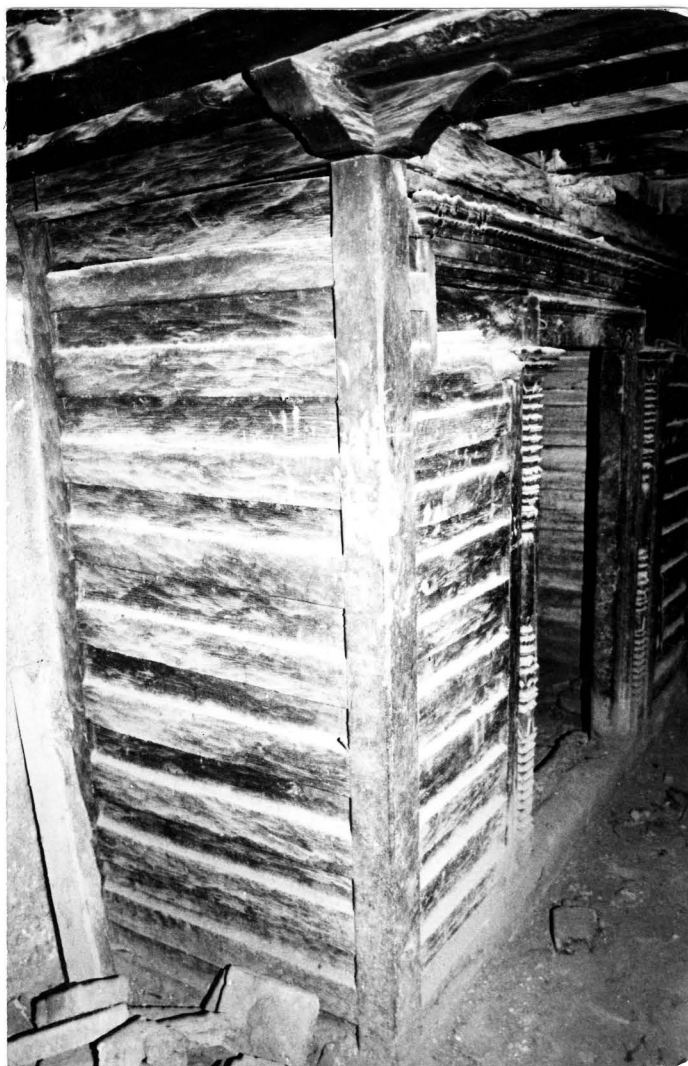
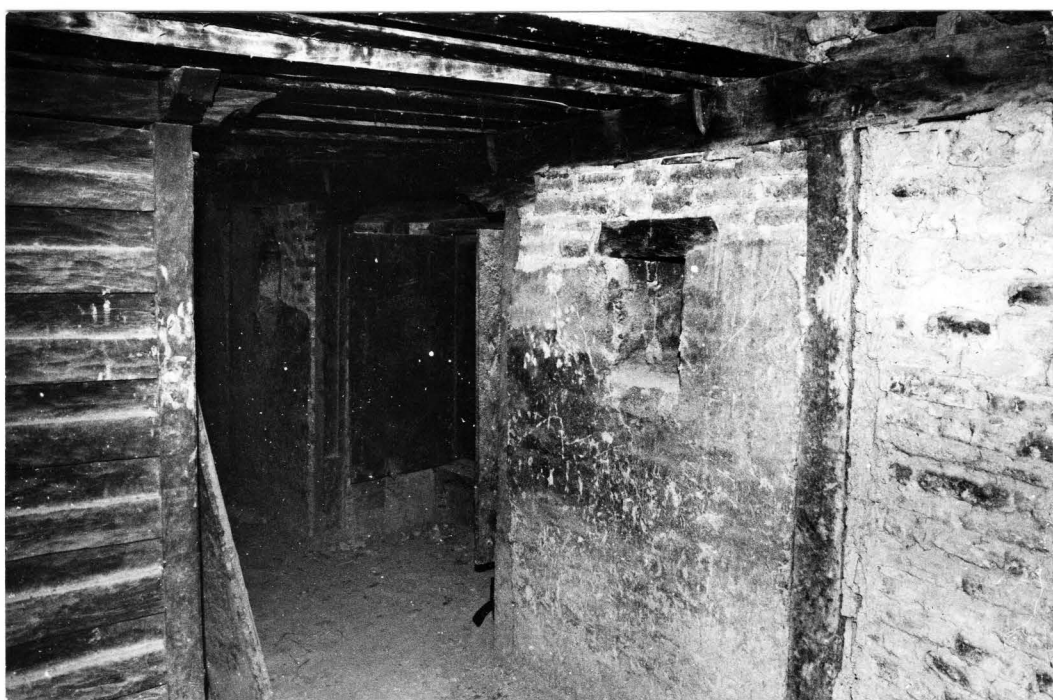
Above : Partition of esoteric shrine, second floor. Below: view towards *san jhya* with esoteric shrine left.  
August 1993.

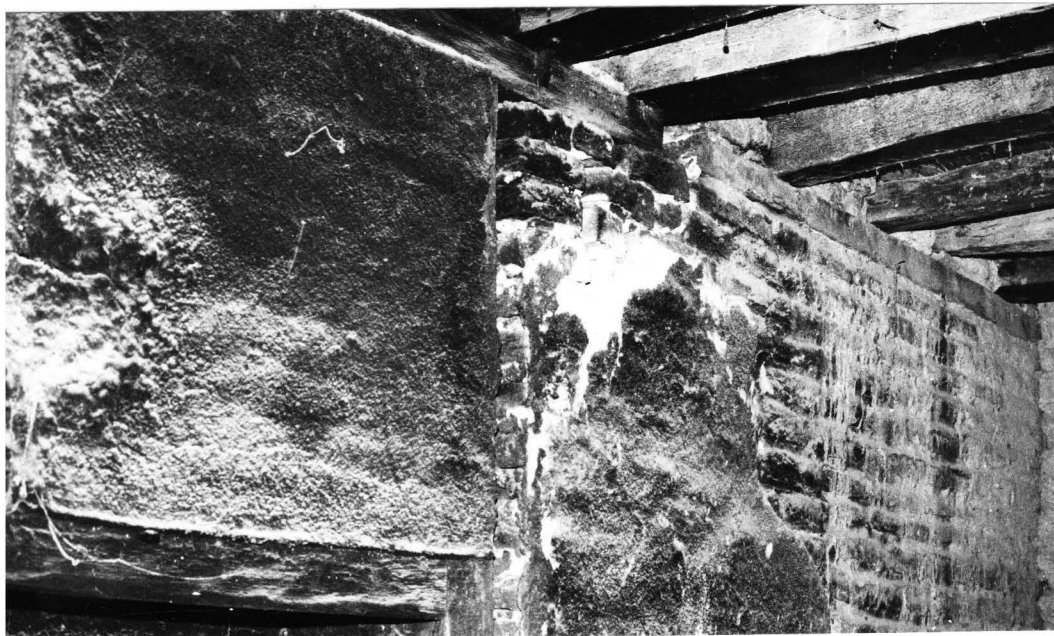
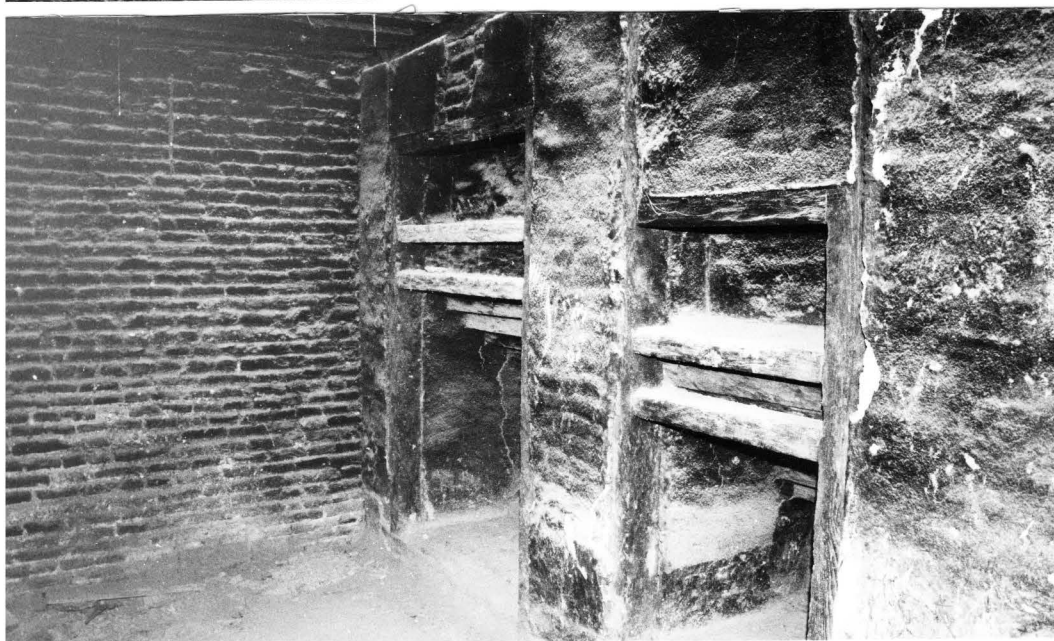
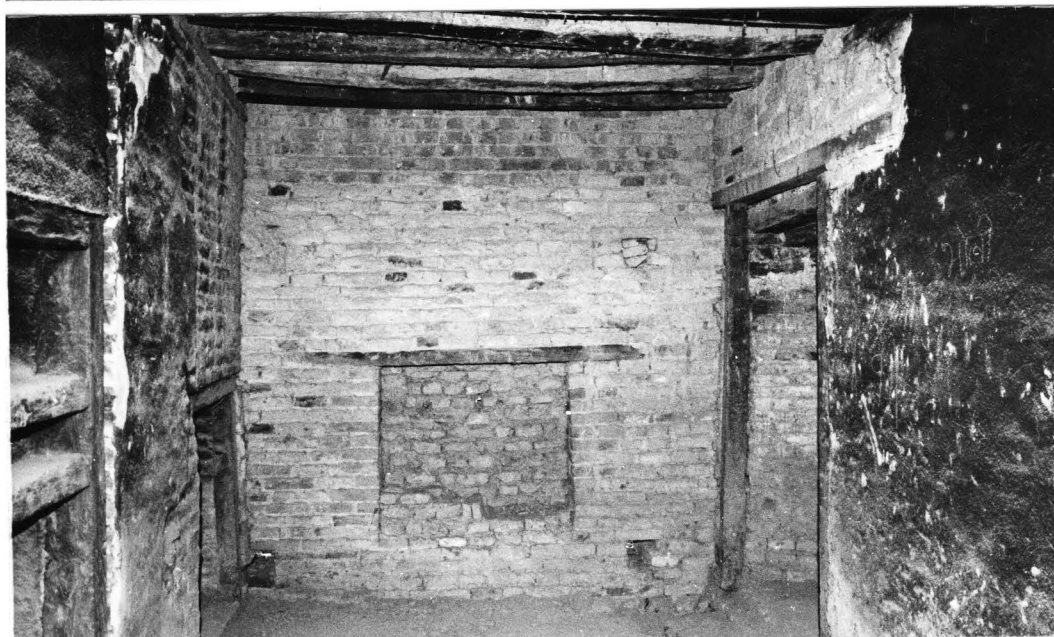
Above: Detail above south window first floor showing intact mud plaster and common brick beneath. Middle: First floor south face of 1954 partition left, central and south windows of principle facade right. Bottom: First floor looking south to blocked window.

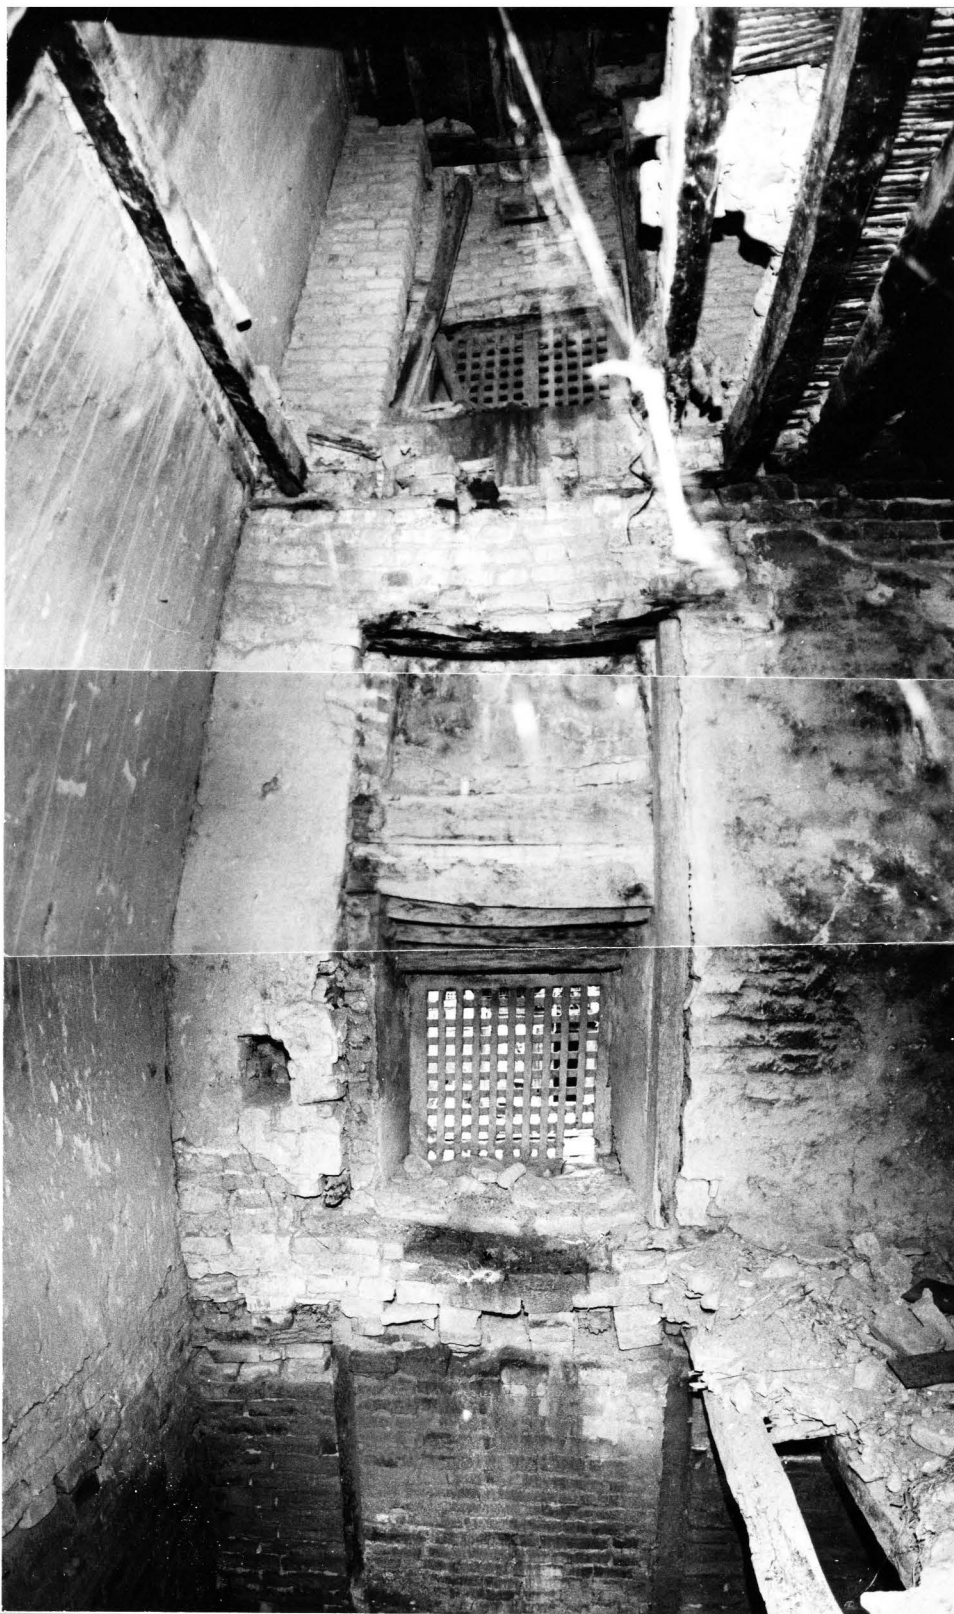
Composite photo view looking east. The three northern openings of the principle facade ( blocked door below) are visible as is collapse of all floor joist in this area.

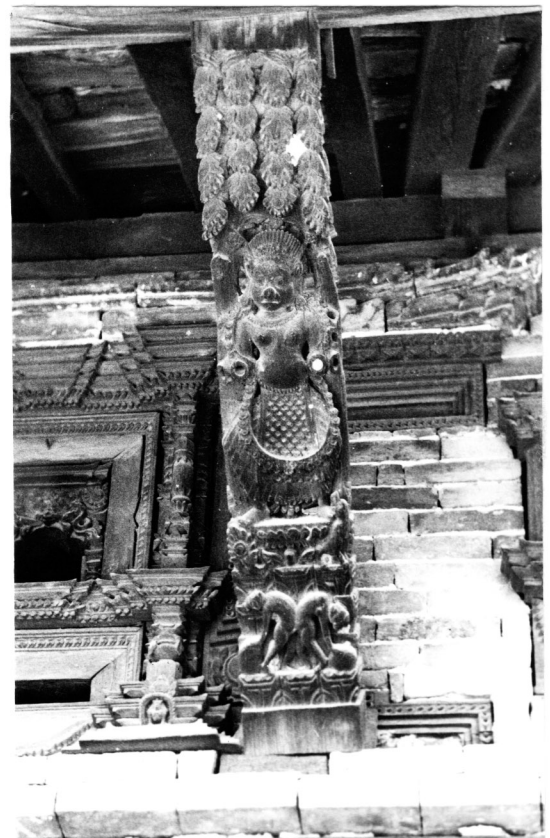
BOTTOM ROOF  
STRUT: 103  
ELEVATION: EAST  
AGE: 19th century ?

CONDITION:  
- structural condition good  
- Four hands are lost

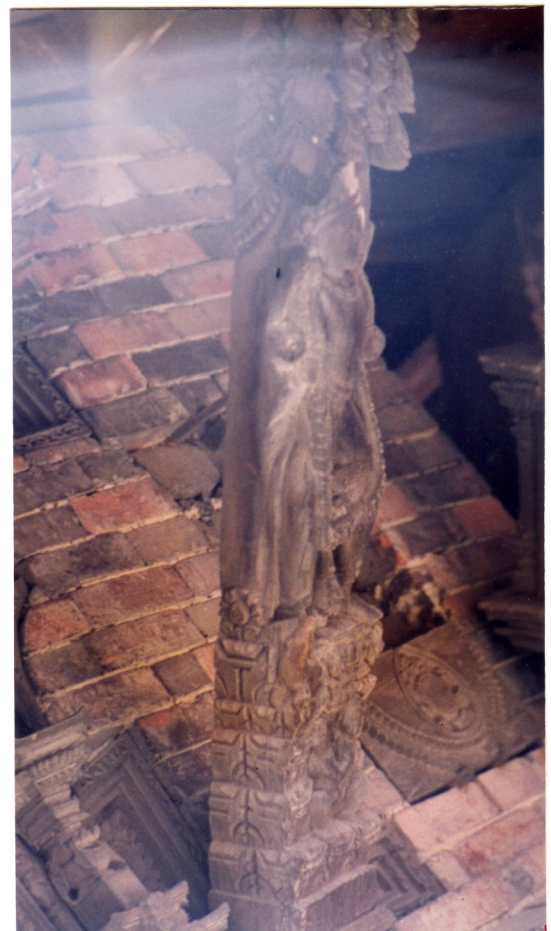
**STRUT: 107**

- structural condition good
- All hands are lost

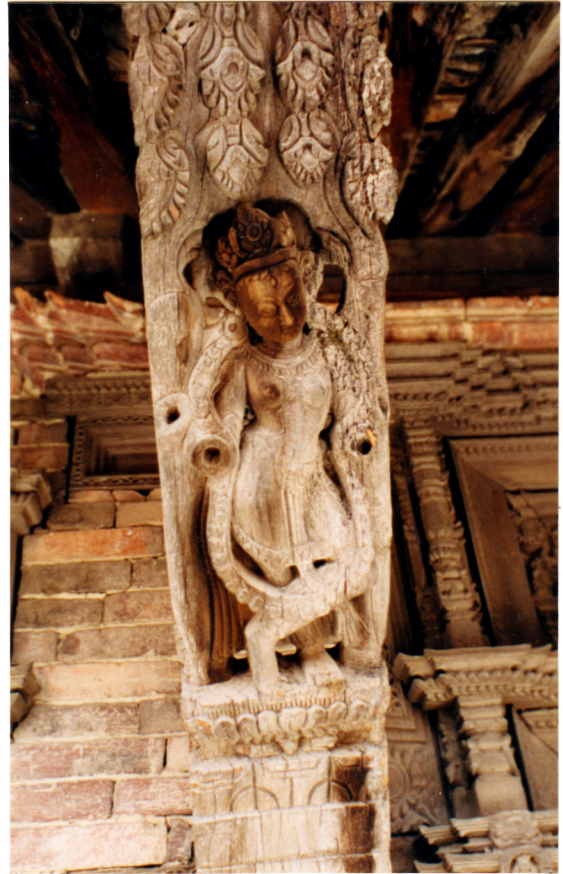
**STRUT: 108**

- structural condition good
- Mildew problem on face and back dripping
- 1/4 Part of right side of strut damaged by wetrot.

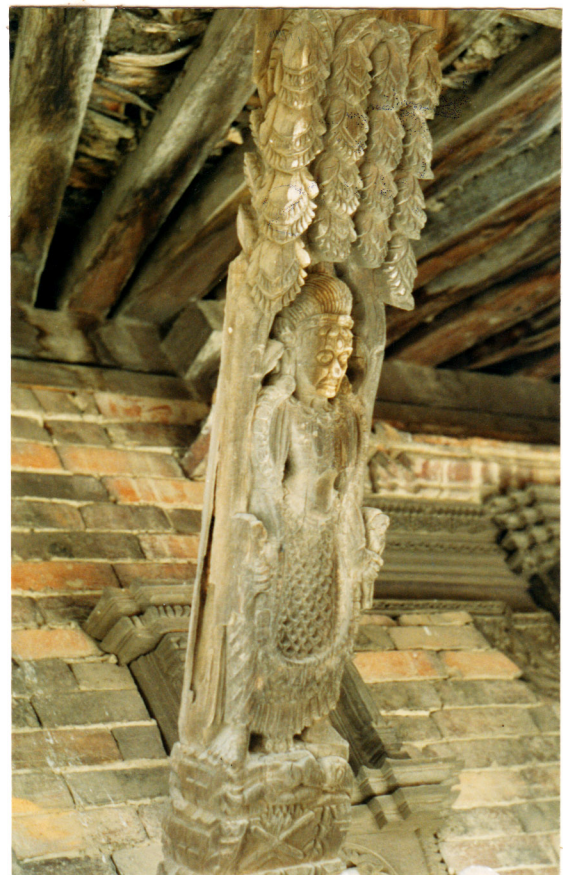
**STRUT: 109**

- structural condition excellent
- Mildew problem on face
-

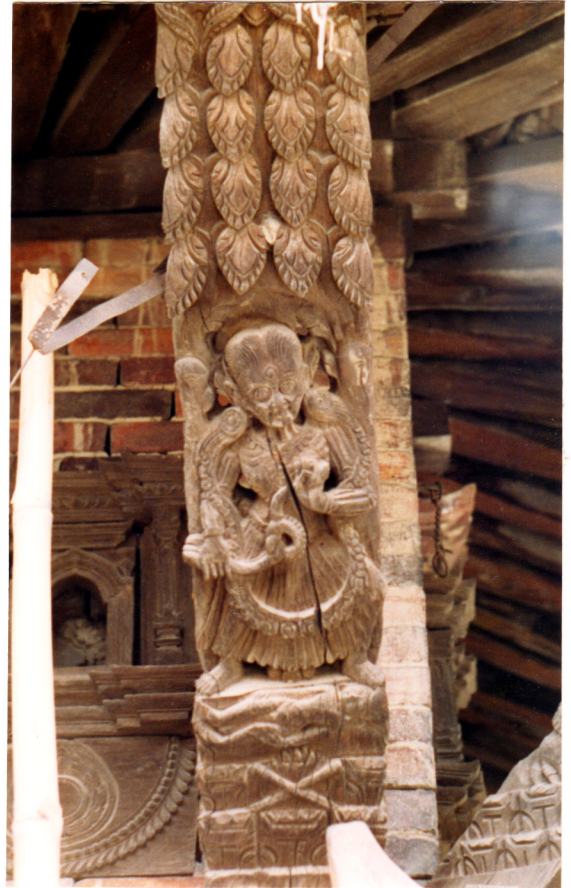
BOTTOM ROOF  
 STRUT: 111  
 ELEVATION: WEST  
 AGE: 19th century ?

- structural condition excellent
- seasoning crack on main body

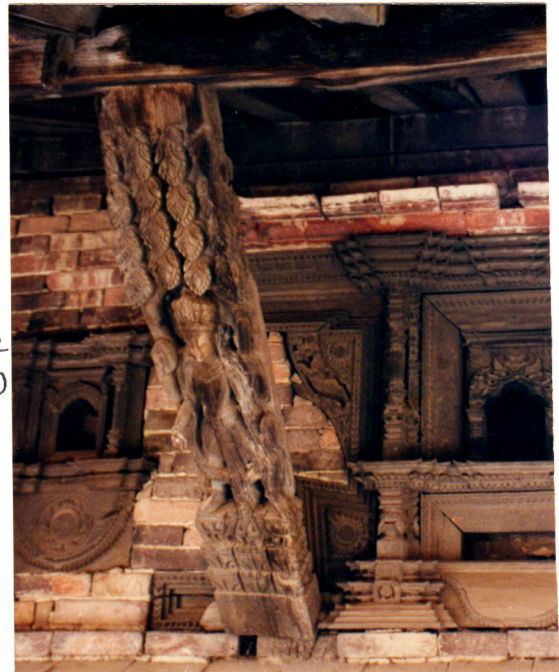
**STRUT: 118**

- structural condition good
- Top 3" and 1/3 part of right side of strut is damaged due to wet rot.

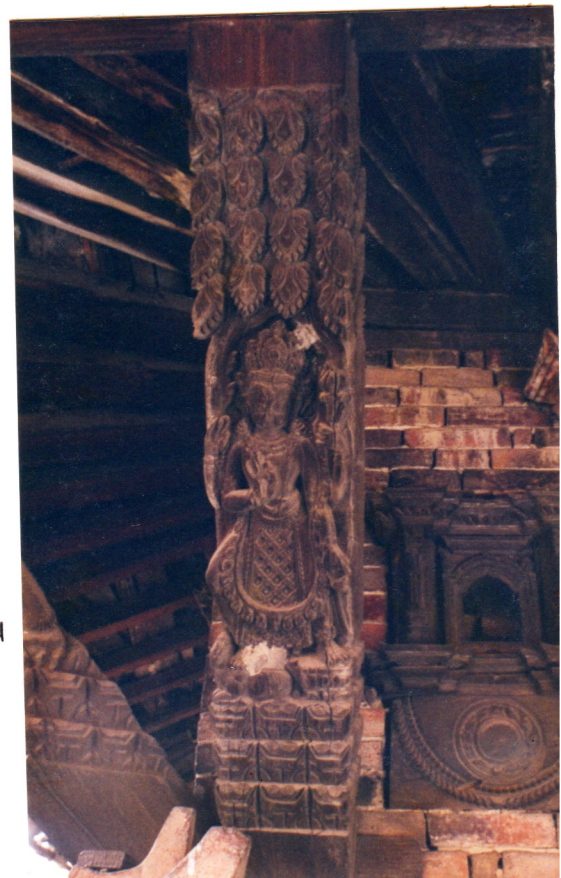
**STRUT: 119**

- structural condition is o.k.
- Top right side (2"X6") damaged by wet rot.

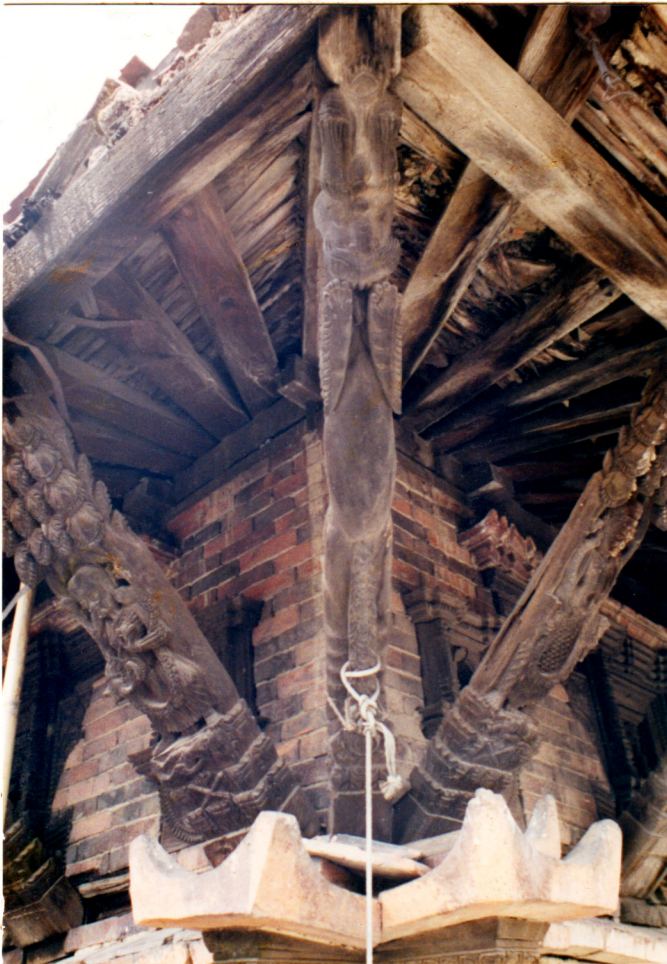
**STRUT:** 105, 110, 115, 120

- All four corner horses are in excellent condition.

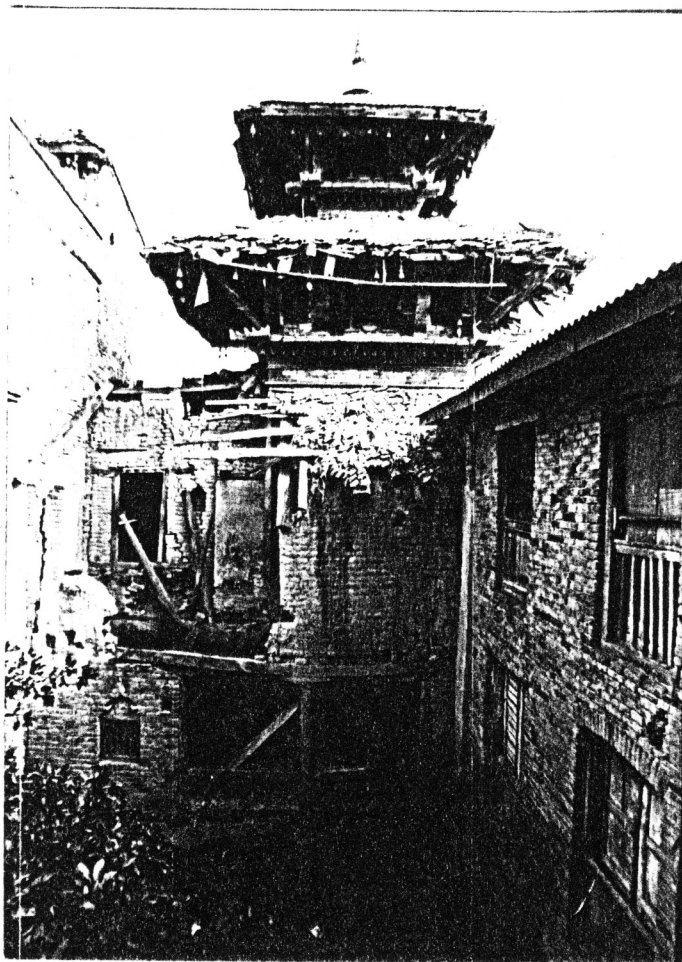
Spring 1992. View from southeast showing the rebuilt south facade and metal roof over the southern portion of the building.
