**RADHA KRISHNA TEMPLE**  
**SWATHA TOL, PATAN**

**HISTORIC STRUCTURES REPORT**  
**MARCH, 1992**

**ERICH G. THEOPHILE**  
**ROHIT K. RANJITKAR**  
**KATHMANDU VALLEY PRESERVATION TRUST**  
**IN COLLABORATION WITH**  
**HIS MAJESTY'S GOVERNMENT**  
**DEPARTMENT OF ARCHAEOLOGY**

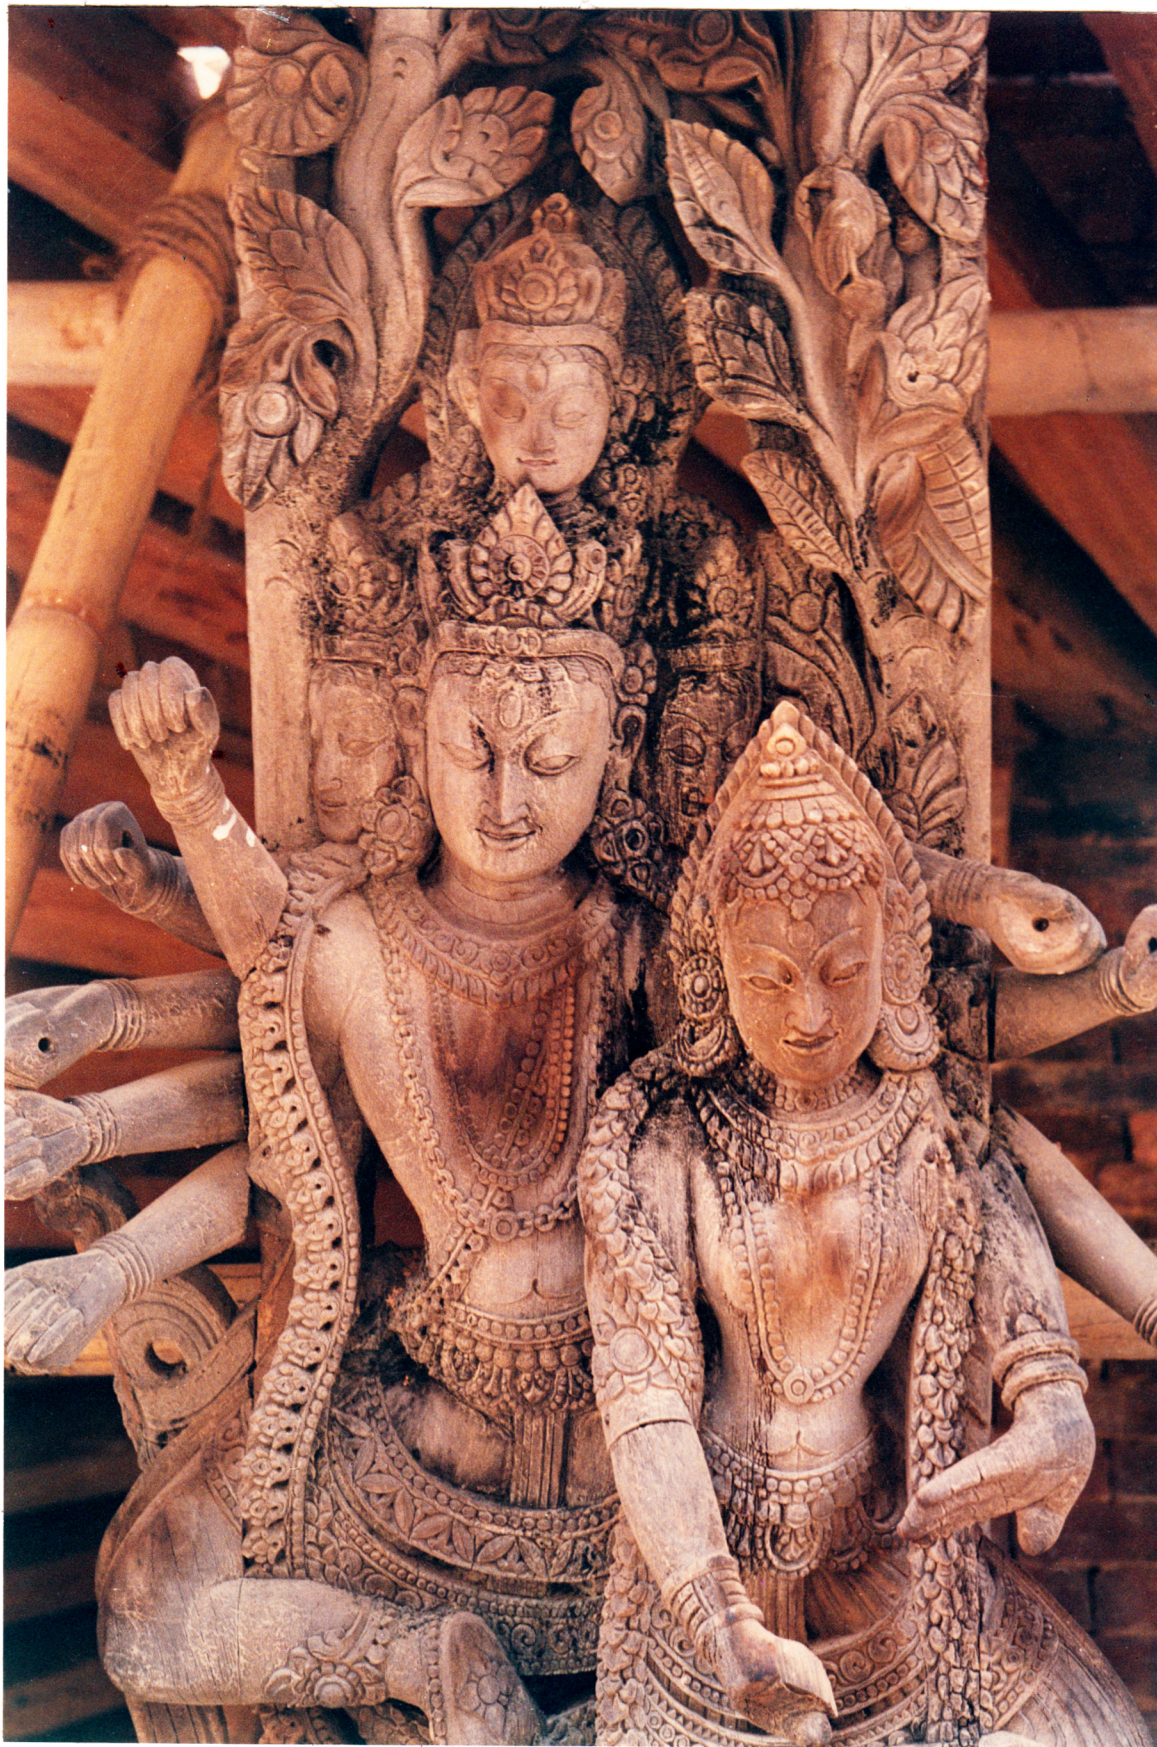
**LOWER ROOF STRUT #109**

THE STRUT, ORIGINAL TO THE TEMPLE (1668) INCLUDES ARMS ADDED IN 1967. DARK PATCH ON LEFT FIGURE IS MILDEW, DISCUSSED UNDER 5.06. PHOTOGRAPH MARCH, 1992.

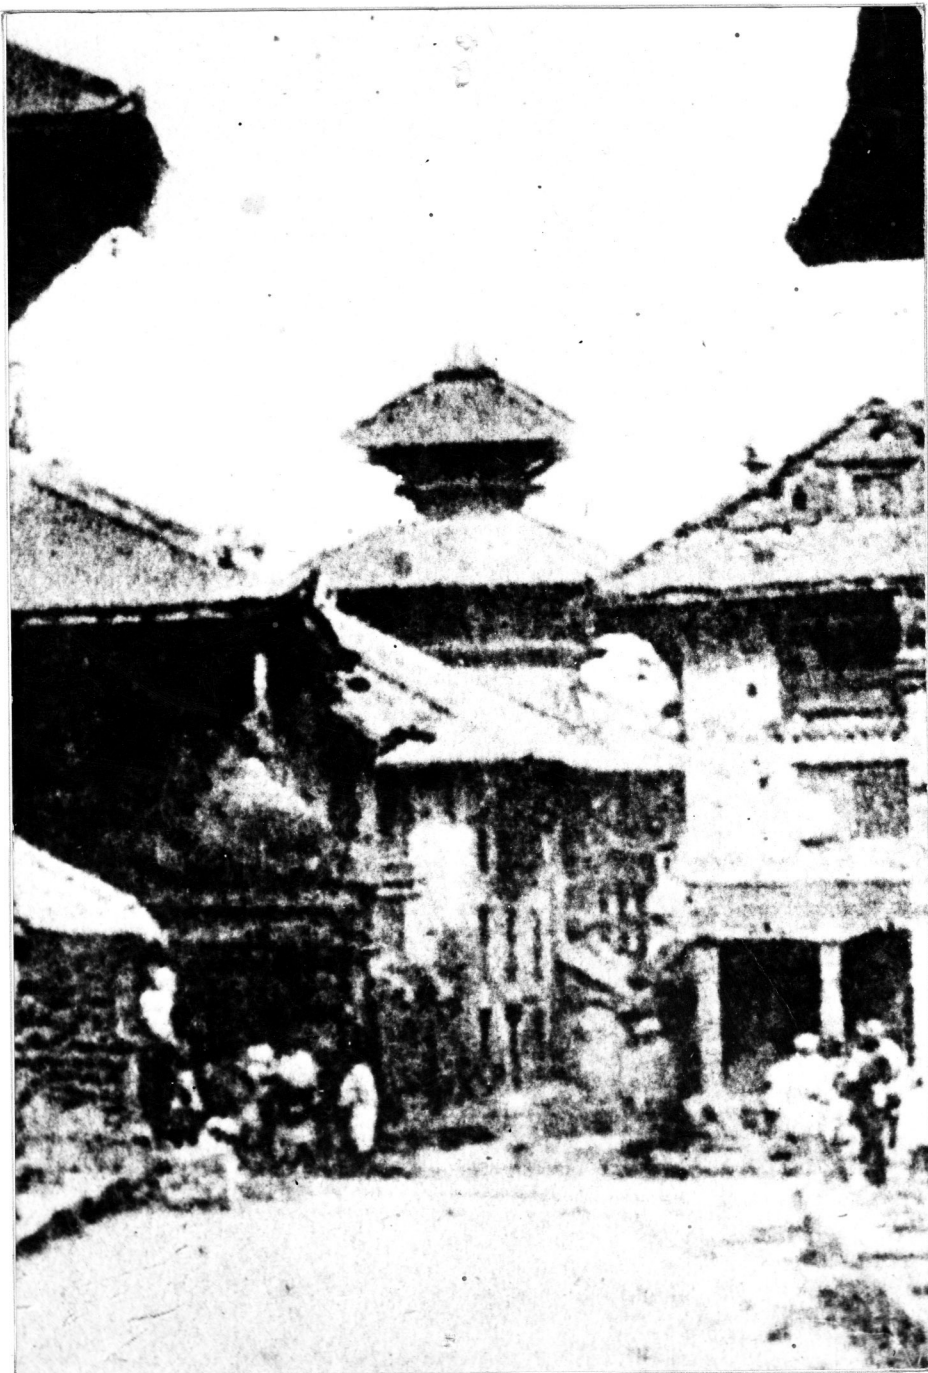
**DETAIL OF 1885 LEBON PHOTOGRAPH**  
(VOYAGE TO NEPAL, 1986 RPT.), ENLARGED BY PROJECT NOTE PROPORTION OF PINNACLE BASE  
(DARK RECTANGLE) DISCUSSED UNDER 5.06.

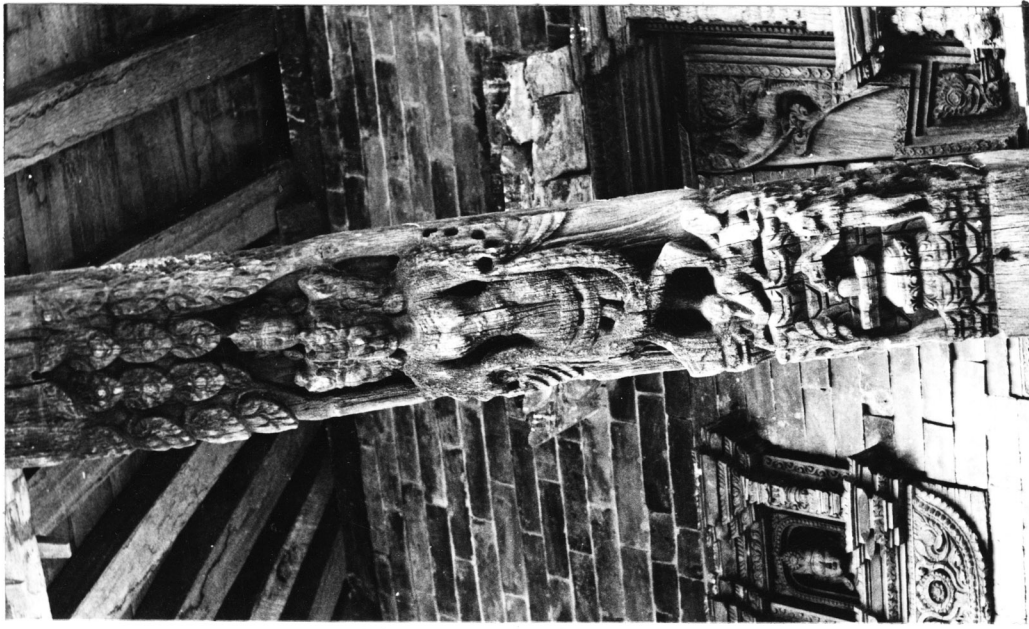
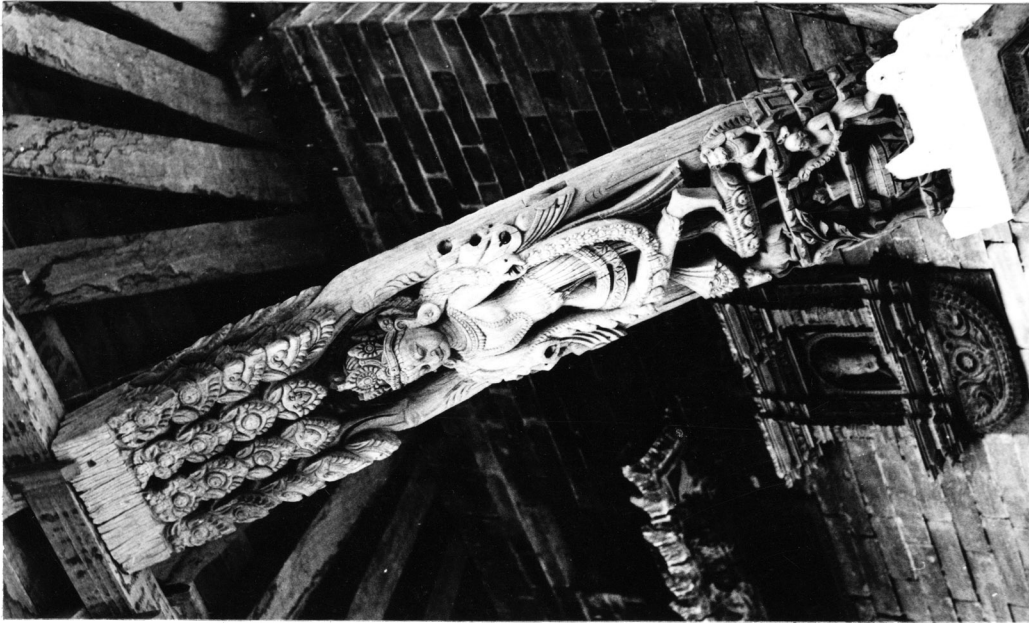
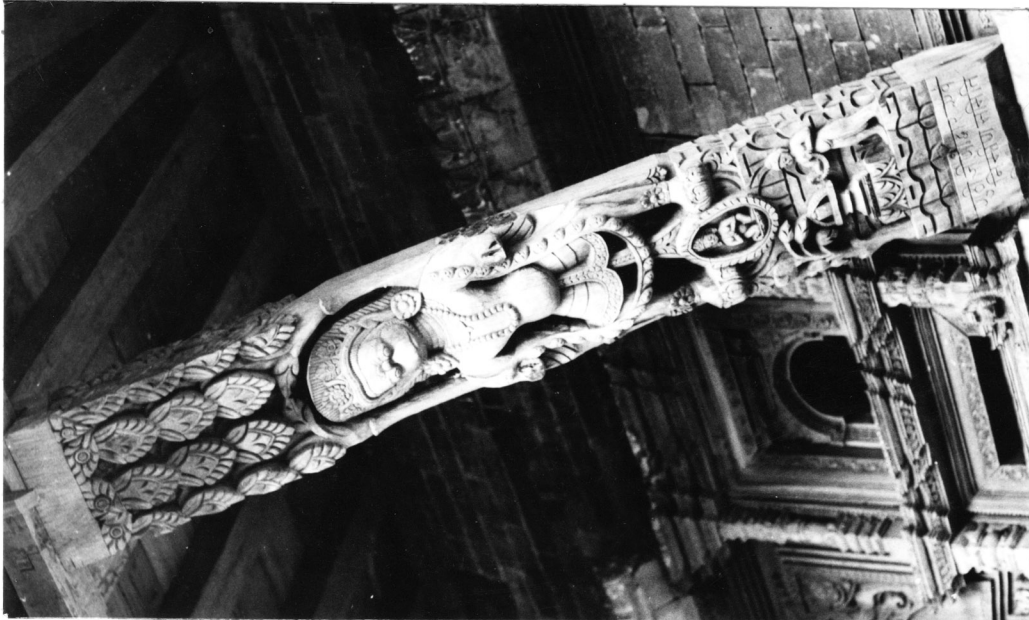
THREE GENERATIONS OF ROOF STRUTS AT THE MIDDLE LEVEL.  
FROM LEFT: STRUTS CIRCA 1967, 19TH C. AND ORIGINAL (1668). (INVENTORY # 207, 201, 213)

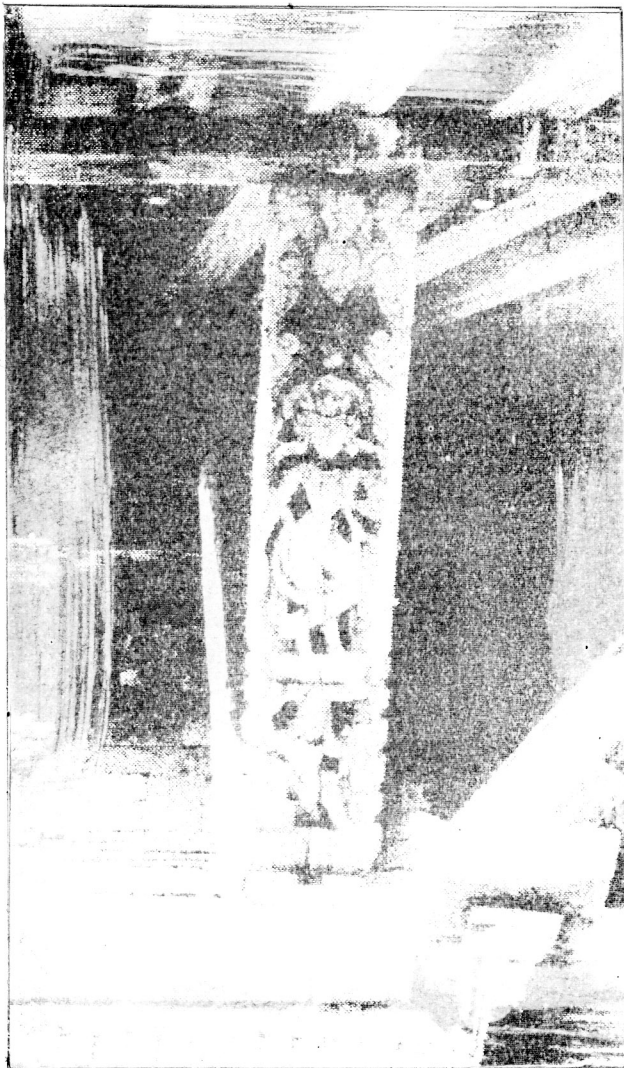
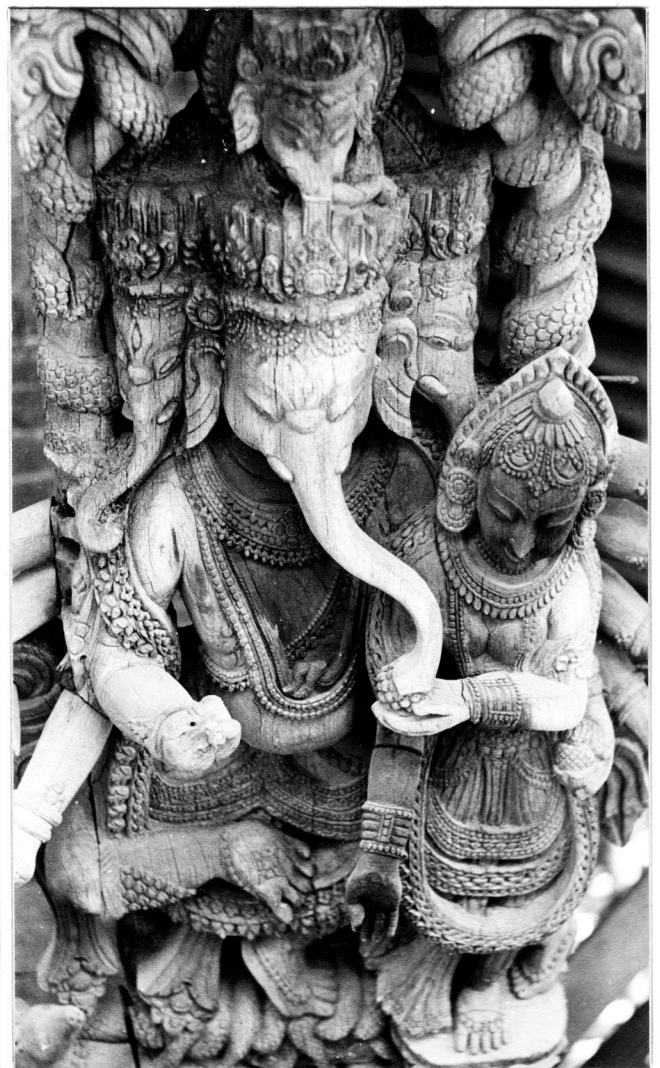
LEFT: ONE OF TWO SURVIVING ORIGINAL STRUTS DEPICTING AṢṬA MĀTR KĀ. (#304)  
 RIGHT: DETAIL LOWER ROOF STRUT (#101) DEPICTING FIVE-HEADED GANESH.

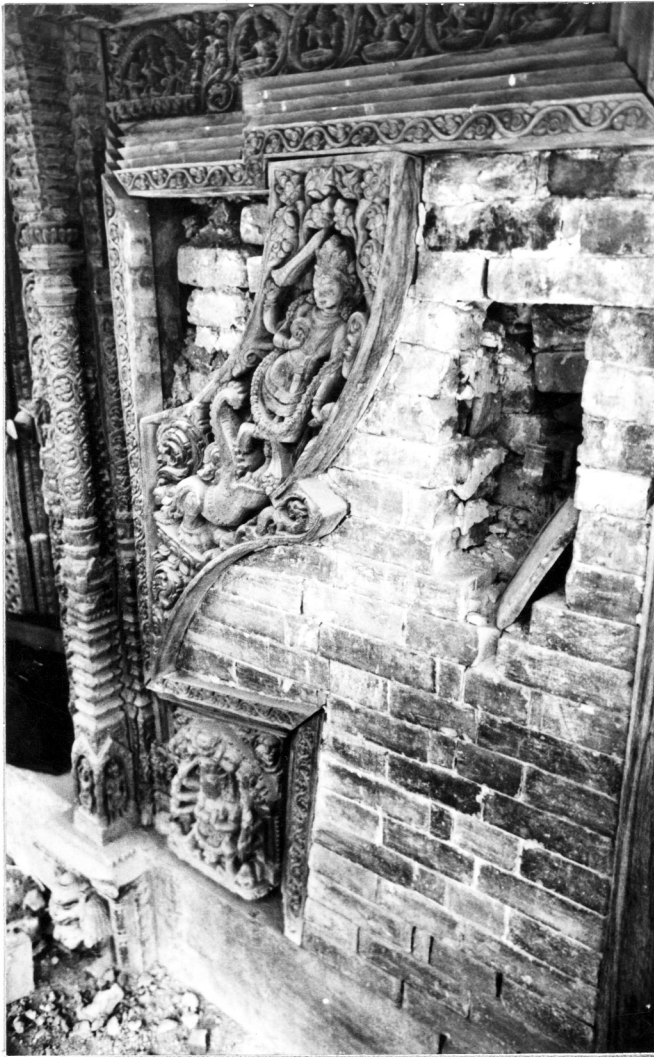
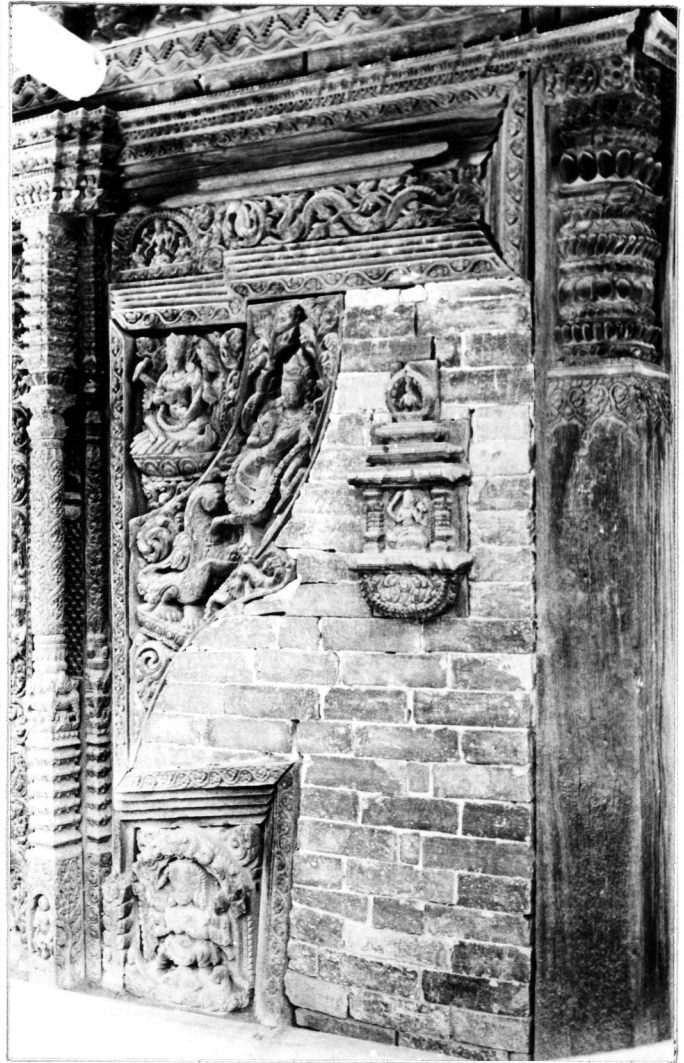
ABOVE: IDENTIFICATION OF ELEMENTS FROM N. GUTSCHOW, NEWAR TOWNS AND BUILDINGS, 1987. BELOW LEFT: THE EAST ELEVATION OF RADHA-KRSNA SHOWING LOST ASTAMATRIKA PANEL AND ADJACENT NICHE, JANUARY, 1992. RIGHT: ONLY ON THE RIGHT SIDE OF THE SOUTH ELEVATION WERE ALL ICONOGRAPHIC FEATURES INTACT.

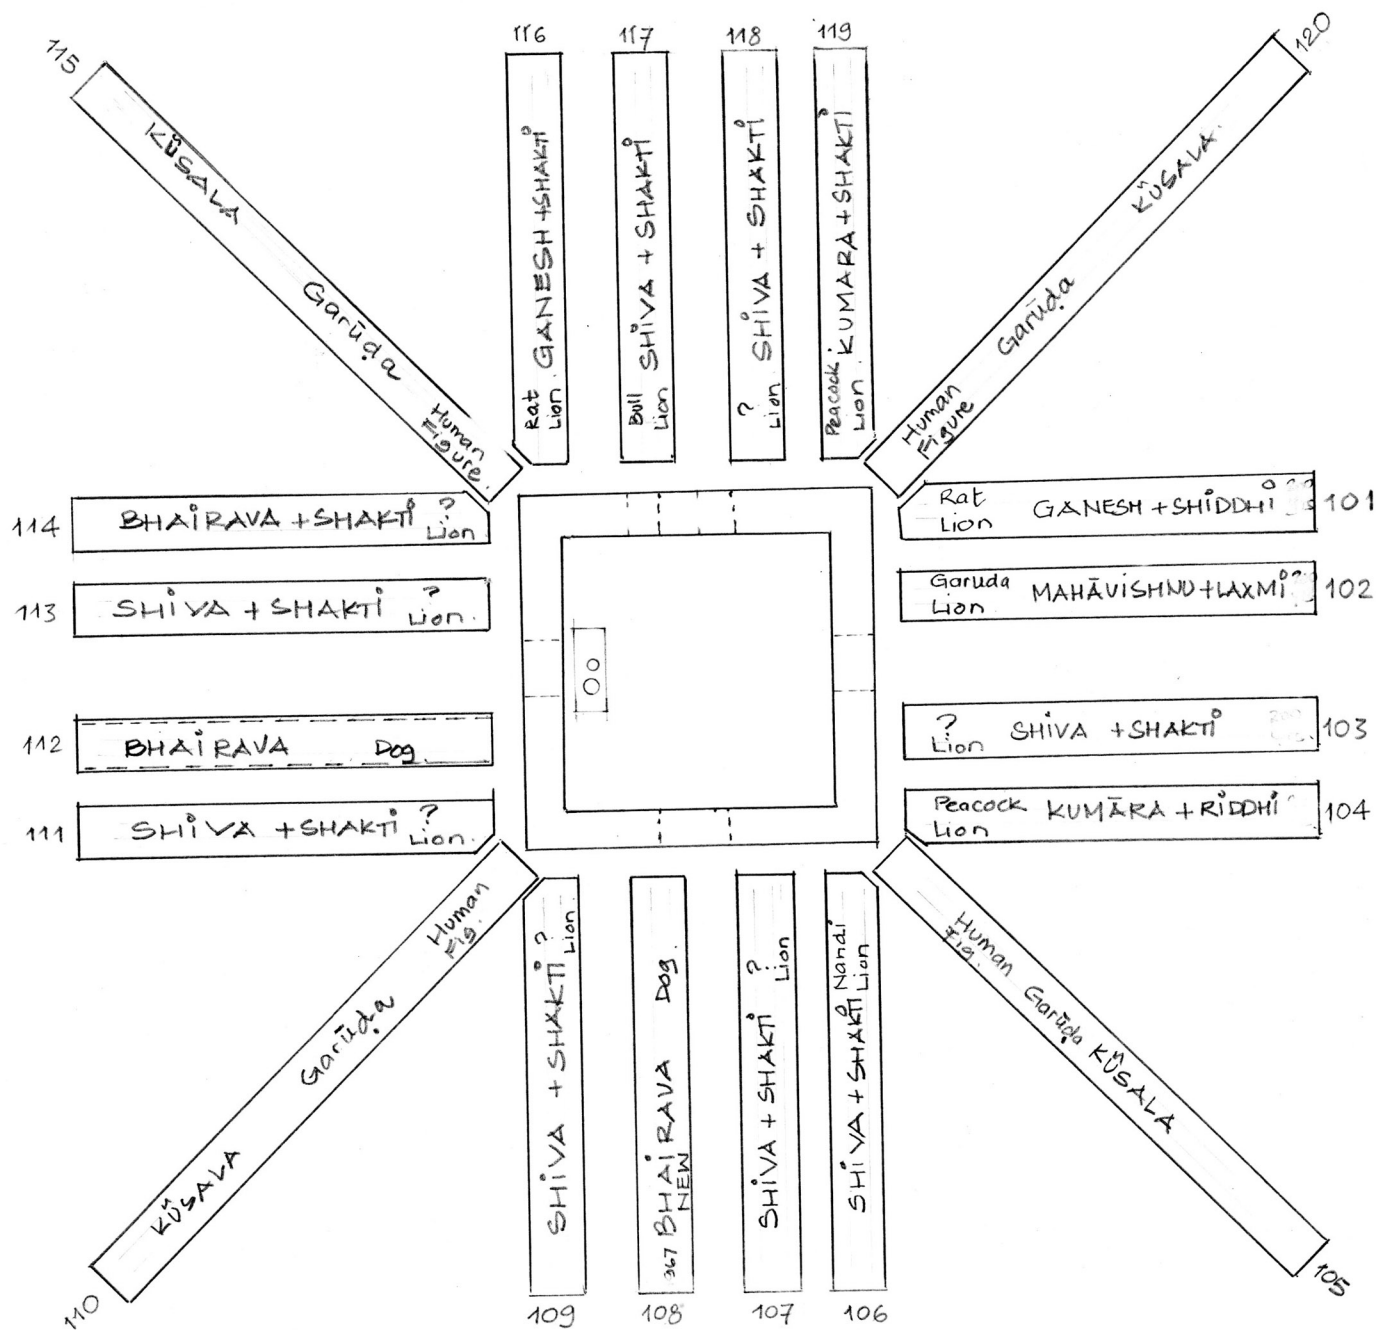
## STRUTS: LOWER ROOF

LAYOUT OF STRUTS INDICATING PRINCIPAL FIGURES AND MOUNTS. STRUT 108 DATES FROM THE 1967 RENOVATION. STRUT 112 HAS BEEN RECOVERED FROM A NEARBY COURTYARD.

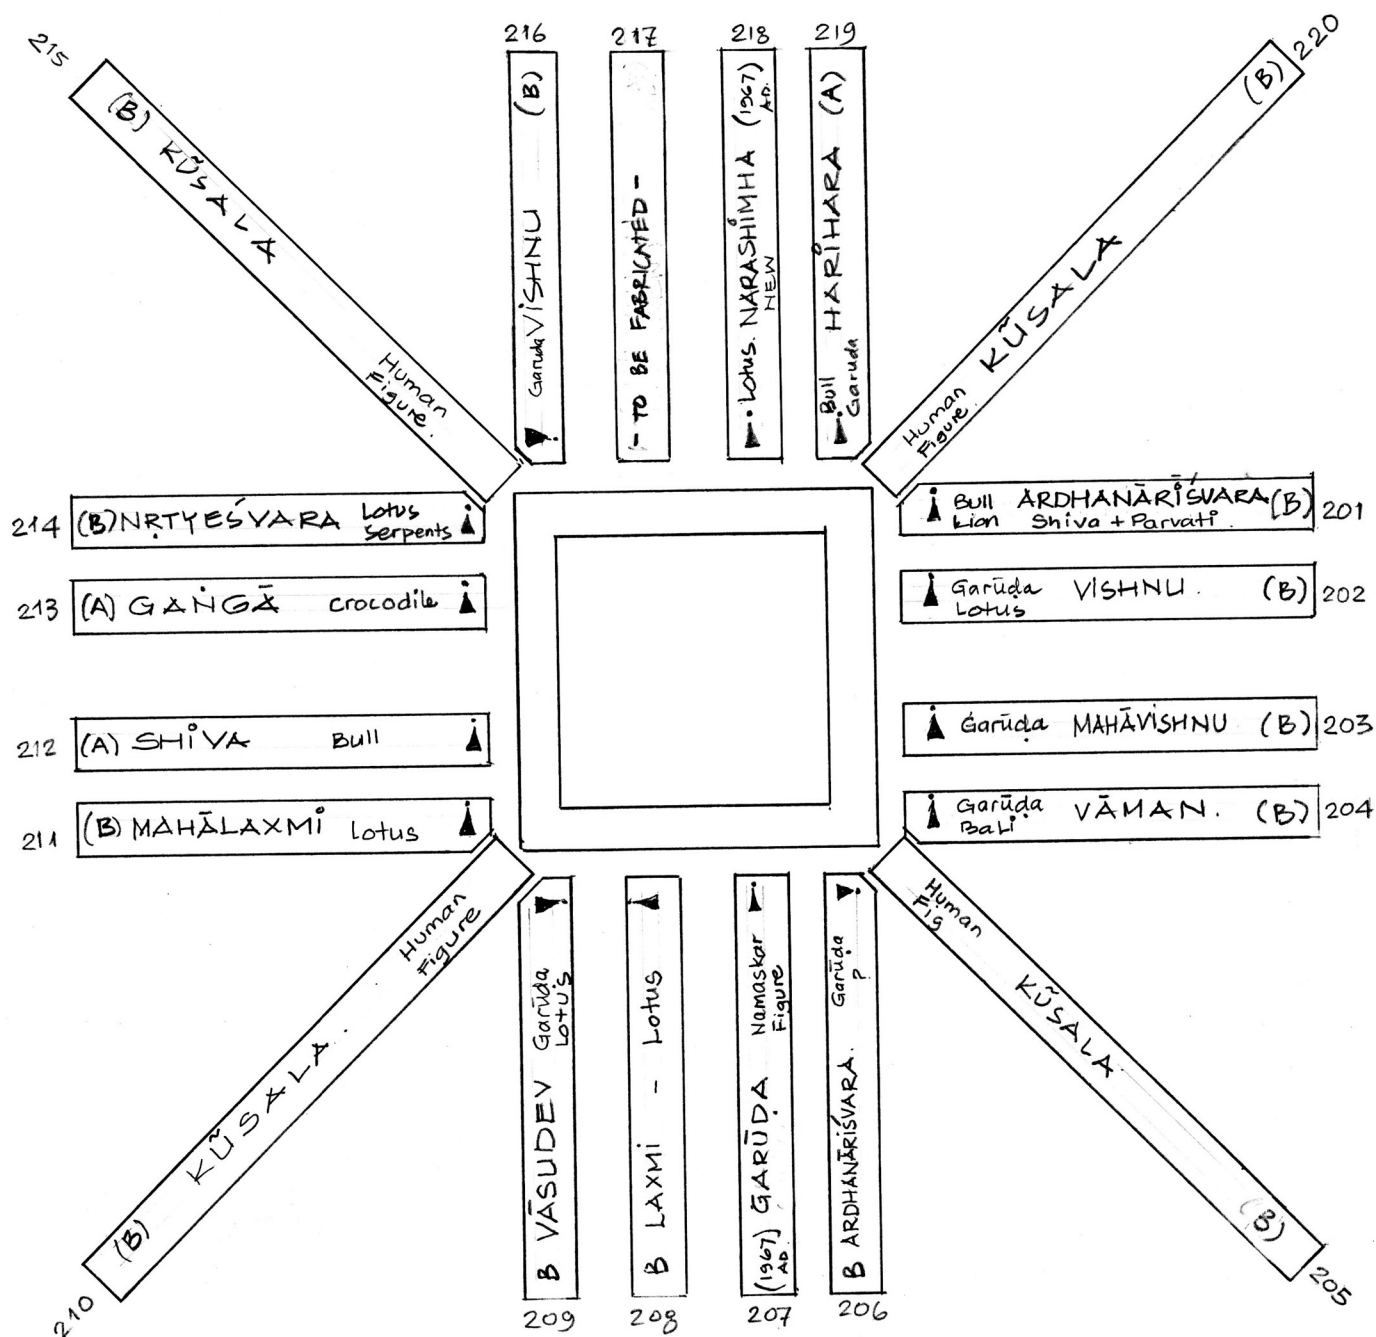
## STRUTS: MIDDLE ROOF

PROPOSED LAYOUT OF STRUTS WITH PRINCIPAL DEITIES AND MOUNTS FOR THE LOST MIDDLE ROOF. DARKENED TRIANGLES INDICATE THE DIRECTION OF THE SUBSIDIARY SCENE SIVALINGA.  
STRUT AGE: A = ORIGINAL 1668; B = 19TH CENTURY. STRUT 207 & 218 DATES FROM 1967 RENOVATION.  
217 IS LOST.

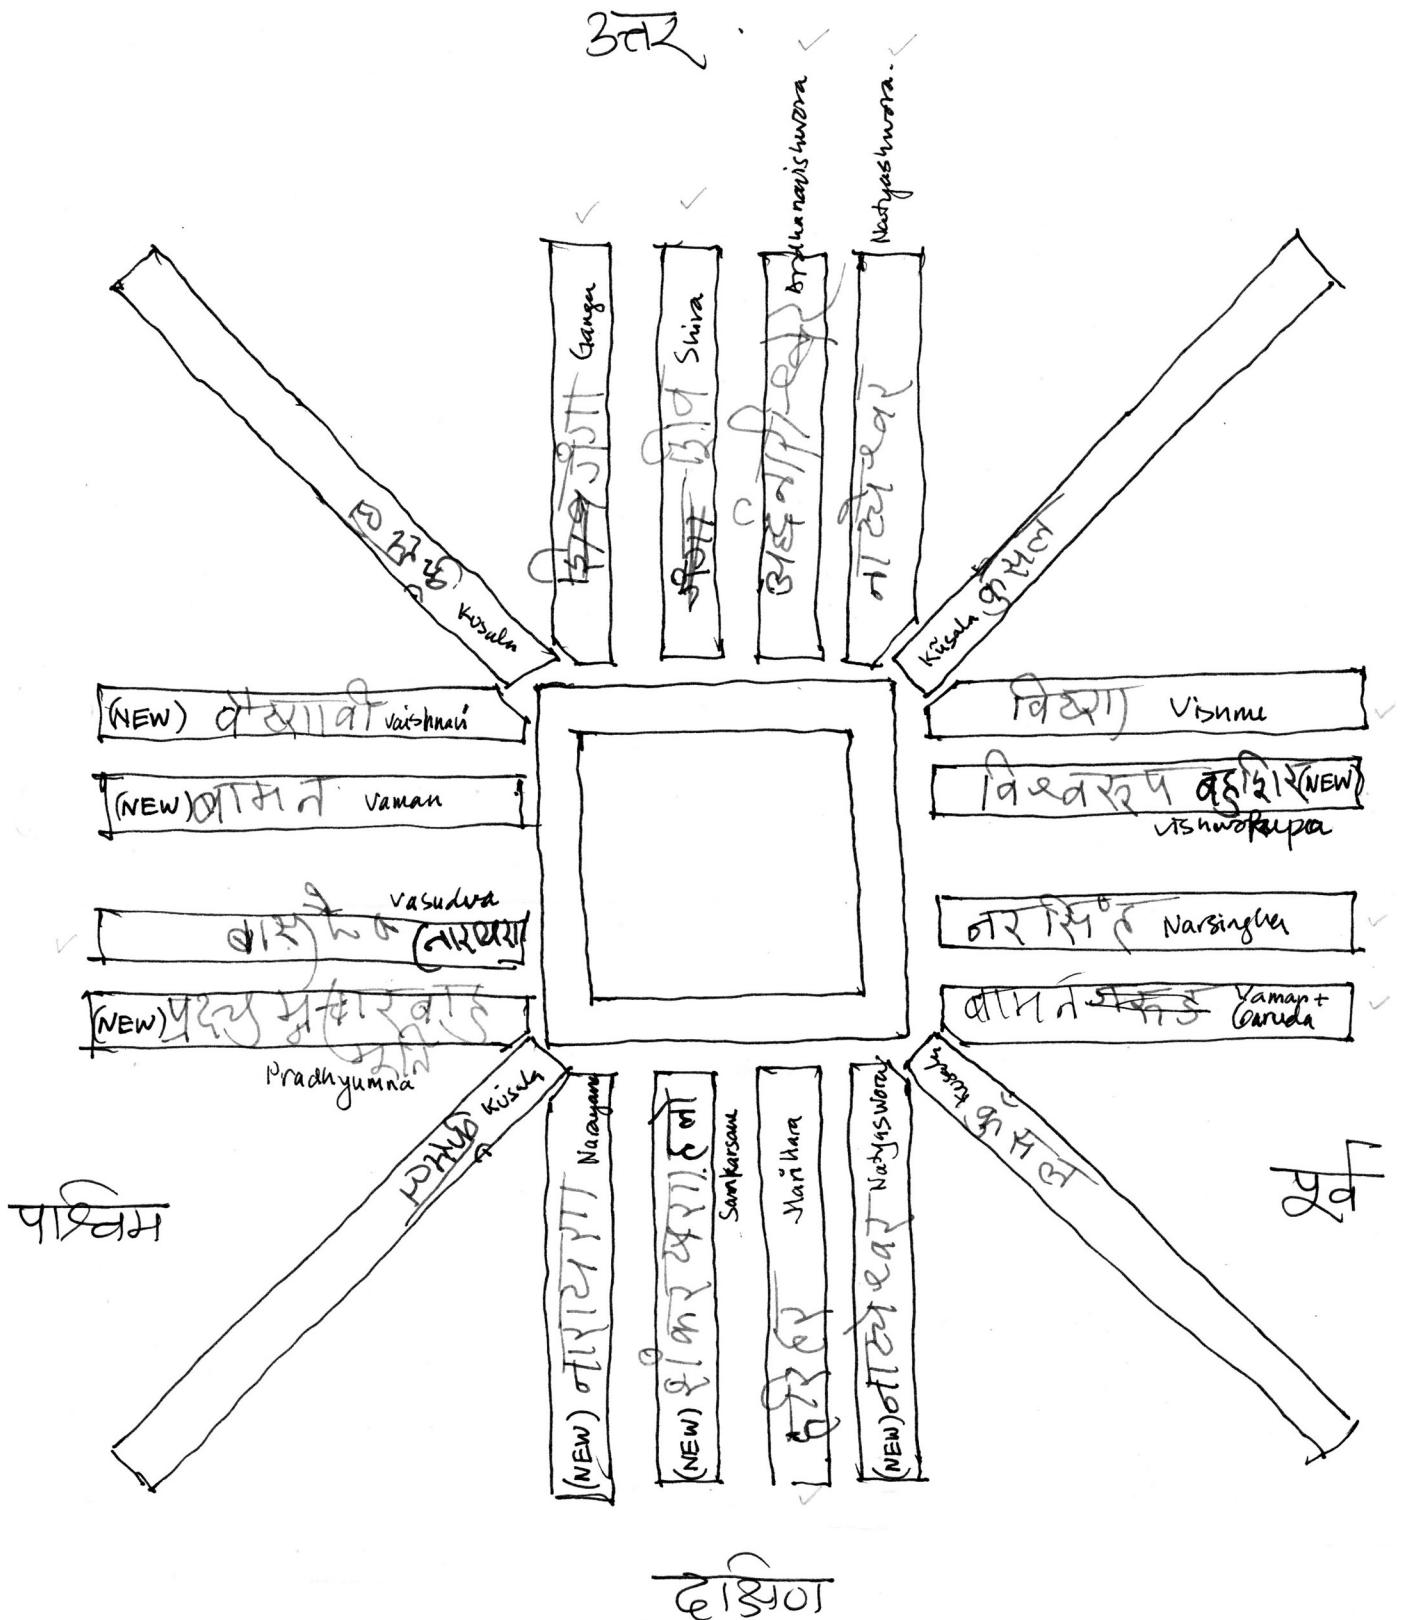
## STRUTS: MIDDLE ROOF

PROPOSED LAYOUT OF STRUTS WITH PRINCIPAL DEITIES BY MADHAN MOHAN MISHRA, HISTORIAN. MISHRA PROPOSED 7 STRUTS AT THIS LEVEL BE NEWLY MADE TO CREATE THIS "IDEAL" LAYOUT OF DIFFERENT INCARNATIONS OF VISHNU.

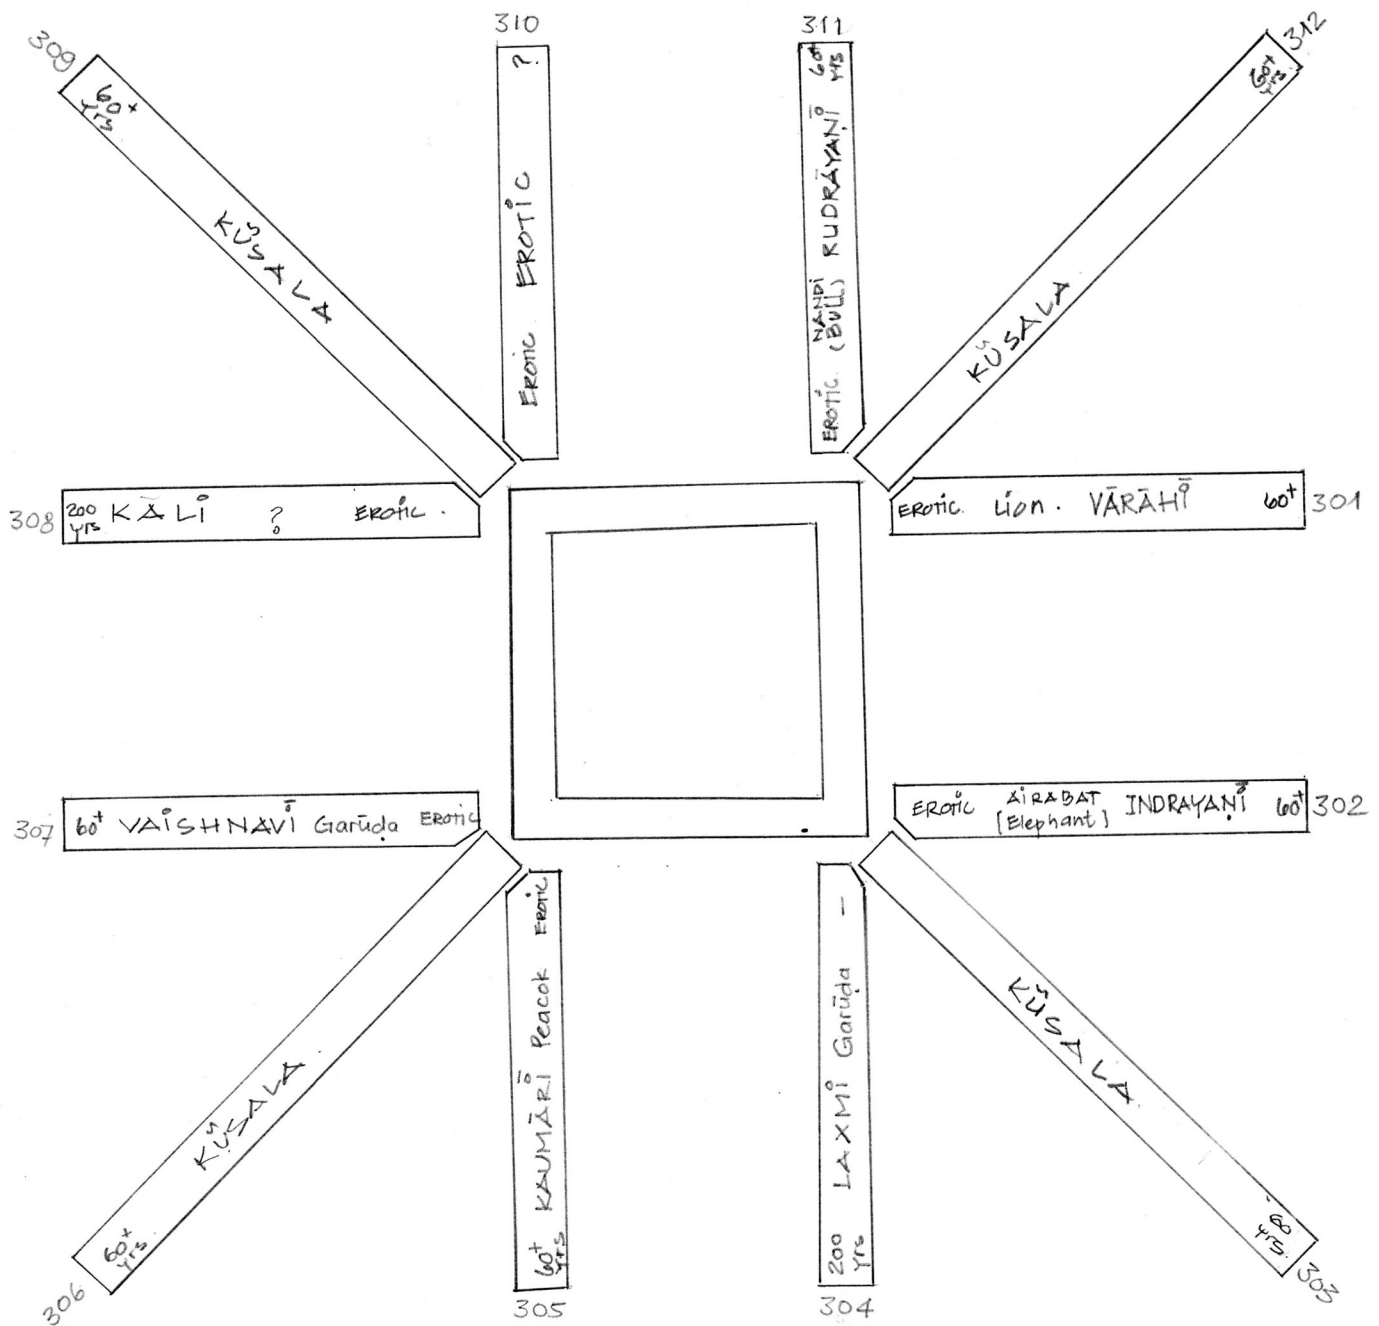
## STRUTS: TOP ROOF

EXISTING LAYOUT OF STRUTS WITH PRINCIPAL DEITIES AND SUBSIDIARY SCENES. ONLY THE FOUR 20TH CENTURY CORNER STRUTS AND #304 AND 308 ARE ORIGINAL TO THE TEMPLE.

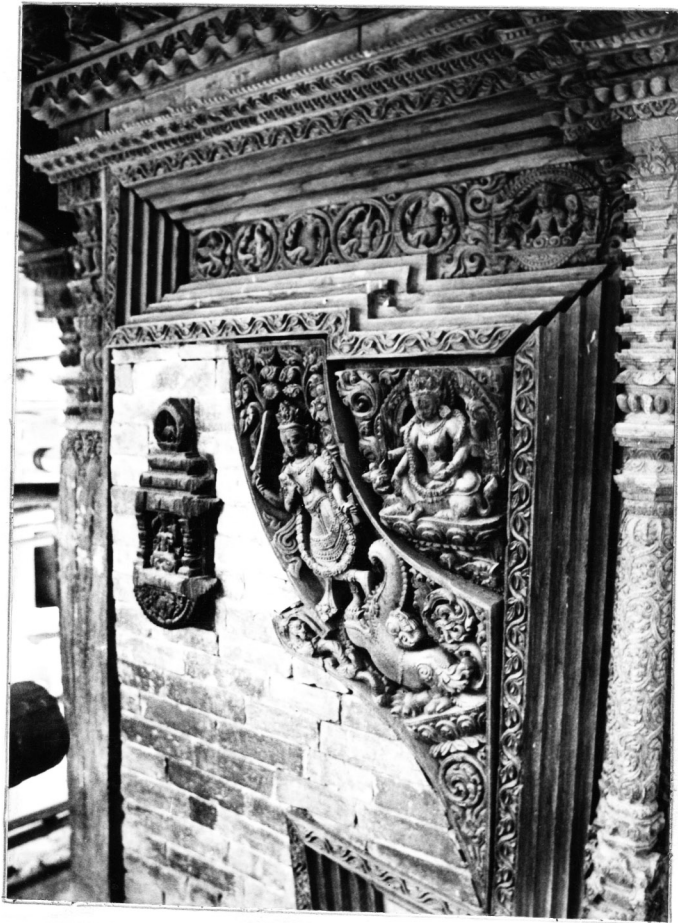
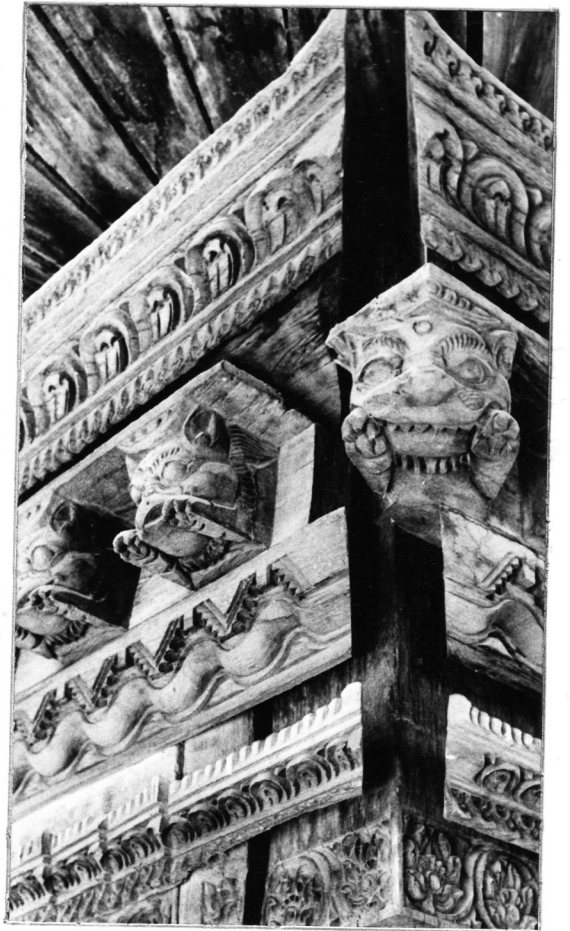
**SPREAD TIMBER JOINTS AT BASE STORY.**  
 LEFT: NORTH ELEVATION, LEFT SIDE. RIGHT:  
 CORNICE AT NORTHWEST CORNER.

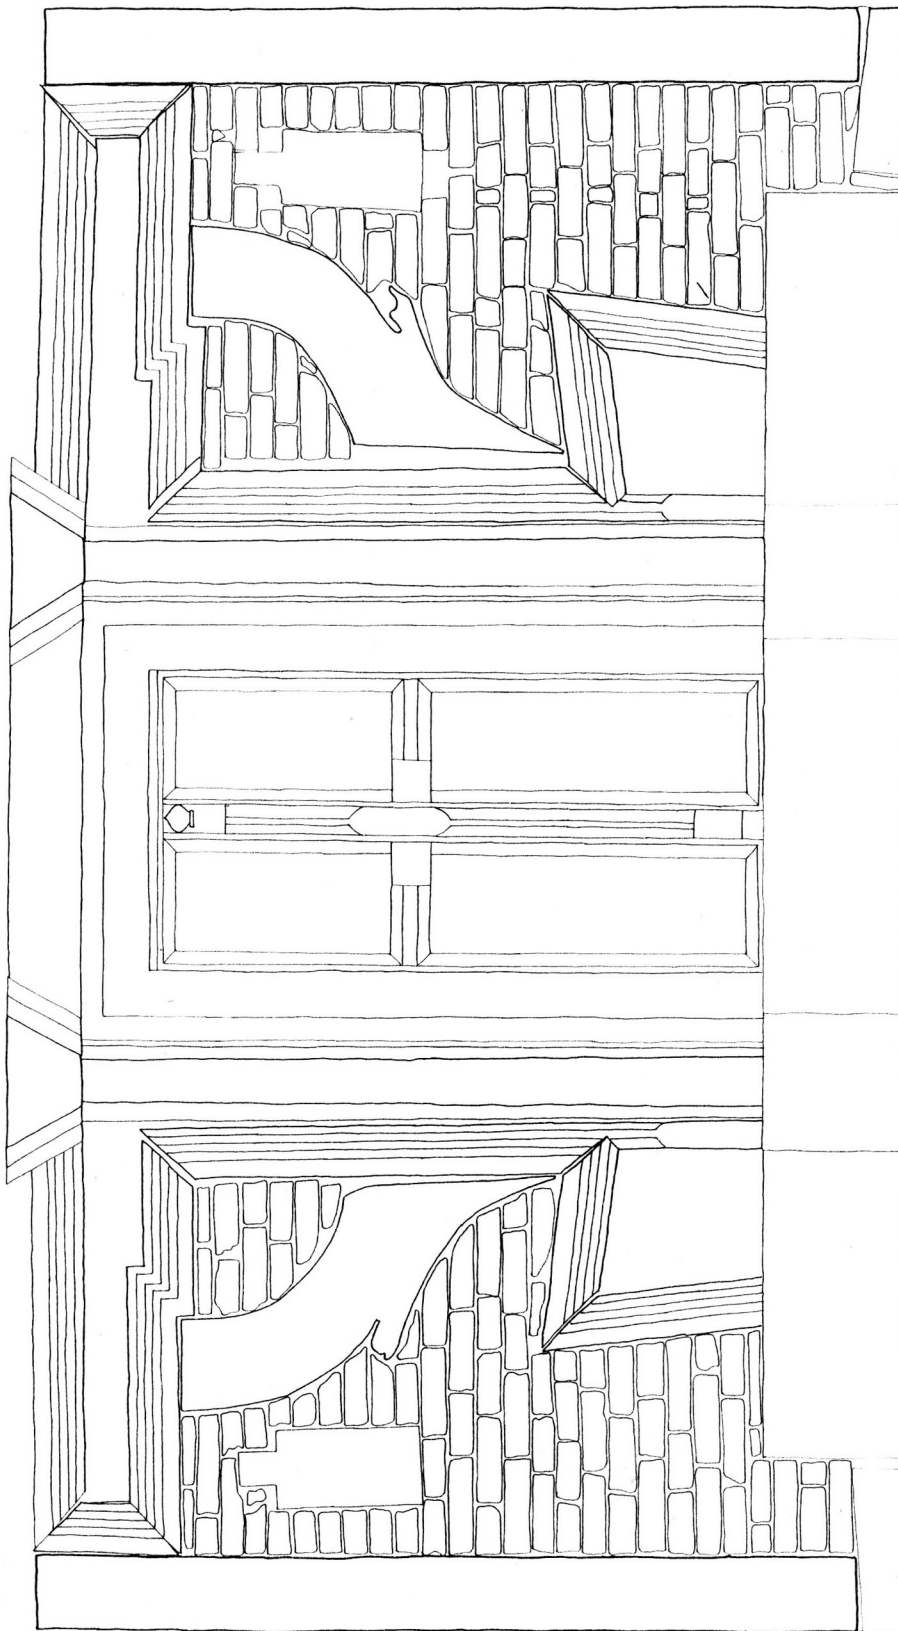
SURKHI (CEMENT) POINTING  
LOST CARVING  
SPREAD TIMBER JOINT (>1")

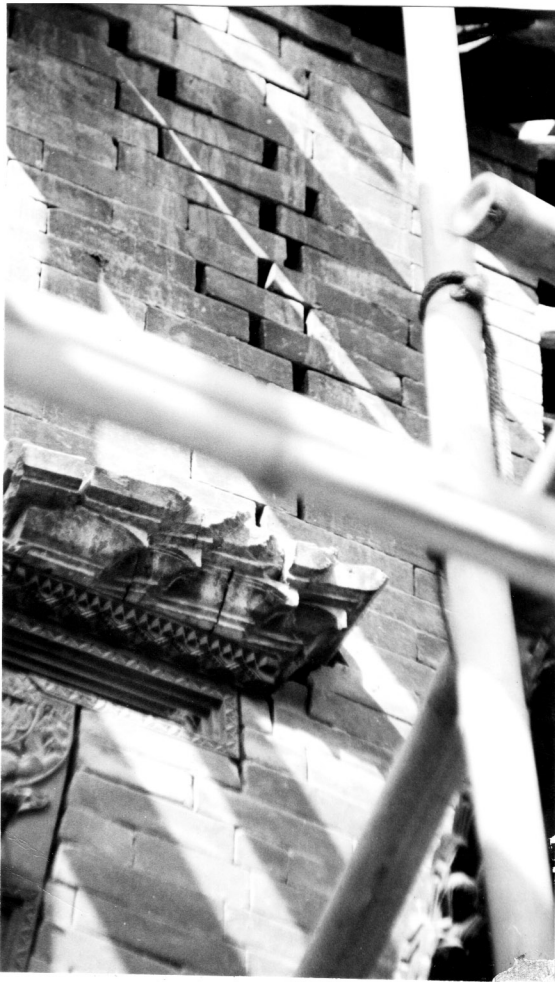
#### WALL CRACKS

LEFT: SOUTH ELEVATION UPPER BASE STORY, RIGHT SIDE. RIGHT: DETAIL OF MIRROR IMAGE CRACK, SOUTH ELEVATION, LEFT SIDE.

the level of the timber cornice above the arcade. The separation is only 1/2" at the lower end. On the western side, the same pattern is found in mirror image, but slightly smaller (3/4" at the top and 1/2" at the bottom). Additionally the top 5 courses of bricks on this elevation bulge outward with a maximum displacement of 3" in the middle. This area is 5'0" long and exactly in the middle of the elevation. This bulging is found primarily in the veneer layer, typical of almost all historical buildings here where few cross bonds are incorporated between the three layers of the walls. In this location, the displacement seems to have resulted from weakened joints in the *daci apā* wall caused by water seepage from the damaged roof above.

Hairline cracks have developed on the inside bearing wall behind these areas, demonstrating both the relative independence of the inner and outer walls and the greater vulnerability of the veneer layer.

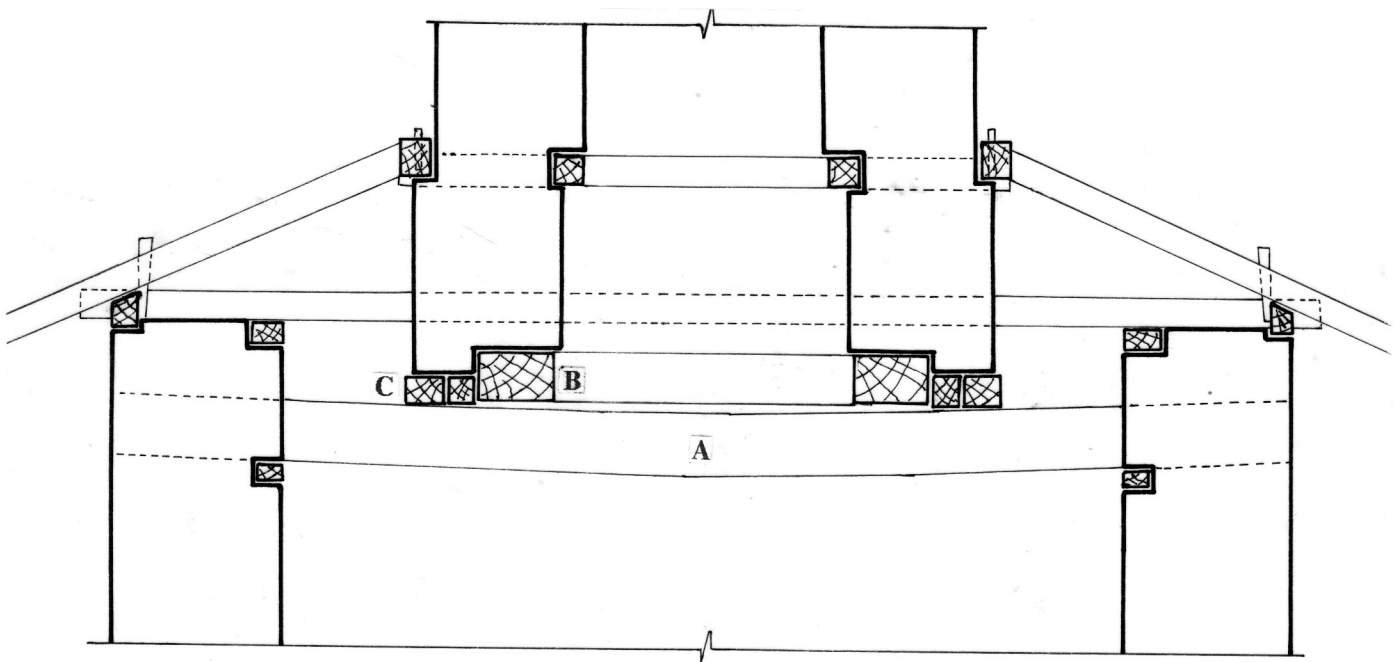
#### SECTION DETAIL: EXISTING

DEFLECTION AT SUPPORT OF UPPER LEVEL

B - 9" X6" PINE SECONDARY BEAMS, GOOD CONDITION

C - 4"X3" SAL TIMBERS SPANNING MAIN BEAMS, GOOD CONDITION

The most serious structural problem of the temple is found where the great load of the uppermost temple level is carried by two layers of timber beams. This construction consists of two main beams of sal timber below (dimensions: 13"x 7") and two perpendicular secondary pine beams above (dimensions: 9"x 6"). The upper pine beams do not rest on the lower sal beams and thus distribute upper loads to all four walls. This construction may date from the 19th century (as discussed in section 3.0).

The lower sal members show signs of wet rot on their upper surfaces in exposed areas, in this case the 18" length between inner and outer walls. A pen knife penetrates

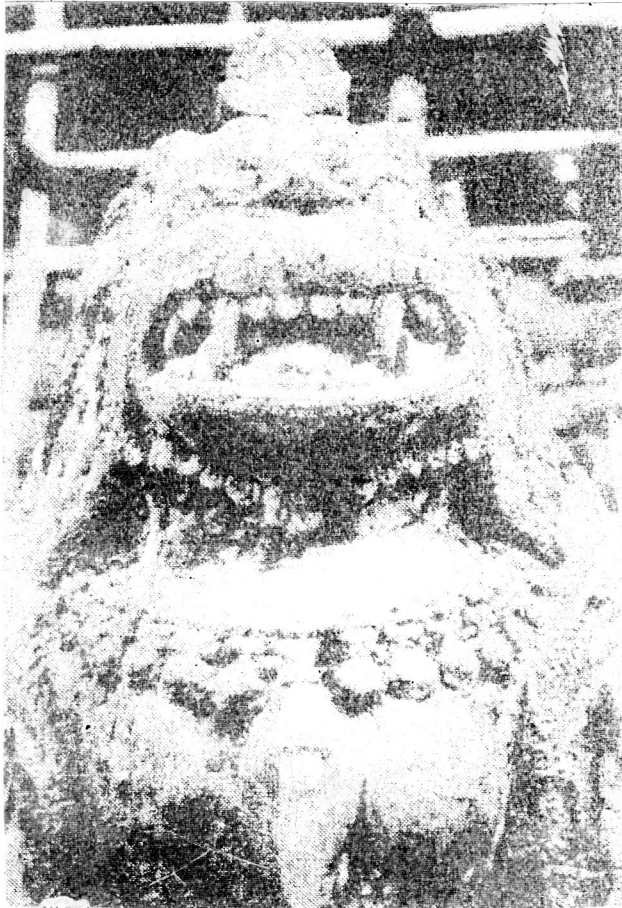
The limestone figures which flank the entry stair clearly demonstrate the importance of protective covering in the monsoon climate. The lower lions, not covered by the bottom roof, are scoured by 1/8-1/4 inch grooves created by and showing signs of ongoing lichen growth in rain-driven patterns. The upper guardian figures, under roof cover, are perfectly smooth and show no signs of lichen growth.

**GUARDIAN LION (LEFT):**  
**LICHEN GROWTH, FEBRUARY, 1992.**
