**RADHA KRISHNA TEMPLE**  
**SWATHA TOL, PATAN**

**HISTORIC STRUCTURES REPORT**  
**MARCH, 1992**

**ERICH G. THEOPHILE**  
**ROHIT K. RANJITKAR**  
**KATHMANDU VALLEY PRESERVATION TRUST**  
**IN COLLABORATION WITH**  
**HIS MAJESTY'S GOVERNMENT**  
**DEPARTMENT OF ARCHAEOLOGY**

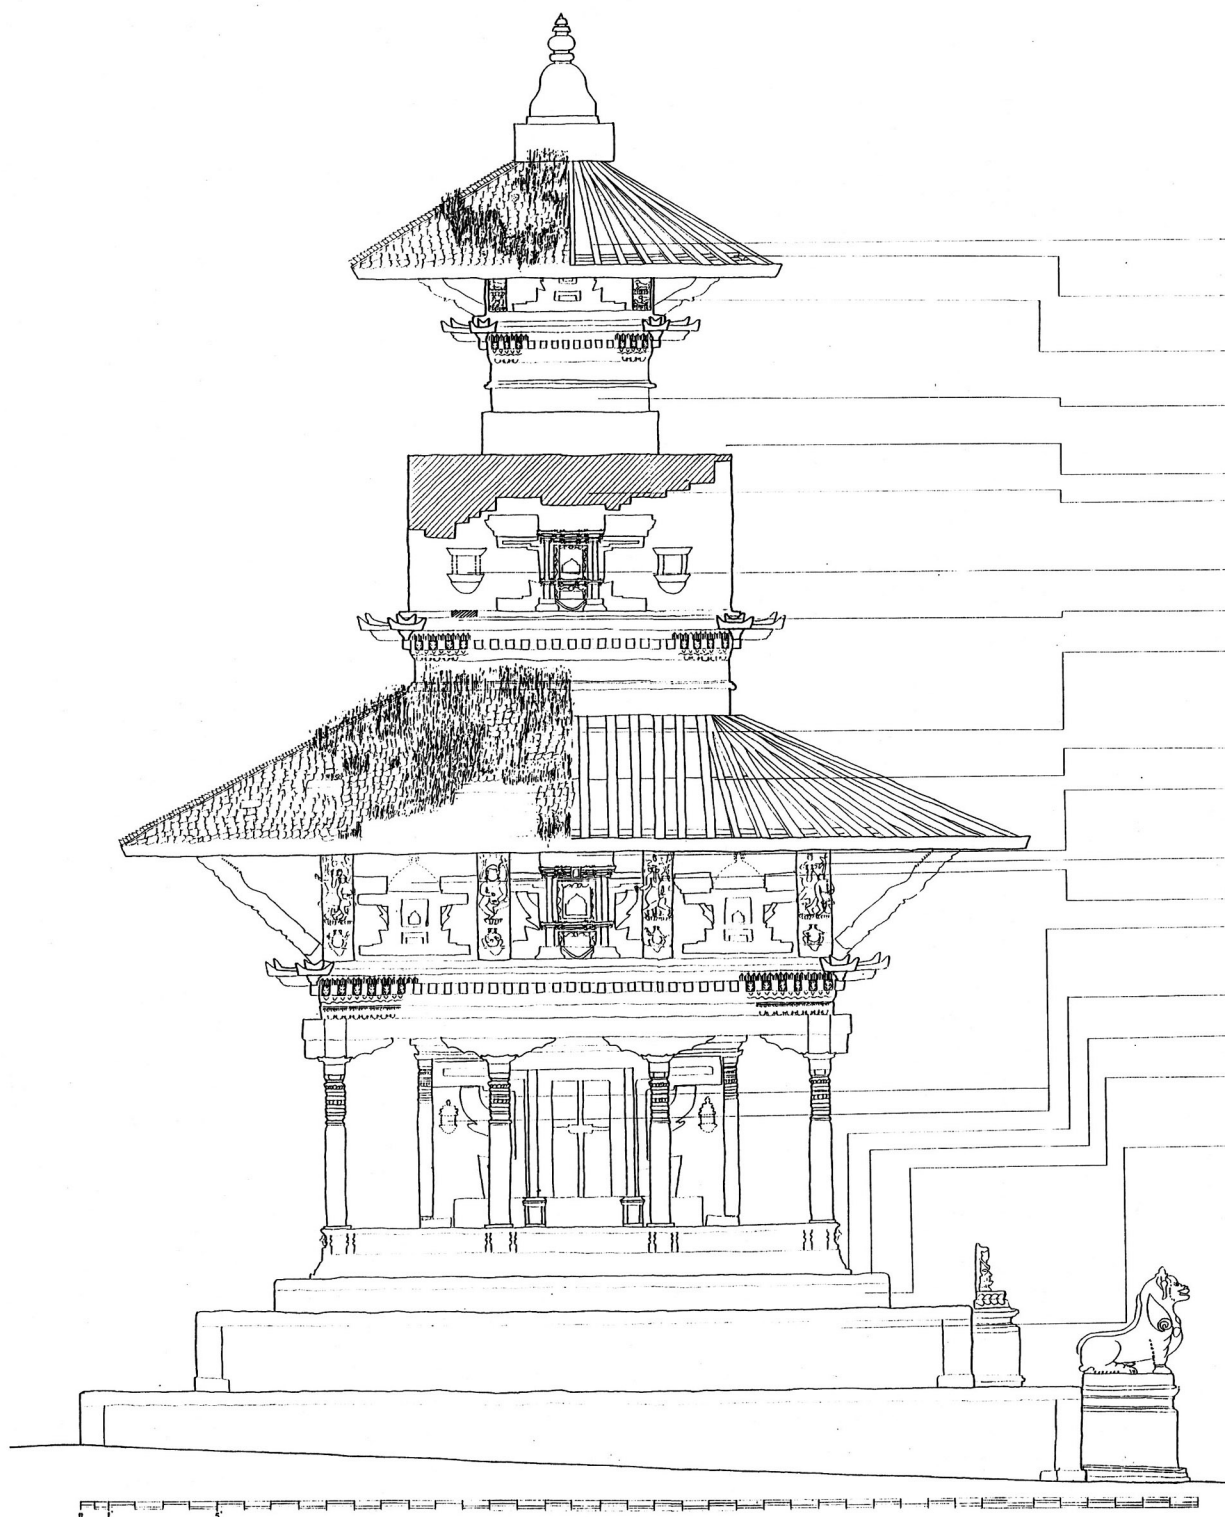
PRINCIPAL ELEVATION: EXISTING CONDITIONS  
KATHMANDU VALLEY PRESERVATION TRUST, MARCH 1992

- Upper rafters: all 1967 sal with damage at *chukul* locations.
- Wall plates severely rotted. Sal purlins in good condition. Eavesboard rotted.
- One of two original upper roof struts (center right): excellent condition.

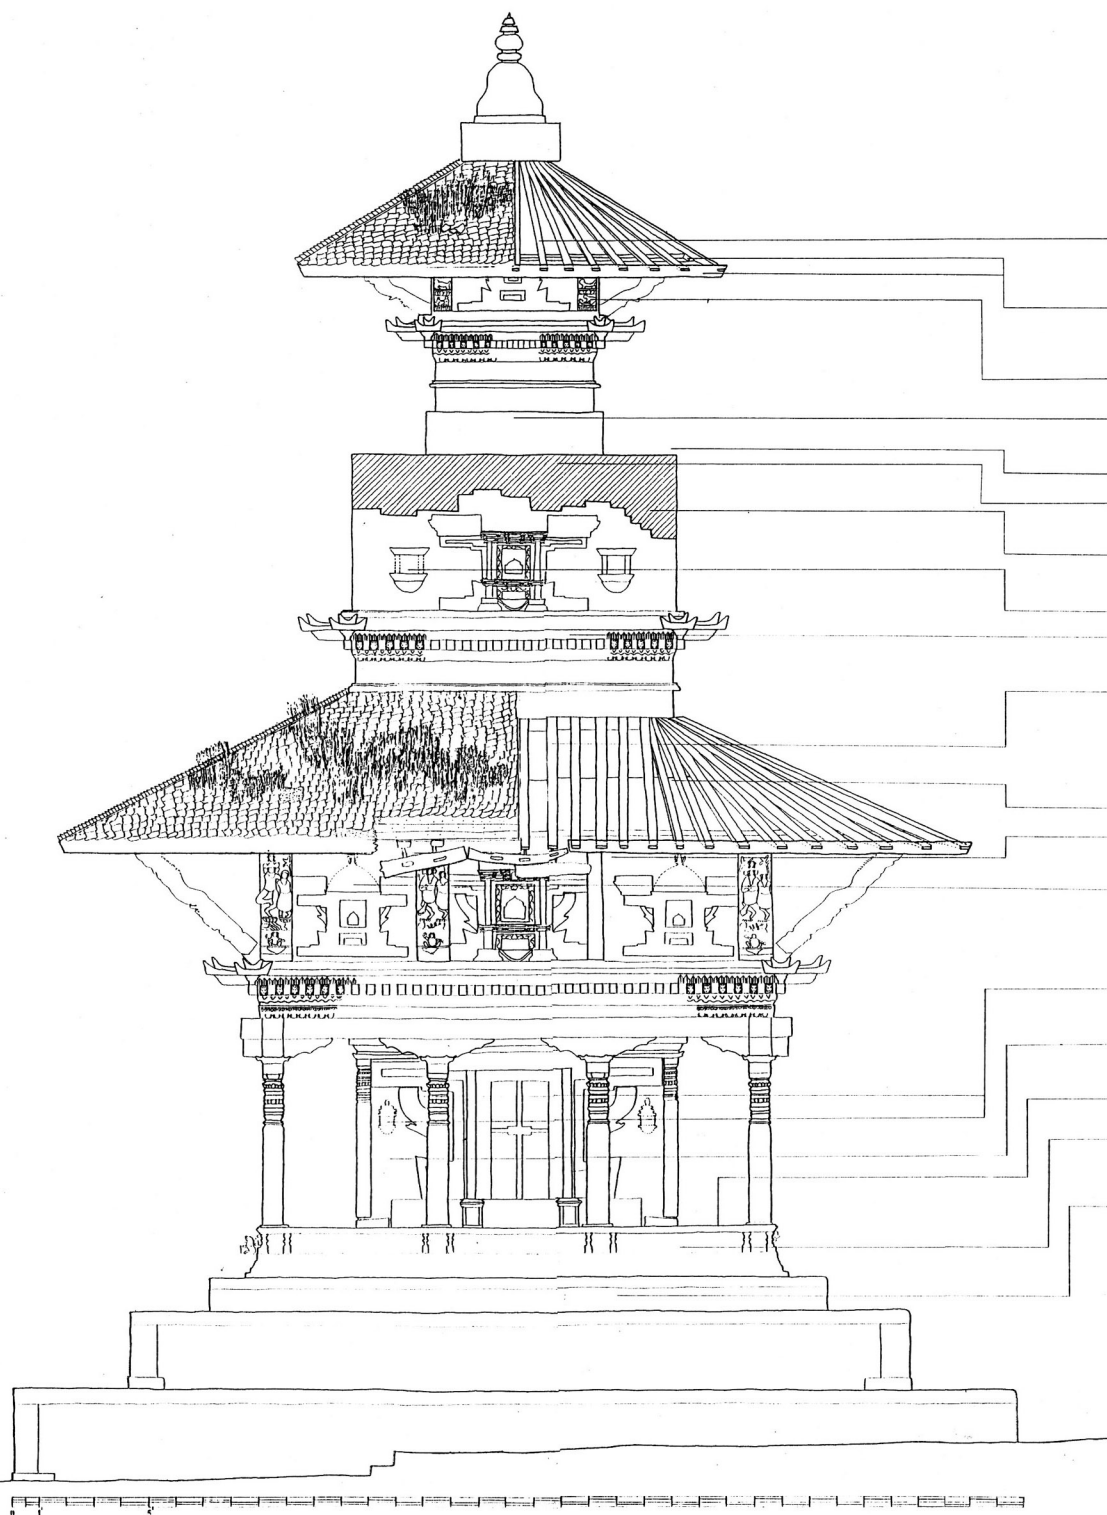
**SOUTH ELEVATION: EXISTING CONDITIONS**  
KATHMANDU VALLEY PRESERVATION TRUST, MARCH 1992

Rafters: 1967 sal members reusable with repairs at *chukul* locations. All older pine rafters rotted.

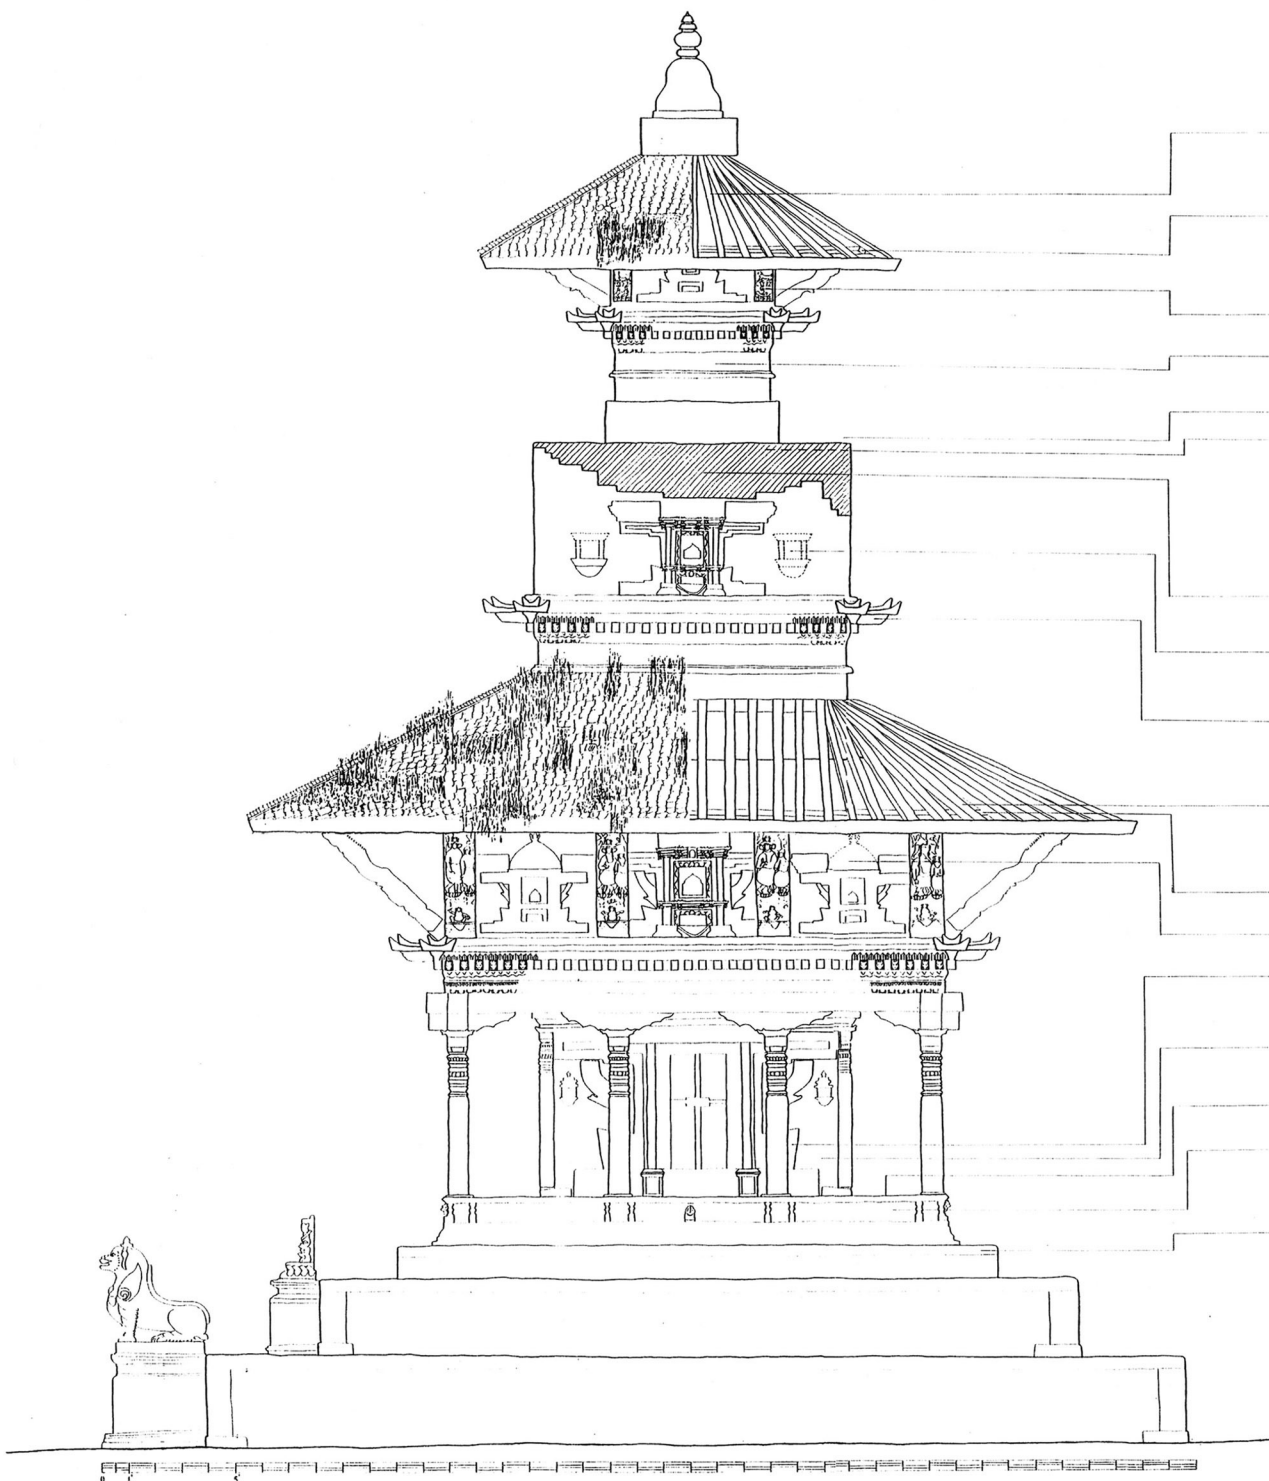
**WEST ELEVATION: EXISTING CONDITIONS**  
KATHMANDU VALLEY PRESERVATION TRUST, MARCH 1992

Rafters: 1967 sal members reusable with repairs at *chukul* locations. All older pine rafters rotted.

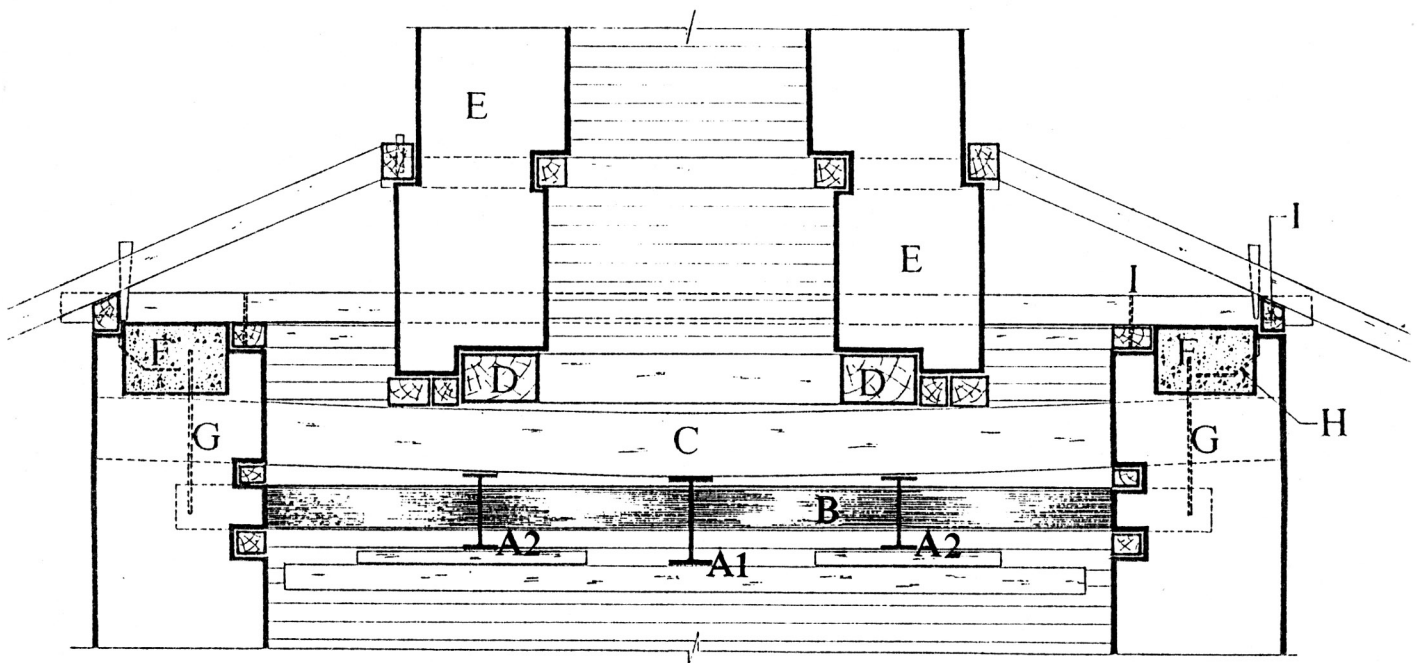
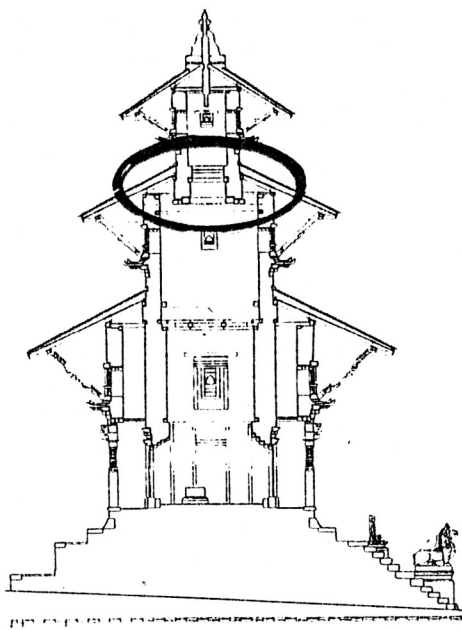
The damaged and undersized timber supports of the uppermost level are to be reinforced by the insertion of new steel I sections. Reinforcement of the existing timber beams only by steel plates bolted to the existing timbers was preferable for conservation reasons, but considered unfeasible by Engineer Rajbhandari given the great shear stress of the timber beams, which would not allow drilling.

The new steel sections are to be inserted flush to the lower surface of the timber beams-- they will thus only carry loads upon further deflection. The new steel structure is sized to carry the entire upper load. Jacking up of the timber structure was considered not only unnecessary, but also dangerous to the upper wall structure. This new grid structure consists of 3 principal sections (2 @ 8"; 1 @ 10") in the north-south direction. Six inch sections in the east-west direction will then be pieced in and welded to create this grid. New timber plates of full wall length will be inserted to transfer these loads to the wall structure.

At all twelve locations where the new steel sections are inserted in to the wall, concealed vertical connections in reinforced concrete will be made to the ring beam above. Proposed is bolting of the steel beam ends to allow connection of 16 mm. rebar in approximately 12"x12" lean cement mortar.

- A New steel beams to carry top level walls/roof
- B New steel cross beams
- C Existing principal timber beams
- D Existing secondary timberbeams
- E Uppermost temple level walls
- F Reinforced concrete ring beam
- G Steel rods connecting new steel frame and new ring beam
- H Steel plates connecting timber wall plates to new ring beam
- I Concealed bolting at timber joints

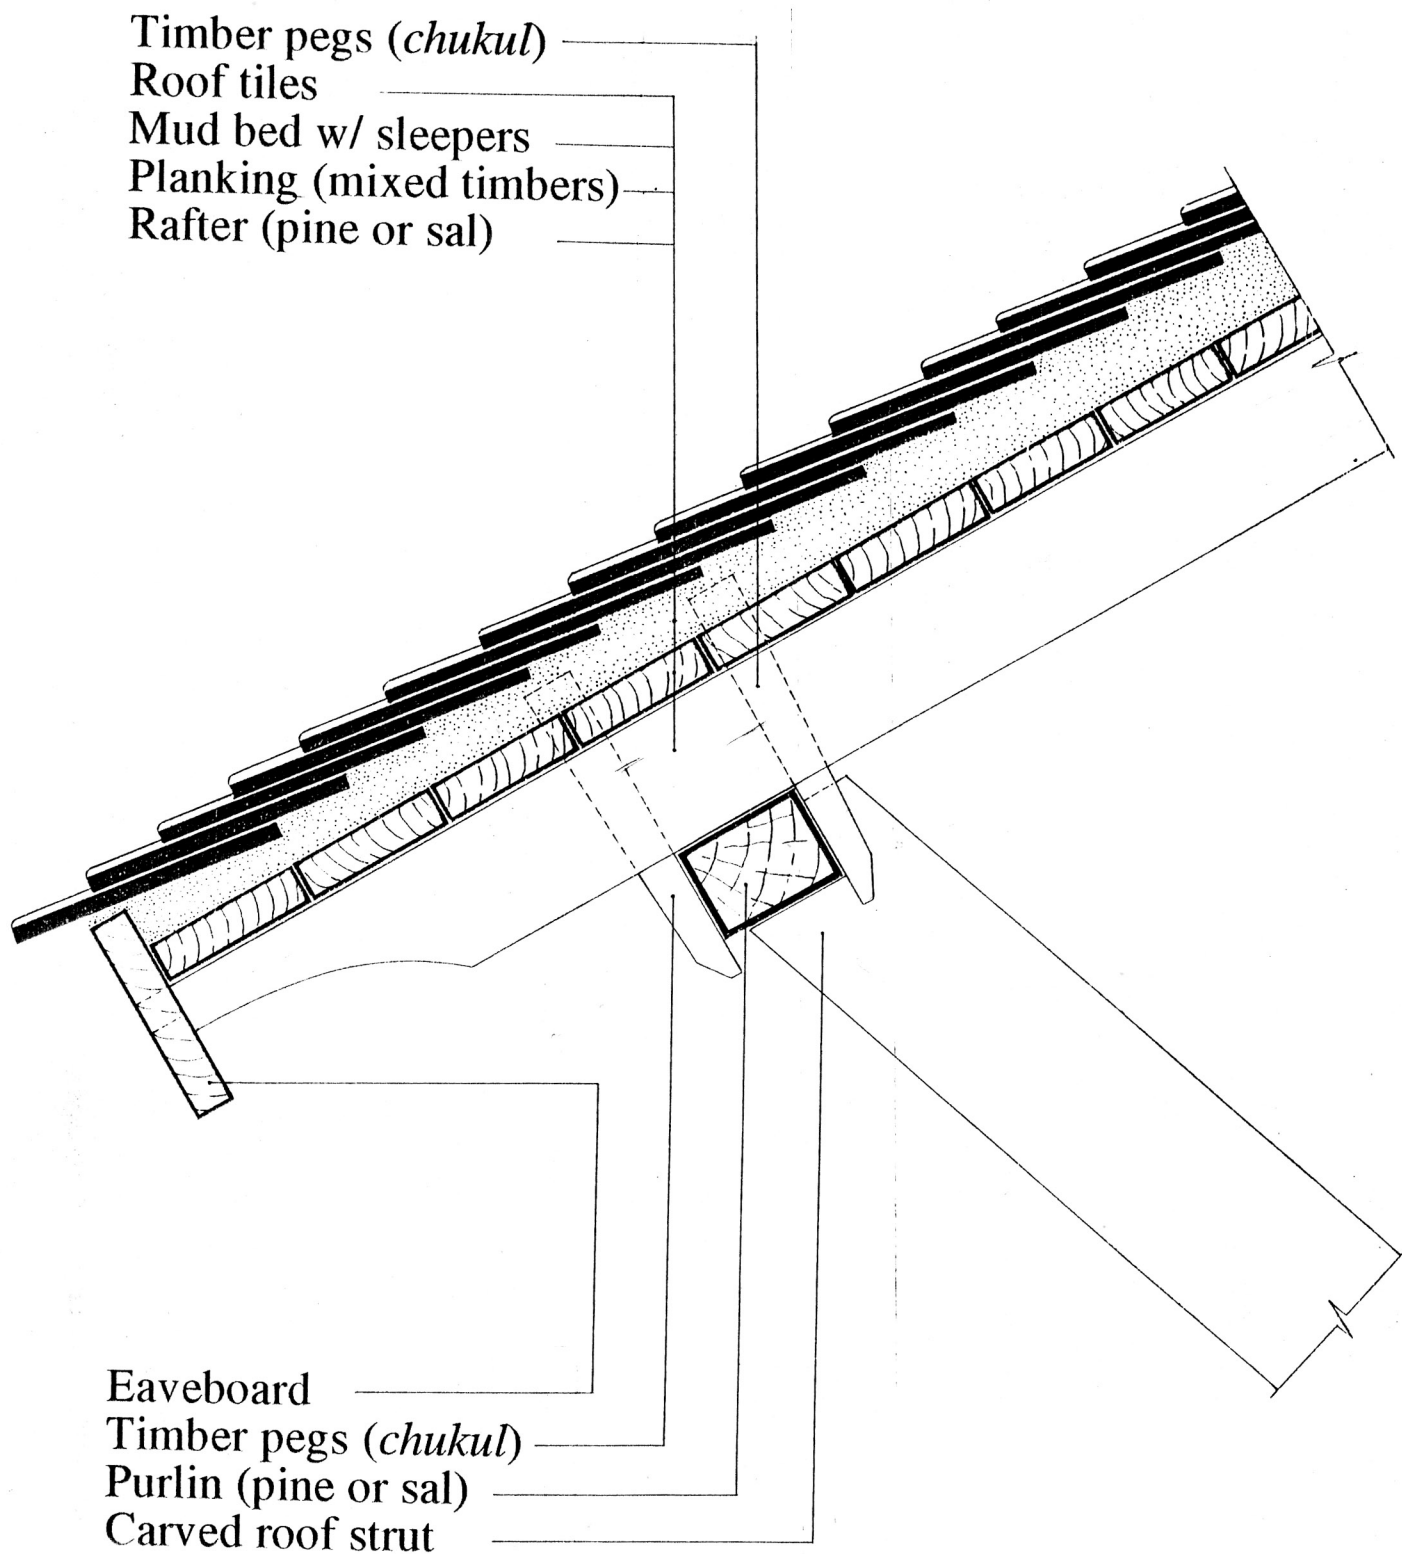
## THE "KEY" PROBLEM

*Section at roof overhang:  
as traditionally detailed*

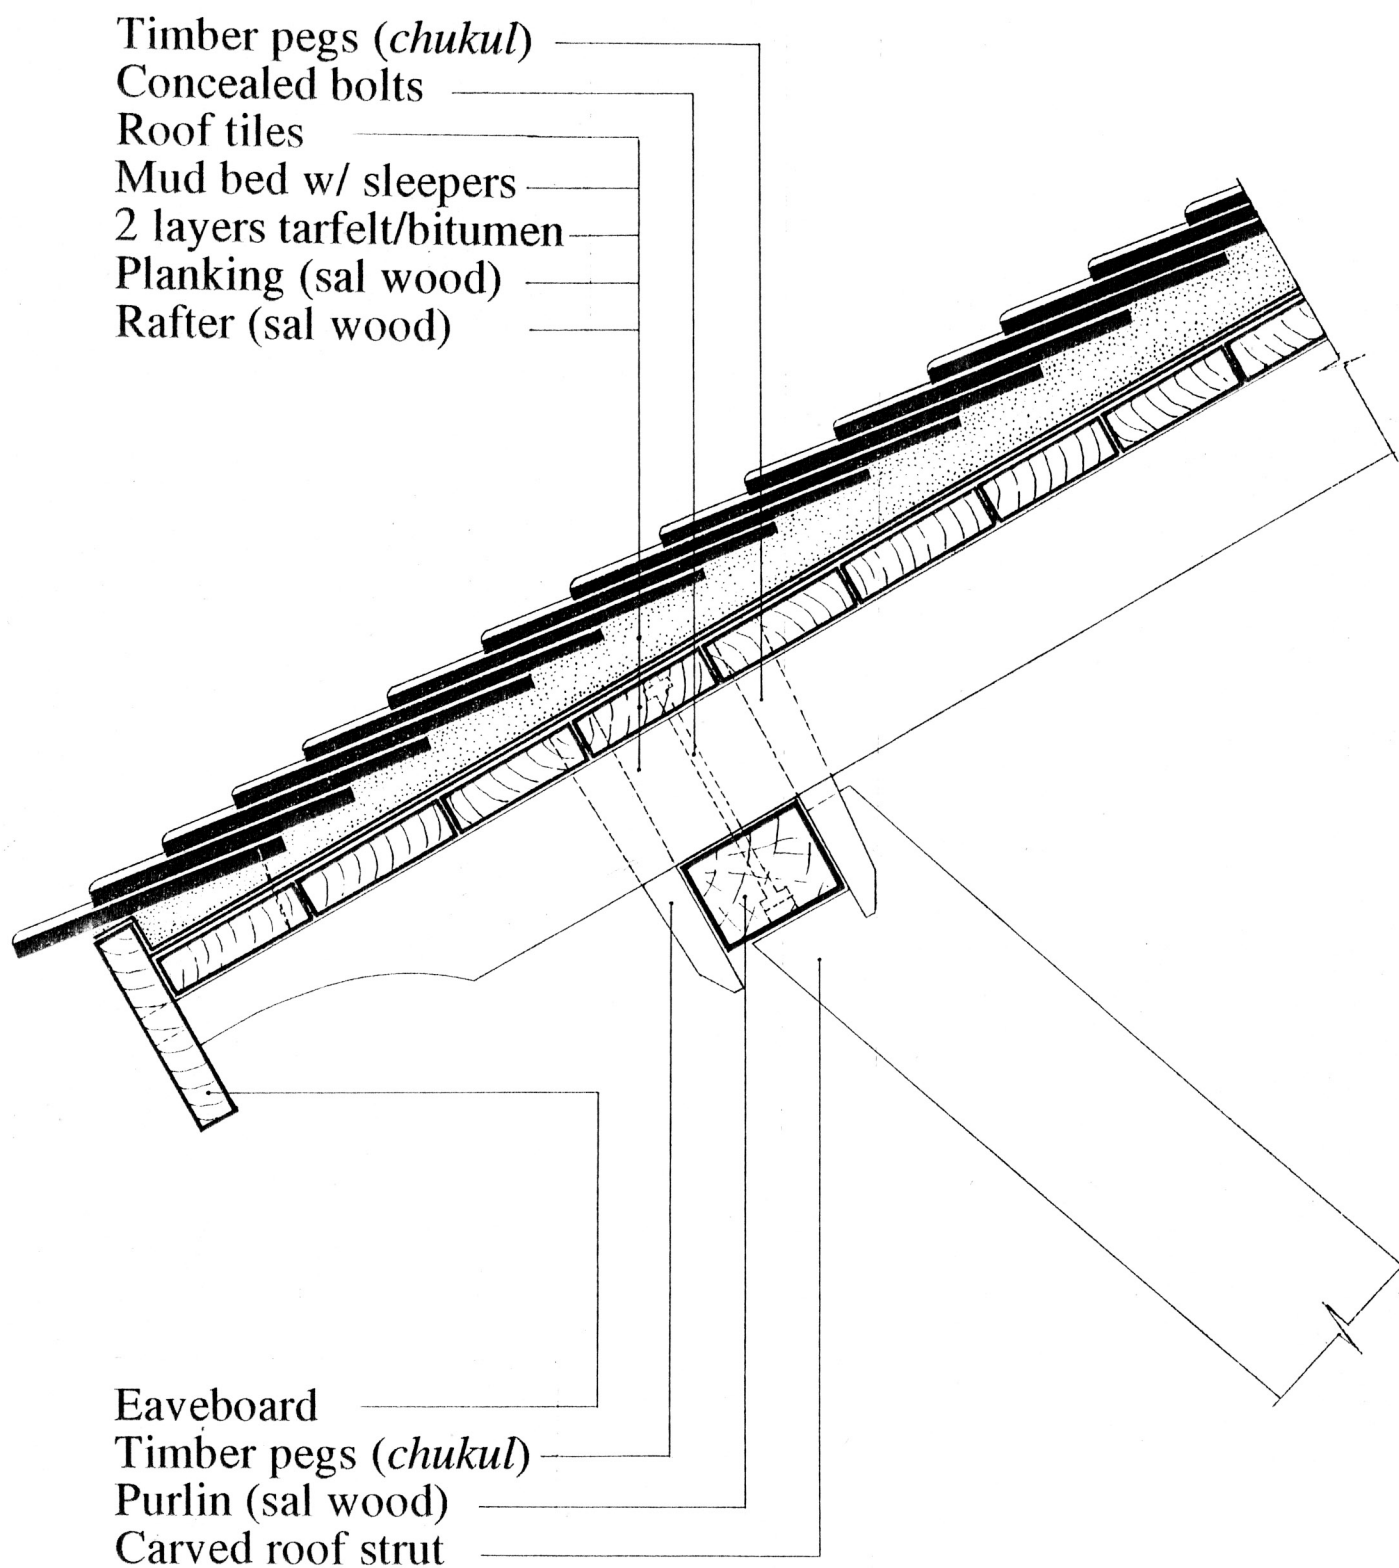
## THE "KEY" PROBLEM

*Section at roof overhang:  
Improved detailed*

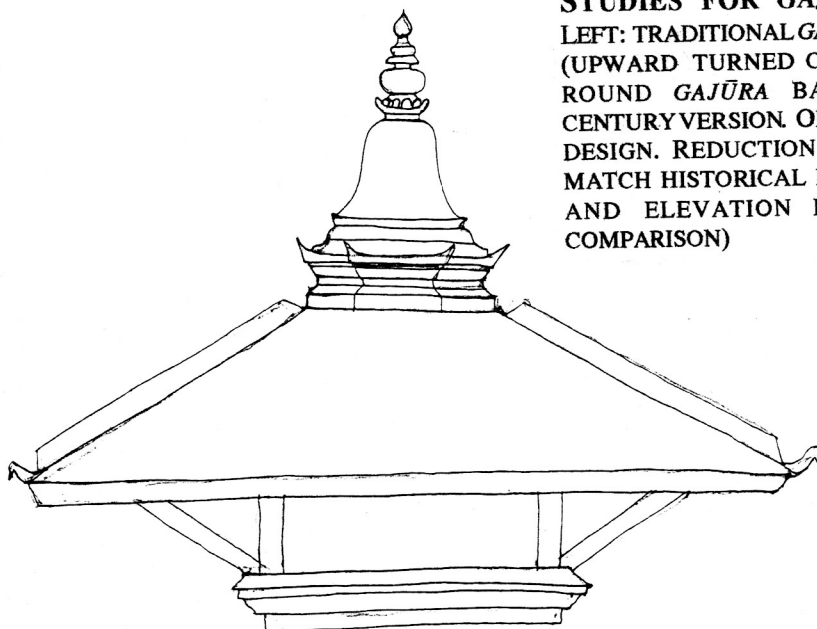
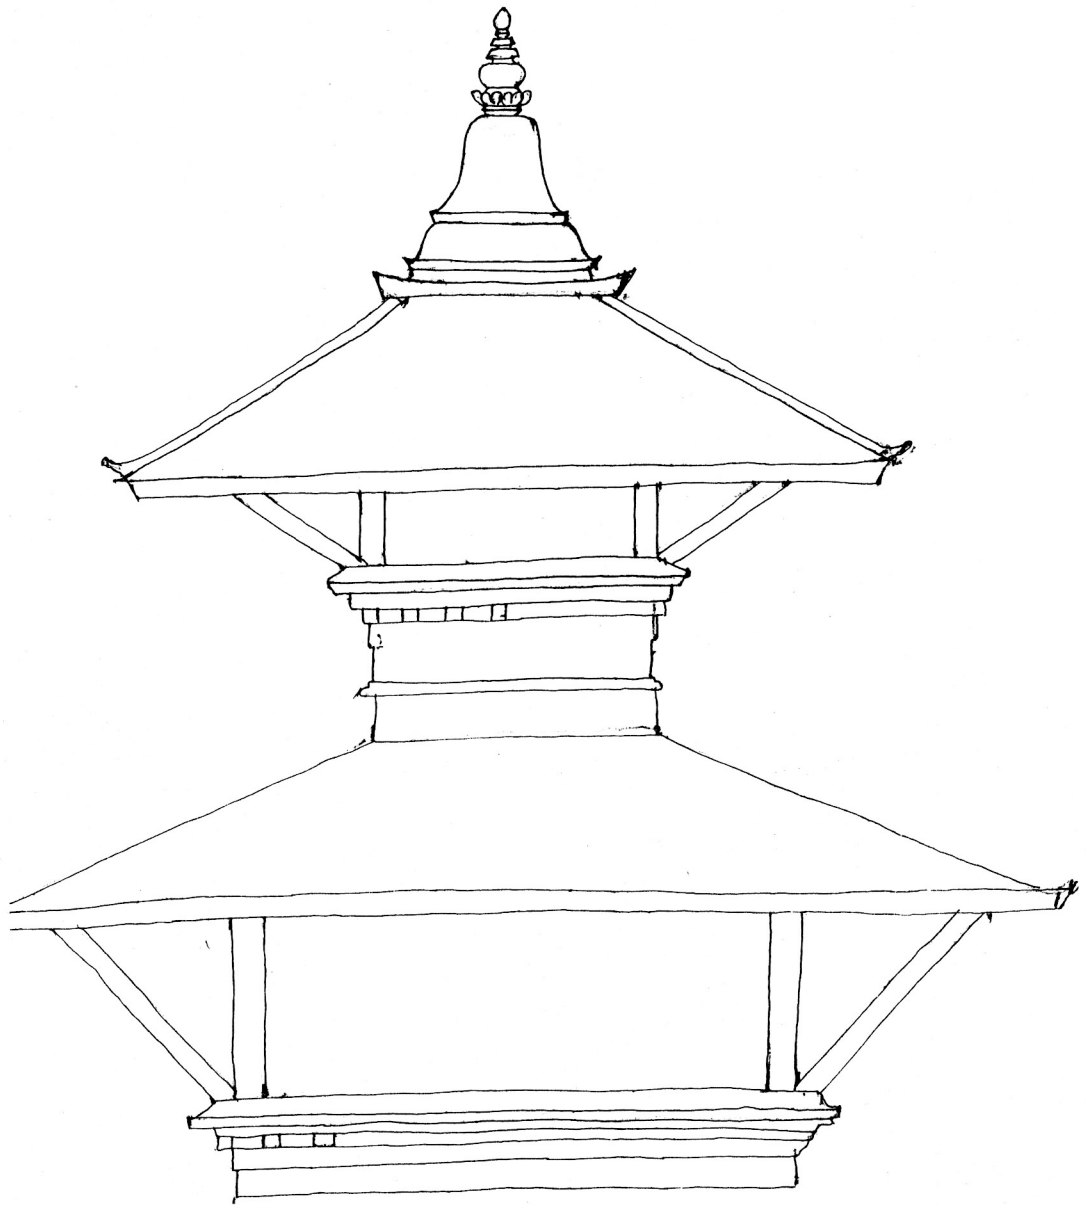
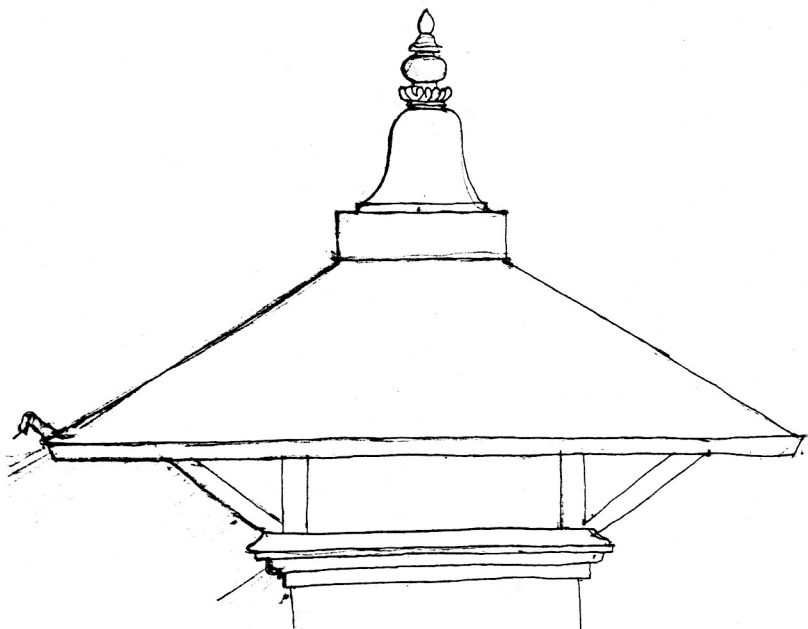
### STUDIES FOR GAJURA IMPROVEMENT

As the material (brick or repoussee?) and details of the pre-1934 earthquake *gajūra* are not determinable, it is proposed that the existing plain copper sheathed box (installed in 1967) simply be cut down some 9" to approximate the proportions of the historical feature, visible in LeBon's photograph. The taller proportions and plain silhouette of this metal box detract from the temple's silhouette.

LEFT: TRADITIONAL GAJURA BASE WITH KULA MOTIF (UPWARD TURNED CORNERS). OPPOSITE ABOVE: ROUND GAJURA BASE, A TRADITIONAL 19TH CENTURY VERSION. OPPOSITE BELOW: COMPROMISE DESIGN. REDUCTION OF EXISTING PLAIN BOX TO MATCH HISTORICAL PROPORTIONS. (SEE PAGES 8 AND ELEVATION FOLLOWING PAGE 10 FOR COMPARISON)

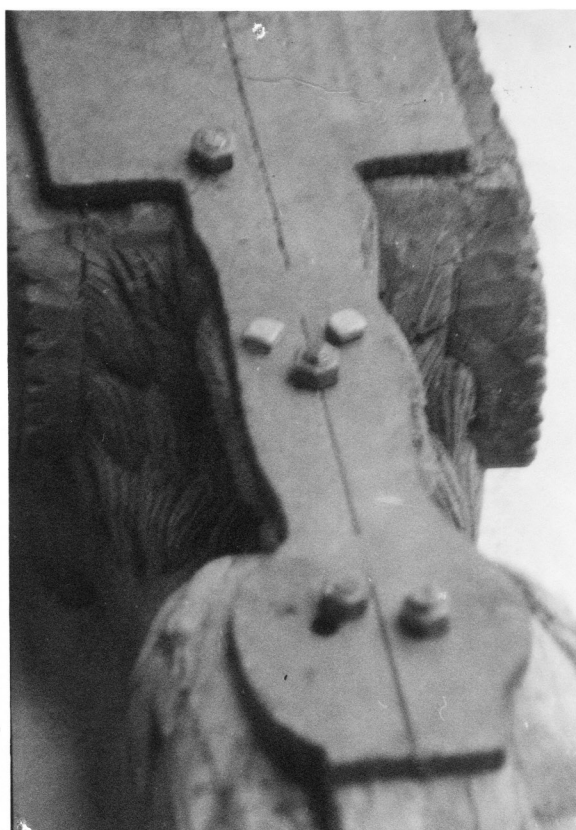
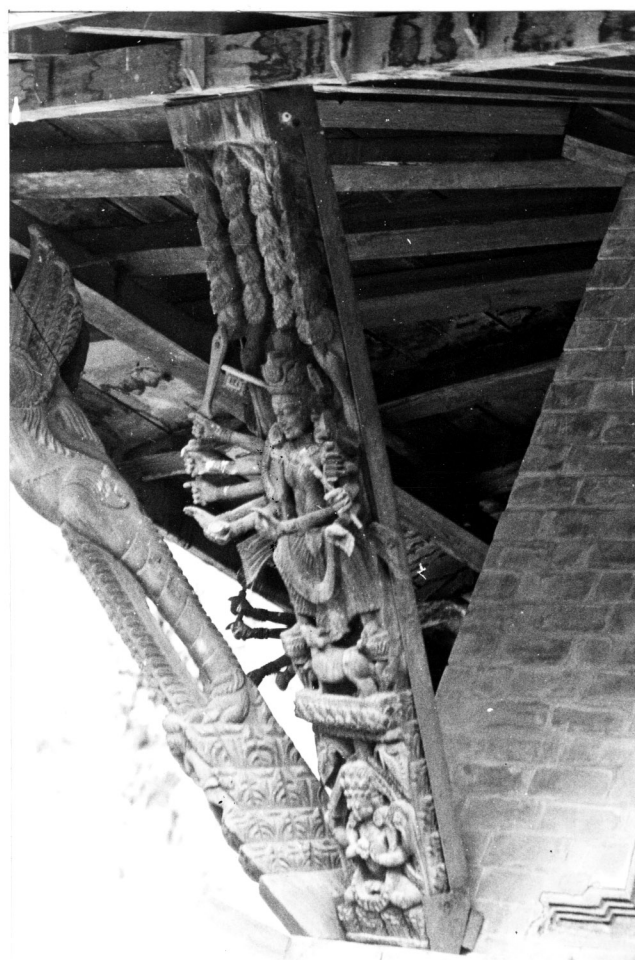
**STRUT REINFORCEMENTS**  
DETAIL OF FLAT STEEL REINFORCEMENT AT  
BISWNATH TEMPLE, 1990. RIGHT: VISIBLE "U"  
SECTION REINFORCEMENT AT BRAHMAYANI  
TEMPLE, PANAUTI, PHOTO 1991.

The current norm in Nepal for structural consolidation of timber elements (Hanuman Dhoka, French project at Brahmayani, Panauti, and Department of Archaeology projects) employs steel painted with anti-corrosive paint. At the Brahmayani temple, the reinforcements consist of a "U" shaped member which wraps the back of the strut and is visible from below. "T" shaped members are proposed for all reinforcements which will be structurally sound, and invisible from below. This project proposes the investigation of several alternatives including (1) locally available nickel-plating steel and iron (2) testing of custom galvanizing, available in the Terai region, though generally of very poor quality, (3) use of imported stainless steel and (4) imported two-component epoxy anti-rust paints.

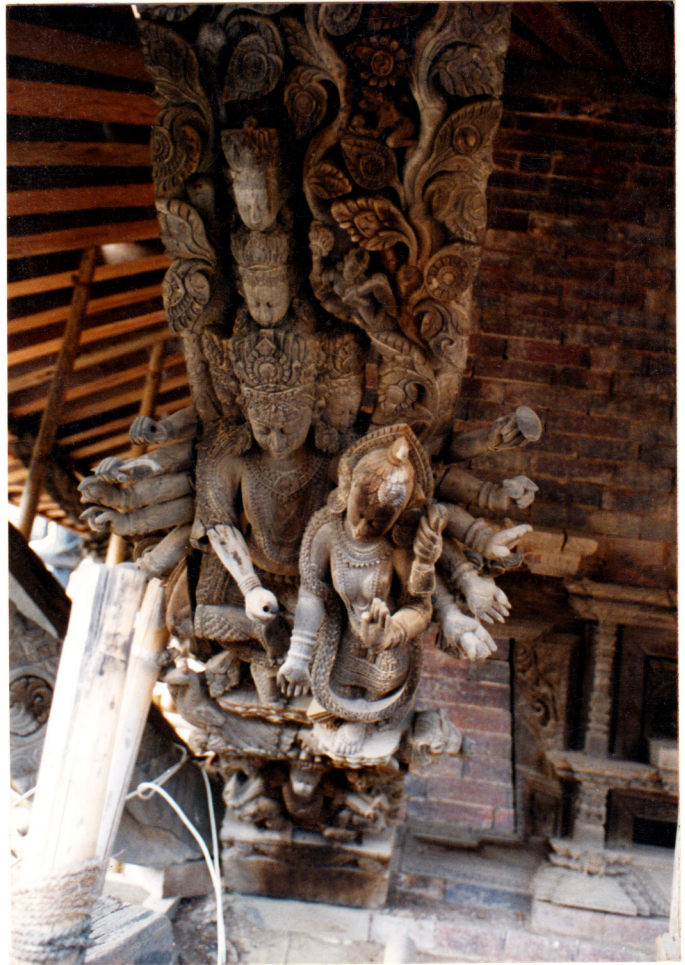
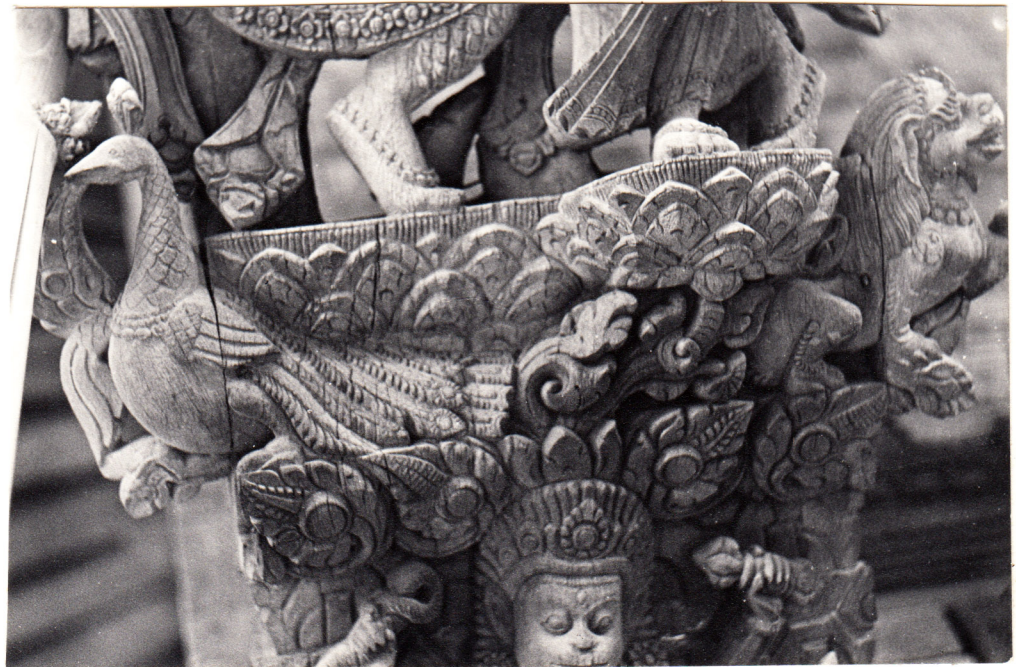
**BOTTOM ROOF**  
**STRUT: 106**  
**ELEVATION: SOUTH**  
**AGE: ORIGINAL (1668)**

- Mildew on leaves, on the crown face and on the drapery, on god's face as well as and on the base of the bull. (1sq.ft.mildew area.)

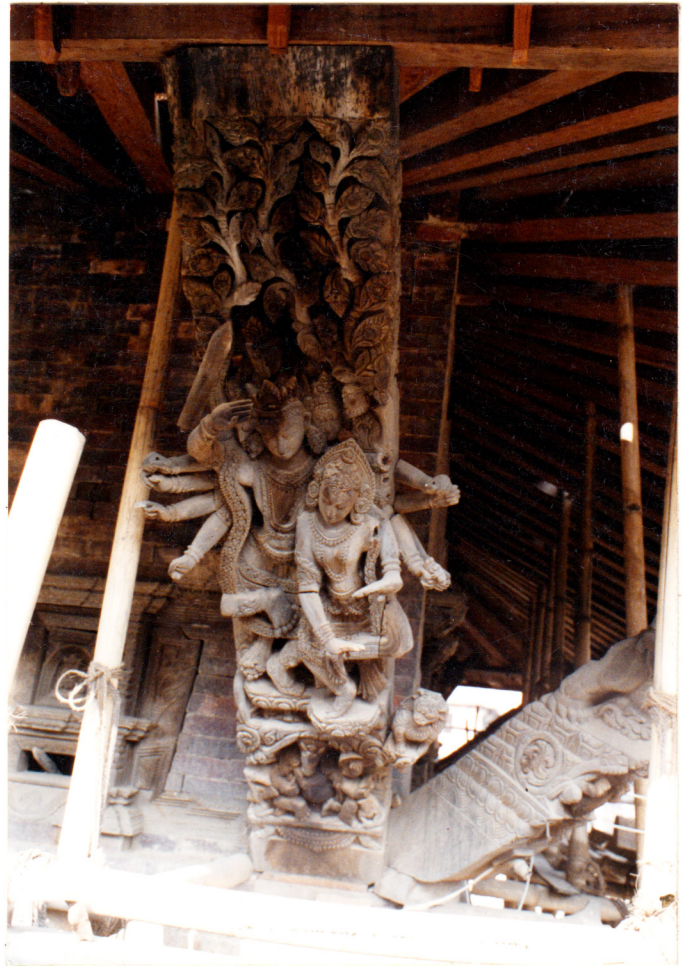
**BOTTOM ROOF**  
**STRUT: 107**  
**ELEVATION: SOUTH**  
**AGE: ORIGINAL (1668)**

- Mildew on leaves, faces of the Bhairava and  
on base scene. (Area 1sq.ft.)

- Structural condition is good.

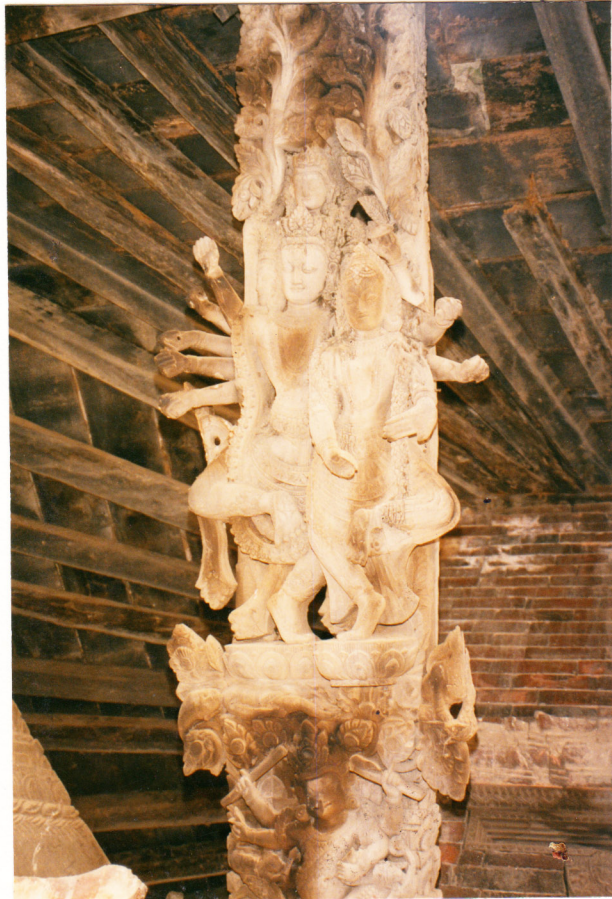
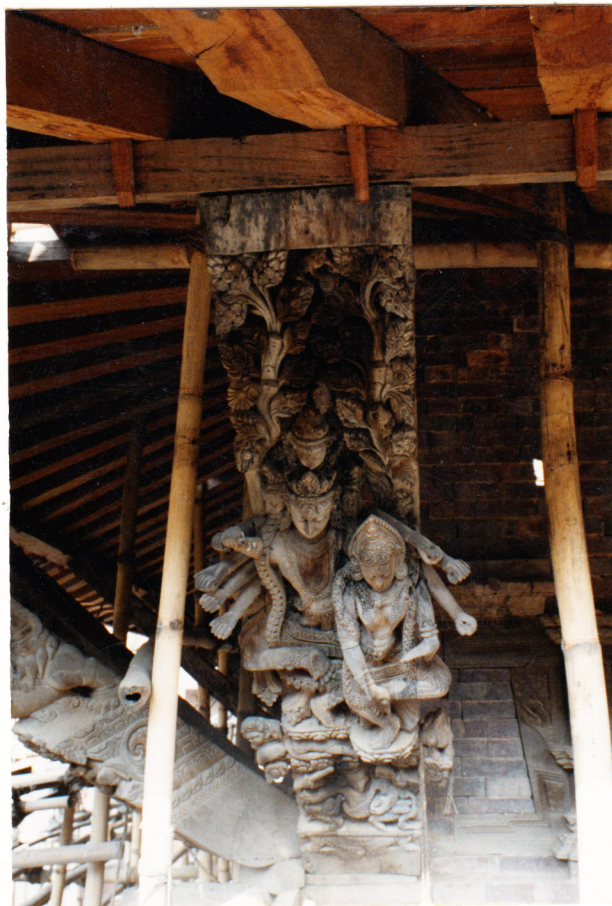
**BOTTOM ROOF  
STRUT: 111  
ELEVATION: WEST  
AGE: ORIGINAL (1668)**

- Head, hands, weapons, and drapery are lost. (Above head all the part are lost, 29" upper portion is lost.)
- Strut has been stored on the ground at the back of Sattal beside Swatha Narayan Temple.
- Structurally condition needs closer study to determine how extensive denaturing from wet rot has penetrated.

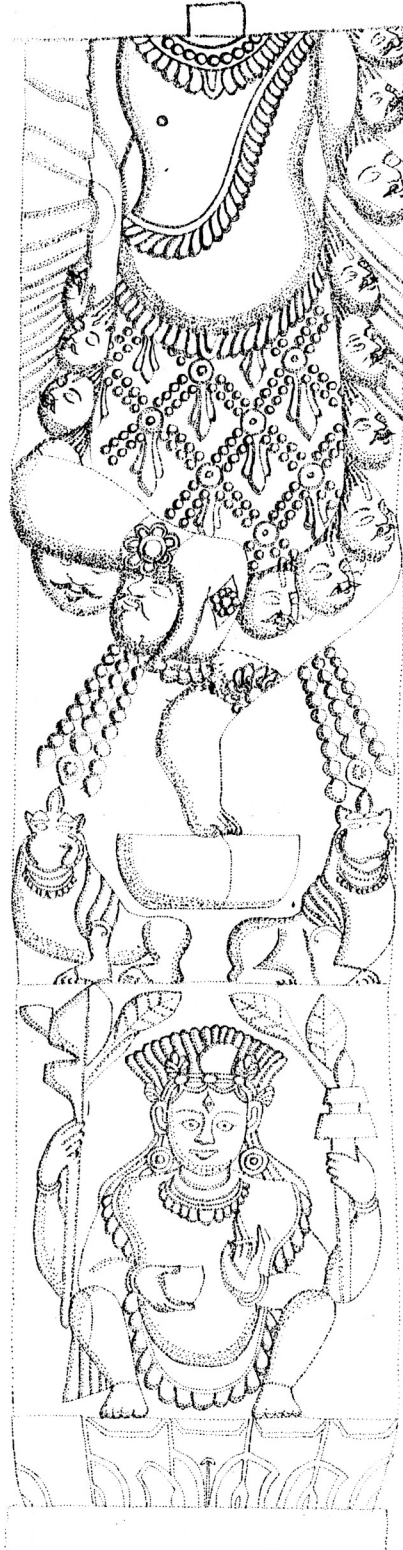
**BOTTOM ROOF**  
**STRUT: 113**  
**ELEVATION: WEST**  
**AGE: ORIGINAL (1668)**

- Mildew problem partially on leaves, on the body of base scene and on crown and garland of the female figure (App. 36 sq. in.).

- Draperies are lost.

On several of the most deteriorated struts (#208, 213, and 118) the injection of a consolidating but irreversible epoxy resin must be considered.

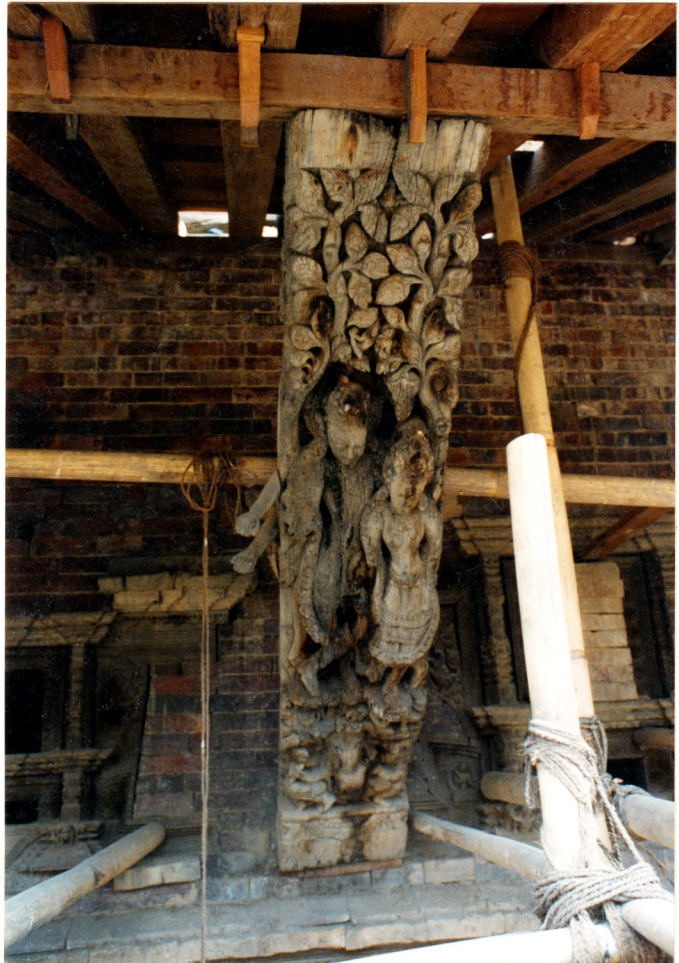
**BOTTOM ROOF**  
**STRUT: 114**  
**ELEVATION: WEST**  
**AGE: ORIGINAL (1668)**

- Tusk of main head is broken.

- Structural condition is good.

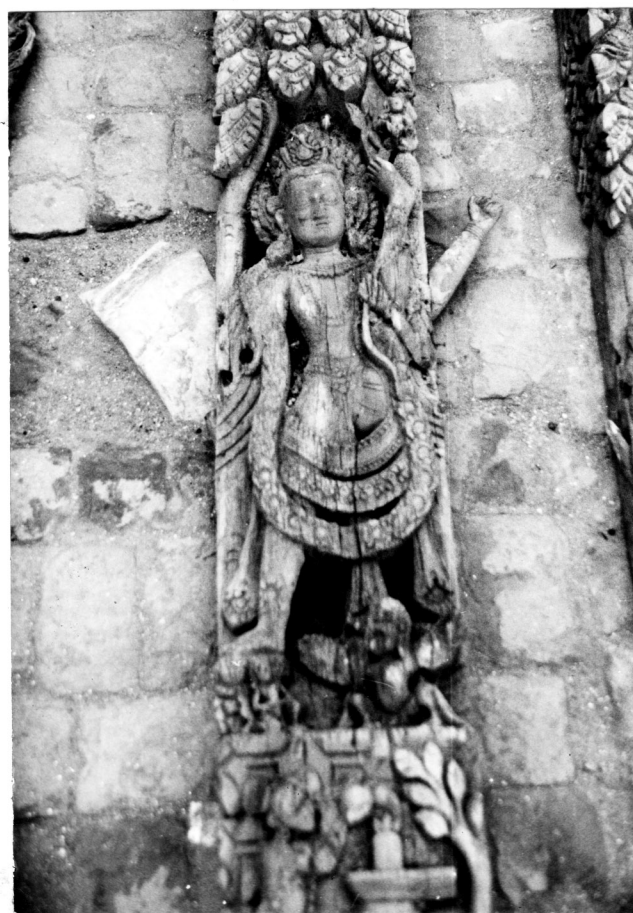
**MIDDLE ROOF  
STRUT: 206  
ELEVATION: SOUTH  
AGE: 19th CENTURY**

- Structurally good.
- Mildew problems on leaves and face.
- All hands are lost.
- Draperies are also lost.

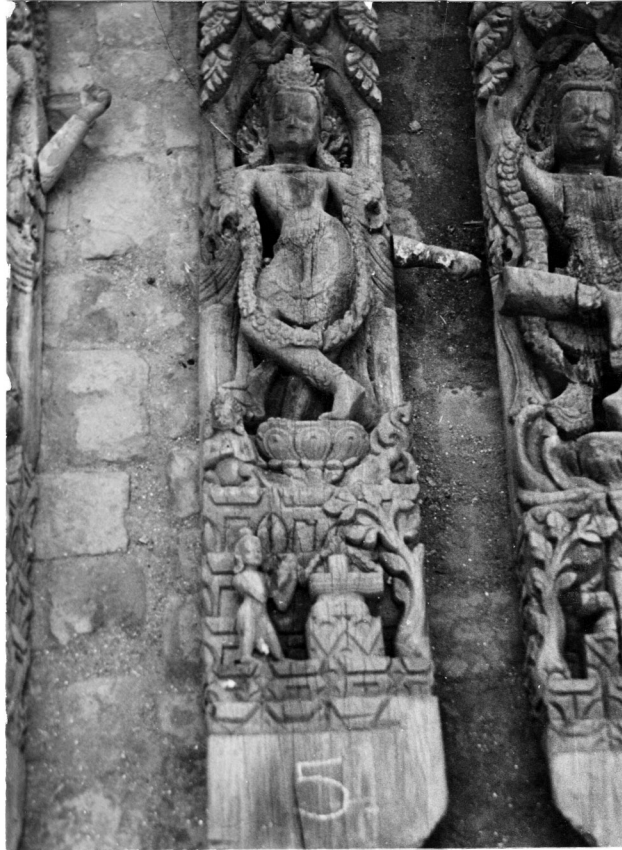
**MIDDLE ROOF  
STRUT: 207  
SOUTH: ELEVATION  
AGE: 1967**

- Dated 1967 AD. by Guthi construction and renovation committee.
- Structurally sound.
- Mildew problems on leaves and face.
- All hands are lost. After 1967 new hands were misfitted by nailing.

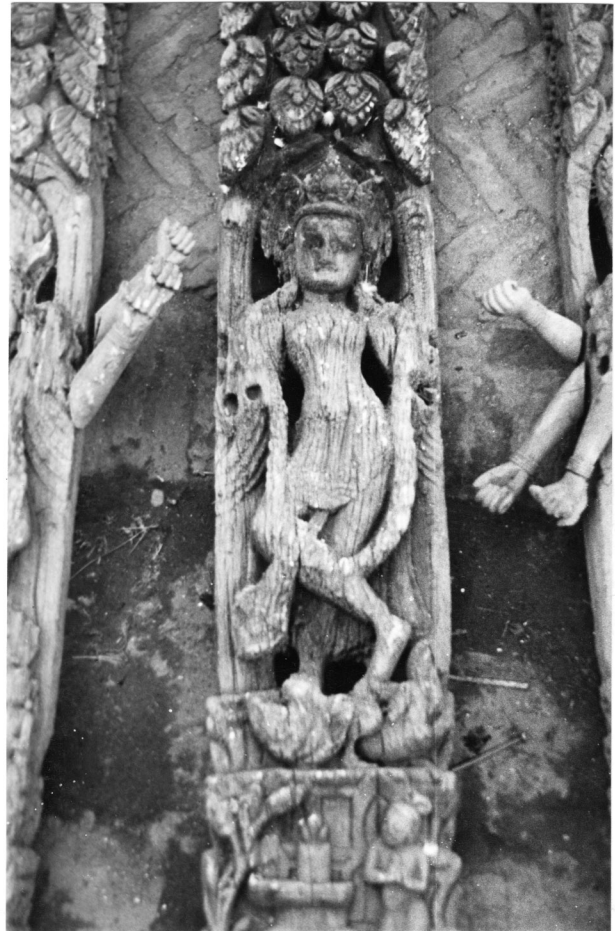
**MIDDLE ROOF**  
**ELEVATION: SOUTH**  
**STRUT: 209**  
**AGE: 19th CENTURY**

- Structurally o.k.
- Mildew problems on leaves and crown.
- All hands are lost.
- Draperies lost

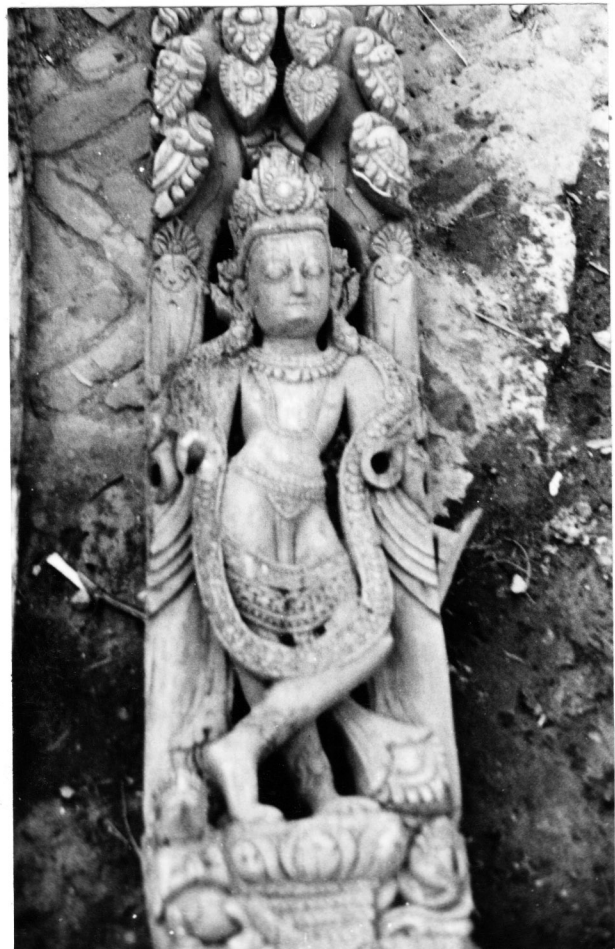
**MIDDLE ROOF**  
**STRUT: 211**  
**AGE: 19th CENTURY.**

- Structurally o.k.
- Mildew problem on leaves.
- All hands are lost.
- Draperies also lost.
