**RADHA KRISHNA TEMPLE**  
**SWATHA TOL, PATAN**

**HISTORIC STRUCTURES REPORT**  
**MARCH, 1992**

**ERICH G. THEOPHILE**  
**ROHIT K. RANJITKAR**  
**KATHMANDU VALLEY PRESERVATION TRUST**  
**IN COLLABORATION WITH**  
**HIS MAJESTY'S GOVERNMENT**  
**DEPARTMENT OF ARCHAEOLOGY**

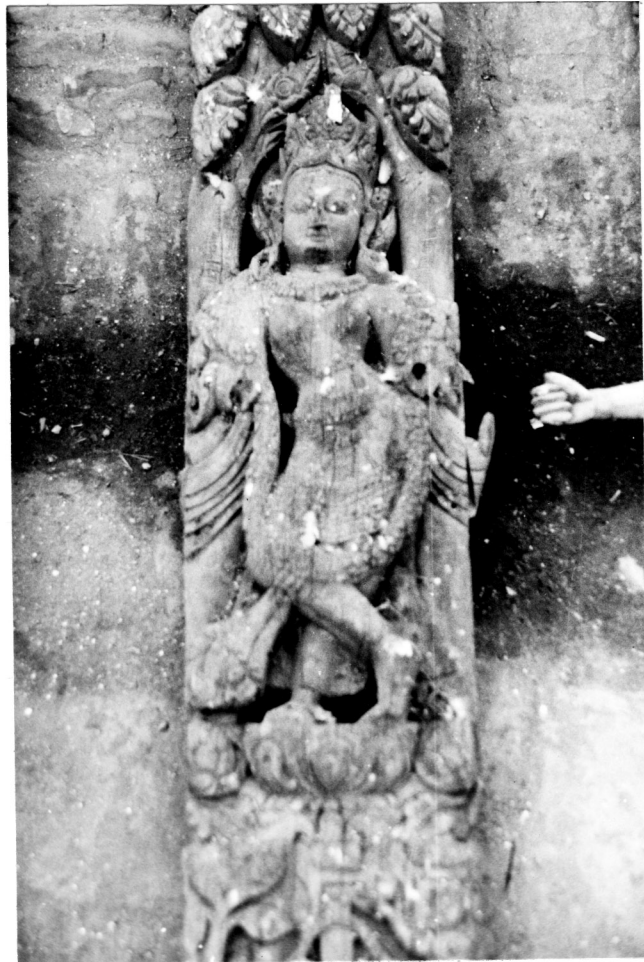
**MIDDLE ROOF**  
**STRUT: 212**  
**ELEVATION: WEST**  
**AGE: ORIGINAL (1668)**

- Ornaments and surface decoration have deteriorated due to wet rot.
- Left head is badly damaged by wet rot.
- Structurally not sound.
- All hands are lost.
- Draperies are also lost.

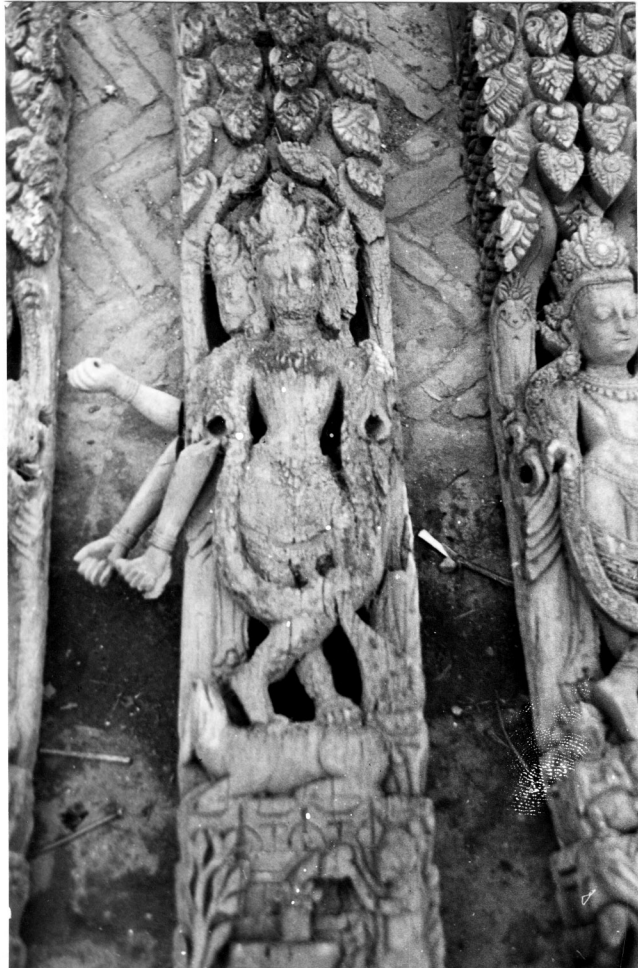
**MIDDLE ROOF**  
**STRUT: 213**  
**ELEVATION: WEST**  
**AGE: ORIGINAL (1668)**

- Outer layer crumbling (3/4" max depth) due to wetrot in many locations.
- Burnt like effect due to heavy mildew problem.
- Structurally weak.
- All hands and draperies lost.

- Only strut with ten hands middle roof.

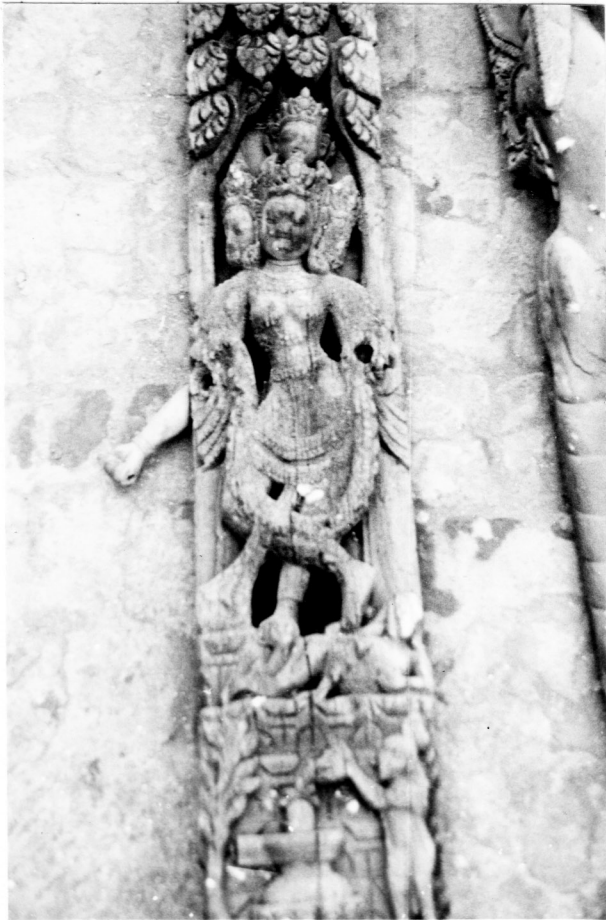
**MIDDLE ROOF**  
**STRUT: 214**  
**ELEVATION: WEST**  
**AGE: 19th CENTURY**

- Right leg has been broken near the ankle.
- Mildew problem at the face and leaves.
- Structurally o.k.
- All hands and draperies are lost.
- A small seasoning crack (1/8") from top to bottom.

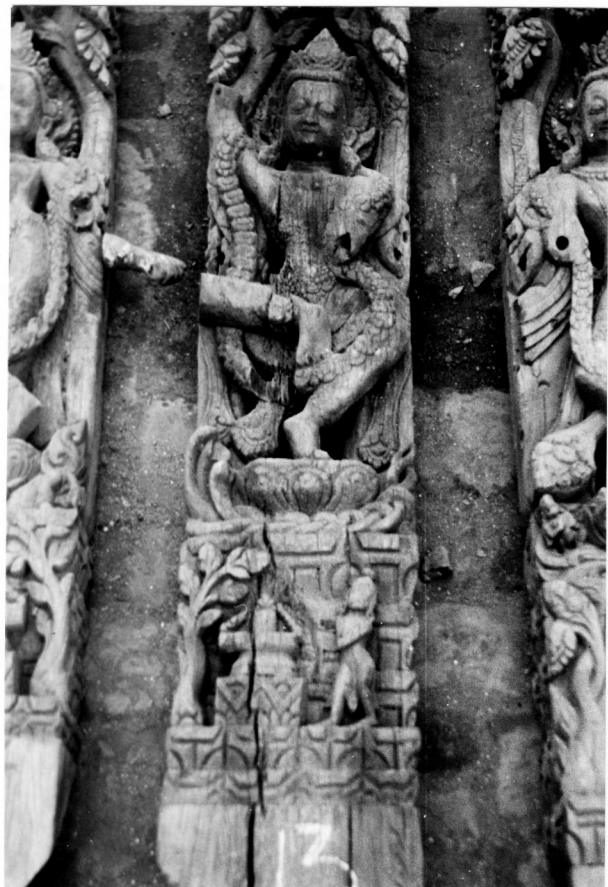
**MIDDLE ROOF  
STRUT: 216  
ELEVATION: NORTH  
AGE: 19th CENTURY**

- Right ankle broken.
- Surface decorations by storage in bad place.
- Structurally poor.
- All hands and draperies lost

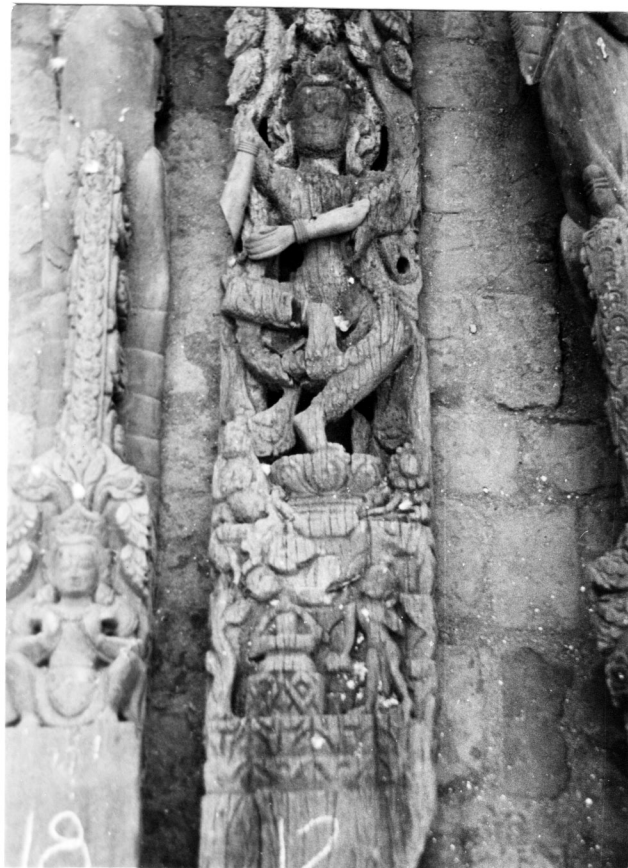
**MIDDLE ROOF  
STRUT: 218  
ELEVATION: NORTH  
AGE: 1967**

- Dated 1967.
- Structurally o.k.
- Mildew problems on face and base.
- All hands lost.

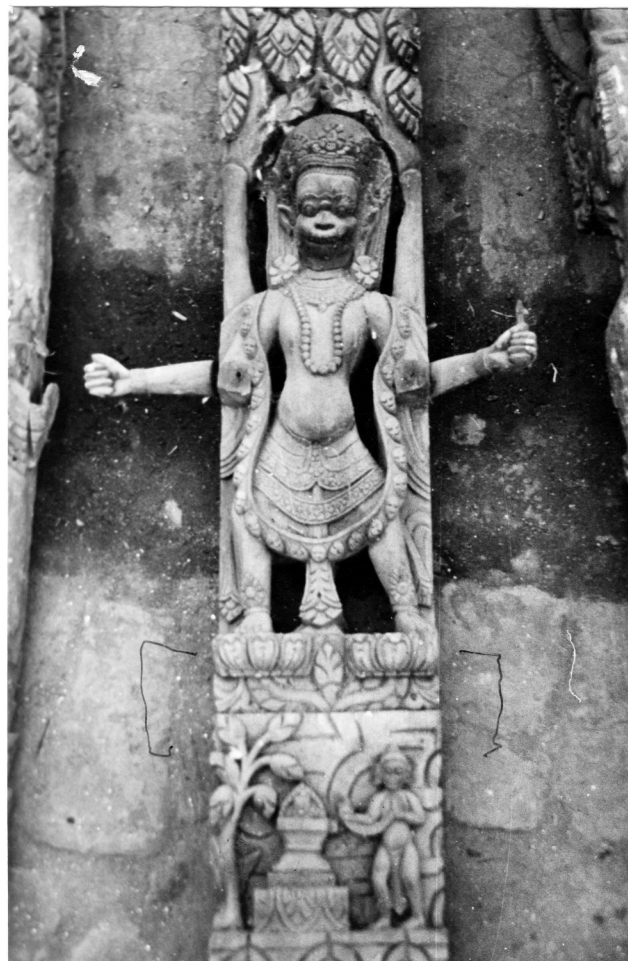
**MIDDLE ROOF**  
**STRUT: 219**  
**ELEVATION: NORTH**  
**AGE: ORIGINAL (1668)**

- The main figure was recovered from the rubble in the upper story left by 1967 renovation. The strut is broken into two pieces and severely affected by wet rot.
- All hands are lost
- Draperies also lost

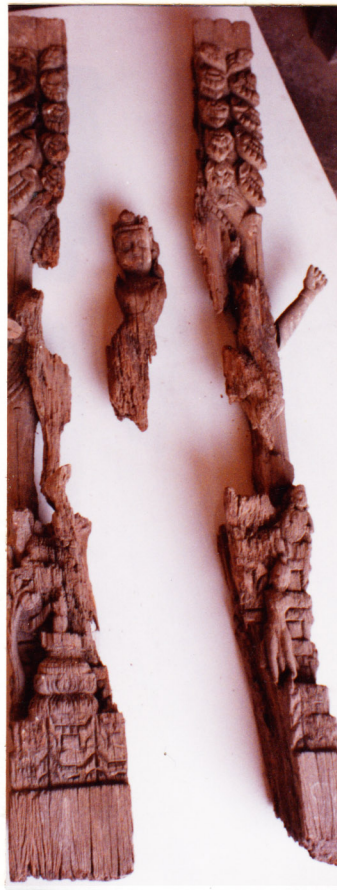
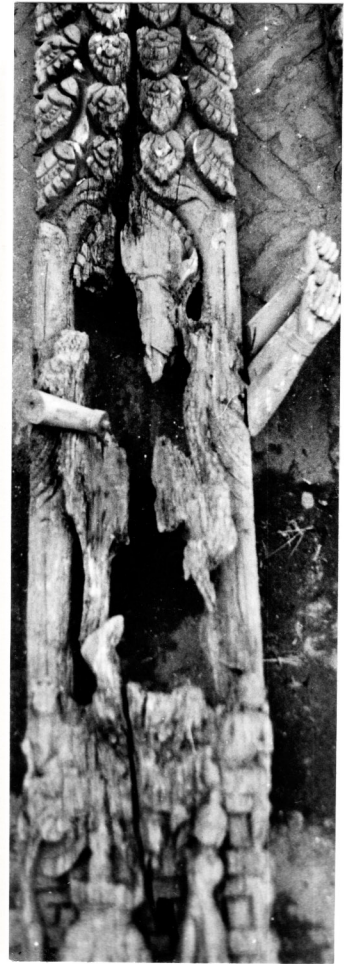
**MIDDLE ROOF**  
**CORNER STRUTS:**  
**205, 210, 215, 220**  
**AGE: 19th C.**

- All corner struts are structurally sound except 205 in which a vertical crack has been developed from top to bottom at one side.
- Patches of mildew are seen generally on top and on the base.
- 215 has been used as firewood (witnessed by the author some 2 years ago), superficially burned at middle portion.

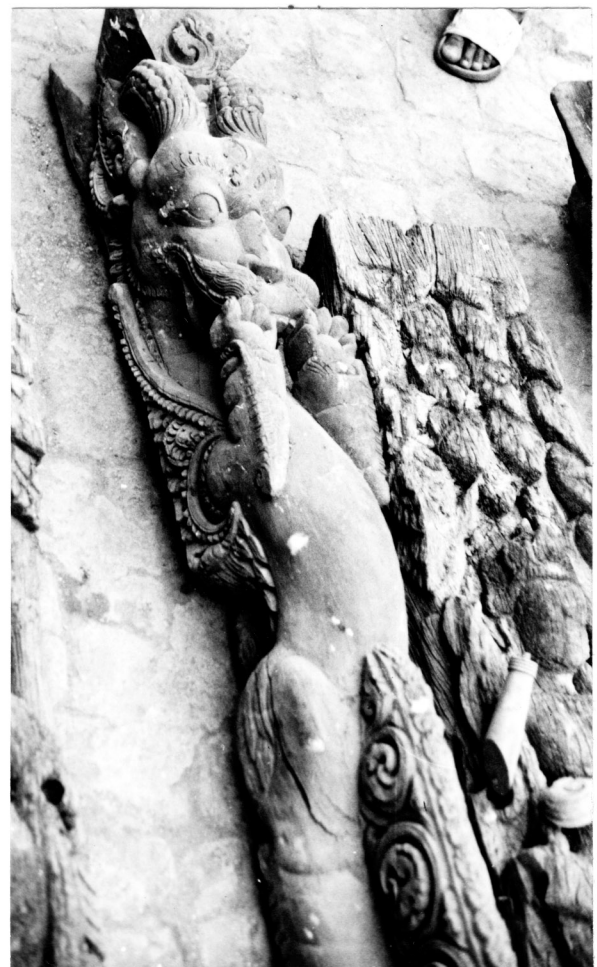
**TOP ROOF  
STRUT: 301  
ELEVATION: EAST  
FROM ANOTHER TEMPLE  
AGE: 19th C.**

- Structurally sound.
- Two hands, one arm lost.
- Stained by pigeon guano.

-Additional timber added at base to fit this element on the temple, typical of all "borrowed" struts at this level. As added timbers, format, and carving style are similar (#301, 302, 305, 307, 308), they appear to come from the same temple. Floral patterns in upper register differ, however.

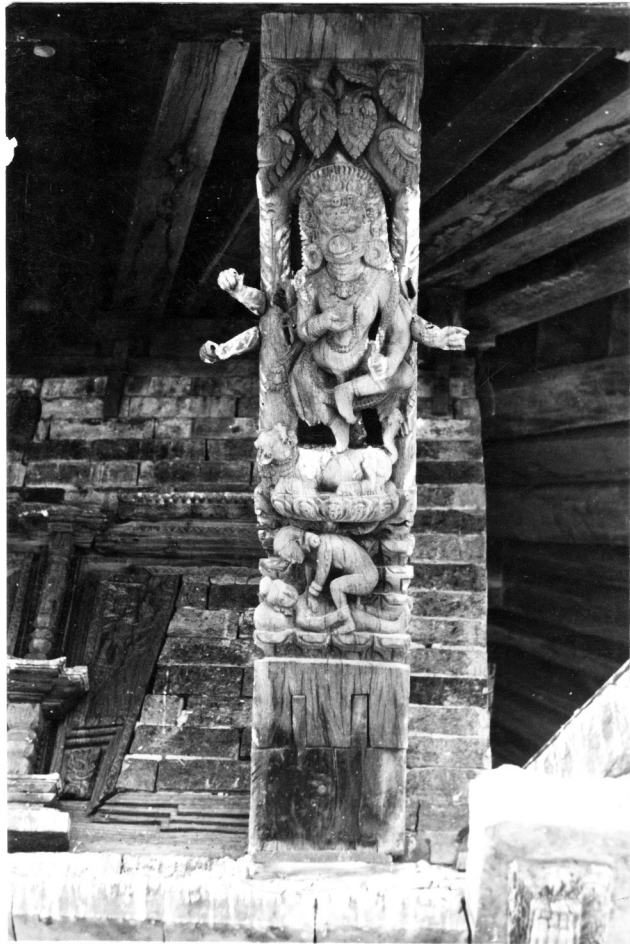
**TOP ROOF  
STRUT: 302  
ELEVATION: EAST  
FROM ANOTHER TEMPLE  
AGE: 19th C.**

- Structurally sound.
- All hands are lost.
- Stained by pigeon guano.

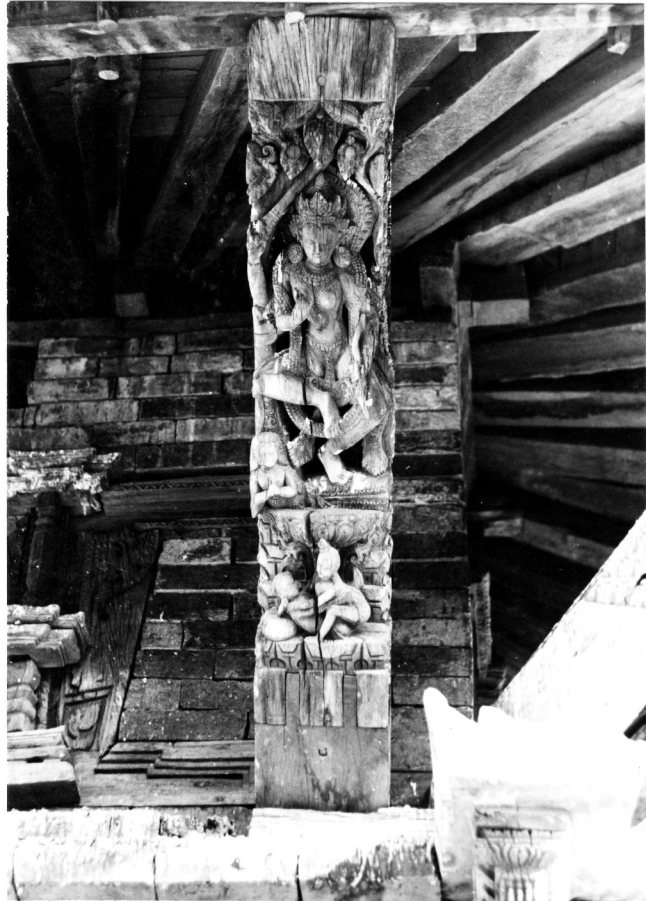
**TOP ROOF**  
**STRUT: 308**  
**ELEVATION: WEST**  
**AGE: ORIGINAL (1668)**

**CONDITION:**  
- Structurally damaged by wet rot.  
- Scoured by wind and rain.  
- All hands are lost.  
- Stained by pigeon guano.

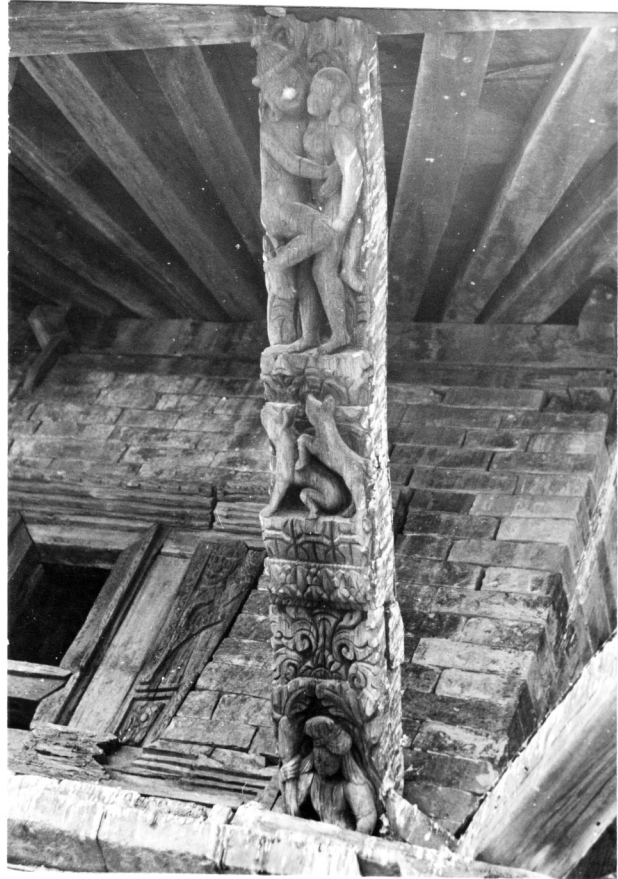
**TOP ROOF**  
**STRUT: 311**  
**ELEVATION: NORTH**  
**FROM ANOTHER TEMPLE**  
**AGE: 19th C.**

**CONDITION:**  
 - Structurally damaged by wetrot. Knife probe  
 to 2"-3".  
 -  
 - Stained by pigeon guano.  
 - Added timber at base. See notes #301.

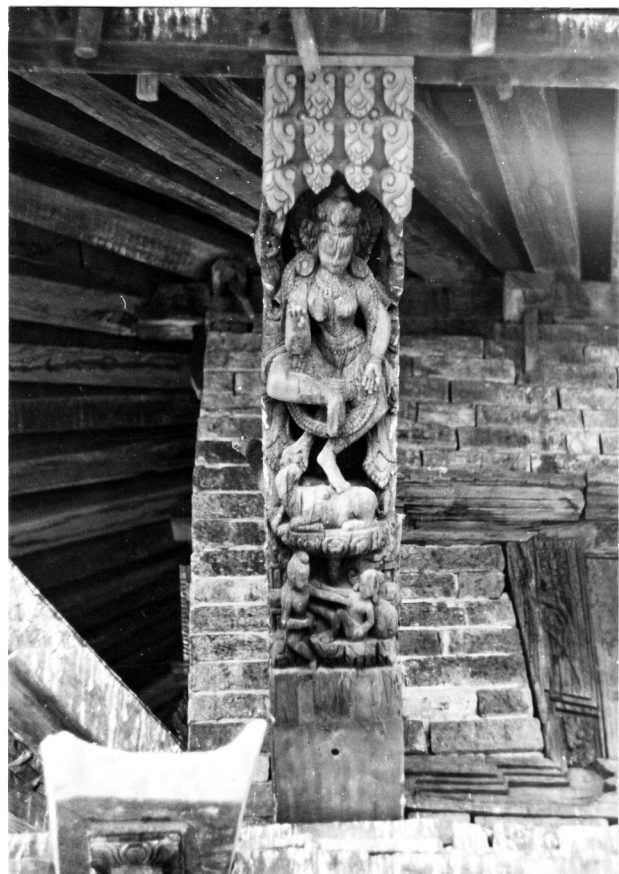
**TOP ROOF  
CORNER STRUTS:  
303, 306, 309, 312**

**CONDITION:**  
- All corner struts in excellent condition with  
limited mildew.
