THE PATAN ROYAL PALACE RESTORATION AND CONSERVATION PROJECT

## SUNDARI COK

CONDITION REPORT  
OF THE  
WOODEN CARVED ELEMENTS IN THE COURTYARD

JULY 2007

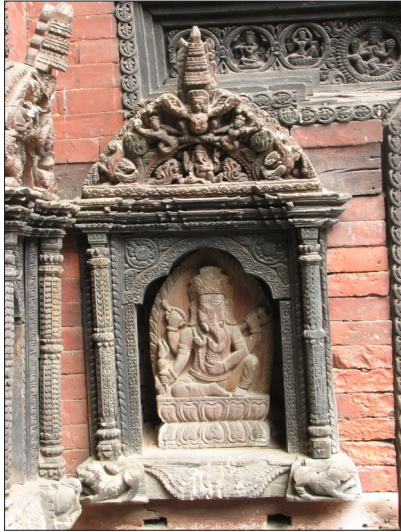
**2.5.N.01** Tympanum-original, frame-pre-earthquake, Statue-new( in 1967 A.D.)

The structure of the element in good condition. The design and carving of the statue is of inferior quality. The carvings at the base of the frame and the lower portions pillars have weathered considerably. 20% of egg pattern of the pillars have damaged. Asserting from the quality of the details on the pinnacle, it can be said that this was later added to an original tympanum. Joint at the left inner frame is open.

The statue in the niche has to be replaced with a high quality carving with an iconographic correct meaning. The open joints of the left inner frame need to be fixed.

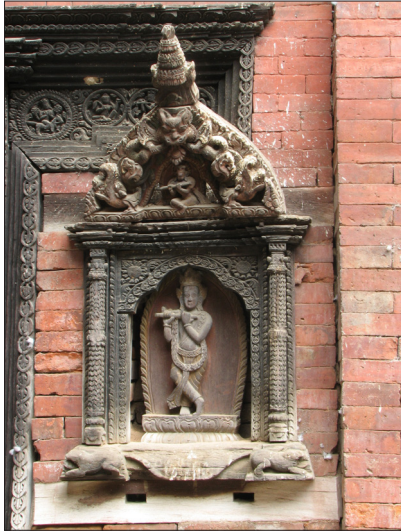
**2.5.N.02** Tympanum-original, frame-pre-earthquake, Statue-new( in 1967 A.D.)

The structure is in good condition except for weathered base and the lower portion of the pillars. These and also the lotus base of the image are bleached due to the action of the rain water. The sill has slight horizontal crack. The statue is of inferior quality. There is a breakage at the base of the pinnacle and upper piece is chipped off. The whole ensemble is painted and traces of polychrome paint is visible in the tympanum.

The statue in the niche has to be replaced with a high quality carving with an iconographic correct meaning. The unsightly colour on the carving needs to be removed. The open joints between the vertical and horizontal members of the frames has to be tightly fixed.

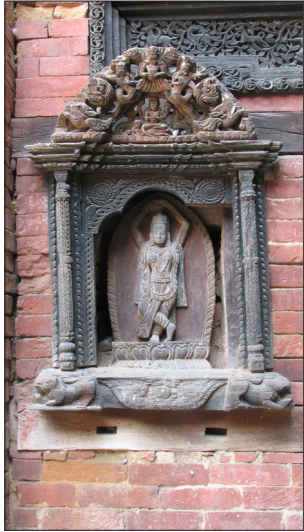
**2.5.N.03** Tympanum-original, frame-pre-earthquake, Statue-new( in 1967 A.D.)

The structure is in good condition. The principal image in the niche is of inferior quality. The sill and the lower segments of columns are heavy weathered and have small breakages at the shaft of the pillars. The left inner frame support of the niche is missing. The joints between the sill and the frame are open due to the natural drying of wood. The lower right section of the tympanum has chipped off and the pinnacle is missing. It has horizontal cracks but these are not critical. This shows polychrome colours which has faded considerably.

The statue in the niche has to be replaced with a high quality carving with an iconographic correct meaning. A copy pinnacle with reference from the other tympanums has to be made to be placed here. The left inner frame with a copy of the existing details needs to be re-carved. The joints of the sill to the frame support has to be cleaned and fixed again.

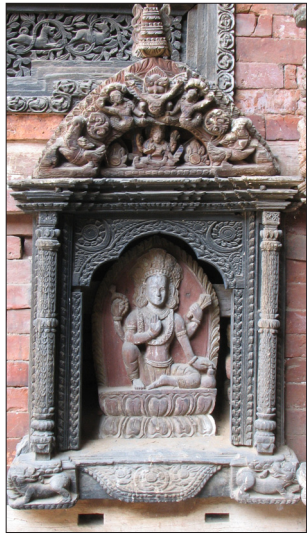
#### 2.5.N.04 Tympanum-original, frame-pre-earthquake, Statue-new( in 1967 A.D.)

The structure is in good condition. The joints between the sill and the frame are open because the upper portion of the sill has weathered considerably. The left pillar of the niche has heavily worn out. The joint at right inner frame has become loose. The carving of the statue is rather poor and is only a recent addition since the original one was lost. The details of tympanum has weathered with a new crudely carved attachment for Garud's head and pinnacle.

The statue in the niche has to be replaced with a high quality carving with an iconographic correct meaning. The joints at the frames needs to be readjusted. The top section of the tympanum has to be recarved to match the original one.

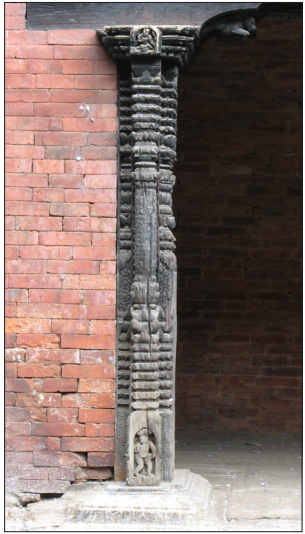
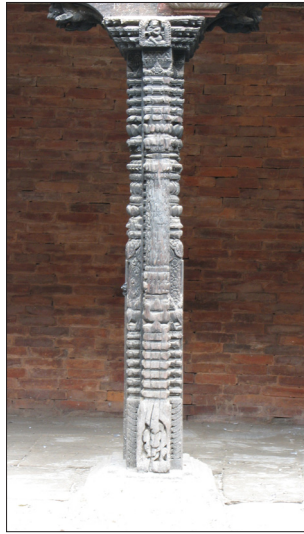
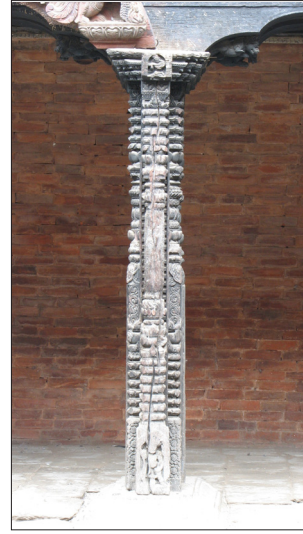
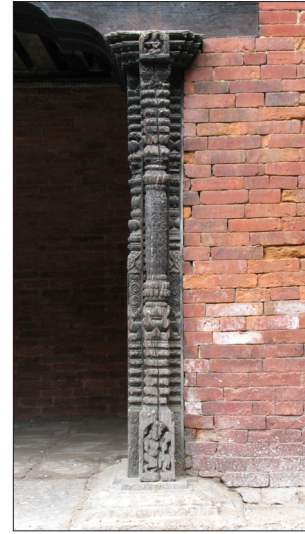
The pillars are in fair condition. The lower portions of the pillars have weathered heavily. There are structural cracks on the 2.5.P.03 and 2.5.P.04. At some areas the carving details are incomprehensible

These should be retrofitted with a additional structural members to share the load from above. An effective design has to be developed for this purpose.

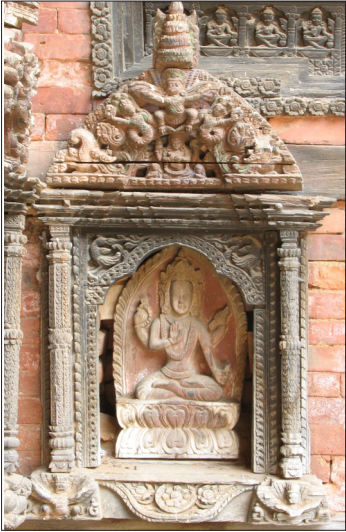
**2.6.N.01** Tympanum is original, frame after earthquake, statue after 1988

Its structure is in good condition. However, the lower portion around the base 10% weathered and this including the lotus pedestal of the deity has bleached considerably. The joints between the vertical and horizontal members of the frame have opened due to drying of timber. The vertical members of the inner frame appears to have been interchanged studying pattern on the arched section of the frame. A section of the cornice above the left pillar have damaged. The joint at the two pieces of tympanum has widened because of natural drying of the timber used. Some fragments of tympanum have come apart for example, the truck of left makara, beak of the central Garud. Though the pinnacle appears authentic, tympanum seems to miss a piece on top below it and was just nailed to it.

The statue in the niche has to be replaced with a high quality carving with an iconographcorrect meaning. The vertical members of the inner frame should be interchanged. The open joints between the vertical and horizontal members of the frames has to be tightly fixed. Same should be done for the joint at the tympanum.

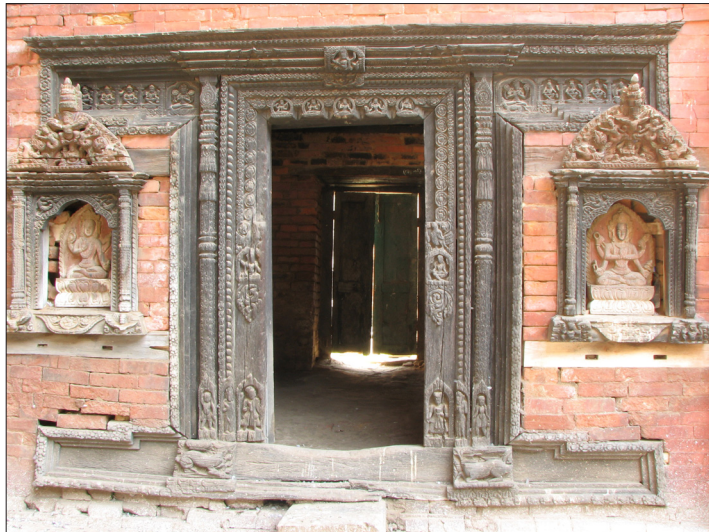
#### 2.6.D.01

The structure is in good condition. The outer frame at the threshold has several breakages and pieces are missing. Both bases for the pillars, the threshold and some parts at the jamb are 70% weathered. Large vertical cracks extending from the top to the bottom area of the are visible at the both the inner jambs. Certain parts of the outer frame, most prominent in the right vertical member have bleached due to the reaction of the rainwater.

About 50 % of wood at the center of the threshold need to be replaced, because of the damaged fragments and the carved details at the outer frame should be copied from the existing ones.

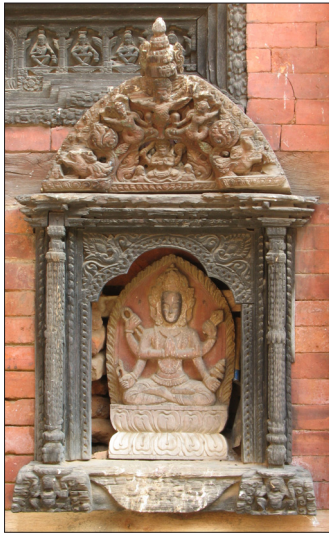
**2.6.N.02** Tympanum is original, frame after earthquake, statue after 1988

The structure is in good condition, but is 75% weathered particularly at the sill and the pillars. A fragment of the cornice above the right column have damaged which disturbs the aesthetic impression of the entire niche. The breakages at the tympanum includes the ones at the trunk of the makaras, the wings of Garud, arms of the naga kanyas and at the pinnacle.

The statue in the niche has to be replaced with a high quality carving with an iconographic ally correct meaning. The damaged cornice needs to be replicated with reference to the authentic one. The pinnacle should be properly fixed

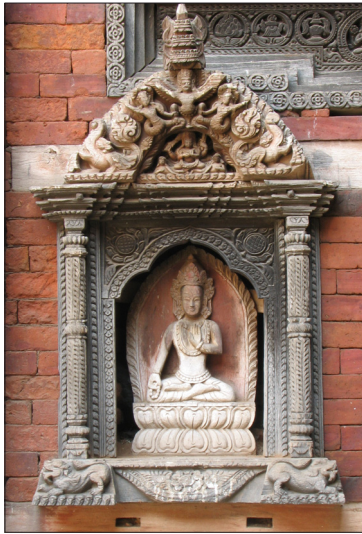
## 2.6.N.03

The structure is in good condition. The lower section of the main image in the niche have bleached with the action of rainwater. The existing pinnacle is not an authentic one and was probably replaced .

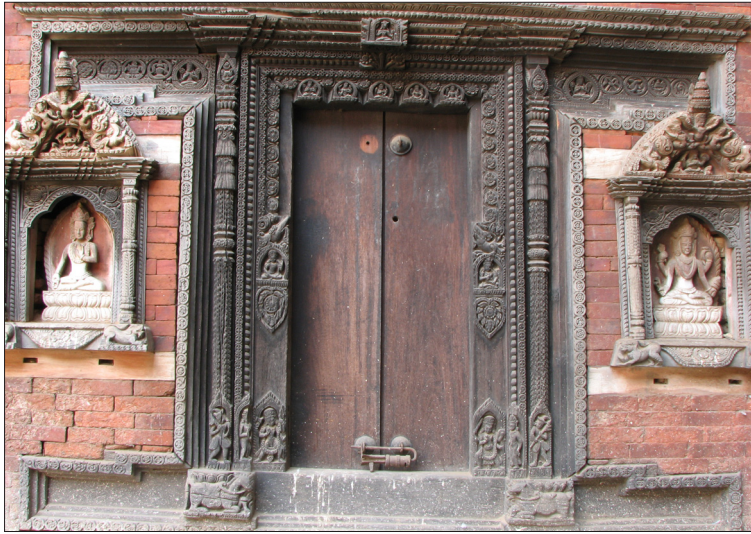
## 2.6.D.02 Door frame-original / authentic, Shutters-original

The structure is in good condition. The carvings are in excellent condition, expect for 5% of cornice around the center are broken and a large vertical crack on the right jamb at the area around the center. Right vertical member of the frame show signs of slight bleaching.

The structure requires only minor adjustments and cleaning.

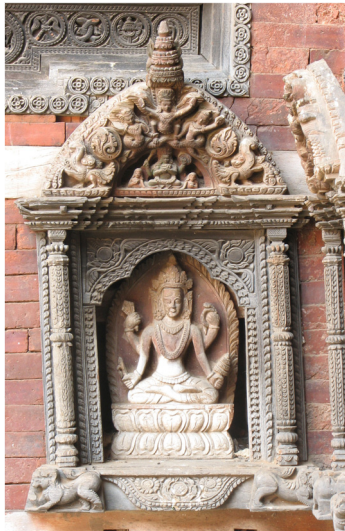
**2.6.N.04** Tympanum original, frame after earthquake, Statue after 1988

The structure is in good condition. The pillars are about 10% weathered. The kulan above the right pillar has broken. The areas above the naga girls and the right wing of the garud of the tympanum have chipped off. The tympanum show traces of polychrome colours. The statue in the niche is of inferior quality. The surface is covered with a grey /brown layer of dust, dirt and bird dropping.

The statue in the niche has to be replaced with a high quality carving with an iconographically correct meaning. The arched pieces of the niche's frame need to be readjusted.

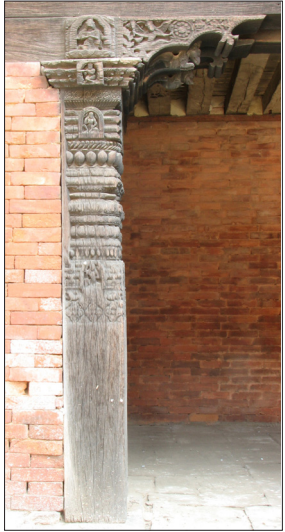
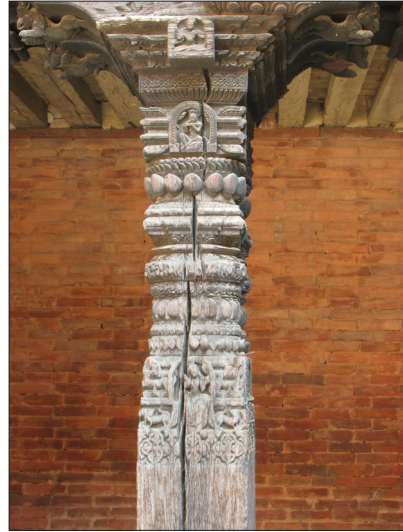
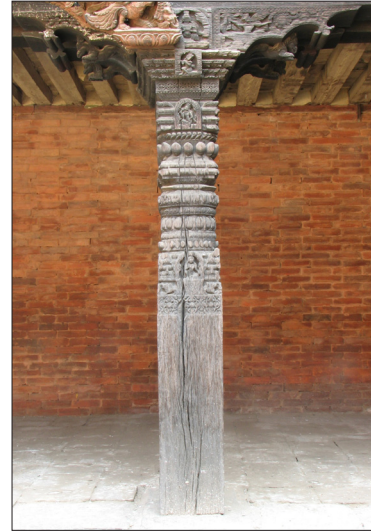
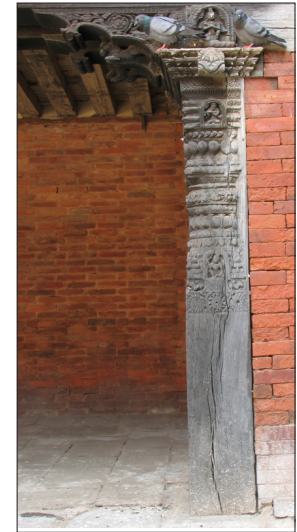
The pillars are in good structural condition however the wood is partially weathered. The weathering is more noticeable at the lower sections where they are mostly affected by rain, in many areas the carvings cannot be comprehended. 2.6.C.02 and 2.6.C.03 have a large vertical structural crack running across their body. Each has some pieces damaged and chipped off. The carvings at the capitals have 20% weathered.

The pillars at the centre of the arcade need to be reinforced. It can be done by introducing a pair of stainless steel plates, positioning them against the crack and bolting them, thus, structurally strengthening it.

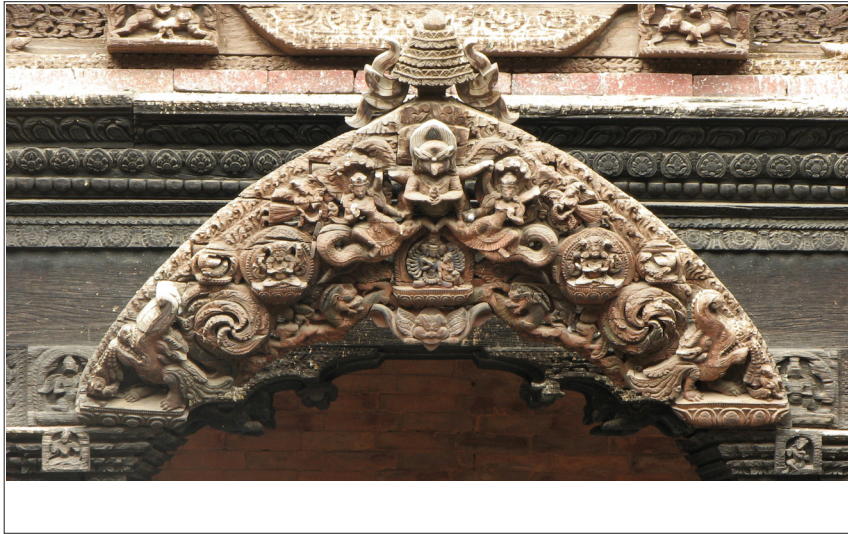
The whole entity show traces of unsightly polychrome colours. The joint between the four sections of the tympanum show thin cracks due to the natural drying of the wood. There are some small breakages at the carved deity at the right part of the periphery. The pinnacle, the upper section at the perimeter including the head of garuda and the cheppu are new additions. The quality of carving is extremely poor.

Replace the crude carvings with new finely executed carvings which are replicated from most intact tympanum i.e. 2.8 T. Stabilize the tympanum with plain wood on the backside. Fix the wood with screws through slot holes, so that the wood can continue the natural movement.

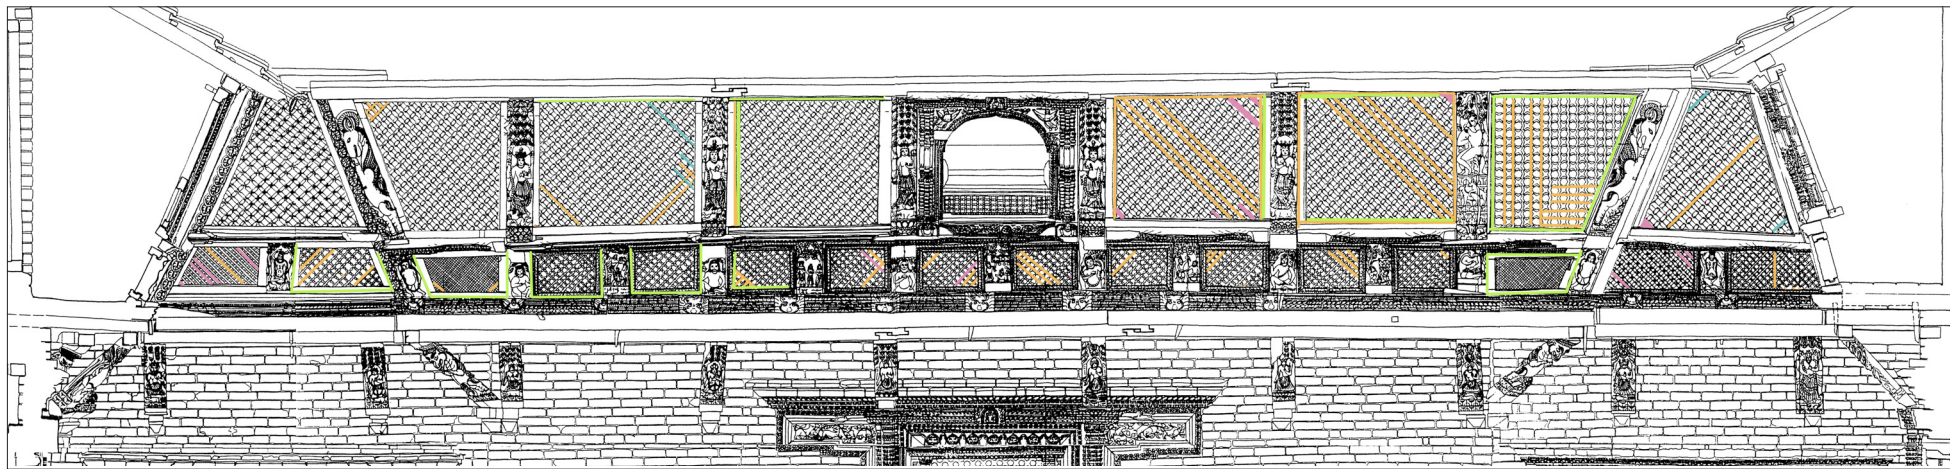
- 2.6.L.01 lattice is salvaged from another place and doesn't fit into the frame. The frame is not original. There are several broken and missing elements

- 2.6.L.02 lattice is not original and is in good condition with small damages elements
- 2.6.L.03 lattice is not original, rotten and damaged parts at the lattice, doesn't fit into the frame.

- 2.6.L.04 lattice is not original, the left vertical frame is broken and the lattice doesn't fit into the frame
- 2.6.L.05 lattice is not original. The frame is broken and the lattice doesn't fit into the frame. Some parts of the lattice are broken and elements are missing.

- 2.6.L.06 lattice is not original.. The frame is broken and the lattice doesn't fit into the frame on the bottom and on top. Elements of the lattice are broken and missing

- 2.6.L.07 The lattice work seems authentic but is from another place and consist in two pieces, it doesn't fit into the frame
- 2.6.L.08 Lattice and frame are not original but in good condition

- 2.6.L.09 frame is not original, the lattice seems authentic and doesn't fit into the frame. The right portion consists of two pieces of lattice and is broken

- Repair the damaged elements with new wooden members and fix them to the existing lattice.
- Repair the broken elements, remove the rotten parts and replace with new elements

- Replace the damaged frame and adjust the lattice into the frame
- Make a new frame. Stabilize the lattice at the broken areas and replace the missing parts with new elements. Fit the lattice into the new frame.

- Make a new frame. Stabilize the lattice at the broken areas and replace the missing parts with new elements. Fit the lattice into the new frame.
- Completely refurbish the latticework with a replica of 2.5.L.03

- Repair the small breakages at the lattice
- Repair the lattice and adjust into a new frame. Completely refurbish the right portion, including the frame.

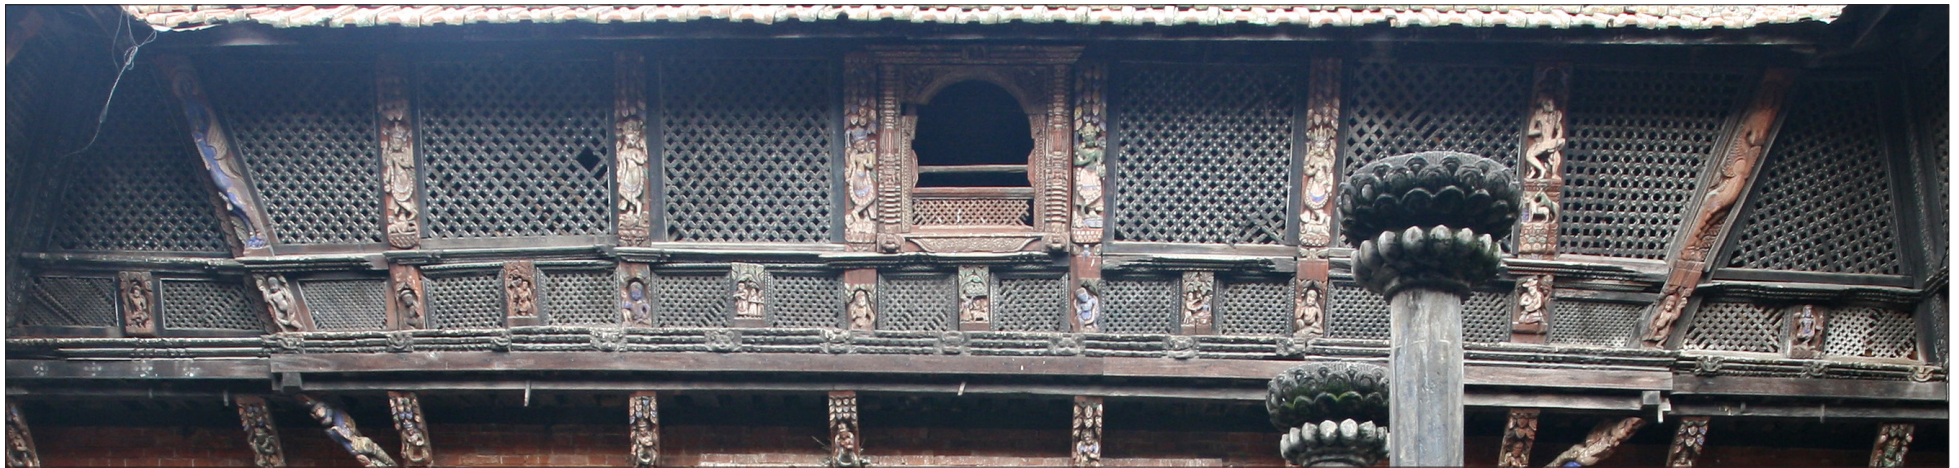
- 2.6.L.10 lattice and frame seems authentic, doesn't fit into the area between the struts., is damaged at some places
- 2.6.L.11 lattice and frame appear authentic and the frame doesn't fit into the area between the struts. The frame is carved.

- 2.6.L.12 lattice and the frame seem original. In the left area, there are small damages at the bottom of the lattice and the lattice does not fit into the frame. Similarly, in the right portion, there some pieces missing and damaged. The frame and the lattice fit together. The frames are carved.

- 2.6.L.13 lattice seems original but the frames are new and carved. Some of the elements are broken and missing in the lattice at both areas.
- 2.6.L.14 frame and the lattice are not authentic, but are in good condition. There are some damaged pieces at the both left and right areas.

- 2.6.L.15 Lattice seem original in both the sides. However, the left vertical frame member of the left portion is new and its remaining pieces are authentic. The frame in the right piece is completely new. Some elements of both the pieces of the lattice are broken.

- Repair the damaged lattice elements and refit it in a new frame
- Refurbish the frame and the lattice with a copy of the authentic pattern of lattice (2.5.L.03)
- Repair the damaged members and replace the missing. Stabilize the lattice in the existing frame, which is in good condition.
- Repair the damaged members and replace the missing. Stabilize the lattice in the existing frame, which is in good condition.
- The damaged pieces should be replaced and the lattice should be stabilized in the existing frame which is in good condition.
- The damaged member of the frame should be repaired. The missing and damaged pieces of the lattice should be restored and the entire set up should be stabilized.
- Replace the frame and the lattice with a copy of the authentic pattern

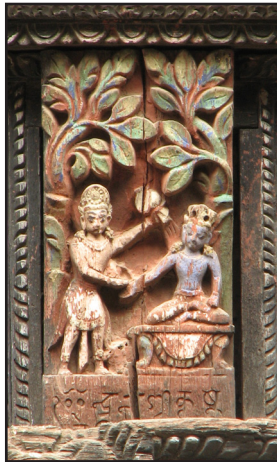
**2.6.F.05** Original

It has weathered slightly and has been painted with unsightly polychrome colors. A large crack has developed at the center of the carving. The quality of the carving is inferior.

The unauthentic color should be removed It should be stablized to be incorporated when restoring the latticework.

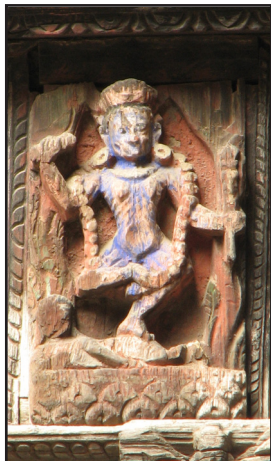
**2.6.F.07** Original

It has weathered heavily. and has been painted with unsightly polychrome colors. The features of the human figure has severely damaged Carving is of inferior quality.

The unauthentic color should be removed It should be stablized to be incorporated when restoring the latticework.

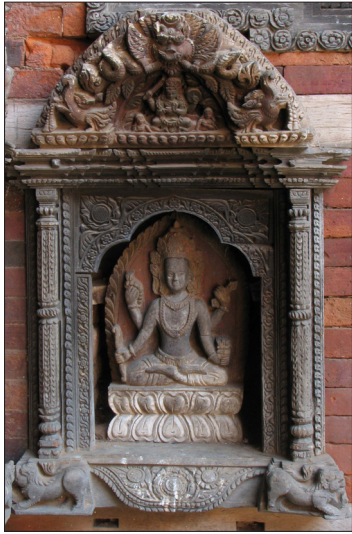
## 2.7.N.01 Tympanum-original, frame-after earthquake, statue-after 1988

The structure is in good condition with the details still intact. However the 15% of left jamb has weathered. The lotus pedestal of the deity has bleached considerably. A section of the cornice above the left pillar is damaged. The tympanum shows traces of polychrome paints. The pinnacle is lost.

The statue in the niche has to be replaced with a high quality carving with an iconographically correct meaning. The pinnacle should be recarved with reference to the authentic existing one in the same facade. Only cleaning is required. The method of cleaning has been attached as an annex with this report.

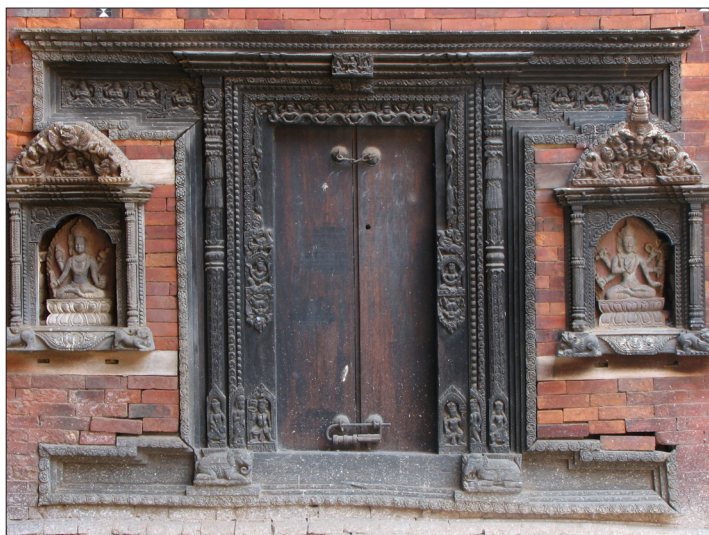
### 2.7.D.01

The structure is in a good condition but the threshold is not stable and has distorted under the weight.. The left extending lintel and the inner lintel have developed horizontal cracks. Likewise, the left inner jamb has vertical cracks.

The threshold needs to be stabilized by introducing a new steel member. Otherwise only cleaning is necessary.

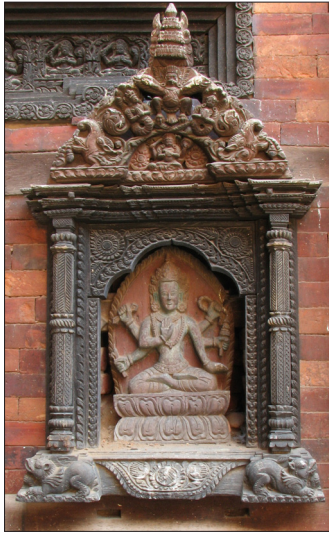
**2.7.N.02** Tympanum-original, frame-after the earthquake, statue-after 1988

The structure is in good condition, the carvings are still intact. The quality of the principal image is rather inferior. The image show traces of polychrome colour.

The statue in the niche has to be replaced with a high quality carving with an iconographically correct meaning. Only cleaning is required.

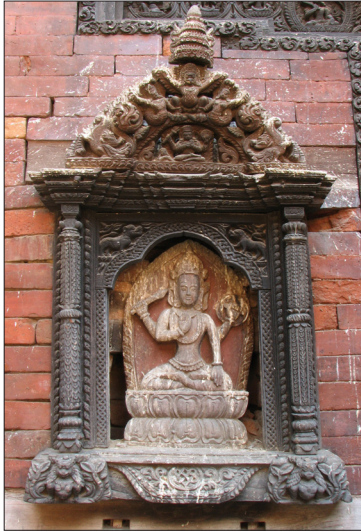
**2.7.N.03** Tympanum-original, frame-after the earthquake, statue-after 1988

The structure is in good condition with intact carvings. The quality of the principal image is rather inferior. There is 5% breakage at the egg pattern in the right jamb of the frame. Similarly center of the cornice are also damaged.

The statue in the niche has to be replaced with a high quality carving with an iconographically correct meaning. Only cleaning is required.

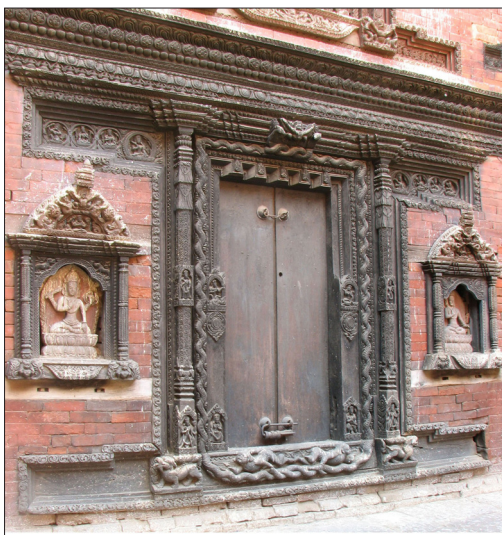
## 2.7.D.02

The structure is in good condition and all the carvings are still intact except for a few elements. The left vertical members of the outer frame at the threshold level have been replaced with new unadorned piece and has cracked. The lower ritual pot above the few layers of kulan at has damaged. The lower portion of the threshold has slightly weathered. The left projecting end of the threshold has a horizontal crack.

Replace the plain member of the outer frame with the carved detail replicated from the original design.

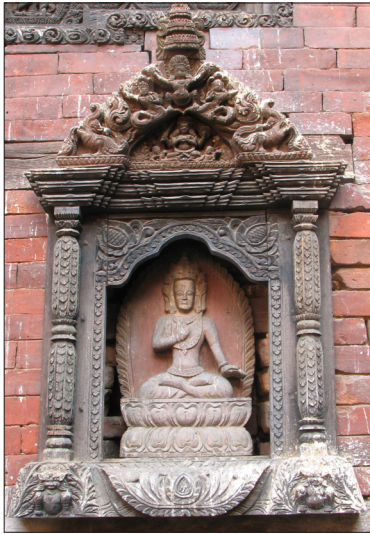
**2.7.N.04** Tympanum-original, frame-after the earthquake, statue-1988

The structure is in good condition. The entire object is very crude and shows different patterns as compared to the carvings at the other niches at the south wing. This is more noticeable at the frame; a strip of lotus leaves flanking the jambs are missing and the cornice is plain without any carvings. This was executed by another craftsmen and dates later than other niches. The quality of the principal image is rather inferior.

The statue in the niche has to be replaced with a high quality carving with an iconographically correct meaning. Replace the frame with a new one replicated from the one in the same facade. However the tympanum should be retained since it is an authentic one.

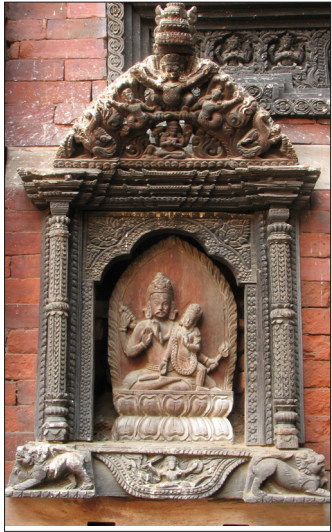
**2.7.N.05** Tympanum-original, frame-after the earthquake, statue-after 1988

The structure of the niche is good condition. The carvings are still intact, some areas have damaged. 75 % of the kulan detail above the pillars have breakages. The quality of the principal image is rather inferior.. The joints of the vertical members with the lintel and the base are slacking. A horizontal crack has developed on the cusped central carving at the base.

The statue in the niche has to be replaced with a high quality carving with an iconographically correct meaning. The joints of the lintel, supports and base need to be fixed.

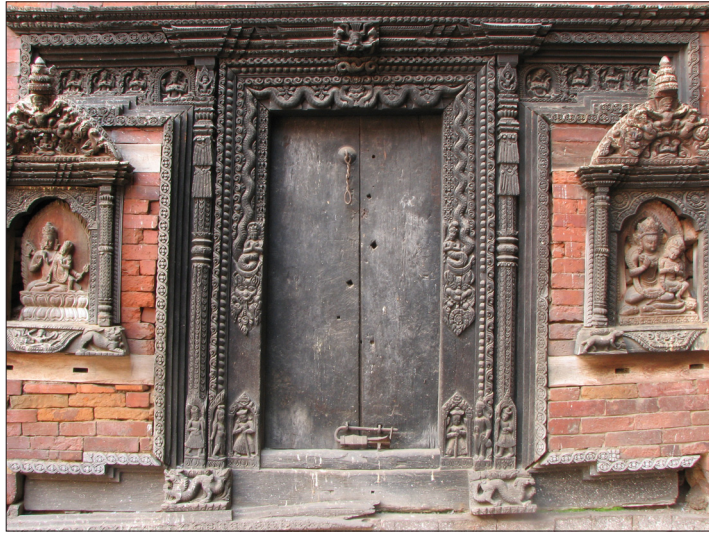
### 2.7.D.03

The structure is in a fair condition. The lower section of the threshold and the outer frame at this area are damaged. The vertical members of the outer frame at the threshold are missing. The left portion of the frame is damaged at the lower level. Likewise, there are some breakages at the middle section of the lintel (kulan). The band of creepers encircling the outer frame has bleached considerably at the lower areas. A horizontal piece of timber is added above the threshold, probably to close the gap caused by the decay of the shutters.

Replace both vertical members of the outer frame at the projecting end of the door sill and the damaged bottom horizontal element of the door sill. These should be carved with the detail from the existing elements.

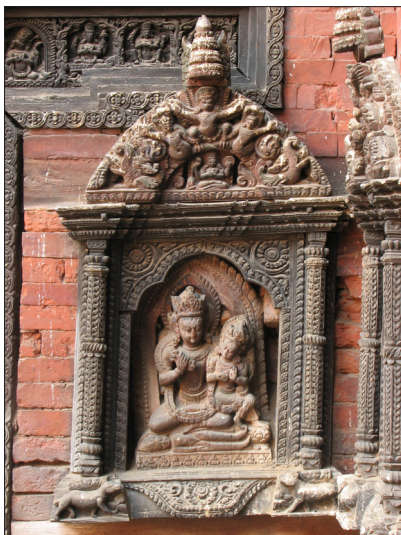
**2.7.N.06** Frame -after the earthquake, Statue and tympanum-original.

The structure is in good condition with the carvings intact. The figures with dogs at the bases have chipped off. The joinery between the jambs and the sill have become loose. The upper portion of the kulan above the jambs have worn out. The main image and the tympanum show traces of polychrome paints.. There are a few minor cracks around the trunk of the right makara and the legs of human base of the principal image of the niche

The joints need to be properly fixed. The loosened jambs should be secured to the cornice and the base. The unauthentic colours should be removed.

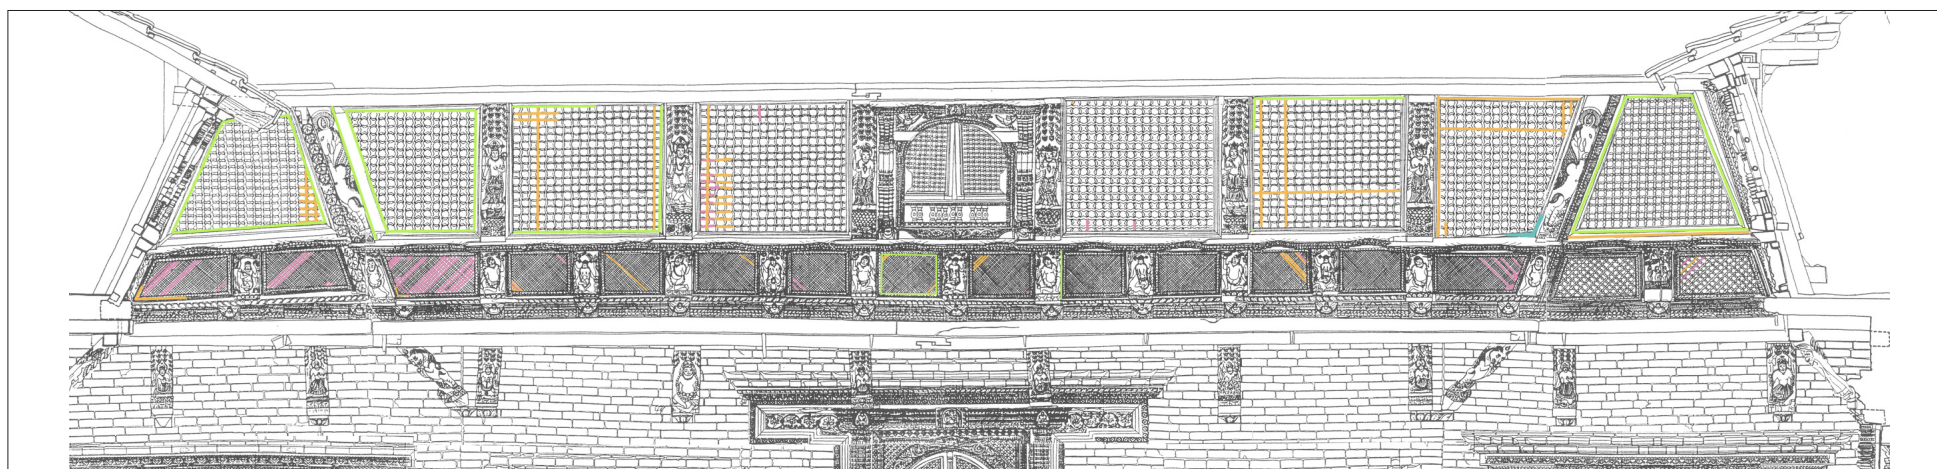
- 2.7.L.01 Frame and lattice do not seem original, some parts are missing and broken on the left bottom. Lattice doesn't fit into the new frame
- 2.7.L.02 New, low grade frame with lattice. The lattice is in good condition, doesn't fit into the frame. There is now existing lower frame part on the bottom and the frame doesn't fit into the space.

- 2.7.L.04 Lattice and frame do not seem original, the frame is broken and the lattice is twisted and shows heavy breakages.
- 2.7.L.05 Lattice and frame do not seem original, two small breakages at lattice on the bottom

- 2.7.L.06 Lattice and frame do not seem original, there are some broken and missing elements. the lattice doesn't fit into the frame.
- 2.7.L.07 Lattice and frame do not seem original, the lattice is twisted and some elements are broken and damaged. The upper frame is broken

- 2.7.L.08 Lattice and frame do not seem original, the lattice is twisted and the frame on the bottom is broken. The lattice doesn't fit into the frame.

- Fit the lattice into the frame, repair the broken parts with new members
- Replace a new frame and fit the lattice into.
- Fix the lattice into the frame.
- Due to the heavily damaged frame and lattice it is necessary to replace with a new frame and lattice of the authentic style.
- Repair the lattice with new members and fix them to the existing lattice. This lattice is a good example to show the history of restoration at the building.
- Due to the heavily damaged frame and lattice it is necessary to replace with a new frame and lattice of the authentic style.
- Replace the broken elements with new members and fix them into the lattice, replace with a new frame and fix the existing lattice into the frame.
- Replace with a new frame and fix the existing lattice into the new frame.

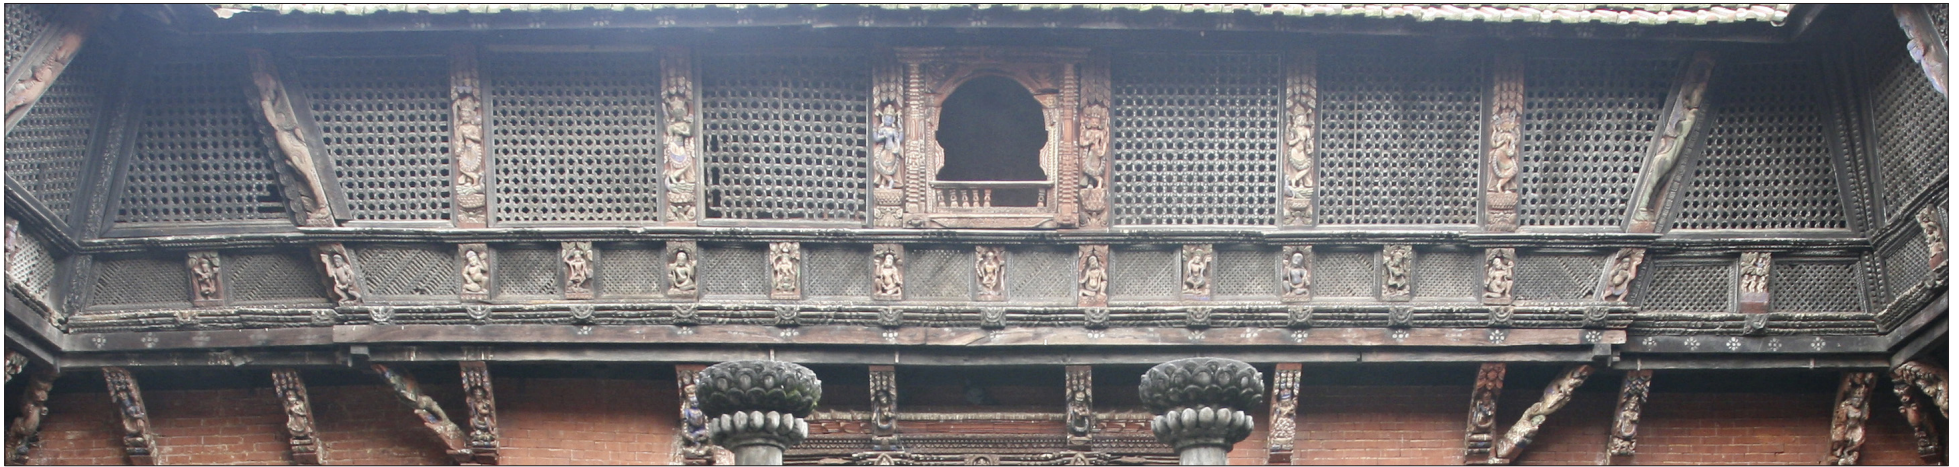
- 2.7.L.09a Lattice and frame seem authentic. Elements at the lattice are broken in both the areas. The frame at the left bottom and the left vertical frame support is broken in the left

- 2.7.L.9b Lattice and frame seems authentic. The lattice is hard damaged and a lot of elements are missing. The frame is broken on the left bottom. 2.7.L.11

- 2.7.L.10 Lattice and frame seems authentic. The lattice has broken and missing elements.
- 2.7.L.11a Lattice and frame seems authentic. The lattice has broken and missing elements.

- 2.7.L.11b Lattice and frame seems authentic. Both are in good condition. One element at the lattice is broken
- 2.7.L.12a Lattice and frame seems authentic. Both are in good condition. One element at the lattice is broken

- 2.7.L.12b Lattice and frame seems authentic. Both are in good condition. One element at the lattice is broken
- 2.7.L.13a Lattice and frame seems authentic. The lattice doesn't fit into the frame, elements at the lattice are missing

- Replace the missing elements into the existing lattice.
- Due to the hard damage at the lattice it is necessary to replace it with a new lattice, repair the broken frame and fit the lattice into the existing frame.
- Repair the broken elements, and fit new wood complements into the existing lattice.
- Repair the broken elements, and fit new wood complements into the existing lattice.
- Repair the broken element at the lattice.
- Repair the broken element at the lattice.
- Fit new wood complements into the existing lattice.
- Replace new wood complements into the existing lattice and fit it into the exciting frame.

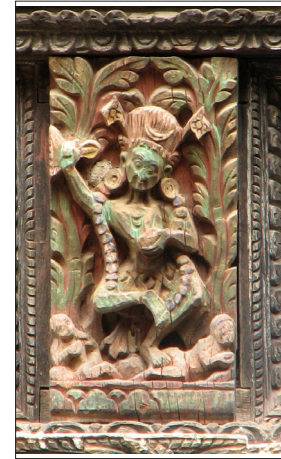
#### 2.7.F.06 Original

It is in good condition. and has been painted with unsightly polychrome colors. Carving is of inferior quality and several fine cracks have developed.

The unauthentic color should be removed. It should be stabilized to be incorporated when restoring the latticework.

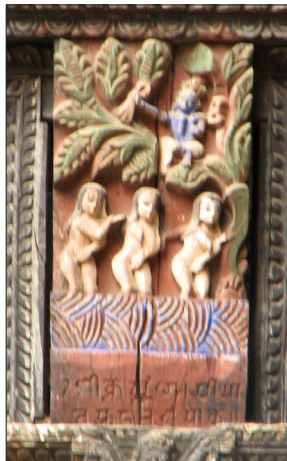
#### 2.7.F.07 Original

It is in fair condition. and a large structural crack is present at the center. It has been painted with unsightly polychrome colors.

The unauthentic color should be removed. It should be stabilized to be incorporated when restoring the latticework.

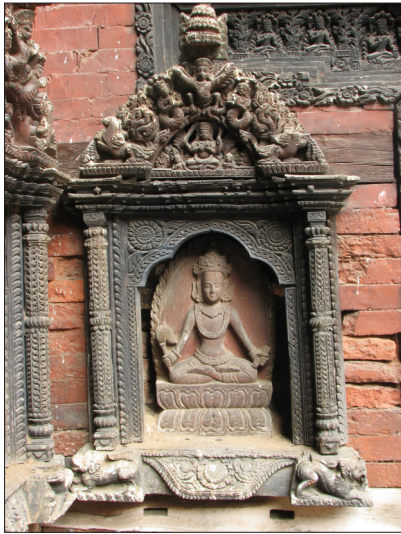
**2.8.N.01** Frame and statue-after earthquake. Tympanum-original

The structure of the niche is in fair condition with all the detail intact. The quality of the principal image housed in the niche is inferior. The entire structure has sheared by an inch, this is evident from the tilted elements and open joints between its horizontal and vertical members of the frame. The carving of the base lions is weathered with 20% damage. The upper portion kulan detail at center of the lintel. The pinnacle has become detached from the tympanum.

The statue in the niche has to be replaced with a high quality carving with an iconographically correct meaning. The niche needs to be removed from its position, thoroughly cleaned and components properly fixed and the tilt be corrected. The pinnacle should be properly fixed.

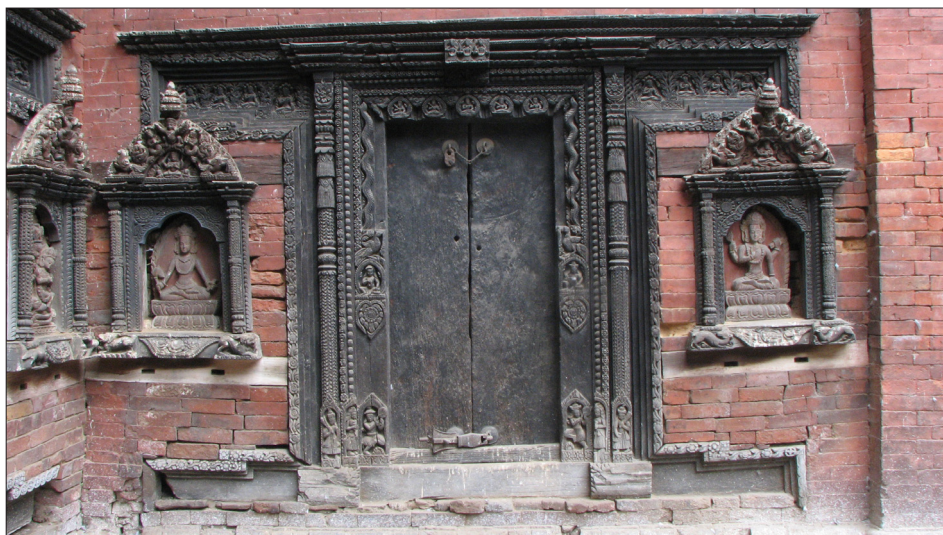
### 2.8.D.01 Frame and shutters-Original / authentic

The lower section of structure shows signs of weathering is 35% damaged. Both carvings at the bases are lost. The right vertical element and the lower horizontal member of the frame at the threshold are missing. Likewise, the outer frame at the threshold level upto the 16 layers of bricks, shows signs of bleaching. The right secondary jamb has developed a long vertical crack, extending from the head of the bottom guardian figure to the middle of the ornate flower pattern. A horizontal piece of timber is added above the threshold, probably to close the gap cause by the decay of the shutters.

The bottom piece of the outer frame at the threshold level needs to be reinstated with new carvings to complete the configuration. The plain right vertical member of the outer frame at the same area should be replaced with a new one carved with details similar to the intact existing ones.

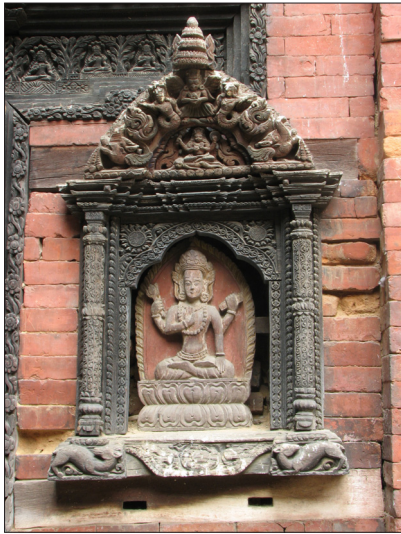
**2.7.N.02** Tympanum-original, frame-after earthquake, statue-after 1988

The structure of the niche is in fair condition with all the detail intact. The carving at the sill (cusped pattern with lotus flower) has worn out. 10% of the bases with the deers have damaged. The quality of the principal image housed in the niche is inferior. The sill has detached slightly from the frame supports making the joints open by quarter of an inch. The upper part of the kulan above both the jambs have breakages. The details of the tympanum are 20% damaged, the trunk of the right makara and face of the left snake girl show breakages. The tympanum shows traces of polychrome colors.

The statue in the niche has to be replaced with a high quality carving with an iconographically correct meaning. The sill needs to be fixed properly with the frame supports. Otherwise, only cleaning will be necessary.

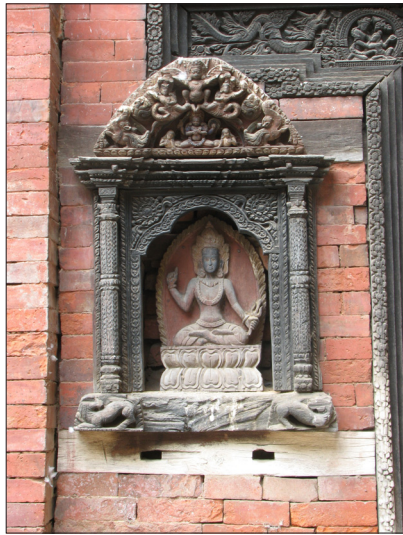
**2.7.N.03** Tympanum-original, frame-after earthquake, statue-after 1988

The condition of the structure is fair. The cusped pattern carving of the sill has weathered completely and has 35% breakages at the base carving & the central cusped pattern is lost. The quality of the principal image housed in the niche is inferior. The jambs have worn out with few fragments of egg motifs broken. The pinnacle is missing.

The damaged carving at the sill should to be kept as a historical evidence or (the damaged carving at the sill should be replaced with reproduction of the element with reference to the similar members from other niches). Recarve a new pinnacle above the tympanum in the traditional style. The statue in the niche has to be replaced with a high quality carving with an iconographically correct meaning.

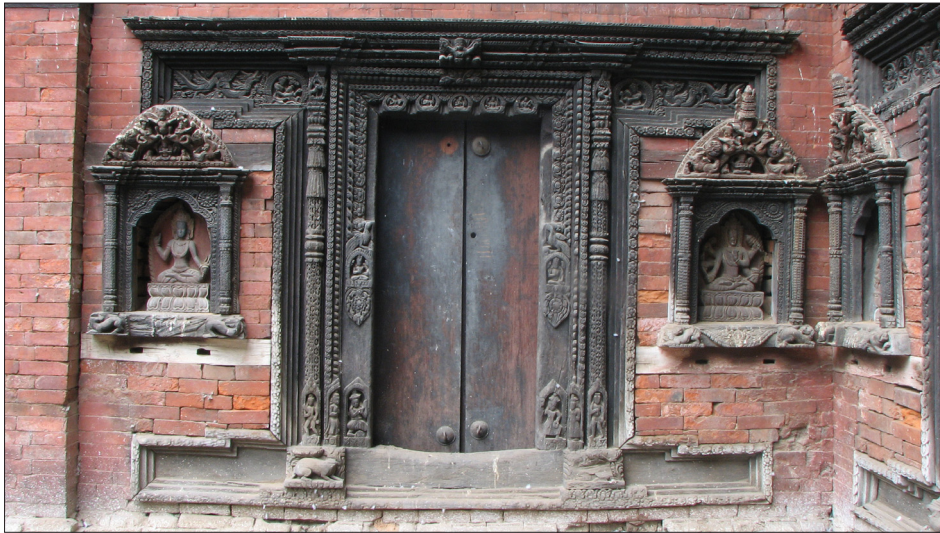
**2.7.D.02** Frame-Original / authentic, Shutters-New (1988)

The structure of the door is in good condition and has most of its carvings still intact. However, 80% of the outer frame at the threshold level have worn out considerably. Both the carvings at the bases are hard weathered with severe damages. The outer frame too has weathered and bleached upto the 18 layers of bricks at the right hand side and 15 layers at the left , thus needs protection from moisture penetration. The upper part of the left jamb above the mystical lion detail has cracked. A large horizontal crack has developed at the entire right projecting end of the lintel.

Since the damages at the threshold are not structural in nature, it should not be replaced. The door is an authentic one so its parts should be retained for its historical importance.

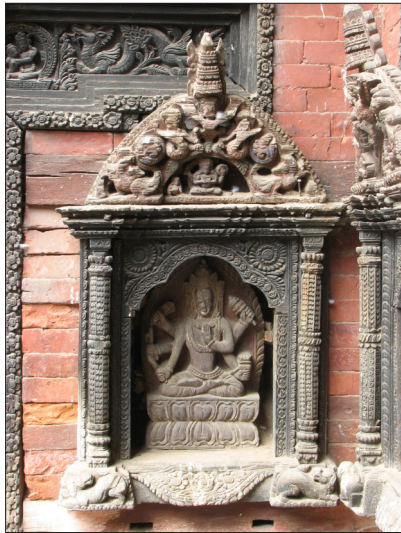
**2.7.N.04** Tympanum-original, frame-after earthquake, statue-after 1988

The structure of the niche is in good condition. The quality of the principal image housed in the niche is inferior. Lower section of the sill has bleached due to the action of the water. 30% of the detail in jambs are worn out. Likewise, the tympanum has weathered considerably with most of its carvings disfigured. The trunks of both the mystical aquatic animals, the faces of the snake girls and the features of garud are lost. It has traces of polychrome paints. The pinnacle is new and crudely detailed as compared to the tympanum and the niche itself.

Replace the image with a new one having iconographically correct meaning. Recarve the pinnacle which matches the quality of carving of the tympanum. For this, we need to take reference of an authentic one from adjacent ones. Thorough cleaning of the niche is essential.

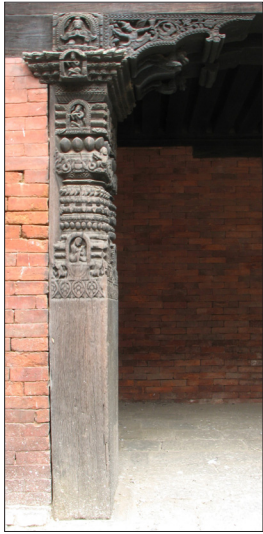
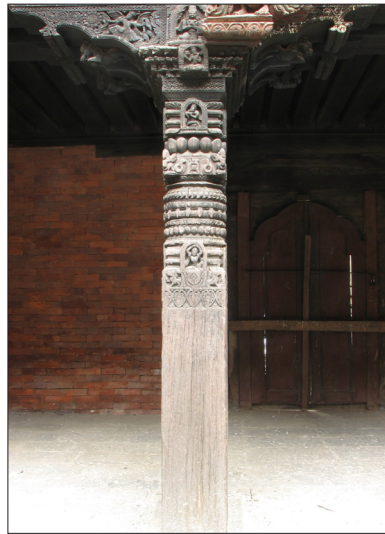
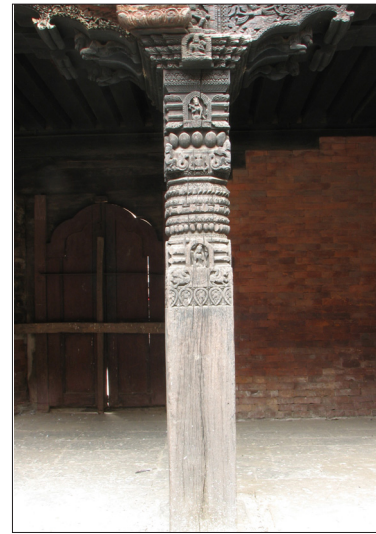
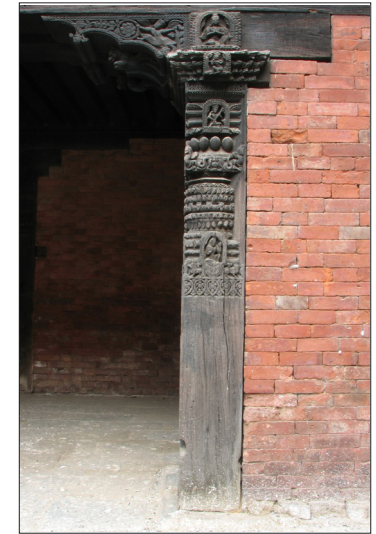
The Pillars are in good condition, the wood is partial weathered.

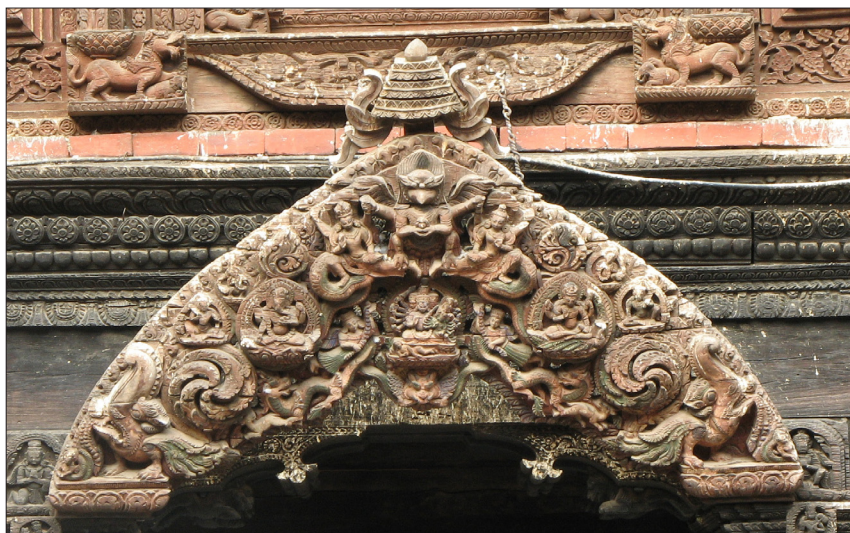
The tympanum consists of four pieces. The top section with the garud's head and pinnacle are crudely done and obviously a new addition to replace the lost one. There joints have opened due to the natural drying of the timber. The edges have weathered and some of the carvings have damaged. A coat of unhistoric polychrome colors covers the tympanum.

Recarve the upper section with finer details to replace the crude existing one. Stabilize the tympanum with plain wood on the backside. Fix the wood with screws through slot holes so that the wood can continue its natural movement. Remove the unhistoric polychrome painting.

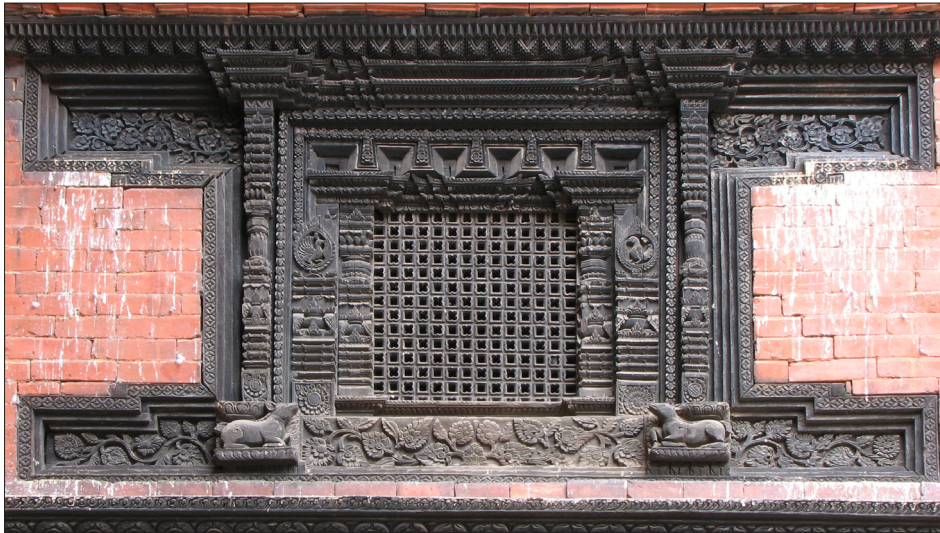
| <b>2.8.W.01</b> | Frame-Original, Latticework-Original |

The structure of the window is in very good condition with only minor cracks in the secondary jambs. The cracks have deveoped at the center of the right frame support and the left secondary jambs. All the carvings are intact.

This is one of the good examples of the intact and authentic window in the courtyard, with minimum damage. However, thorough cleaning of the window is rather essential for its longevity.
