THE PATAN ROYAL PALACE RESTORATION AND CONSERVATION PROJECT

## SUNDARI COK

CONDITION REPORT  
OF THE  
WOODEN CARVED ELEMENTS IN THE COURTYARD

JULY 2007

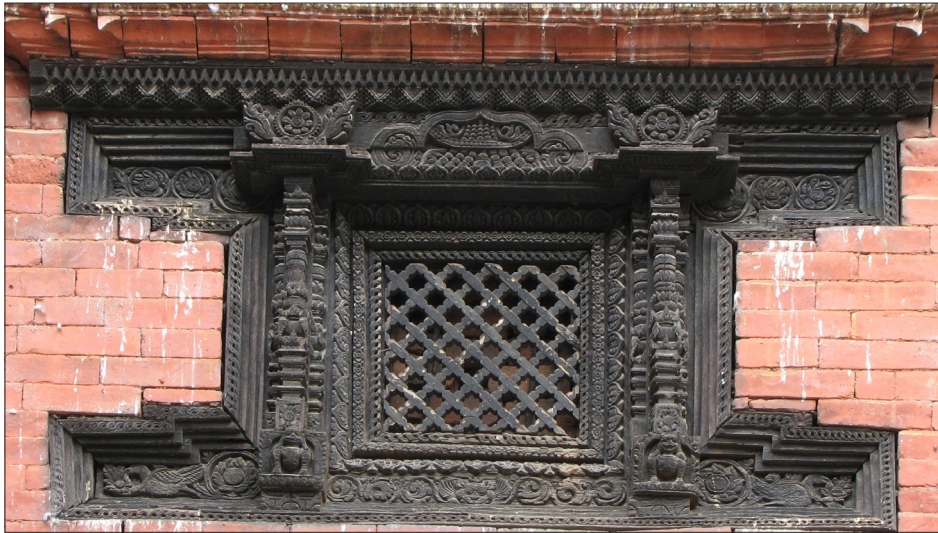
**2.8.W.02** Frame-original, Lattice-new

The structure of the window is in a good condition. The lower portions of the sill including the inner frame are slightly weathered. The bottom and the vertical members of the outer frame at the sill have worn out. There is a minor vertical cracks in the left jamb, extending from its center to its top. The left jamb has shifted by half an inch from its original place above the mountain motif. The lattice work is not authentic and is ill fitted in the frame. .

Readjust the left jamb to its original position. Replace the lattice work with the one copied from the 2.8.W.04. Thorough cleaning of the window is essential.

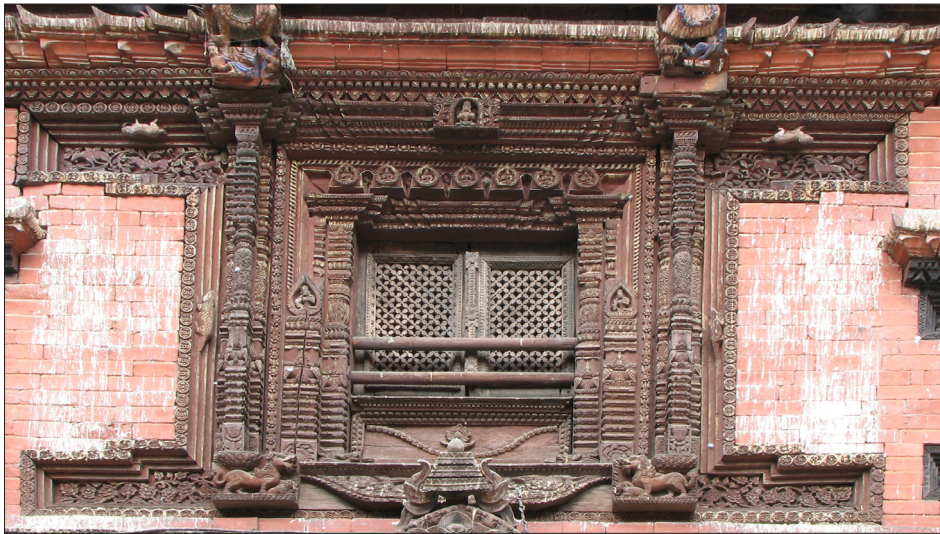
**2.8.W.03** Frame-original /authentic, Shutters-new (added in 1990s)

The structure of the window is in good condition. It has been coated with unsightly red colour and has yellow colour highlighting some details. However, the shutters have not been painted since they have been added only recently, replacing the old ones. The right secondary jamb has a large vertical structural crack starting from the base with lotus flower in a block till the pedestal of the deity at the center. The apron plank is a new one and gaps have developed around it due to the natural drying of the wood.

Remove the unhistoric layer of colour from the window. Reinforce the damaged secondary jamb with steel member to strengthen it. Recarve the apron plank with reference to 2.7.W.3, which is an authentic one.

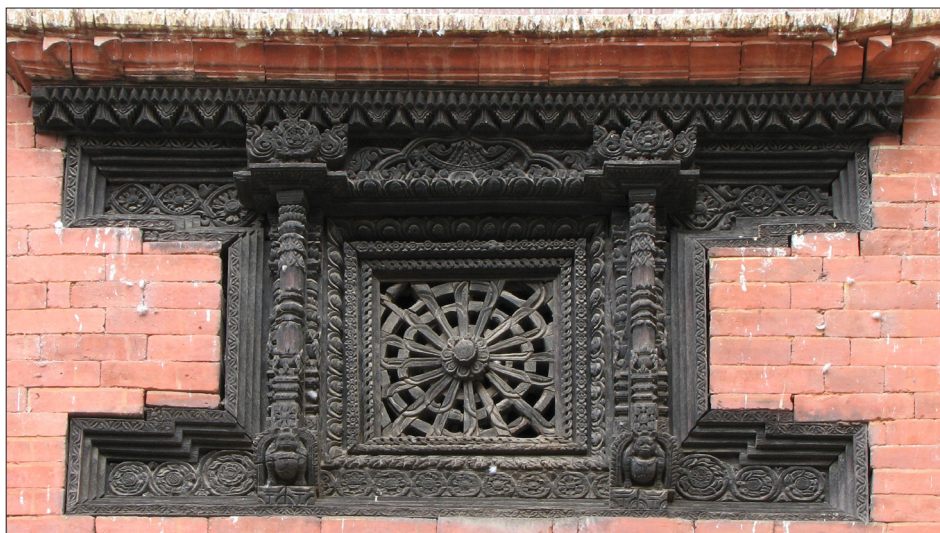
**2.8.W.04** Frame-original, Lattice-original

The construction is in a good condition. The lower section of the window, around the sill and the projections are slightly weathered. The right base of the jamb has a crack. 5% of the latticework is damaged. Some breakages can be noticed in the right top members of the lattice work. The broken pieces have been replace with new plain ones.

Repair the broken pieces of the lattice. The new details should be copied from the intact existing ones. And the plain members should also be replaced.

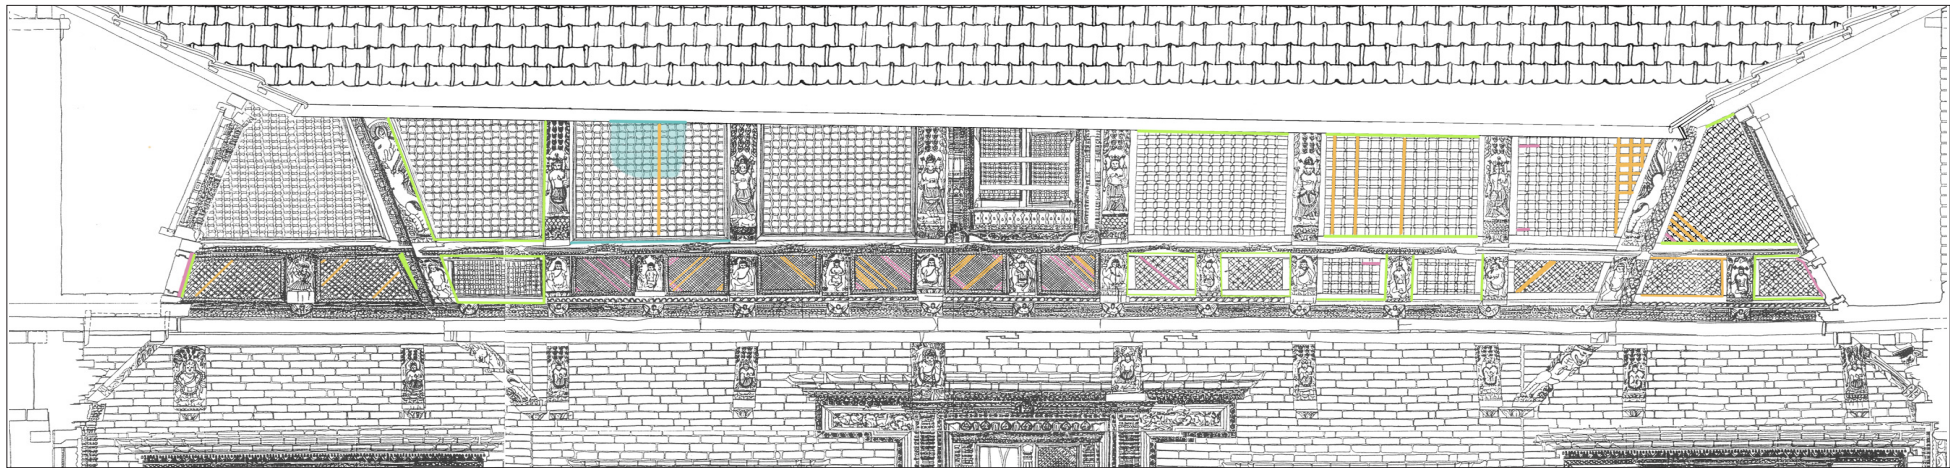
- 2.8.L.01 The lattice and the frame are new and in a good condition
- 2.8.L.02 Frame and lattice are new but a good copy in high quality
- 2.8.L.03 Frame is new, lattice seems authentic, the upper part in the centre is rotten the frame on the bottom is rotten. Elements of the lattice are broken.

- 2.8.L.04 Lattice seems authentic, frame is new, both are in good condition.
- 2.8.L.05 Lattice and frame is new, the lattice work is low grade. The frame and the lattice on top are not fitting, cause the frame is not right crafted for the wood connection.

- 2.8.L.06 Lattice and frame are new, the lattice work is low grade. Elements of the lattice work are broken.
- 2.8.L.07 Lattice and frame are new, the lattice work is low grade. Elements of the lattice work are broken.

- 2.8.L.08 Lattice and frame are new, the lattice work is low grade. The lattice seems replaced from another building, it is too small and twisted with low grade wood complements.

- It is a good example for showing the conservation history.
- It is a good example for showing the conservation history.
- Due to the extensive decay a new lattice and frame has to be replaced.
- A new frame and lattice has to be replaced in the traditional pattern style.
- A new frame and lattice has to be replaced in the traditional pattern style.
- A new frame and lattice has to be replaced in the traditional pattern style.
- A new frame and lattice has to be replaced in the traditional pattern style.
- Repair the lattice. Replace the vertical frame support and fit it into the frame.

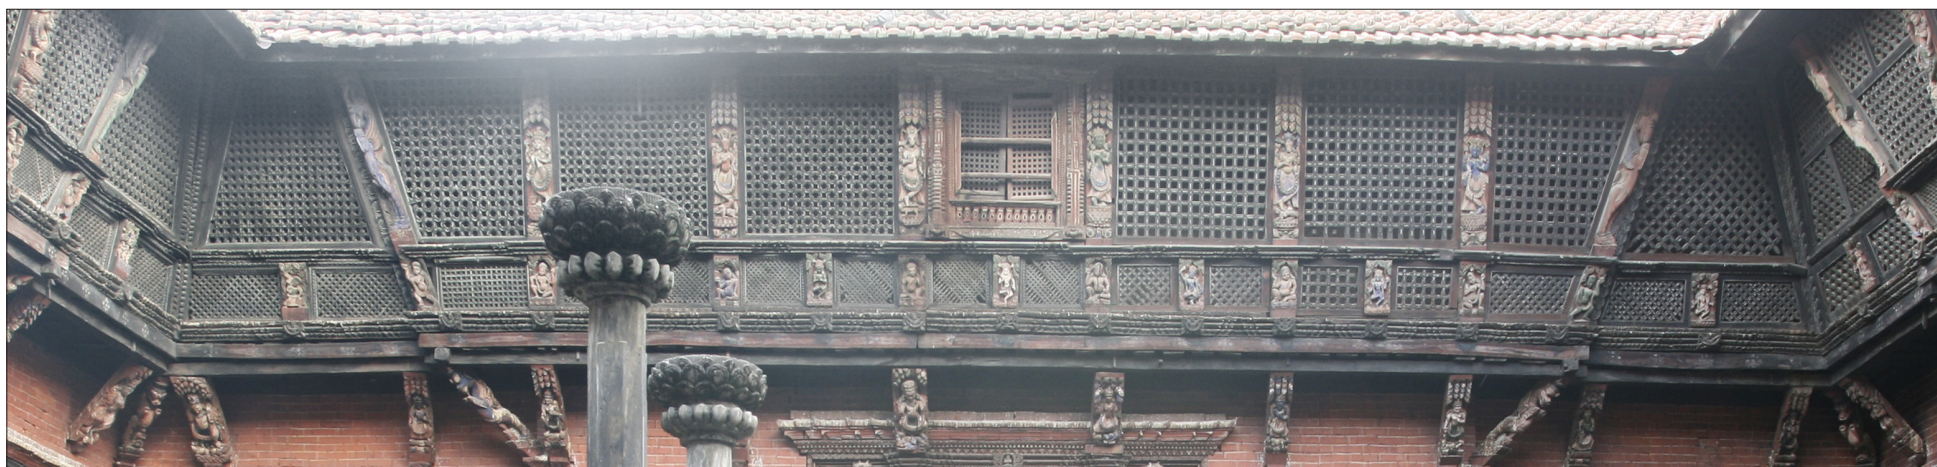
2.8.L.09 a Lattice and frame are new, elements of the lattice are broken. The right vertical frame is missing. Frame and lattice are not fitting.

2.8.L.9b Lattice and frame are new, elements are broken. The lattice doesn't fit into the space.

2.8.L.11aThe lattice seems authentic, the frame is new. Some elements are missing

2.8.L.11bThe lattice seems authentic, the frame is new. Some elements are missing and broken

2.8.L.12aThe lattice seems authentic, the frame is new. Some elements are broken

2.8.L.12b The lattice seems authentic, the frame is new. Some elements are missing and broken

2.8.L.13aThe lattice seems authentic, the frame is new. Lattice doesn't fit into the frame, Some elements are missing and broken

2.8.L.13bThe lattice seems authentic, the frame is new. Some elements are missing and broken

Repair the lattice and fit it into the frame.

Replace the new lattice and frame.

Replace the missing parts with wood complements in the traditional pattern style.

Replace the missing parts with wood complements in the traditional pattern style. Repair the broken elements.

Repair the broken elements.

Replace a new frame and lattice in the traditional pattern design.

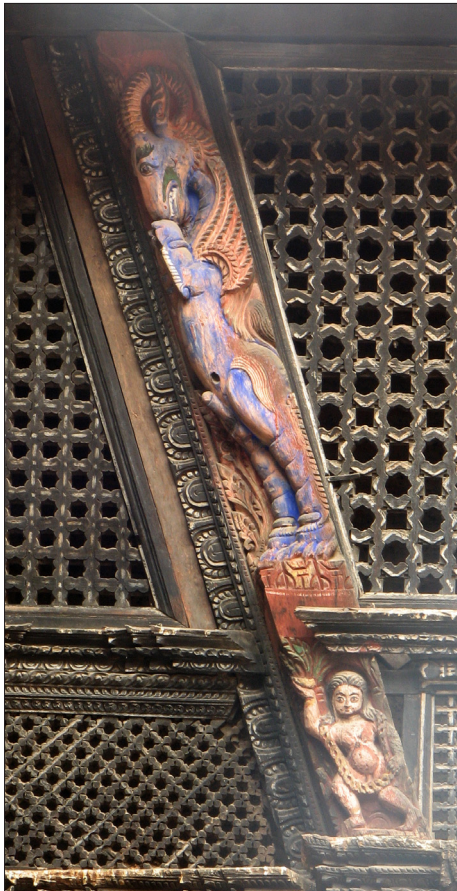
**2.8.S.01** Original

It is in a rather good condition with no structural damage. The area with the auxiliary figure is slightly worn out. There is a hole at body of the main figure above the legs. It has been painted with unsightly polychrome colors. The facial features such as the eyes, mouth have been highlighted with black paint. The quality of carving is inferior as compared to the doors and windows at the lower levels.

It needs to be stabilized and reinforced with steel members for seismic strengthening. The unhistoric paint from the strut needs to be cleaned.

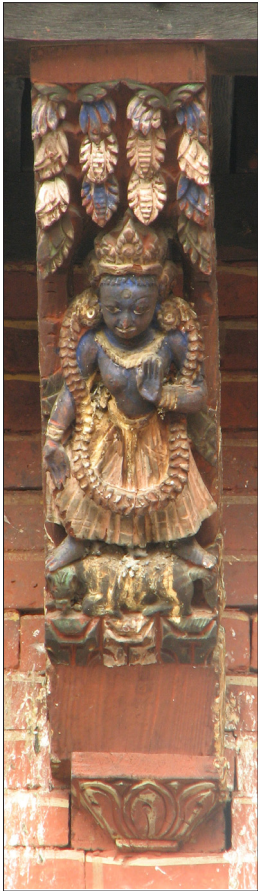
**2.8.S.16** Original

-layer of foliage

It is in a good condition. The detailing of the carvings is very crude and are of inferior quality. The back portion of the strut is affected by the long accumulating bird dropping and dirt. It is colored with unsightly polychrome paint

The unhistoric color from the figures should be carefully removed so as not to damage the fabric of the strut. Then it should be restablized and a plank added behind it to prevent its further damage from bird dropping

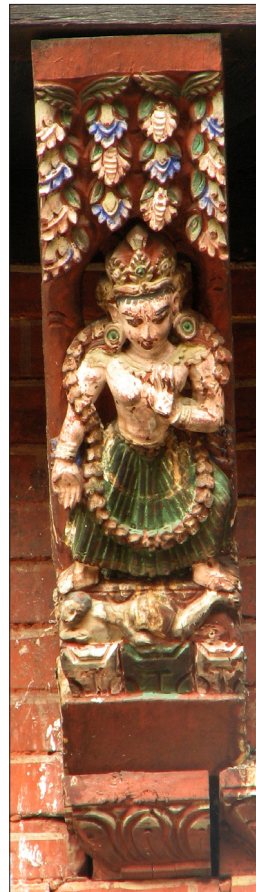
**2.8.S.17** Original

-layer of foliage

It is in good condition. The quality of carving is inferior. The continuous settlement of dirt and bird dropping has damaged the back of the strut. A layer of unhistoric polychrome colors covers it.

A plank needs to be fixed behind the strut to prevent the further its decay from the bird droppings. The unhistoric color should be removed.

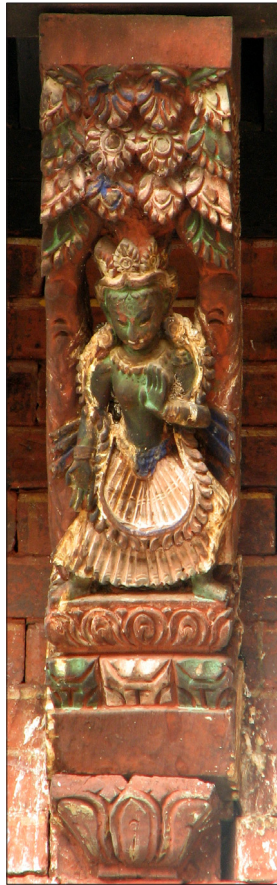
**2.8.S.19** Original

-layer of foliage

The strut is in good condition. The carving details are of low grade. The back area of the strut has weathered due to the accumulation of dust and bird dropping. It is coated with unsightly polychrome color.

The unauthentic color should be removed. It should be stabilized and a plank placed on the backside to protect it from bird droppings.

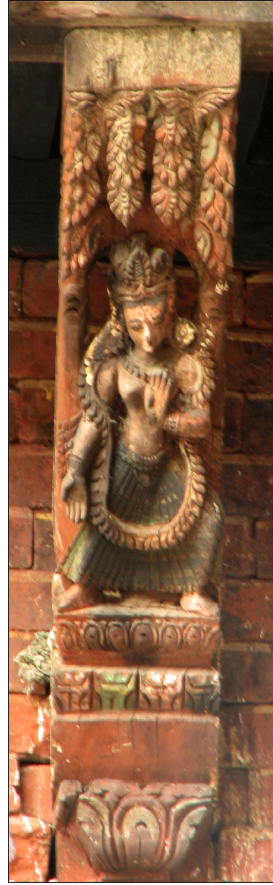
**2.8.S.20** Original

-layer of foliage

It is slightly weathered and has a few cracks on the base. The accumulating bird dropping and the dirt has damaged the back of the strut. It is coated with unsightly polychrome color.

The unhistoric color from the figures should be carefully removed so as not to damage the fabric of the strut. Then it should be restablized and a plank added behind it to prevent its further damage from bird dropping

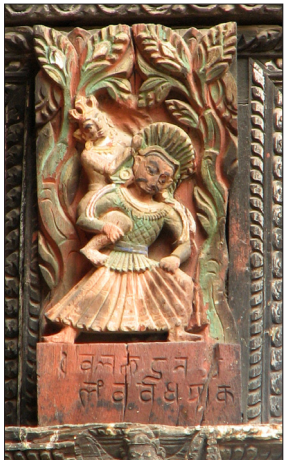
**2.8.F.01** Original

It is in fair condition. and has been painted with unsightly polychrome colors. There is crack at the foliage level and also at the base. Carving is of inferior quality.

The unauthentic color should be removed It should be stabilized to be incorporated when restoring the latticework.

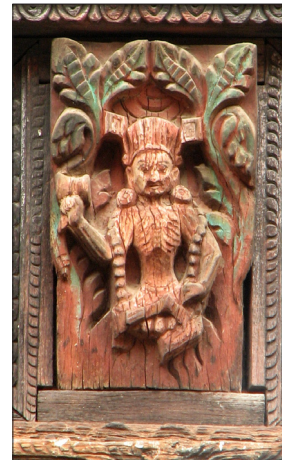
**2.8.F.02** Original

- foliage
- a tantric figure (Camunda) with a skull garland and carrying a drum his hands. The other attribute has weathered.
- base is lost and has been replaced with a plain piece of wood

It has weathered completely and the base is missing. It has been painted with unsightly polychrome colors. Carving is of inferior quality.

The unauthentic color should be removed It should be stabilized to be incorporated when restoring the latticework- The base should be recarved on the basis of other similar element..

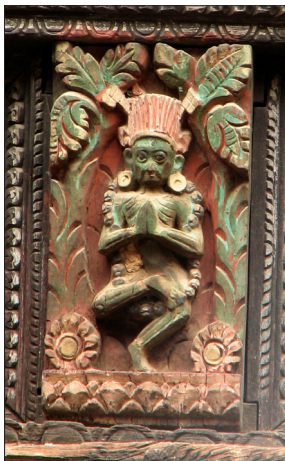
**2.8.F.03** Original

It is in good condition. and has been painted with unsightly polychrome colors. Carving is of inferior quality.

The unauthentic color should be removed It should be stabilized to be incorporated when restoring the latticework.

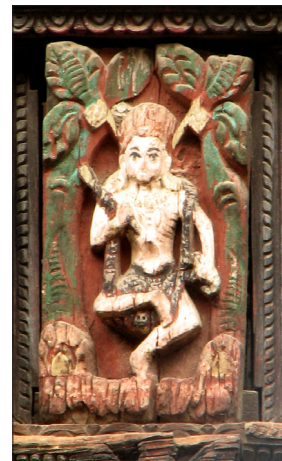
**2.8.F.04** Original

- foliage
- a tantric figure. The attributes have damaged.
- lotus pedestal

It has worn out heavily and attributes are damaged. It has been painted with unsightly polychrome colors making the carving incomprehensible. Carving is of inferior quality.

The unauthentic color should be removed It should be stabilized to be incorporated when restoring the latticework.

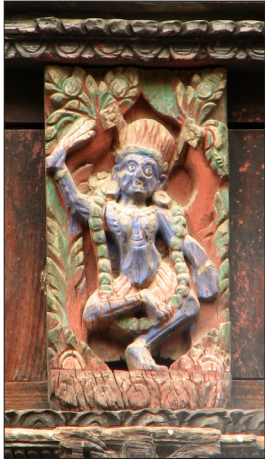
#### 2.8.F.05 Original

-a tantric figure (Camunda) with a skull garland The attributes are damaged.

The unauthentic color should be removed It should be stabilized to be incorporated when restoring the latticework.
