# KAL BHAIKAV

KATHMANDU DARBAR INITIATIVE

## FINAL REPORT

ROHIT K. RANJITKAR\* LUMANTI JOSHI  
**KATHMANDU VALLEY PRESERVATION TRUST**  
MAY 2005

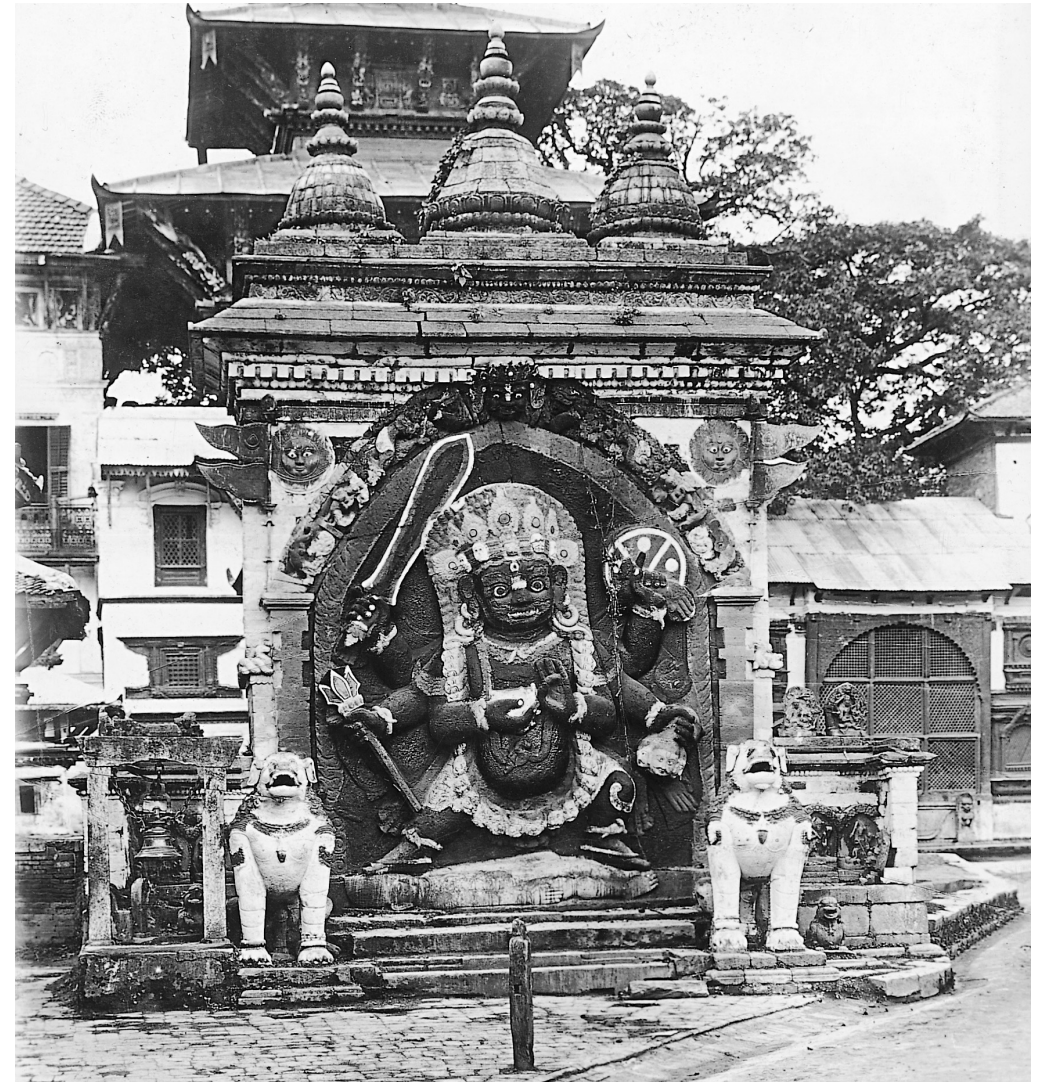
**right:** Kal Bhairav in 1910, before the 1934 earthquake. The details such as the tympanum was found missing prior to the restoration, still existed during this period. This photograph served as the prime reference to deduce the form and intricate details of the lost but vital elements. *Photo courtesy: Manju Rana.*

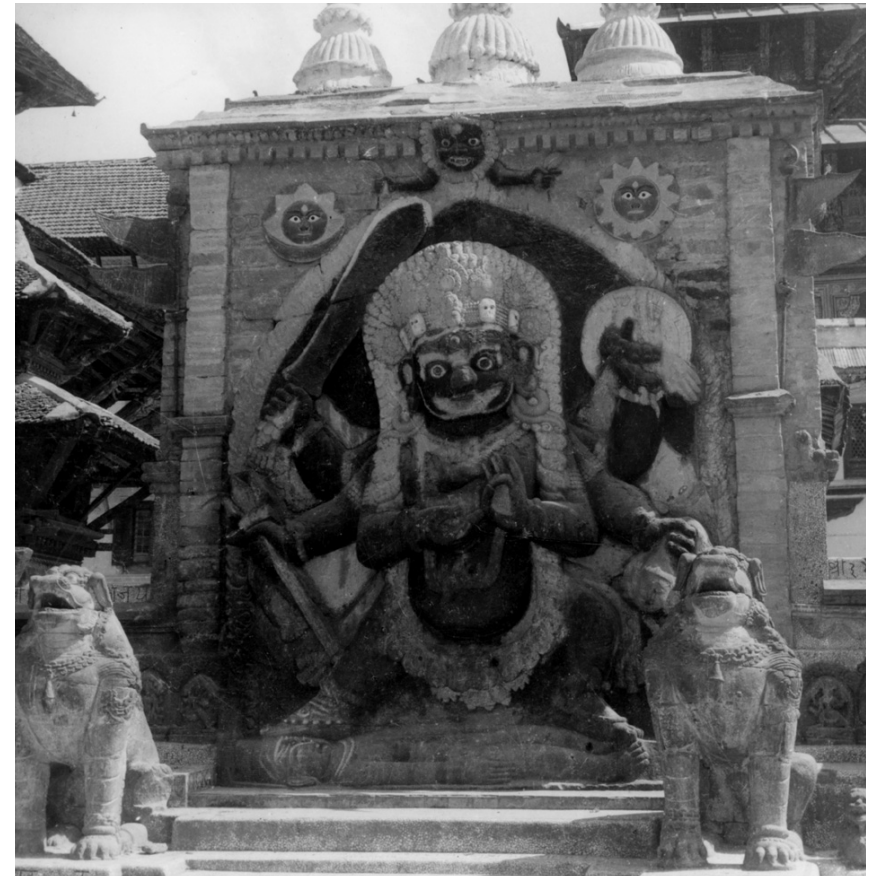
**right:** The photograph from early 1950's shows the changed configuration of the monument, most probably after the earth quake. *Photo courtesy: Bahadur Photo Lab.*

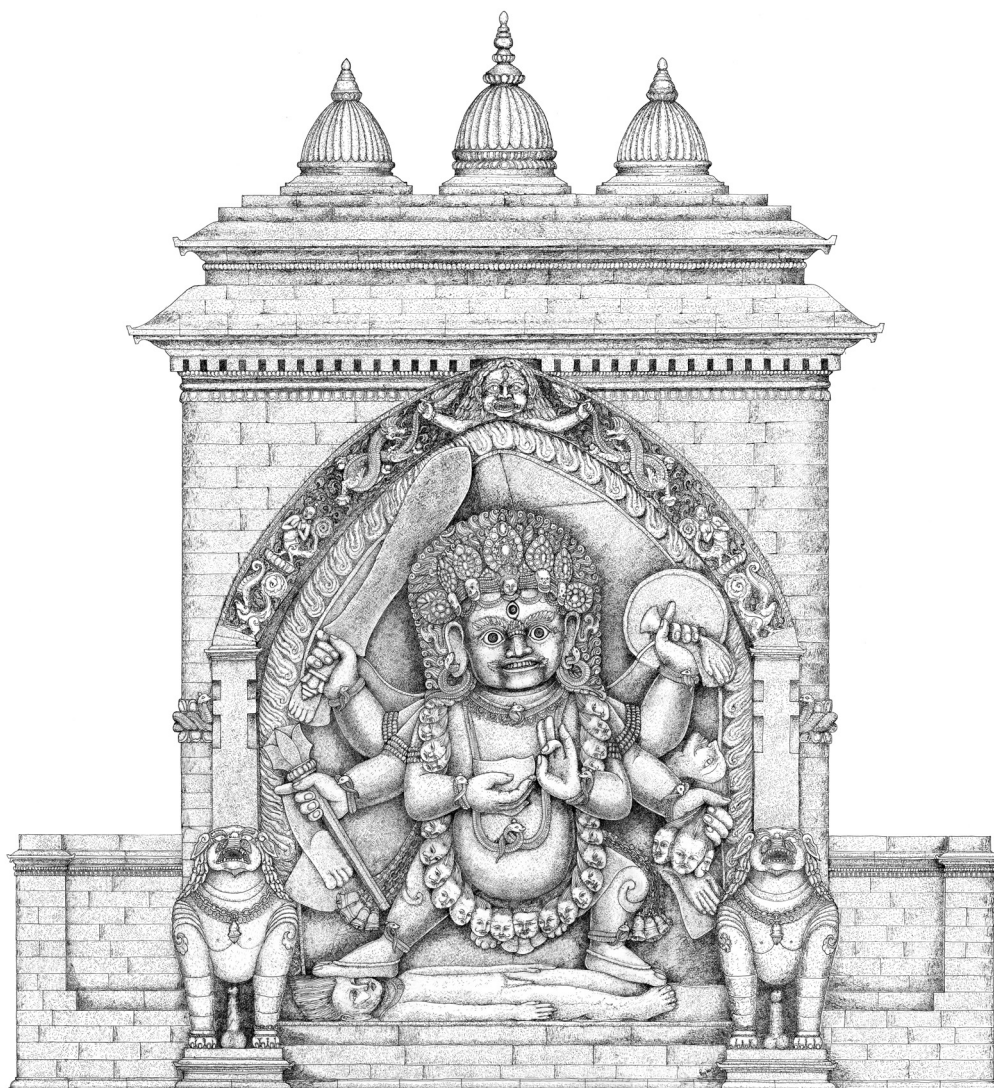
**KAL BHAIRAV**  
KATHMANDU DARBAR INITIATIVE  
**HISTORIC PRINCIPAL ELEVATION**

*left:* This is a preliminary drawing of the monument prepared based on the old photographs. However, it did not include the positions of the images of the deities as well as the other artifacts added over the period of time. Thus, further refinement of the proposed restoration drawing was done, which is included in this report. *Drawing by: Rajan Shrestha, 2002.*
