# The Jalasayan Narayan Pokhari Restoration

Hanuman Dhoka Durbar Museum Development Committee  
Kathmandu Durbar Square, UNESCO World Heritage Site

Historic Structure Report/ Conservation Notes

July 2013

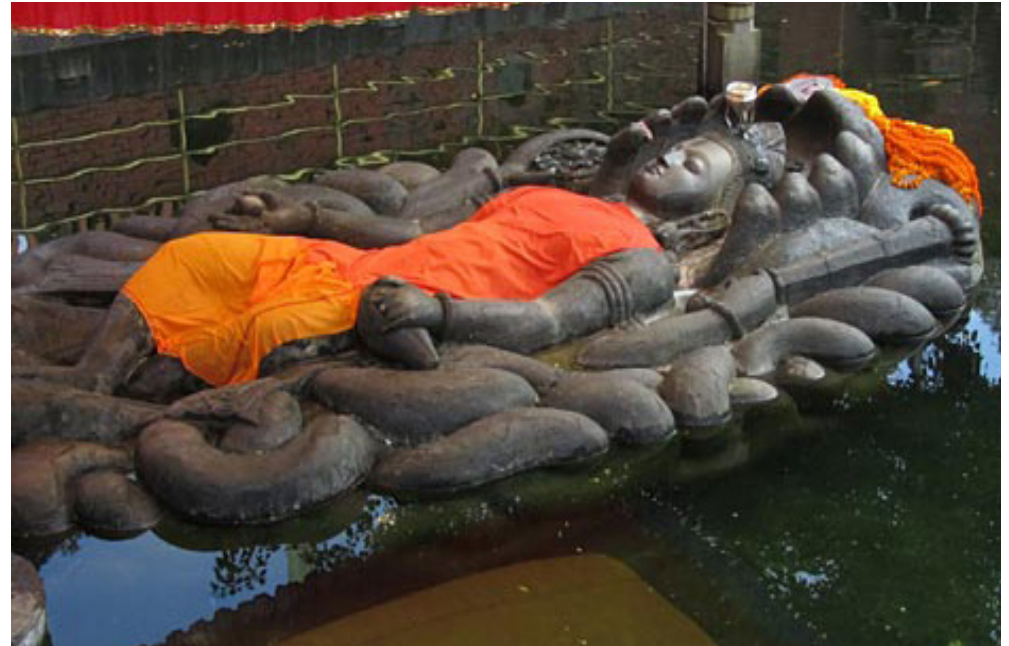
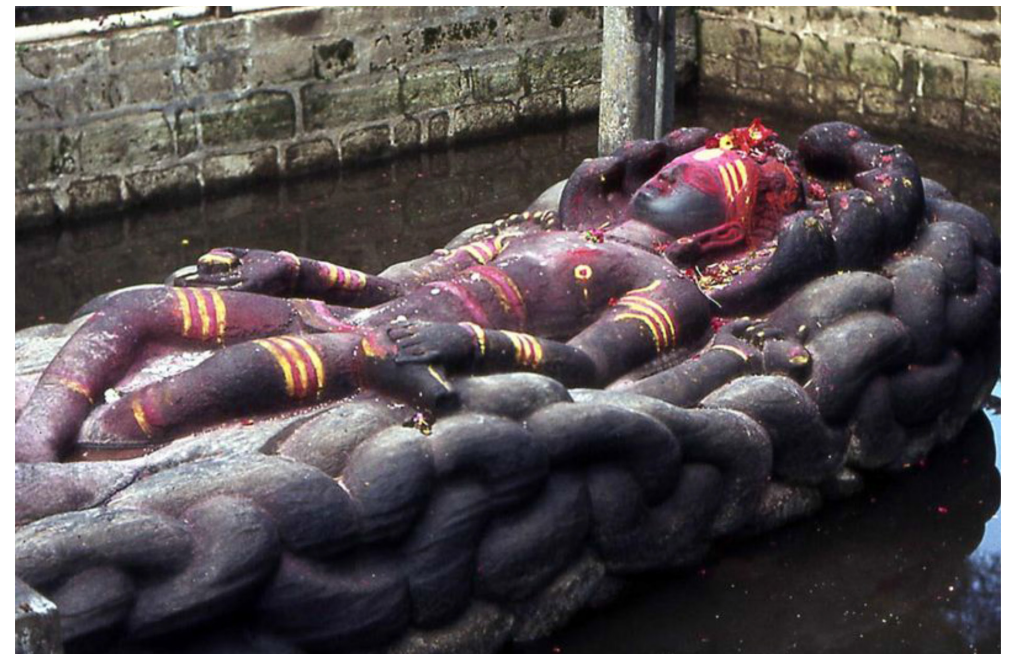
*Top: Budhanilkanth Narayan. Photo Source: <http://sacredsites.com>*

*Top left: Existing condition. Body of two standing heads in the periphery of the main shrine and the other eleven snakes.*

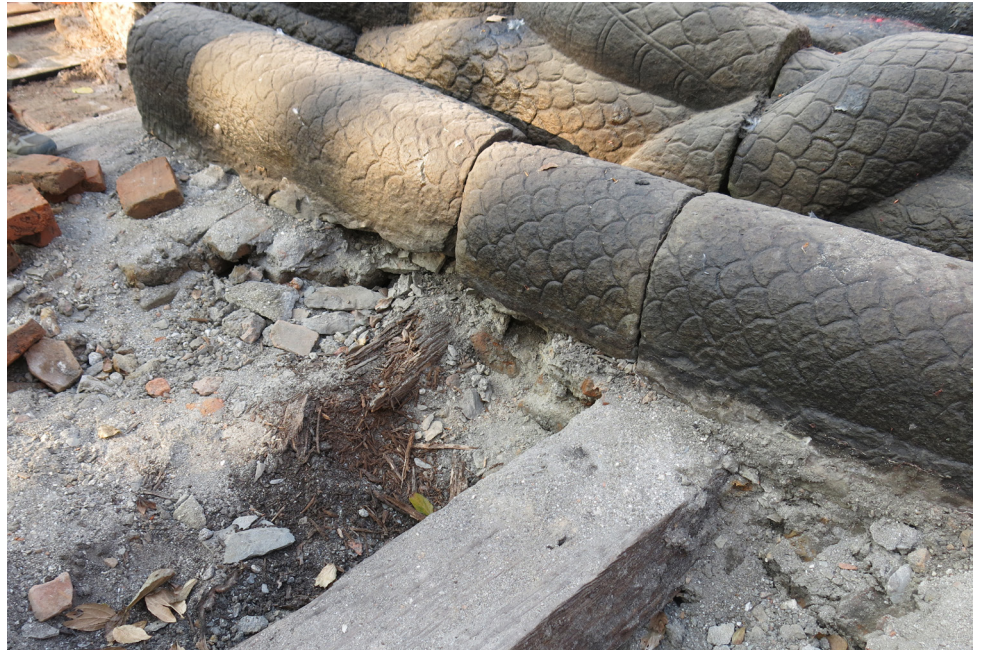
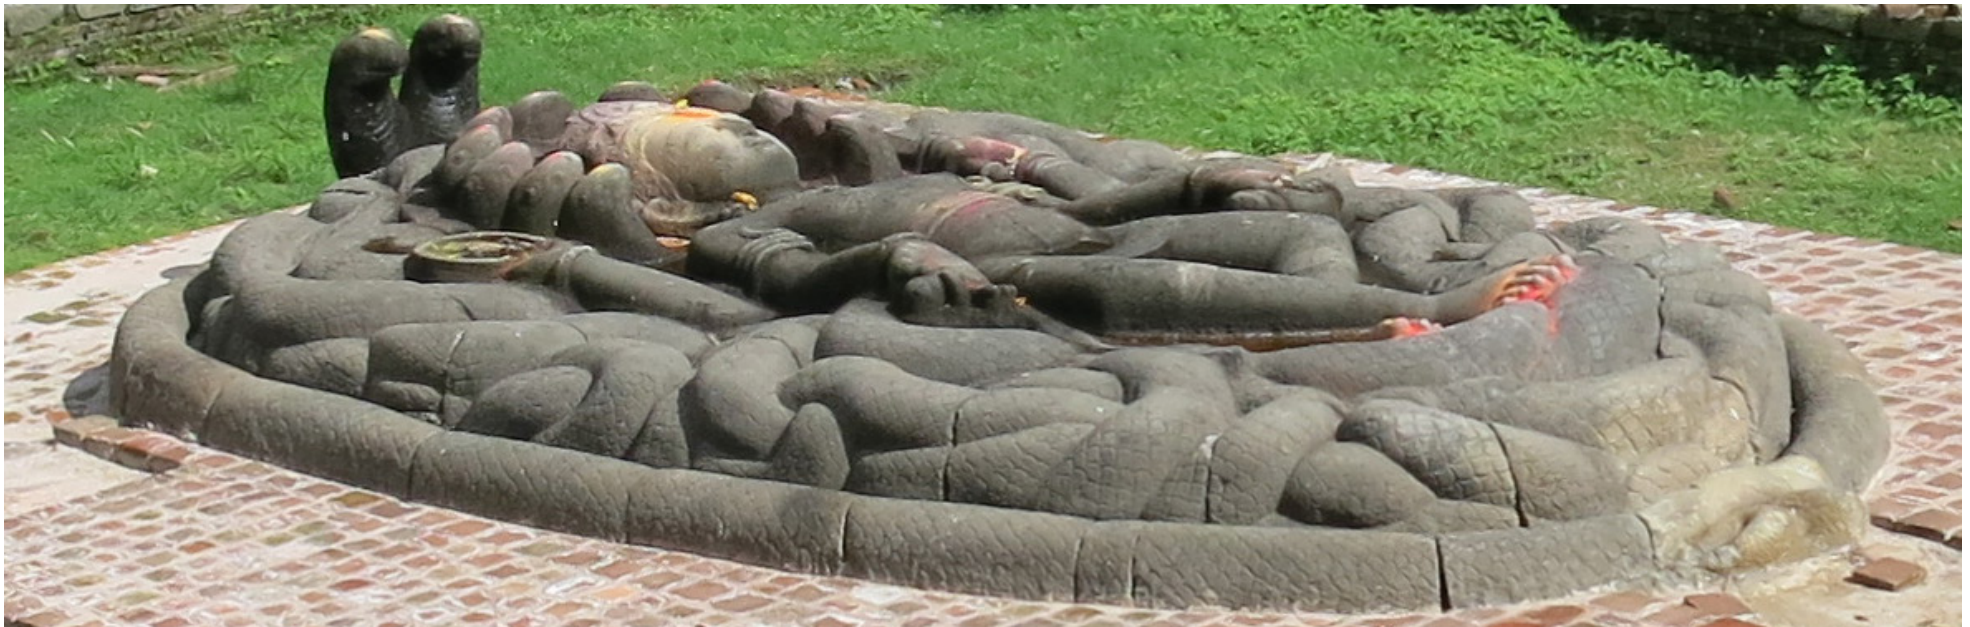
The image is not built on a proper base/ foundation. This is probably why the shrine was placed on timber lumbers to prevent settlement. There is no record of any repair or restoration work of this monument to date. Until a two decades ago, the whole platform was sunken under water. This means that the timber elements would have deteriorated slowly. After the pond dried out, the timber was exposed to seasonal variation of moisture and became damaged faster.

*Top: Timber members were kept below the stone images to stabilize the weight of the stones from settlement. Almost all of the timber elements were in very bad condition and some of them were completely rotten. There was no proper base for the stone pieces. During excavation, only rubble was found beneath the stones.*

Hanuman Dhoka Palace Development Board repaired the base for the main image during the course of the study period. All the rotten timber members were replaced with additional timber beams to protect them from further settlement.

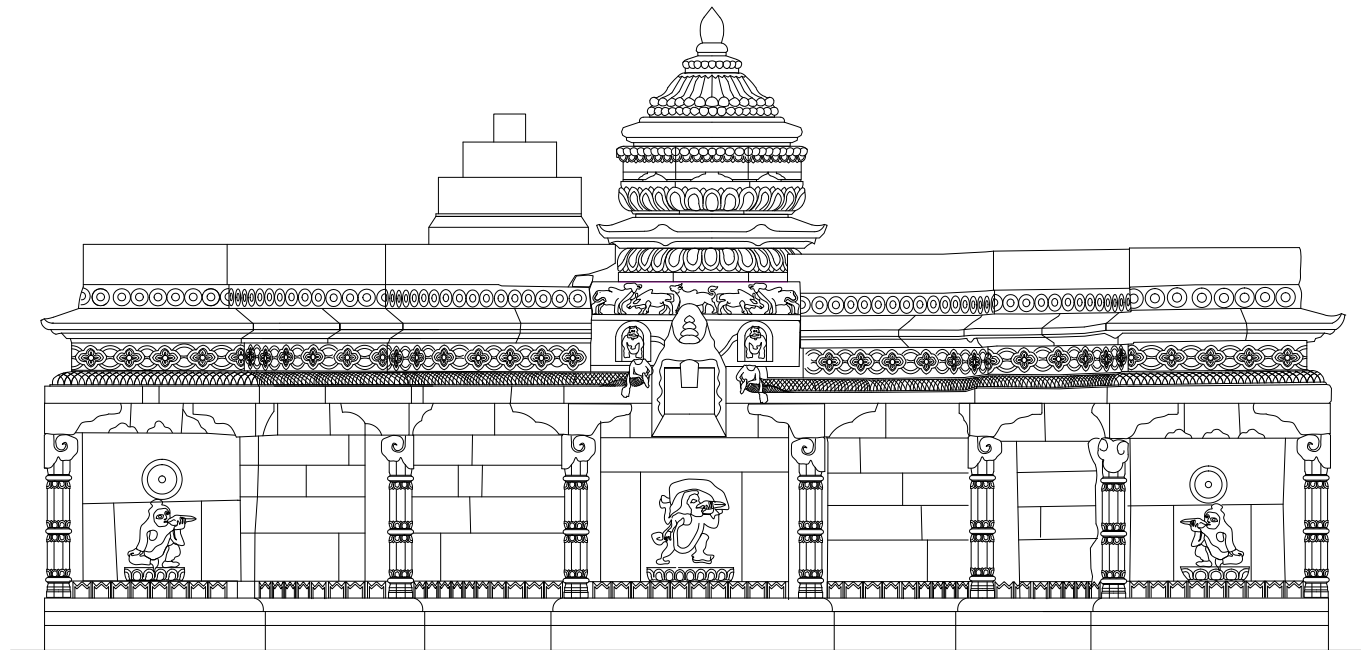
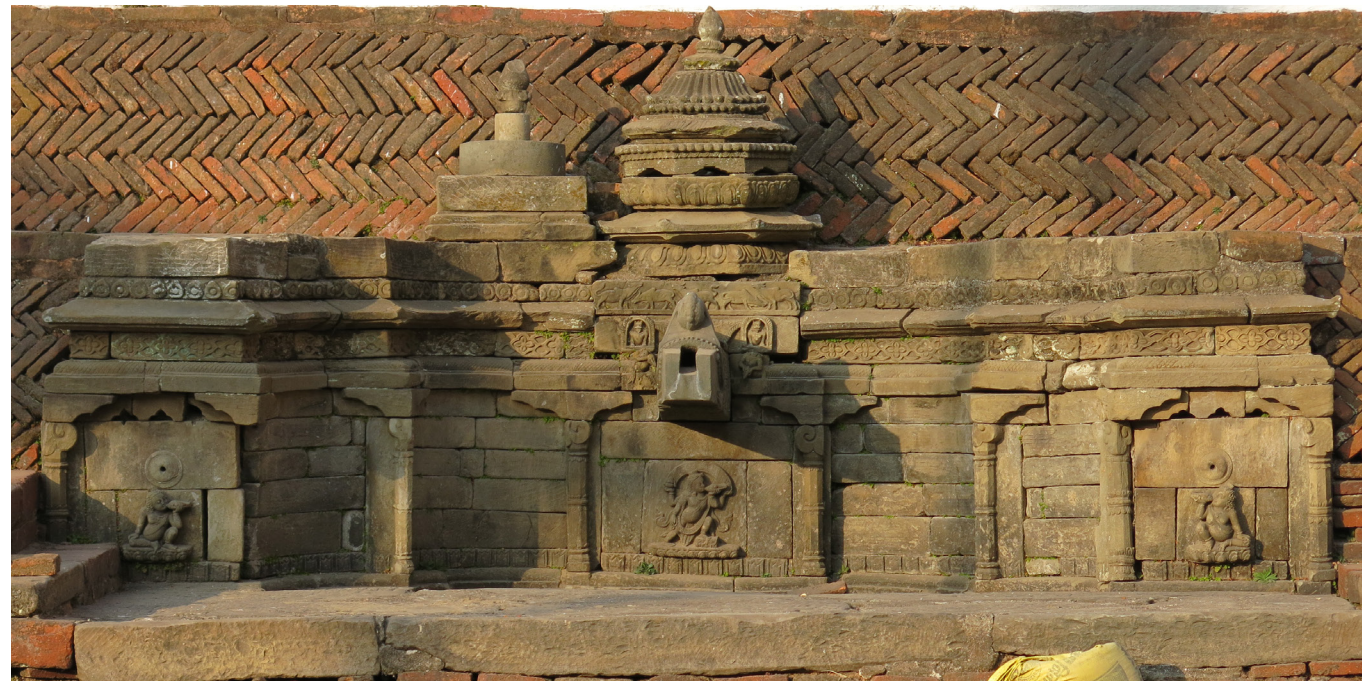
There are two hitis on north and east side of parapet walls, located at the centre of the wall. Stone pieces are in good condition, but there are big settlements in many places, especially on the center including miniature stone temple. The temple is not sitting on the center, which indicates sloppy maintenance or repair from past. A few stones from top edge are broken and one stone on the right corner has been replaced with brick.

There are no major damages on the stone wall surfaces. The miniature temple behind the hiti appears incomplete. Remaining elements indicate that it was a miniature shrine that stood on small pillars. Some of the sections are missing and they are stacked in the wrong configuration, most probably after the 1934 earthquake. The Shiva Linga beside the small shrine does not seem to be original to this place. The hiti has been dry for many decades, as reported by Hanuman Dhoka office.

*Top photos: Heads of Nagkanya on both side of the hiti is broken. Some sections from the miniature shrine is missing. The stone pieces are not even stacked in the right order.*

*Bottom photos: One corner stone pillar on the left side is missing. Steps made from large brick are not built in its proper place, overlapping carved stone elements. But on other side still in proper location including drain for escape water from hiti.*

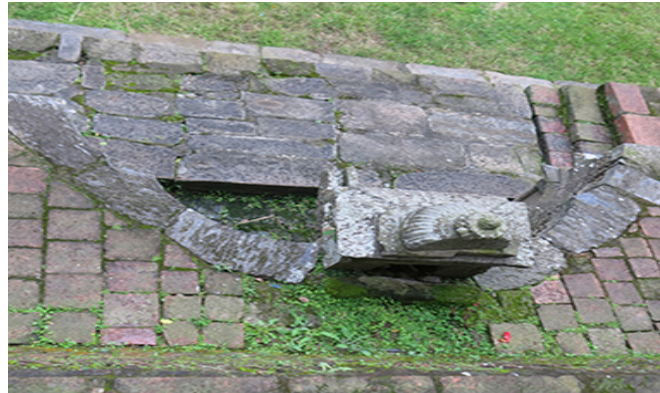
Bottom: Even rain water is not flowing to the pond, due to the lack of a proper drainage outlet. Almost all the stone pavement is missing on the hiti floor. Nagkanya on the right is intact, but left side is missing.

Bottom right: small miniature temple leans backwards.

Top right: Looks like miniature temple is sliced (?) at the back.

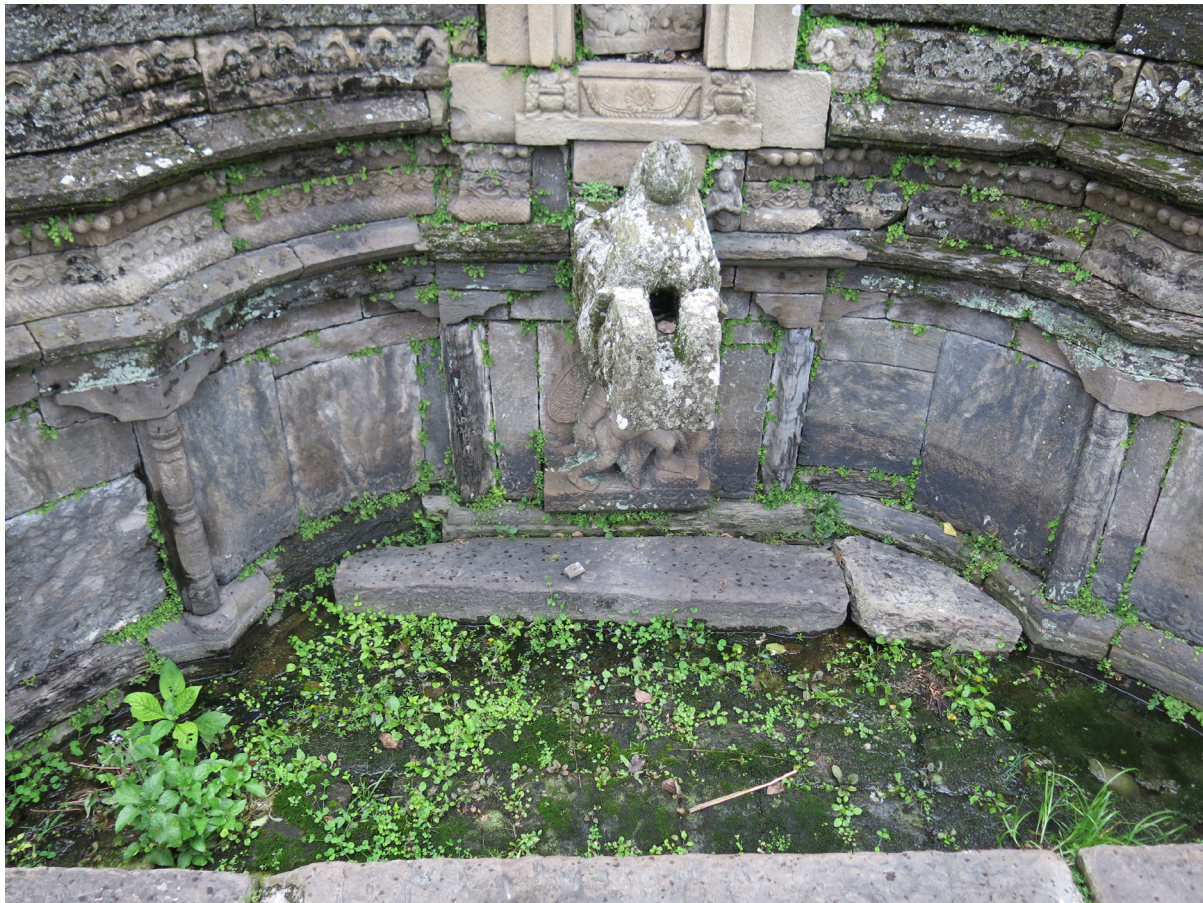
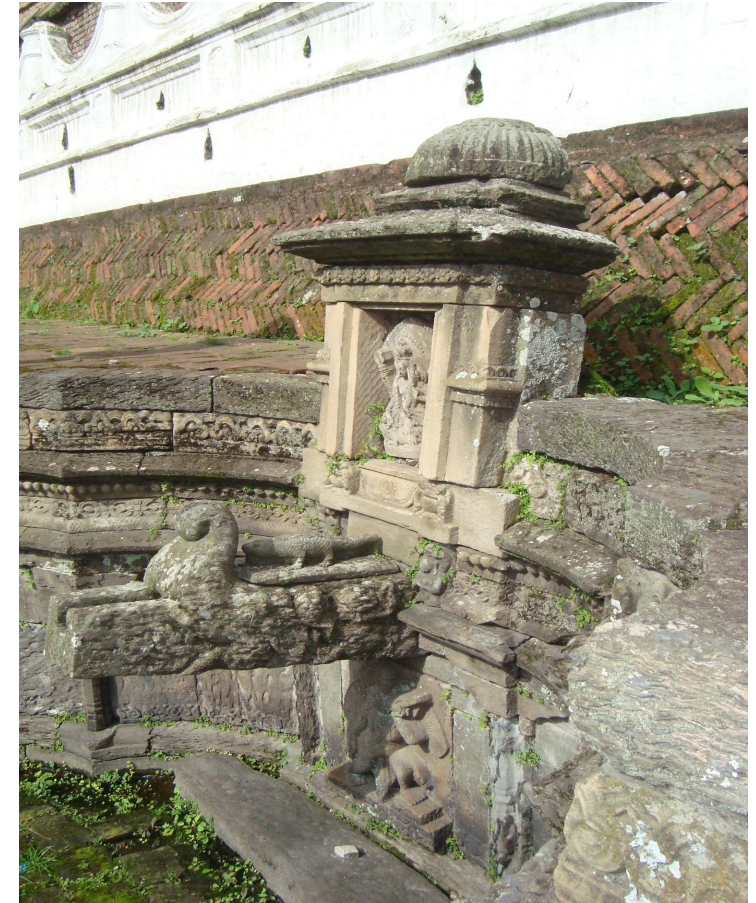
The stone pieces of the eastern *hiti* are also in good condition. Big settlements have caused the miniature temple to lean backwards. Plinth floor just behind the temple is also sunk and missing flooring materials. Otherwise there are no major structural problems. Most of the stones are in good conditon too. No running water on this *hiti* as well. The stone flooring of sunken floor of the *hiti* was replaced with brickworks made worst by drainage problem.

Quite often small miniature shrines are located just behind, on the main wall, above the *hiti* level. All the elements on small shrine on eastern *hiti* still exist, but are inclined backwards. This needs to be sloped in the right direction to allow water to flow properly. It makes sense to also straighten the inclined back shrine to its right position, because it needs to be dismantled to straighten the *hiti*. Few small details are missing, such as one of the Nagkanyas, which can be replicated on the basis of the same one on the opposite side.

Flooring should be rebuilt with stone, as it is now replaced with brick soling without proper drainage. As usual damp is visible in the structure, because it is directly attached to the earth, requiring regular cleaning and removal of grass, especially during the rainy season. The back floor of the miniature temple urgently needs repair to prevent water seepage thru stone wall.

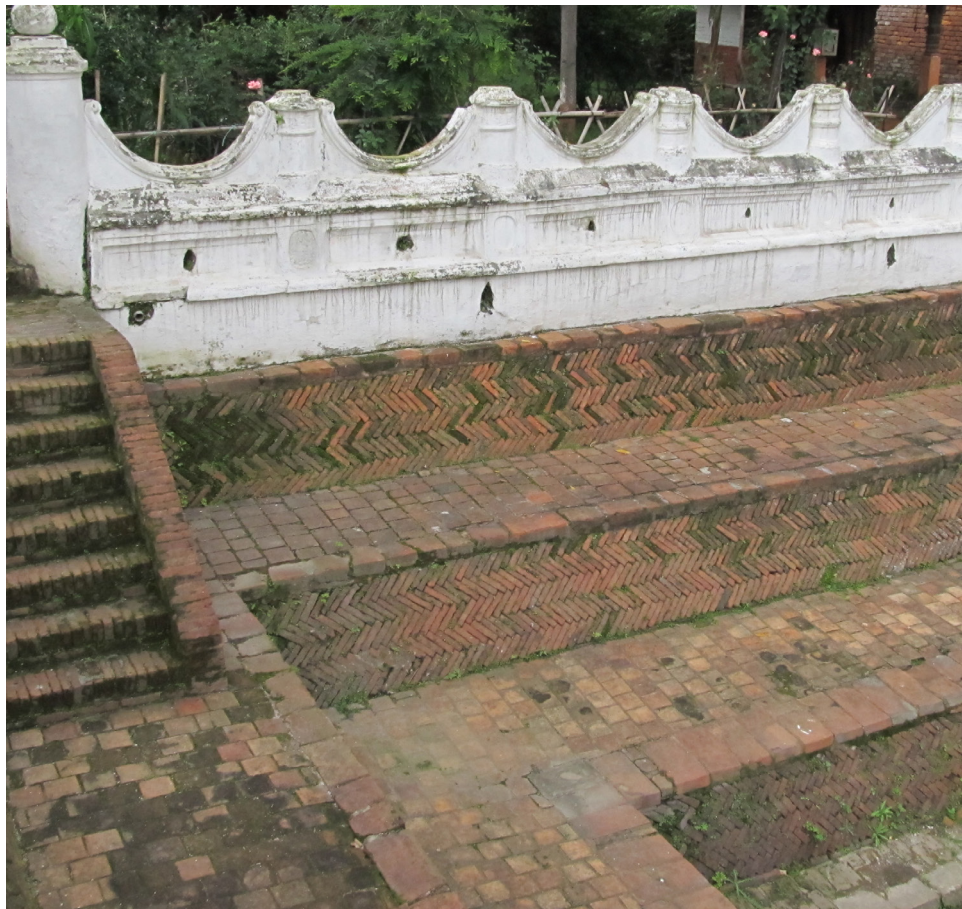
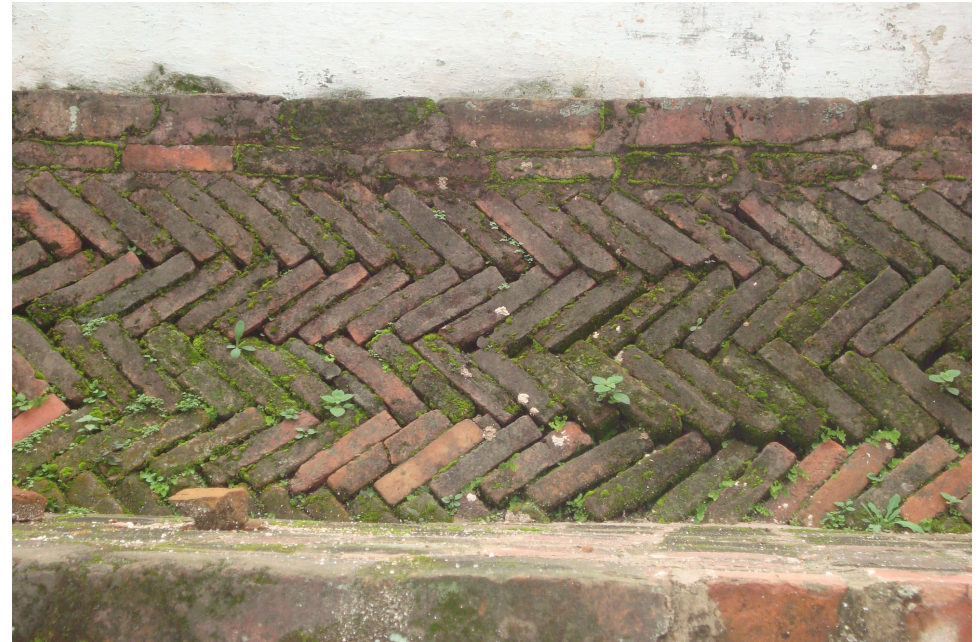
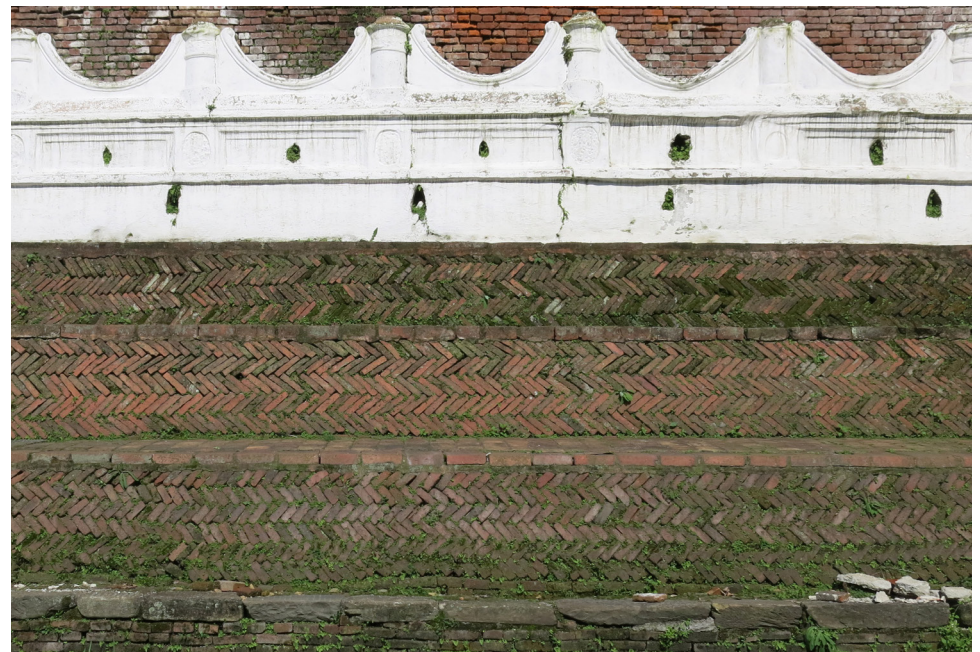
There is evidence of some repair within the last few decades on all levels. The traditional floor tiles are of different types and are not always perpendicular to the edge, as they were intended to be. Minor settlements were found in a few places, otherwise most of the plinth floor areas are in decent condition.

*Bottom Left: 2nd edge bricks are laid on header bond, whereas 3rd and 4th level are very irregular. On the 4th level most of the bricks are laid on stretcher bond.*

*Bottom Right: On the west side of the 3rd level a large area was settled on the joint between edge brick and tile pavement, allowing rainwater to penetrate the plinth structure. Similarly, on the west side of the 4th level, large edge bricks were settled in the wrong angle, accumulating rainwater. Photo: Jun., 2013.*

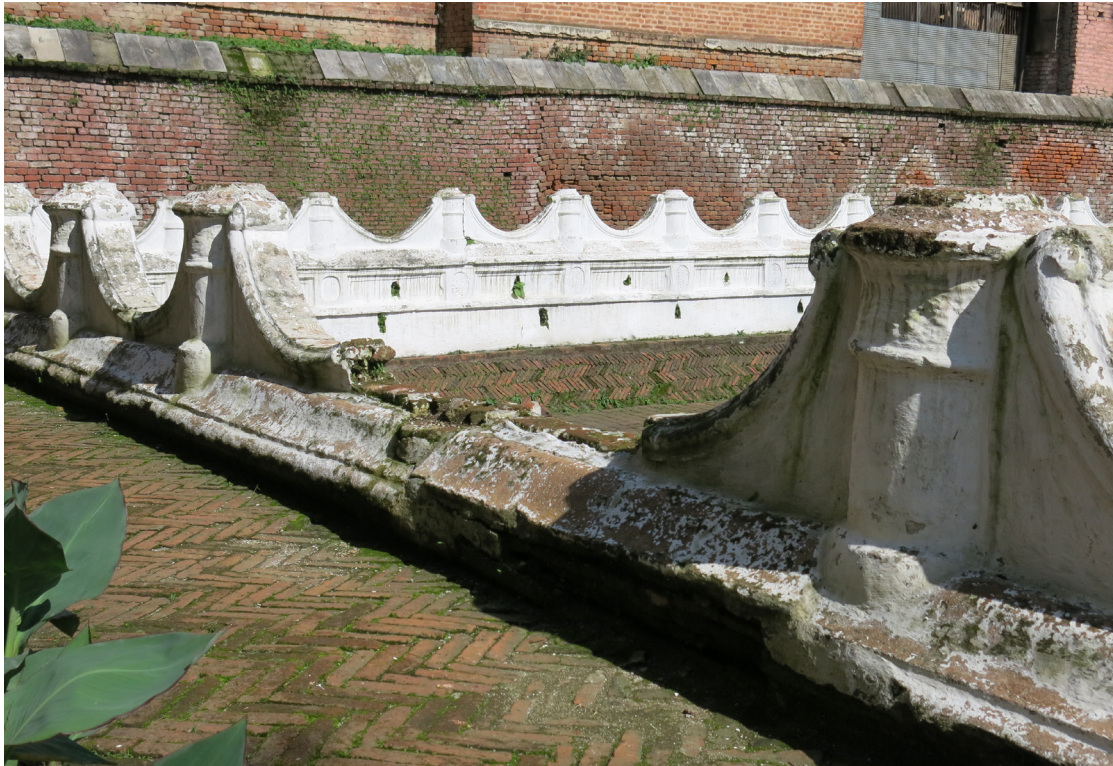
There are cracks on several places. Some of them are only superficial cracks on plaster only, while a few cracks show evidence of structural damage.

In some places the plaster work has fallen but instead of being repaired the damaged parts have just been whitewashed.

*Left: Upper parapet, North. This is the only large section that is missing. Photo: Jan., 2013.*

*Right: North Entrance to the pond. Stucco plaster is broken off on the pillar and large vertical cracks are also visible. Recent repair work shows superficial beautification rather than the restoration of broken areas to increase the stability of the structure. The stucco plastered area was whitewashed and damaged elements were not replaced. Photo: Jul., 2013.*

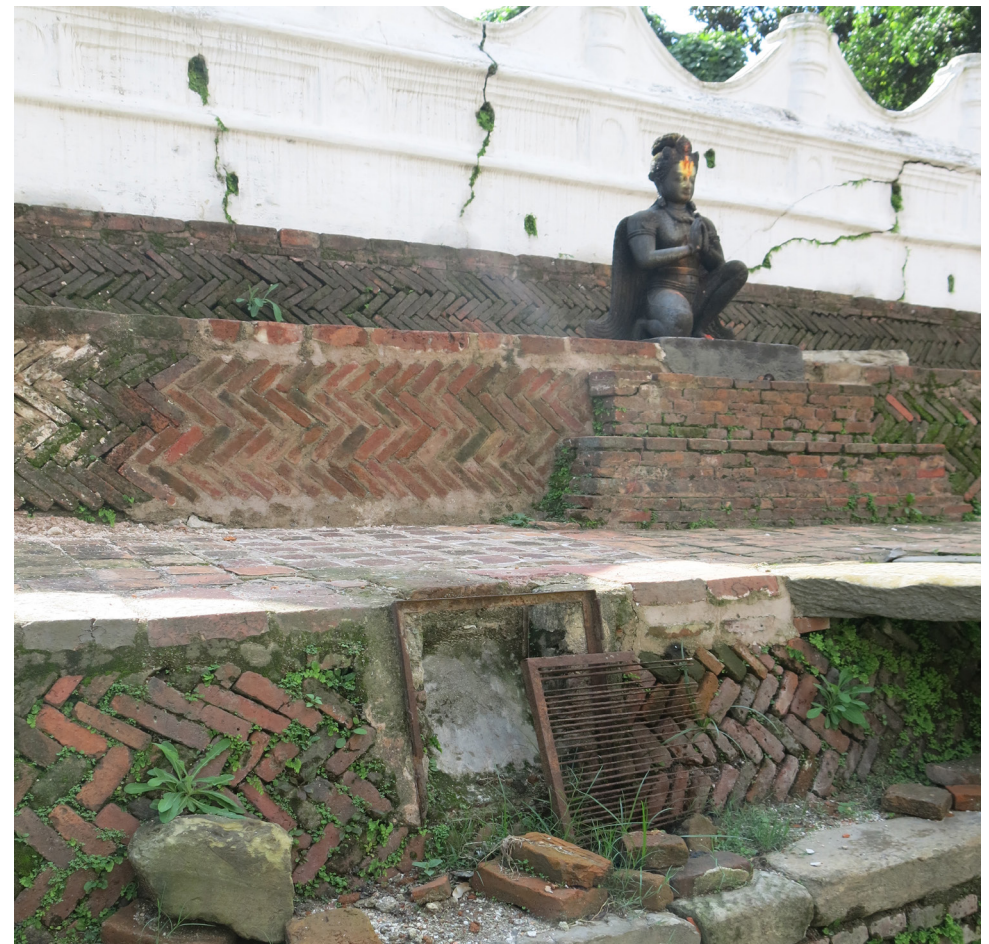
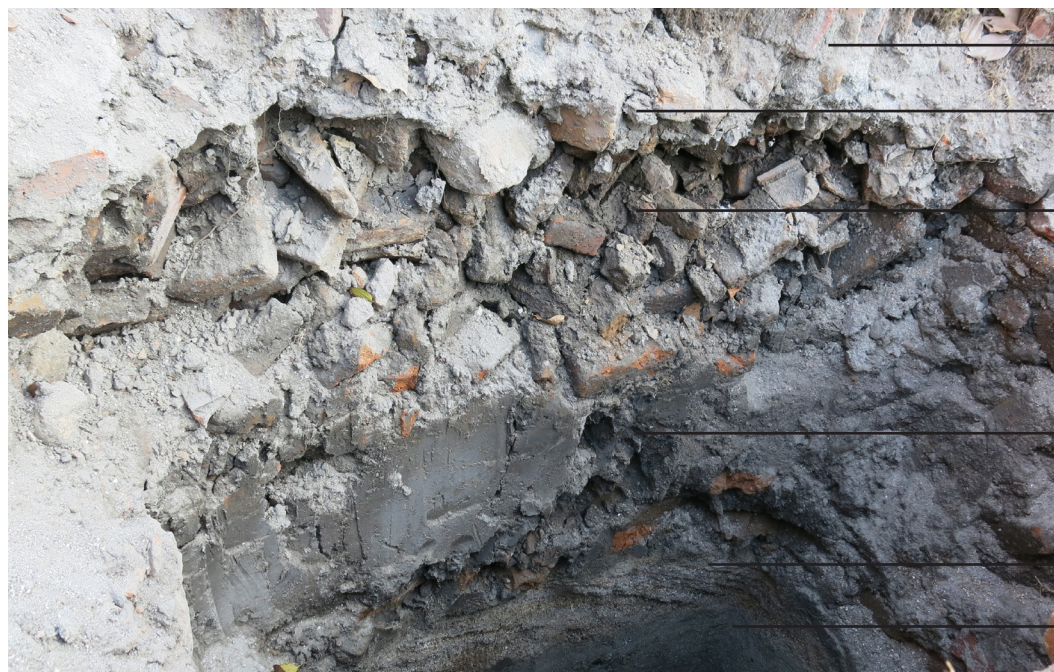
The surface of the pond is paved with on-edge bricks without any solid base. This is insufficient to keep water trapped in the pond. It is thus likely that the water table was always higher in this area. Now a days the whole pond surface is covered with grass.

*Trench was excavated to examine the condition of the pond. There was no virgin soil found up to 5 feet trench. About 2 feet was only rubble filling, and some soil was found below that, but again some brick bats are mixed with mud.*

Flooring: Before the wall reconstruction, the floor of the pond needs to be repaired properly. The existing floor level will be retained. The existing on-edge brick soling should be removed carefully, so that those bricks can be reused in the same area. Another 12.5" should be excavated to allow for brick soling, black soil, and an additional layer of brick soling before final brick soling on edge. See drawing for details.

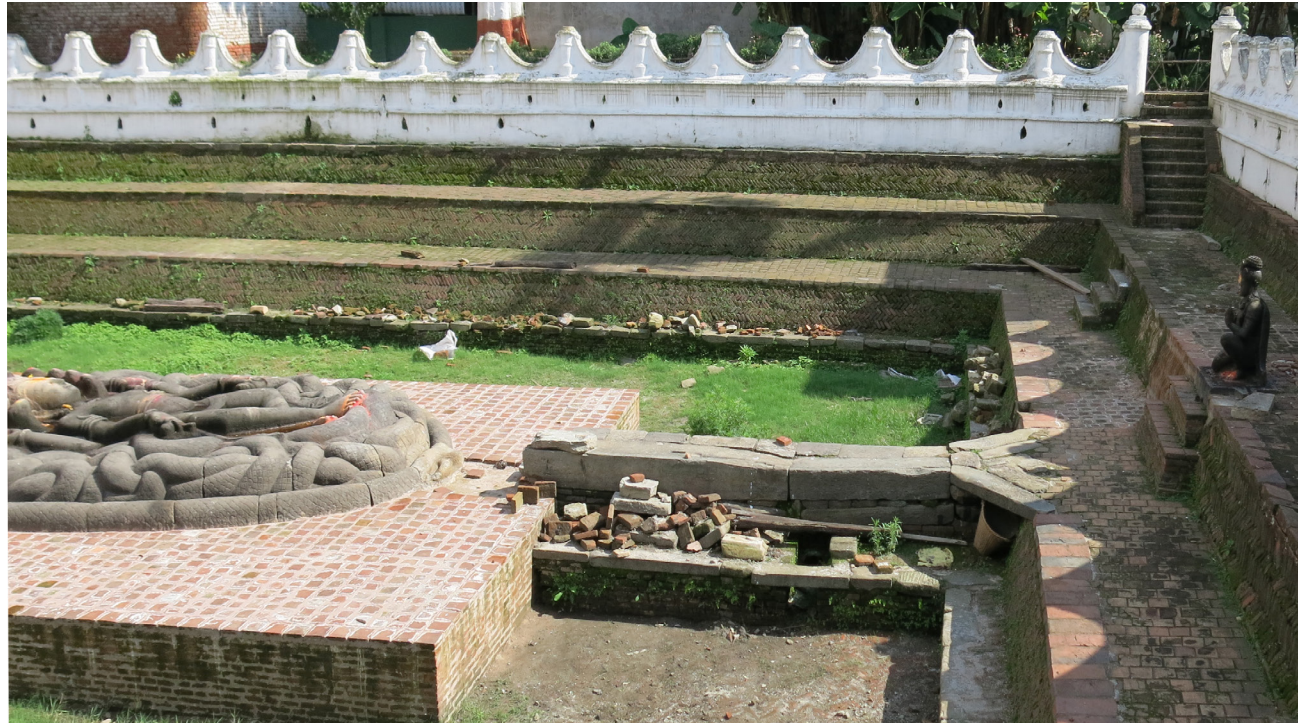
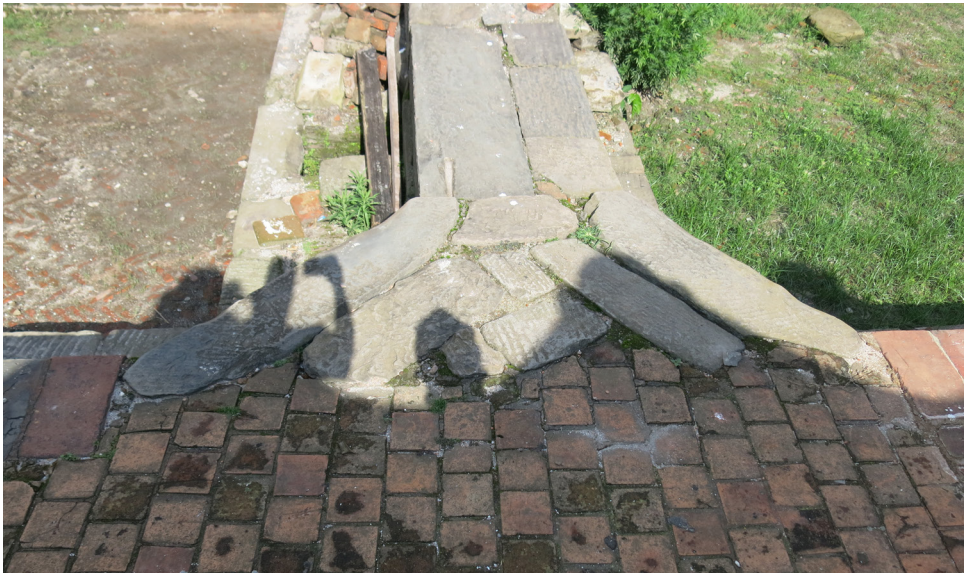
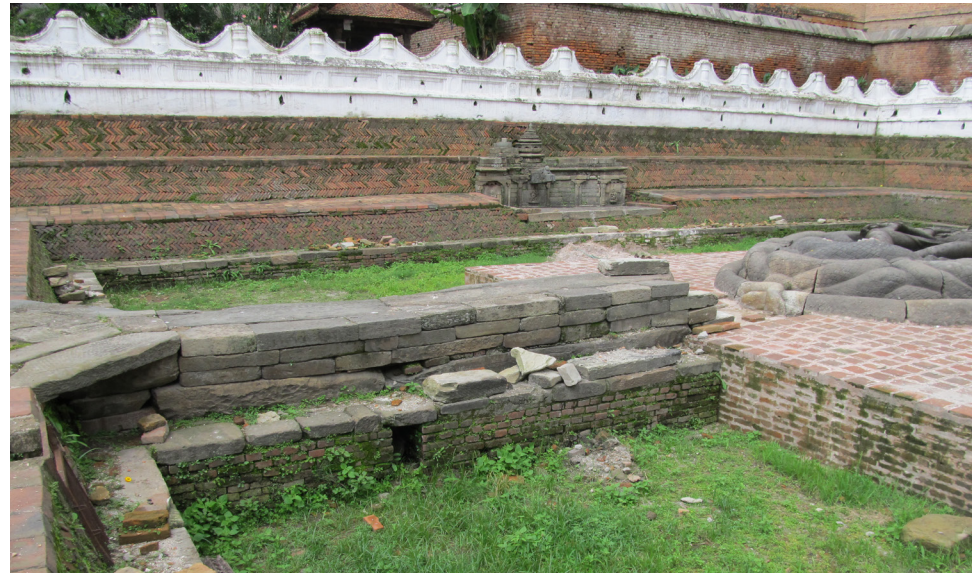
*Bottom left: Stone pavement and telia tile pavement is merged on same level.*

*Bottom right: Bridge from South side. Upper level is fully built with stones and lower level which is an extension of the lower-most plinth, a brick wall with stone edges.*

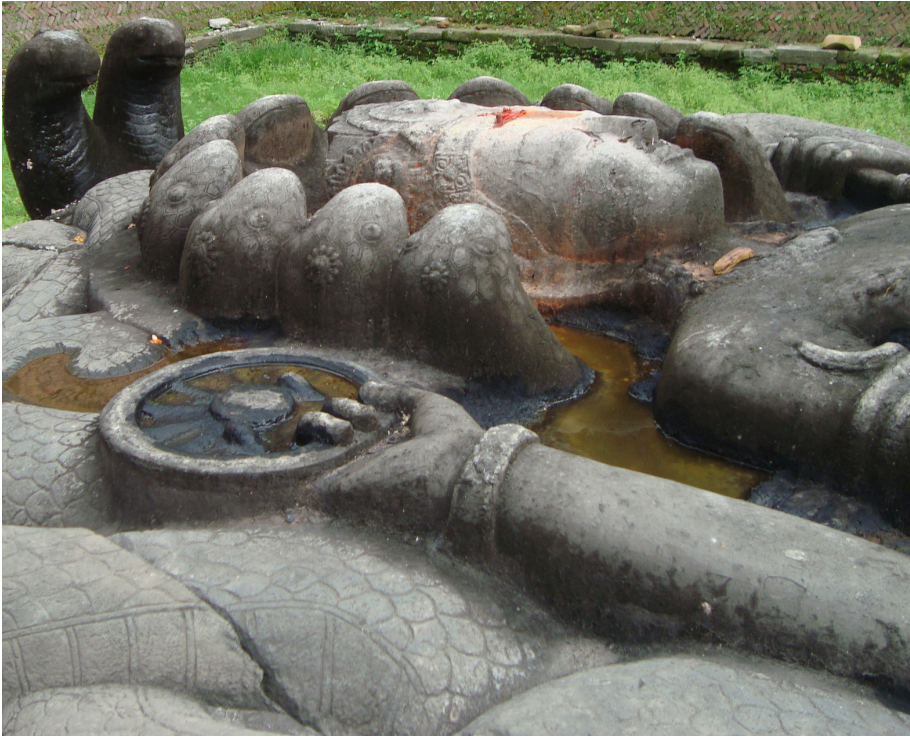
*Right: Many layers of oiling made thickness of dirt on stone surface, which after certain period peeling out from the stone surface. If stone is hard, might not make any damage on stone surface. It will be more of esthetical problem.*

*Bottom left: Top: Photo was taken just after oiling of the main stone image. This is ongoing tradition, might be since few generations or centuries, which is not easy to stop. But certainly due to hard stone this won't make damage in short period. Photo: Jan., 2013.*

*Bottom right: Oiling on top surface washed out quickly by sun and rain, compare to vertical sides. Photo: Jun., 2013.*

Pools of water form on the sculpture after rainfall in few places, which might adds to the damage in the long run. The only way to solve this problem is to make a drill hole to drain water from these areas, but it is not recommended to make any such interventions to the historic image. But of course some one can take out water by some utensils/ jug as a maintenance measure and wipe it out.

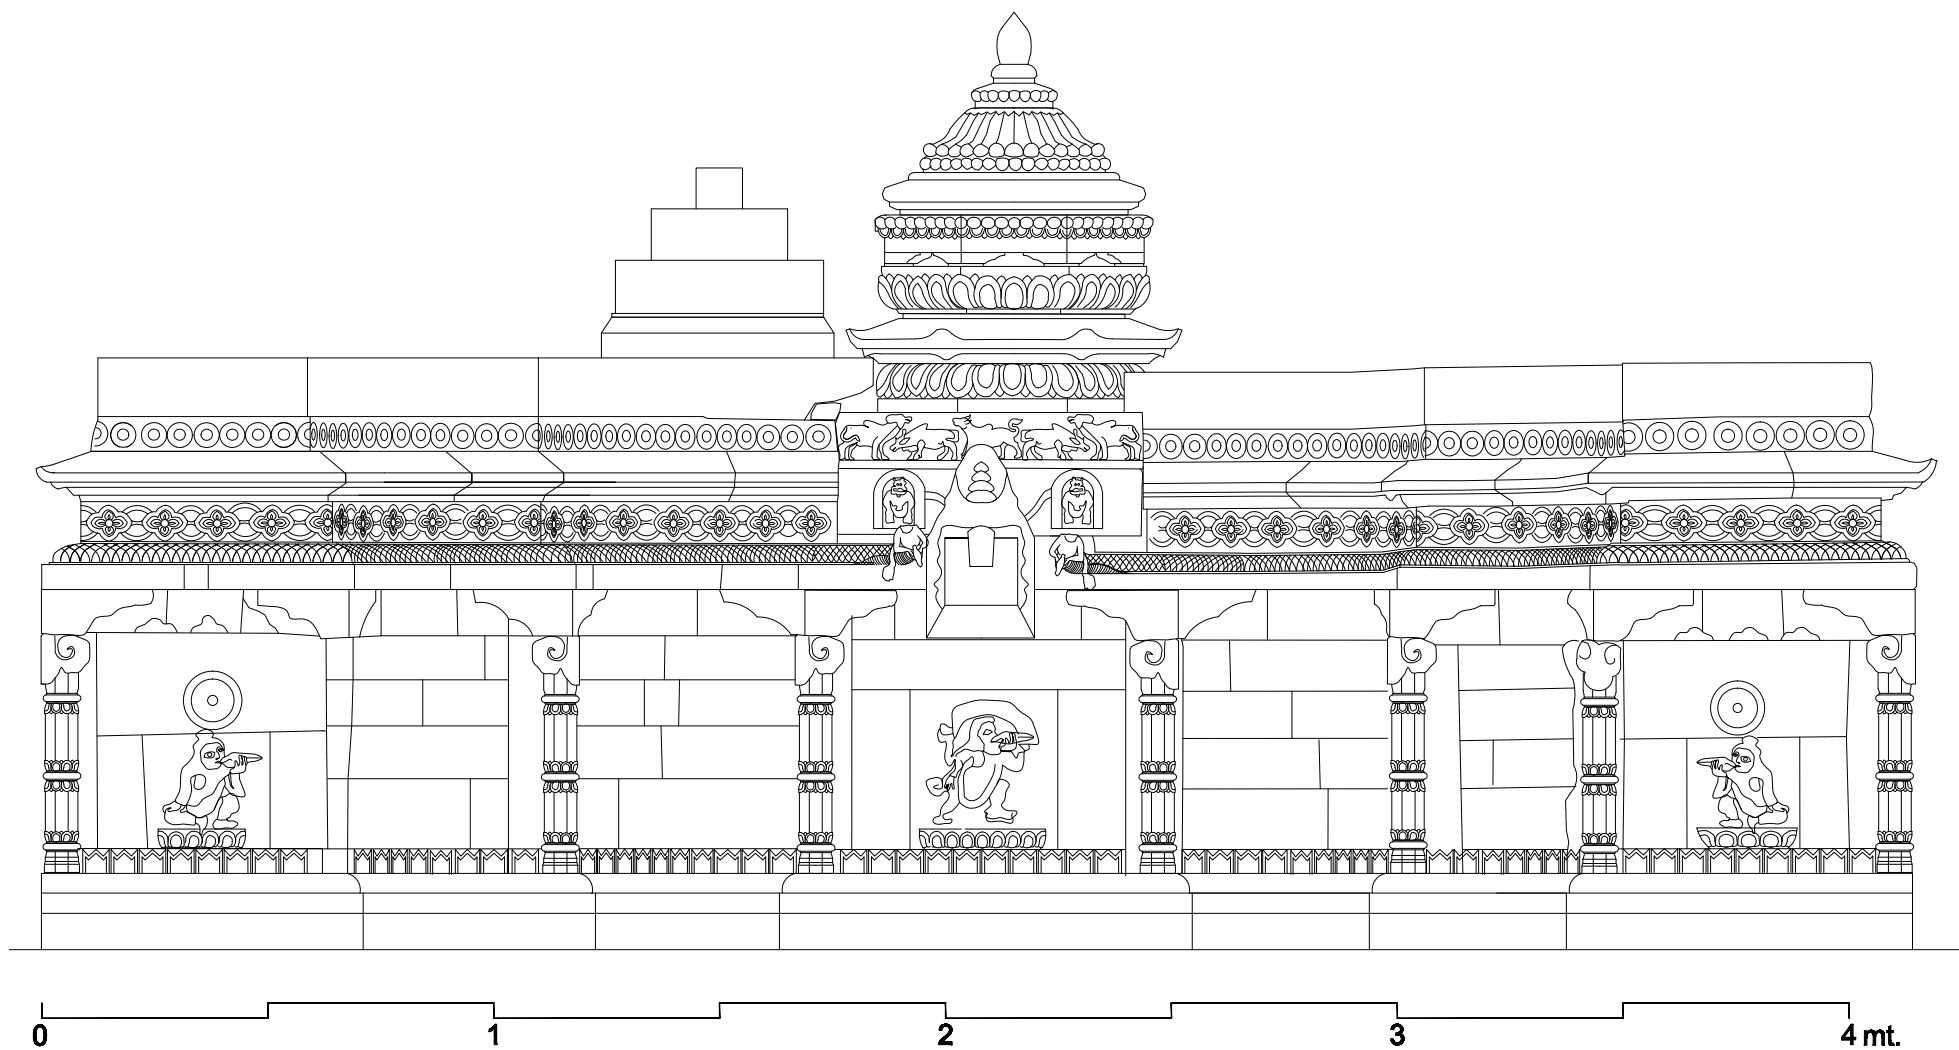
*North Hiti. Existing elevation.*

It is clearly visible from existing elements that some of the sections are missing from the back shrine. There are pin holes for miniature octagonal pillars on the lower base and a large part with capital (*meth*) was just put on top. Even one of the big piece is not in right order. It is recommended to make eight new octagonal pillars to restore the miniature shrine and put back stone pieces in historic configuration.

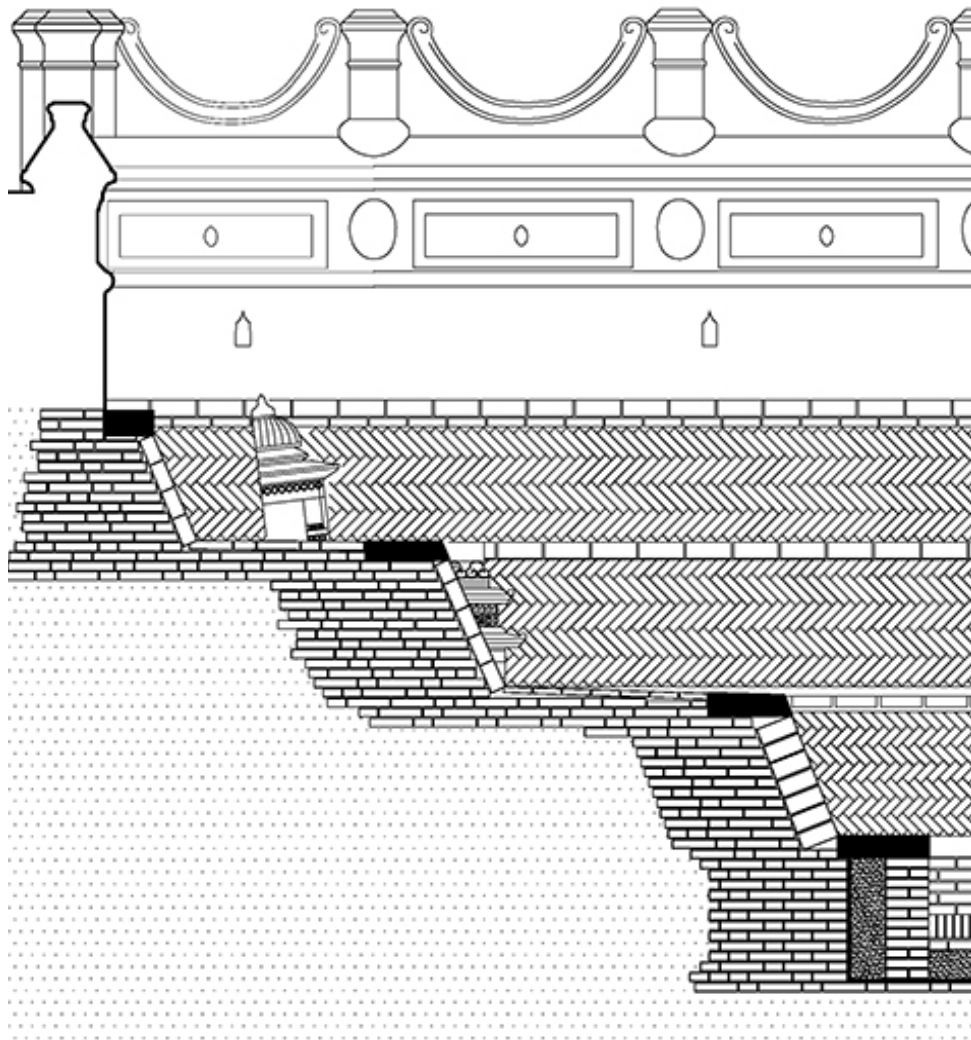
Top right: 2nd level with angled edge brick still intact all around. Photo: Jun. 2013.

Top: Section shows rebuilding of plinth edge with proper angle (in black) on different level. 1st plinth with straight edge stone as most of them are exist, 2nd and 3rd plinth with sloped large edge bricks as existis on 2nd level plinth and top most plinth retain existing with straight angled large brick as exist. Some of unusable bricks can be replced with unused from 3rd level.

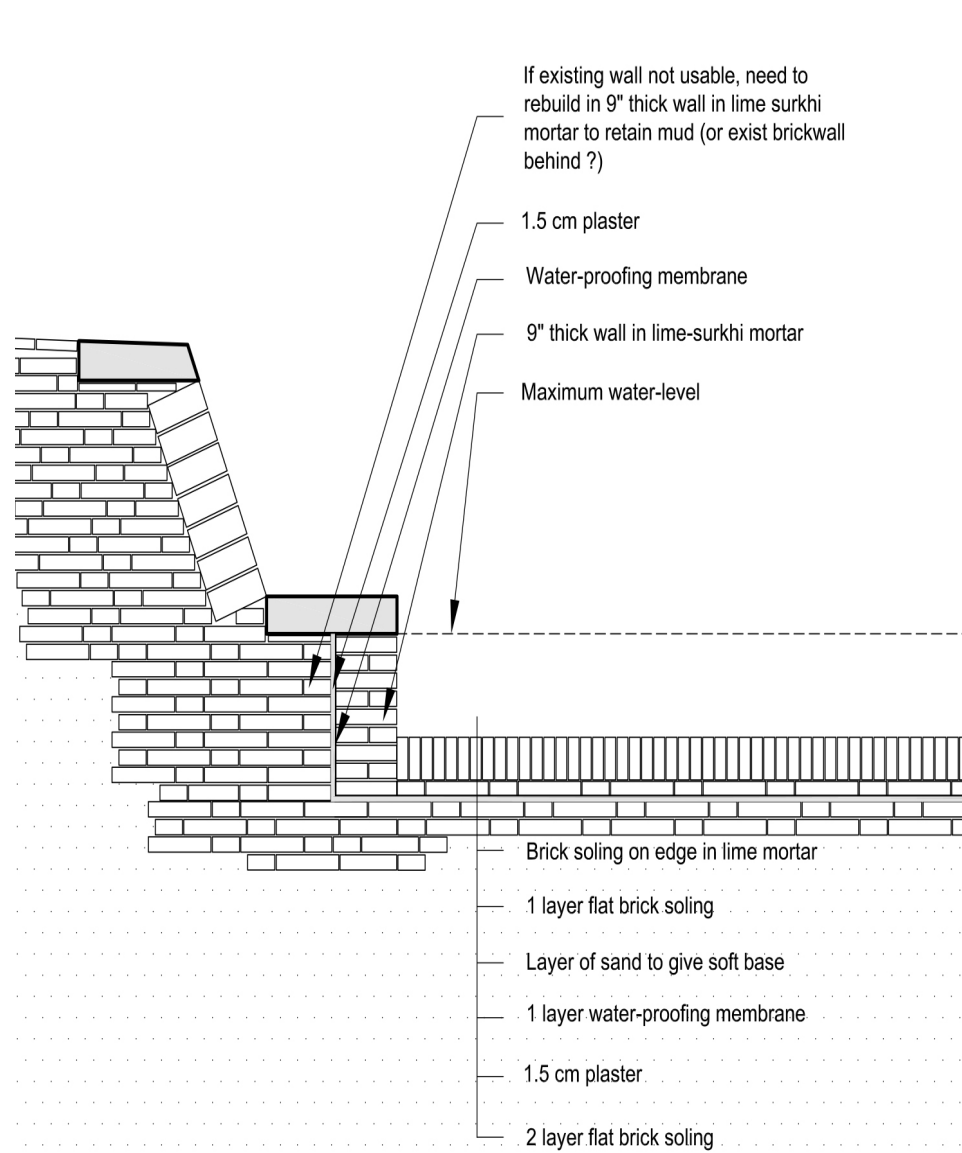
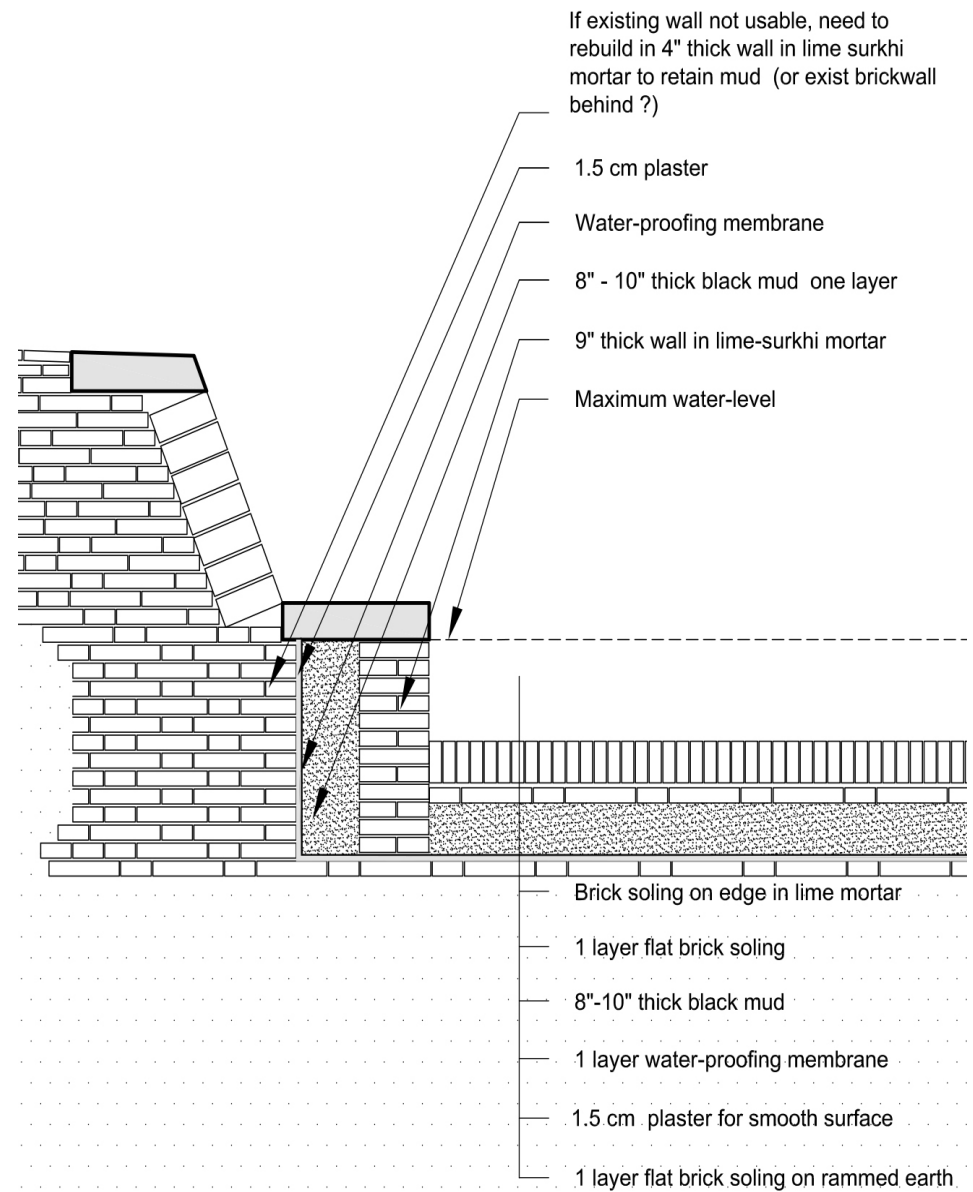
*Proposed typical section thru plinth walls and pond level. First option without thick mud layer, because this pond was not built with such way to prevent water leakage. It was built on place where water table was high. So it is recommendable to keep simple with layer of water proofing membrane to keep water even artificially. This will give good appearance of pond visually and religiously. Second option with thick mud layer.*

Historically, the Bhandarkhal Pond was sealed with black soil on the base and on the walls to protect seepage. This is typical for ponds which were fed by the source through channels. The black soil in Bhandarkhal was damaged in the last few decades. It is recommend to use this traditional technology in the Jalayasan Narayan pond as well, but it is also highly recommend to add an extra layer of waterproofing membrane as back up, in order to retain water in the future.
