# The Jalasayan Narayan Pokhari Restoration

Hanuman Dhoka Durbar Museum Development Committee  
Kathmandu Durbar Square, UNESCO World Heritage Site

Historic Structure Report/ Conservation Notes

July 2013

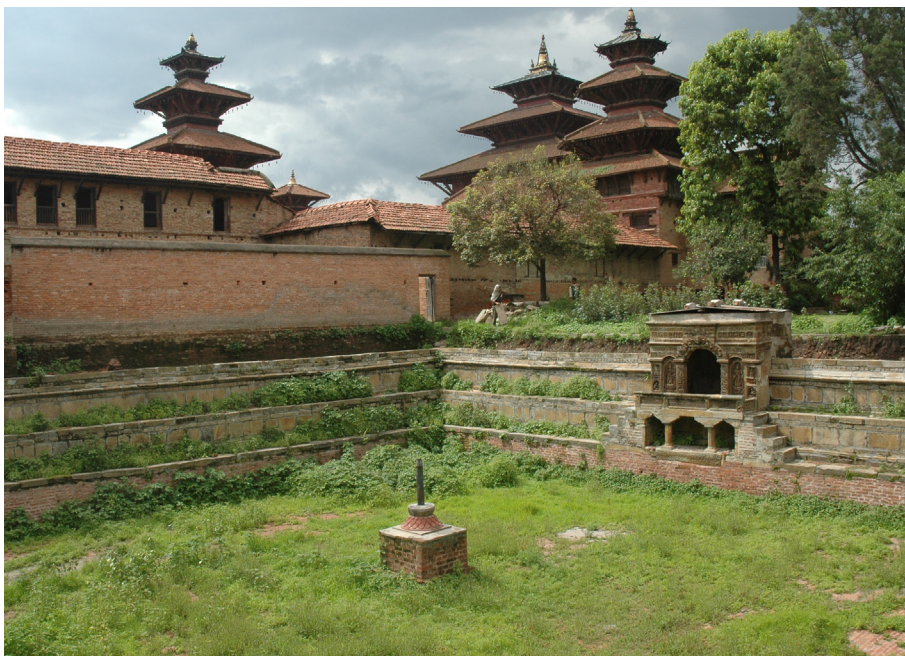
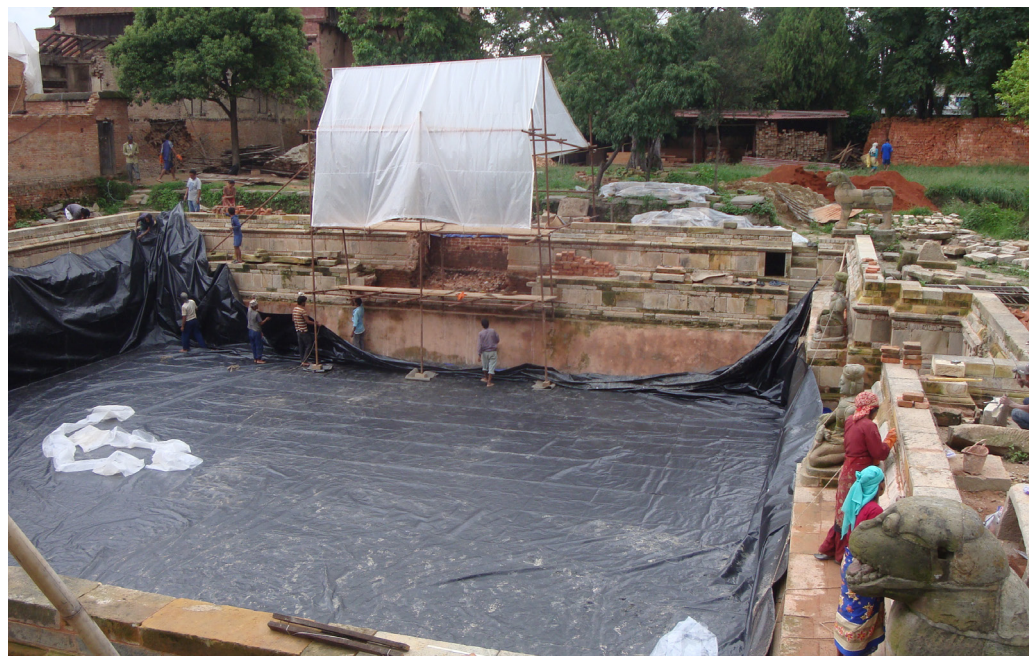
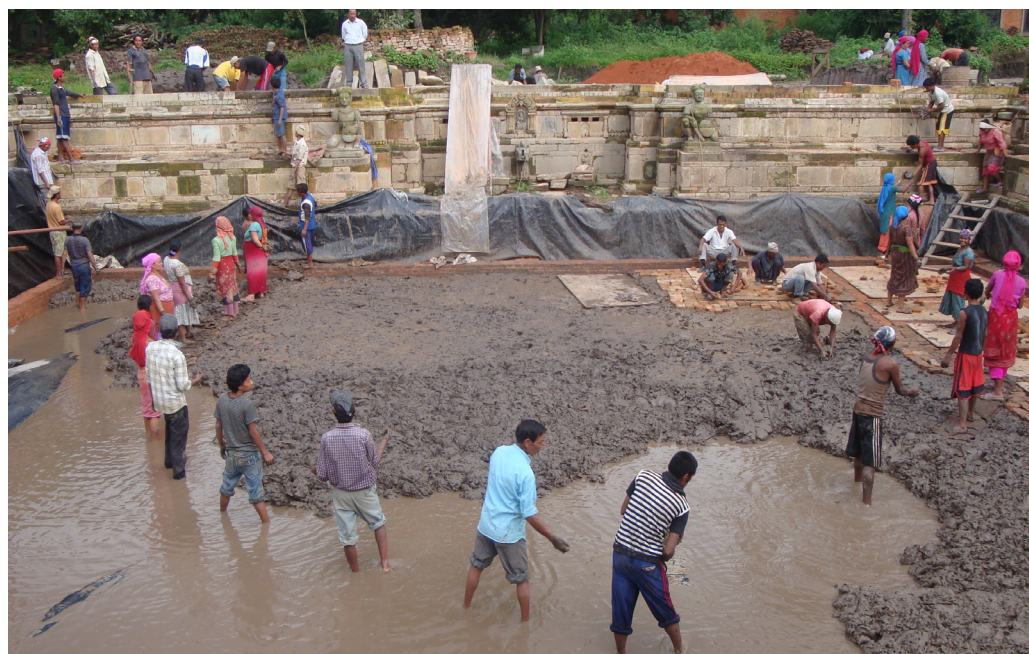
*Bhandarkhal Pond, Patan Palace.*

*Top left: There was no water retained in this pond before the restoration, since part of the traditional black clay waterproofing system had been unknowingly removed during repairs.*

*Top right: One layer of thick plastic sheet was introduced as back up to prevent water leakage after proper foundation and base was built to prevent settlement.*

*Bottom: Black mud was laid (8"-10") above the water proofing membrane.*

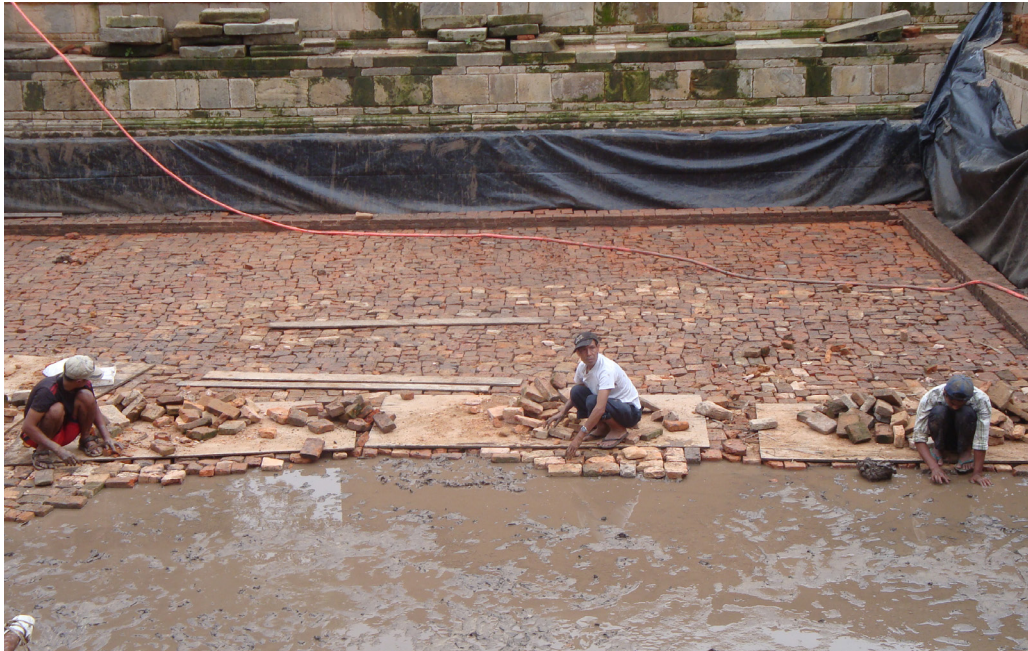
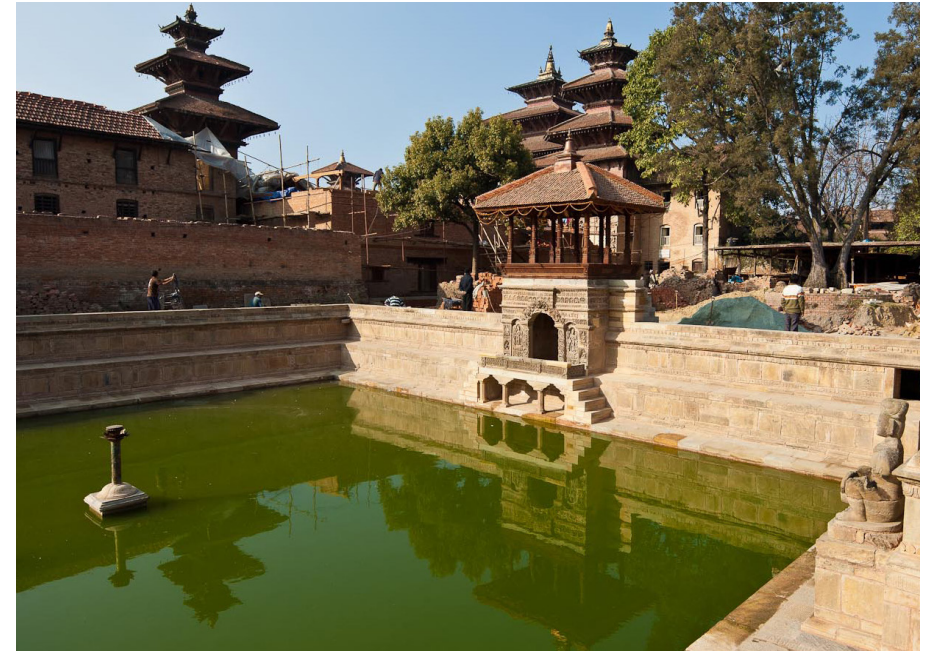
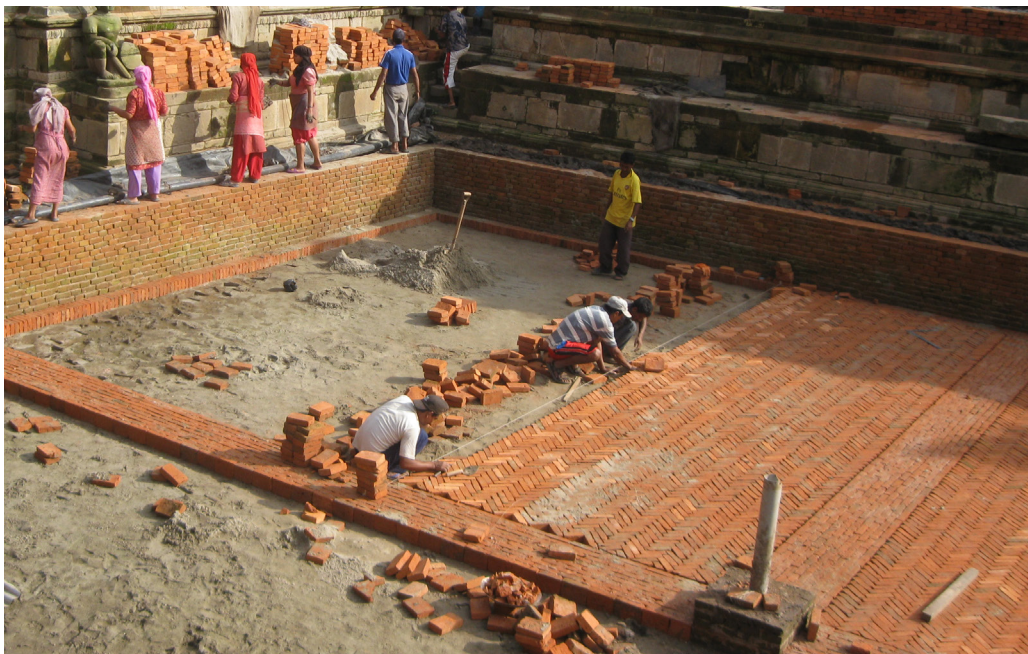
*Top left: One layer of flat brick soling was placed above the mud.  
 Bottom left: On-edge bricks on sand with lime surkhi pointing, were laid out in the historical pattern.  
 Top: After completion.*

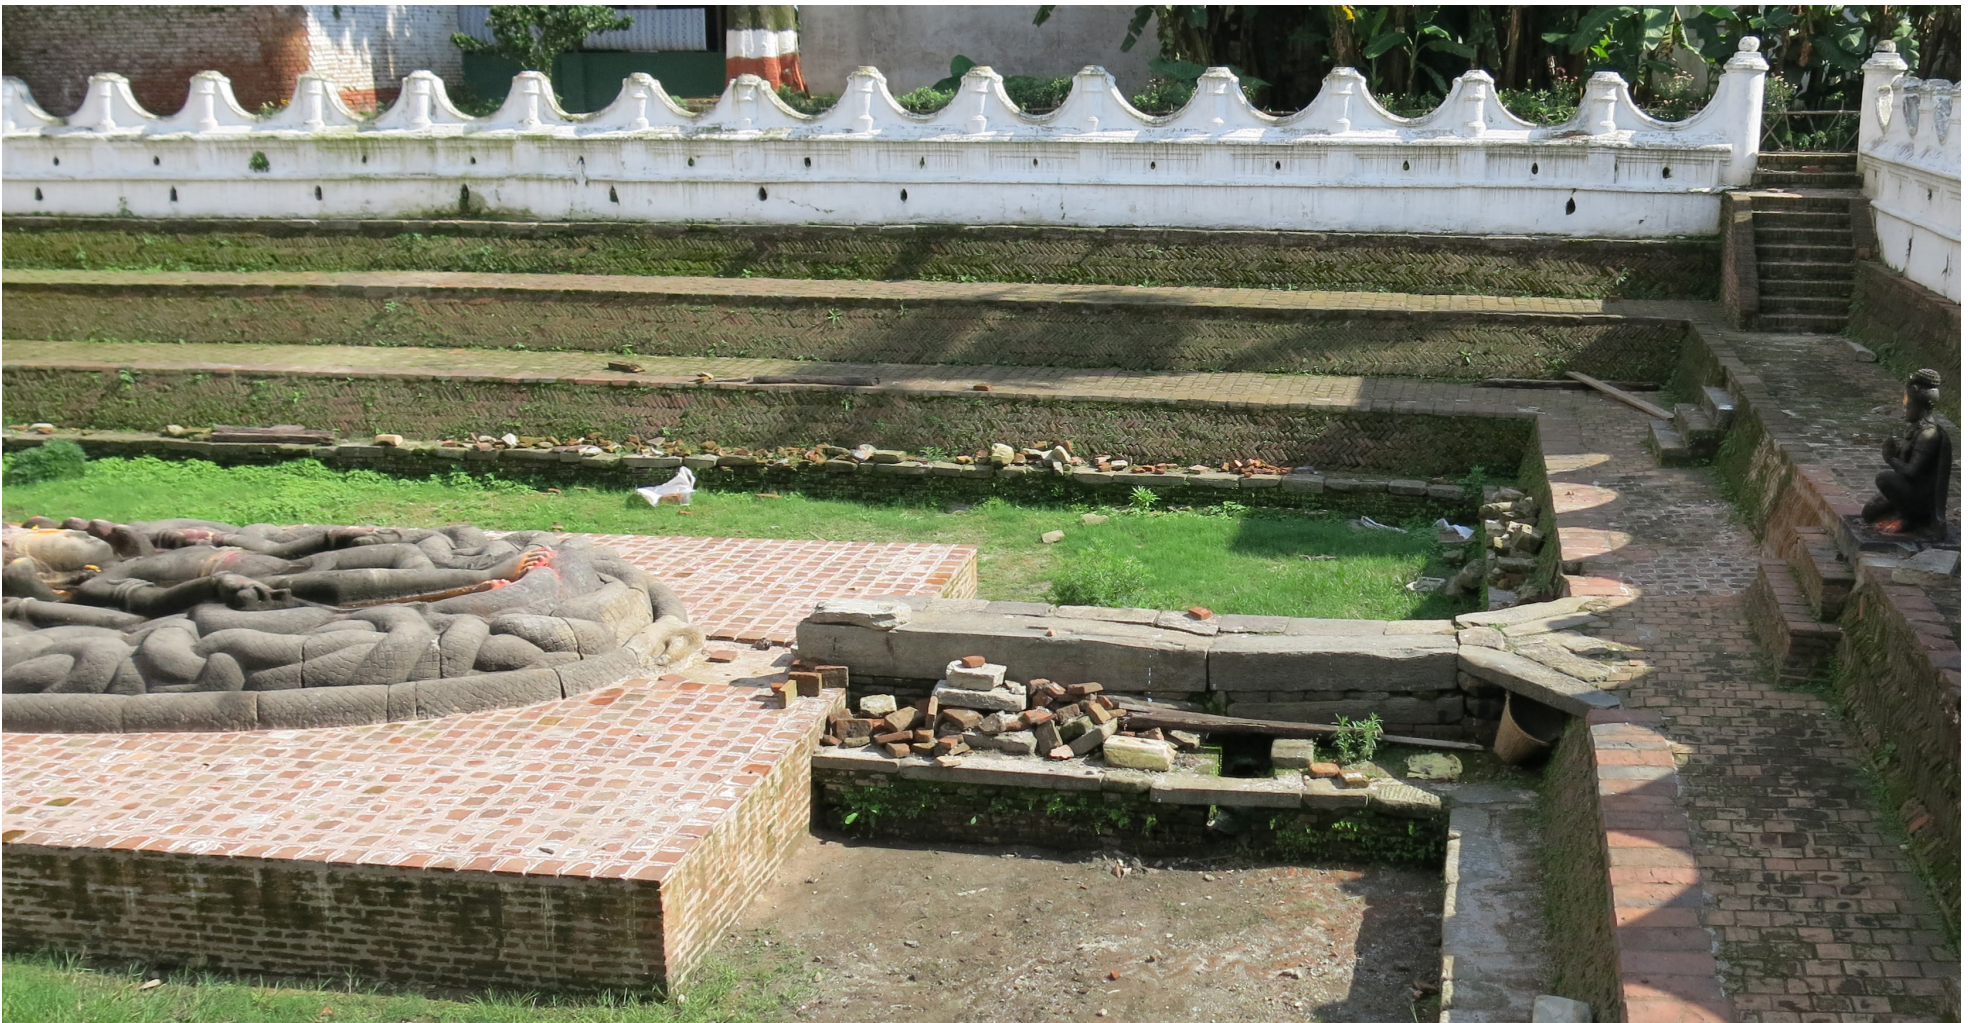
The bridge is about 10" higher than the platform and was built covering the lower part of the snakes on the main shrine. It does not seem that the bridge would have originally covered the snake surface. The bridge should just be built up to the stone edge without overlap. The main bridge level, made of stone, has minor settlement in the middle, which does not need to be leveled.

The height between the bridge and platform is not comfortable for the worshippers, so it is recommended to add one step in stone. The lower step of the bridge is leveled with the lower-most plinth, and will need to be rebuilt to install the waterproofing membrane.
