# RESTORATION OF PATAN ROYAL PALACE COMPLEX

MUL CHOWK, KOT PATI, STONE GATES

**PHASE I - FINAL REPORT**

KATHMANDU VALLEY PRESERVATION TRUST

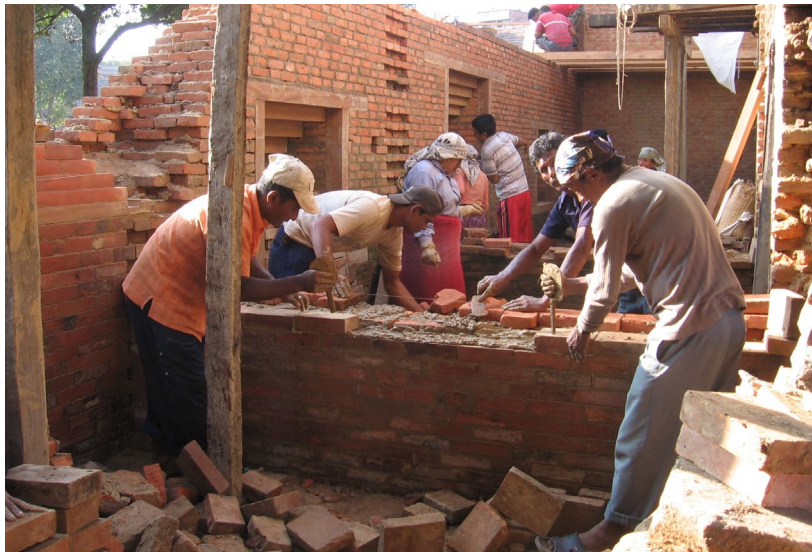
June 2011: Rebuilding the partition wall on the east wing ground floor using traditional *ma-apa* bricks in mud mortar.

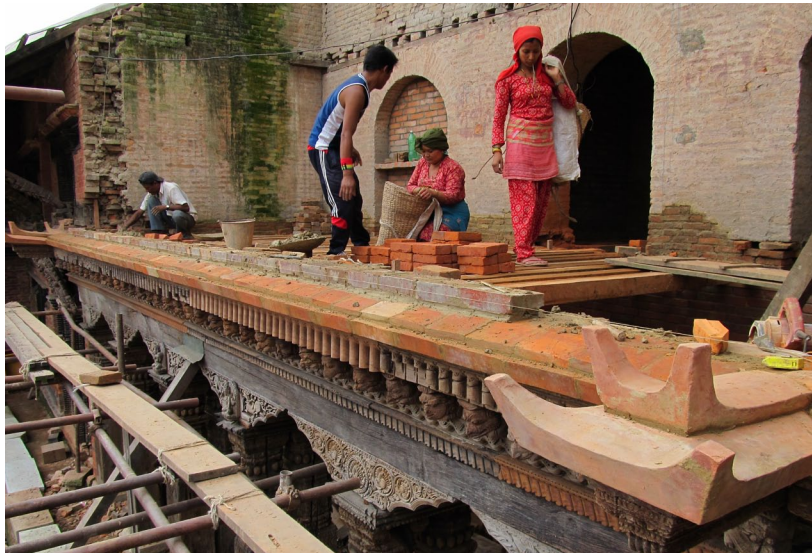
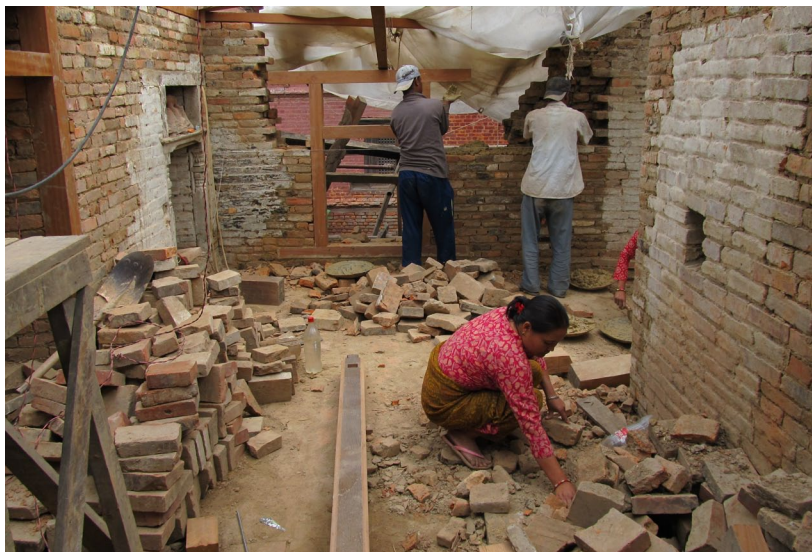
July, August, September 2011: Rebuilding the north wing façade.

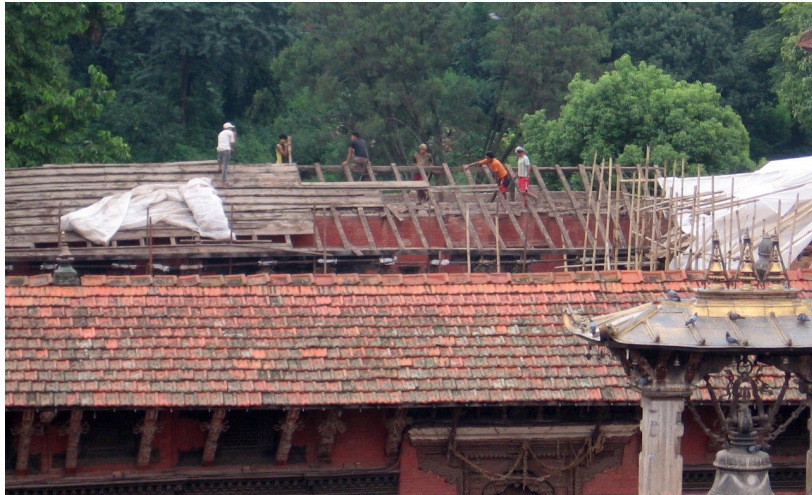
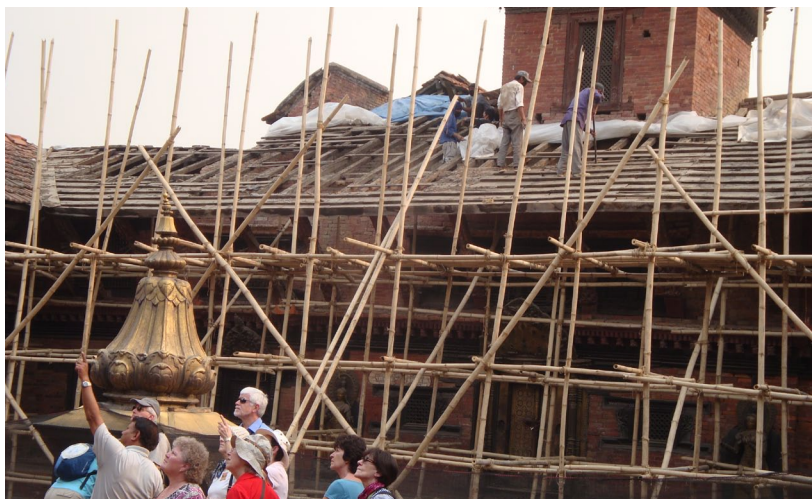
August 2010, March 2010, January 2011:  
Removing the existing roof structure  
from the east, south and north wings.

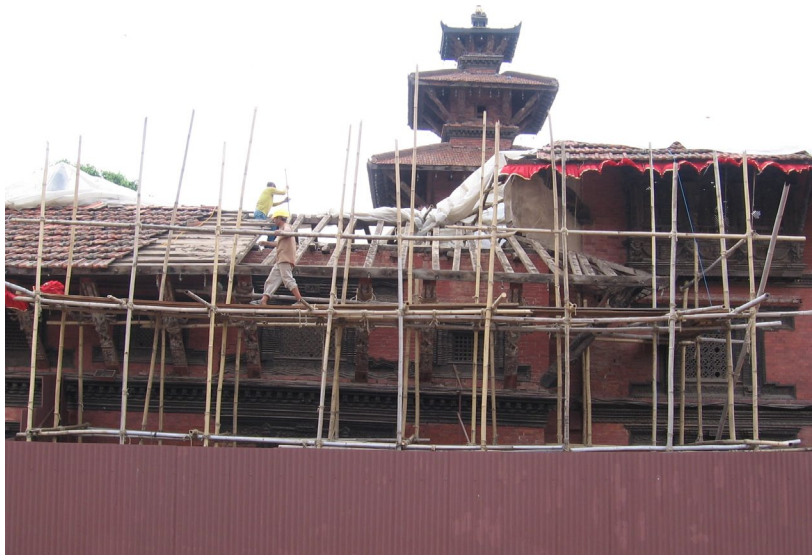
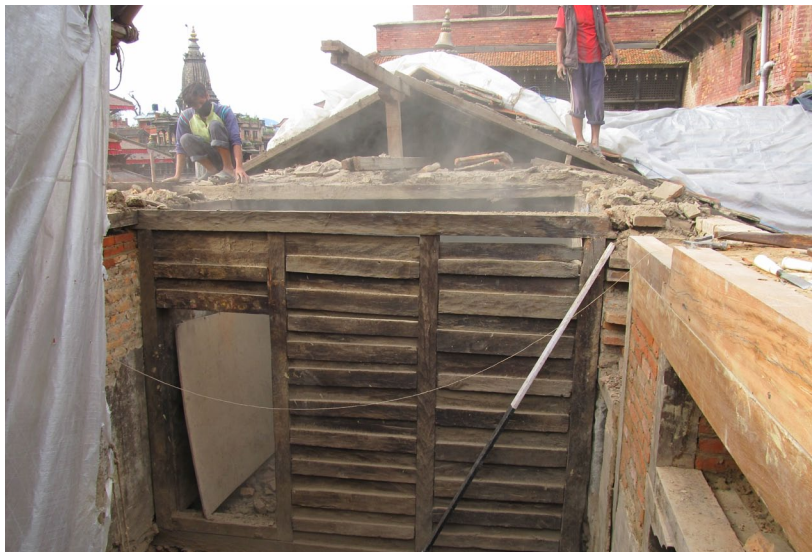
June 2011, August 2011: Removal of roof structure from the west wing.

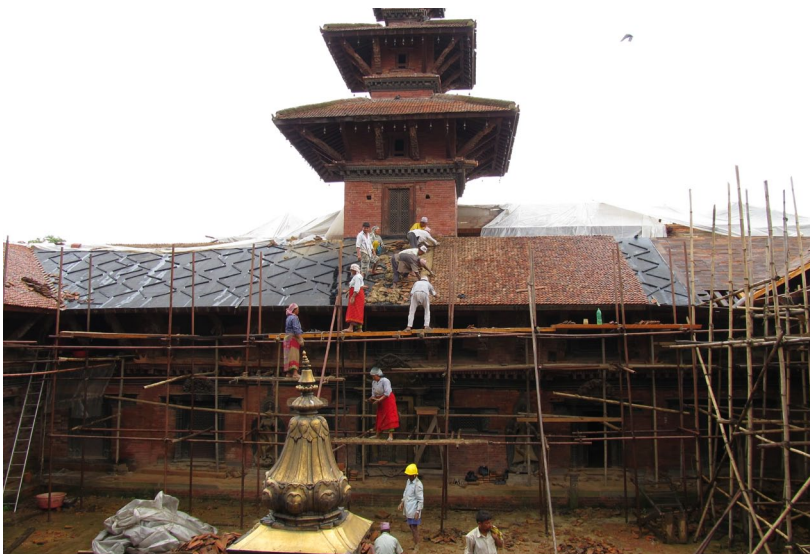
July 2011: Installing *jhingati* roof tiles over a mud-bed on a waterproof membrane.

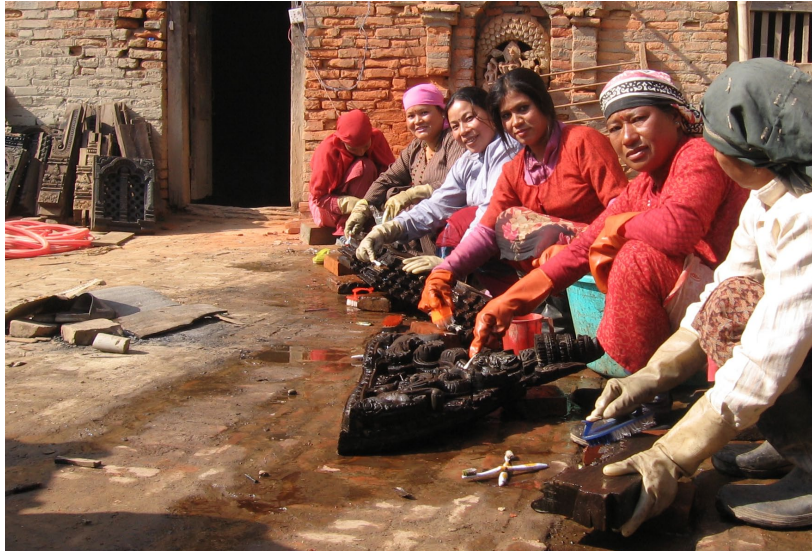
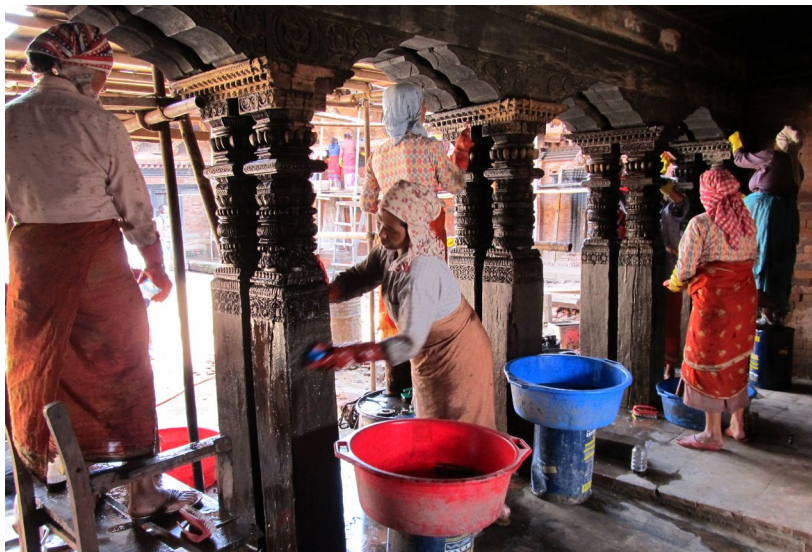
December 2010, September and October 2011: Removing black paint from pillars and cornices using water and caustic soda.

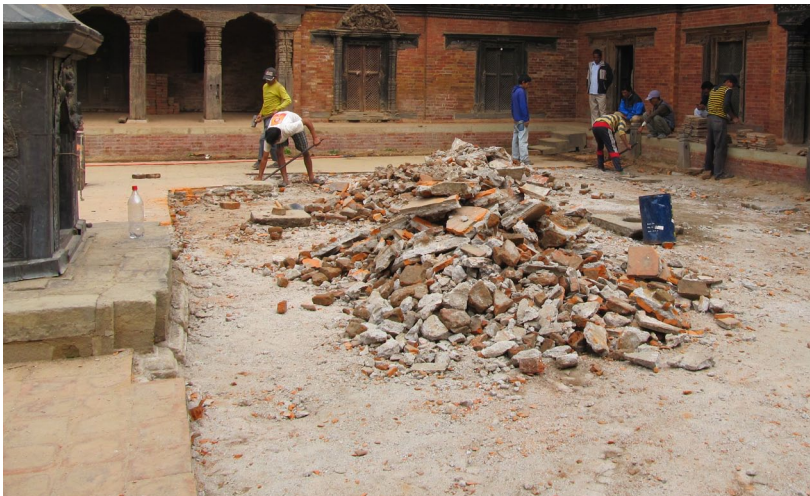
The Mul Chowk courtyard paving was thought to be at the correct level. However, after the removal of the 1972 paving laid in cement mortar, the original on-edge brick paving was found at a historic level 5 inches below. A similar situation was discovered at the three open arcades on the ground floor, where the raised floor levels had caused damage to the historic pillars. This is why all floors were completely rebuilt at the correct level using traditional materials. These unexpected discoveries meant that more time and energy had to be spent on adjusting the level of the courtyard.

January 2012: Courtyard during excavation.

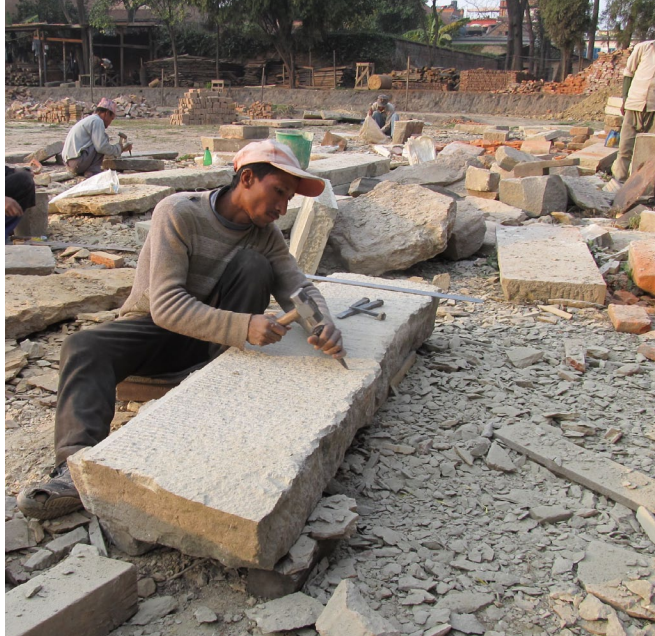
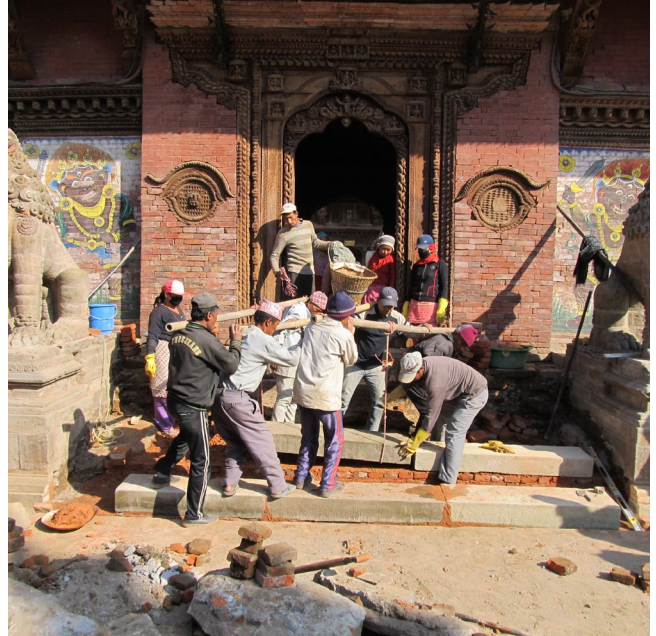
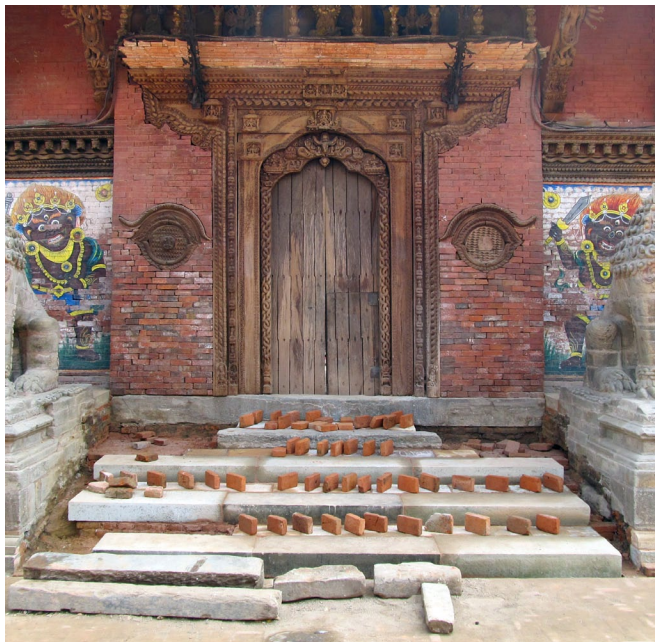
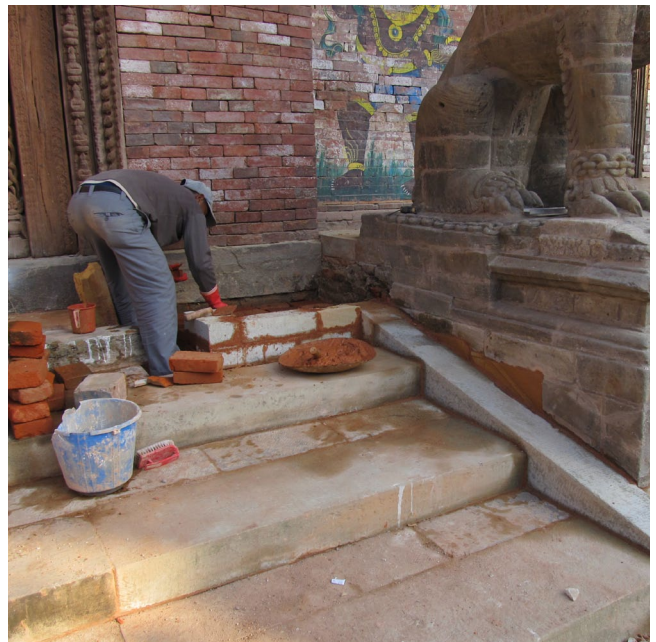
February 2012: Raw step-stones were shaped, sized by chiselling, and carried to the main entrance of Mul Cok for rebuilding and re-setting the entry steps. Unfortunately, not all existing stone pieces were reusable, and some new stones had to be custom cut.

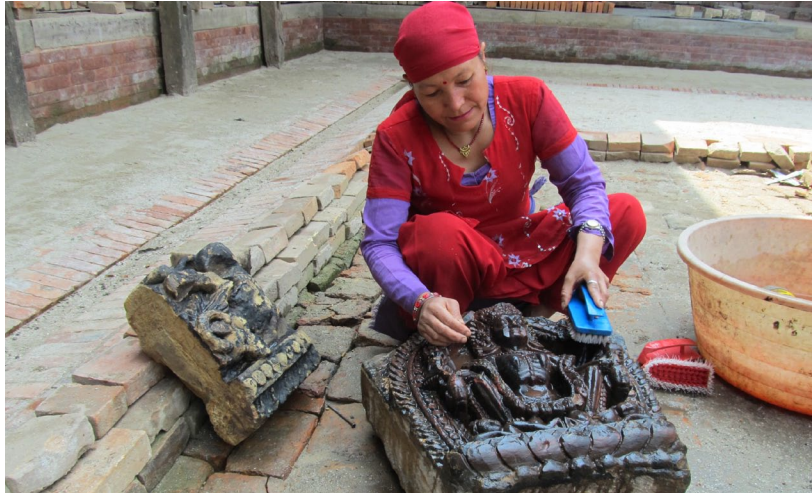
March 2012: Woman cleaning a stone element of the gate using acetone.

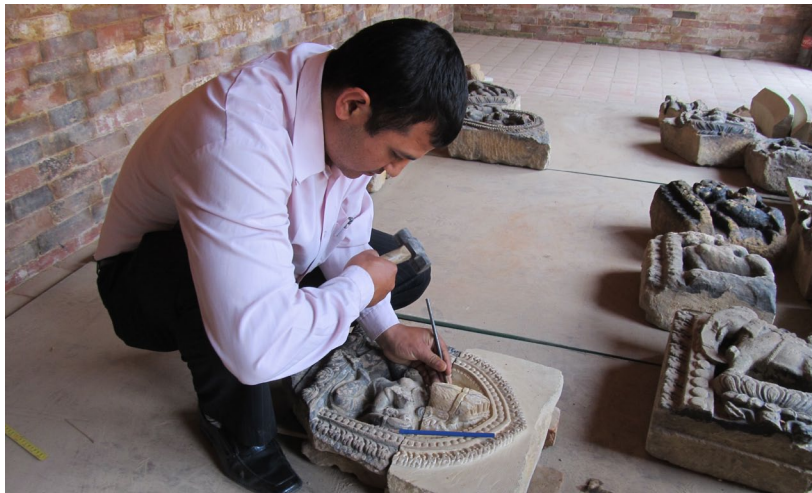
April 2012: Artist carving the missing head of a stone sculpture.

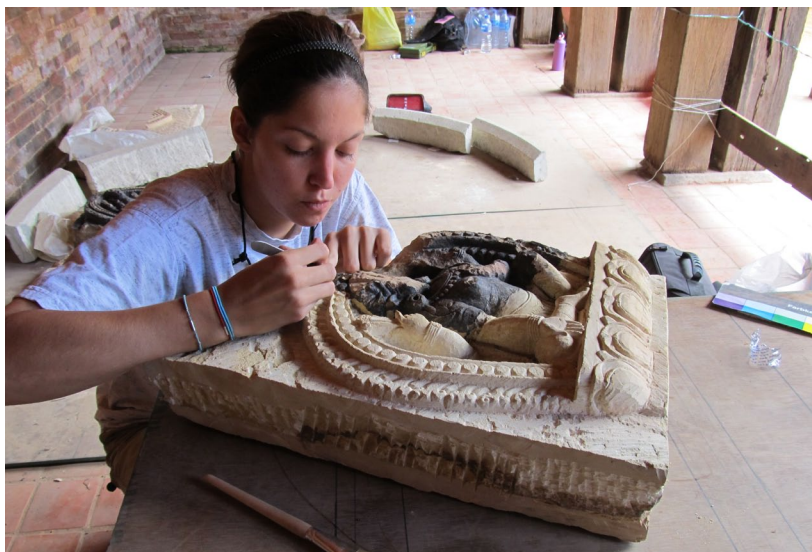
June 2012: An Austrian volunteer cleaning a stone sculpture.

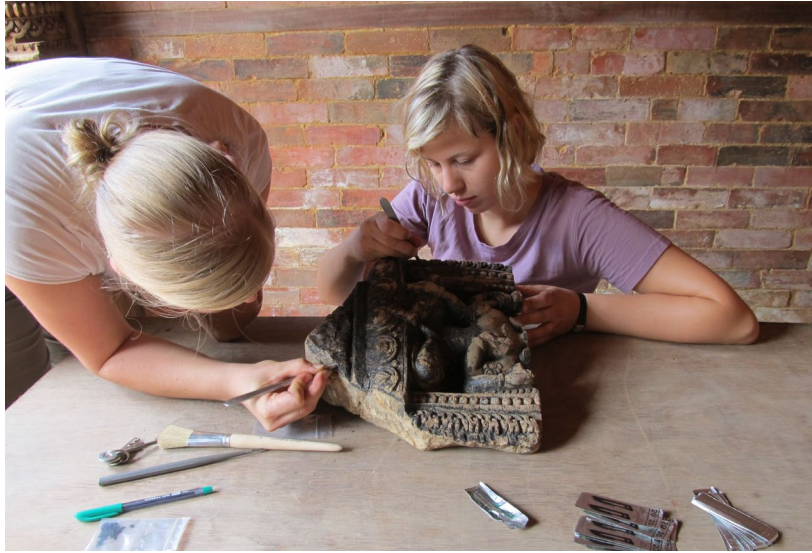
July 2012: Stone sculptures had to be carefully cleaned to preserve the fine relief carvings.

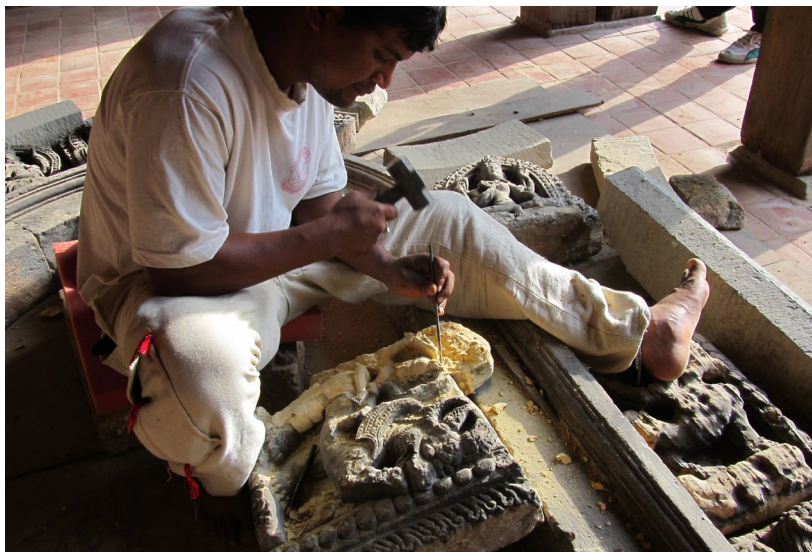
September 2012: Local artist recarving damaged parts of a stone sculpture.
